Rail Accident Investigation Branch

Rail Accident Report

Near miss with track workers and trolleys at South Hampstead, London 11 March 2018

Report 20/2018
December 2018

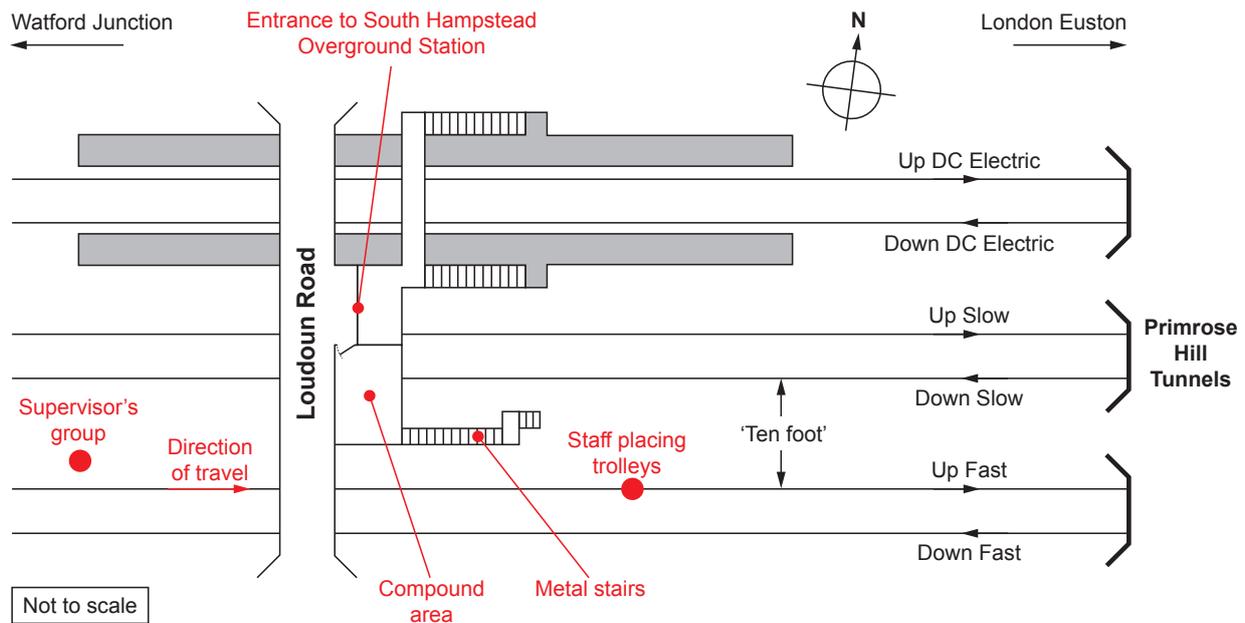
Figure 2: Schematic showing the lines at South Hampstead and the location of the work group at the time of the incident

- 9 There are a total of six running lines in the area (figure 2). In order from northernmost to southernmost they are: the up and down DC electric lines, which are mainly used by London Overground trains; the up and down slow lines; and the up and down fast lines. The up fast line, on which the train was approaching, has a line speed of 80 mph (129 km/h) at the location of the incident reducing to 55 mph (89 km/h) just before the portal of Primrose Hill tunnel, approximately 100 metres to the east.

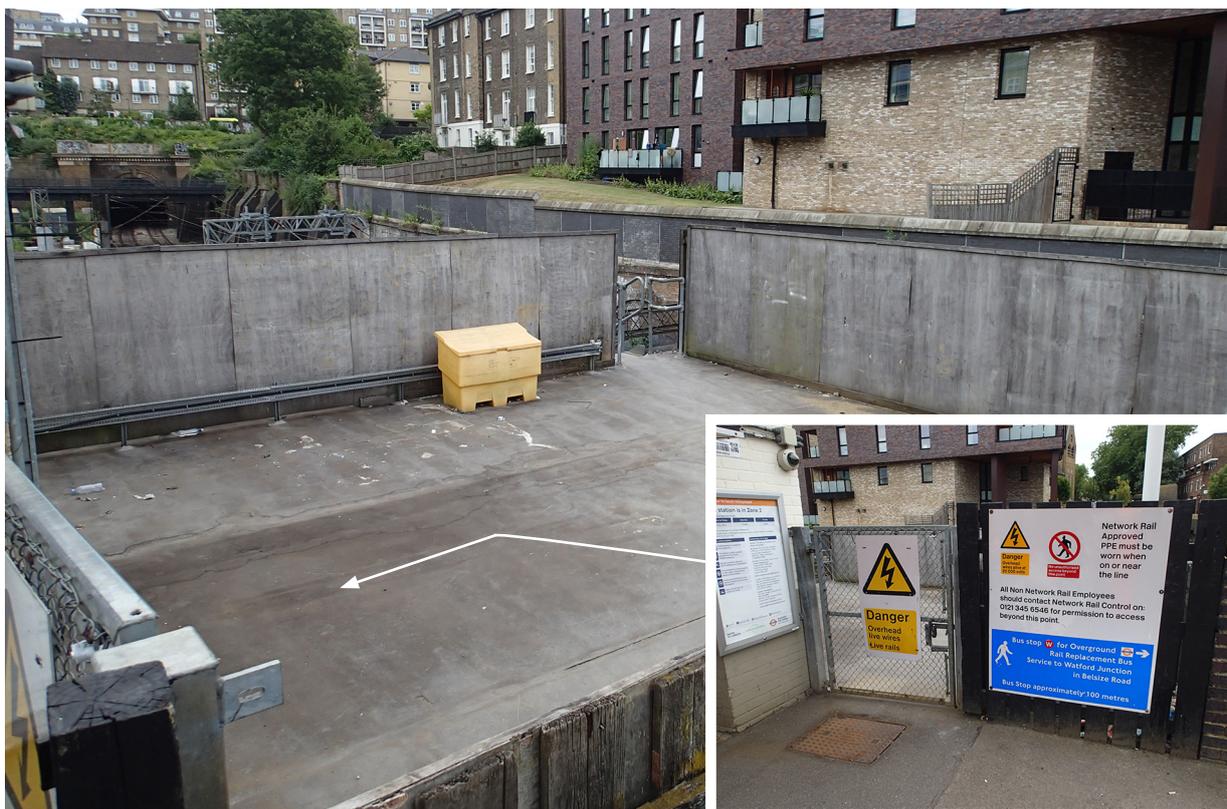
- 10 Directly alongside the station entrance is an access point, entered through a pedestrian gate into a raised compound area above the down slow line (figure 3). A flight of metal stairs leads from the compound to track level. When descending the stairs, the fast lines are to the right, the slow lines to the left. There is a wide space (known as a 'ten-foot') between the fast and slow lines at the bottom of the stairs (figure 4).

Figure 3: View of the compound area from Loudoun Road. (Inset: view of the entrance to the compound, alongside South Hampstead station.)

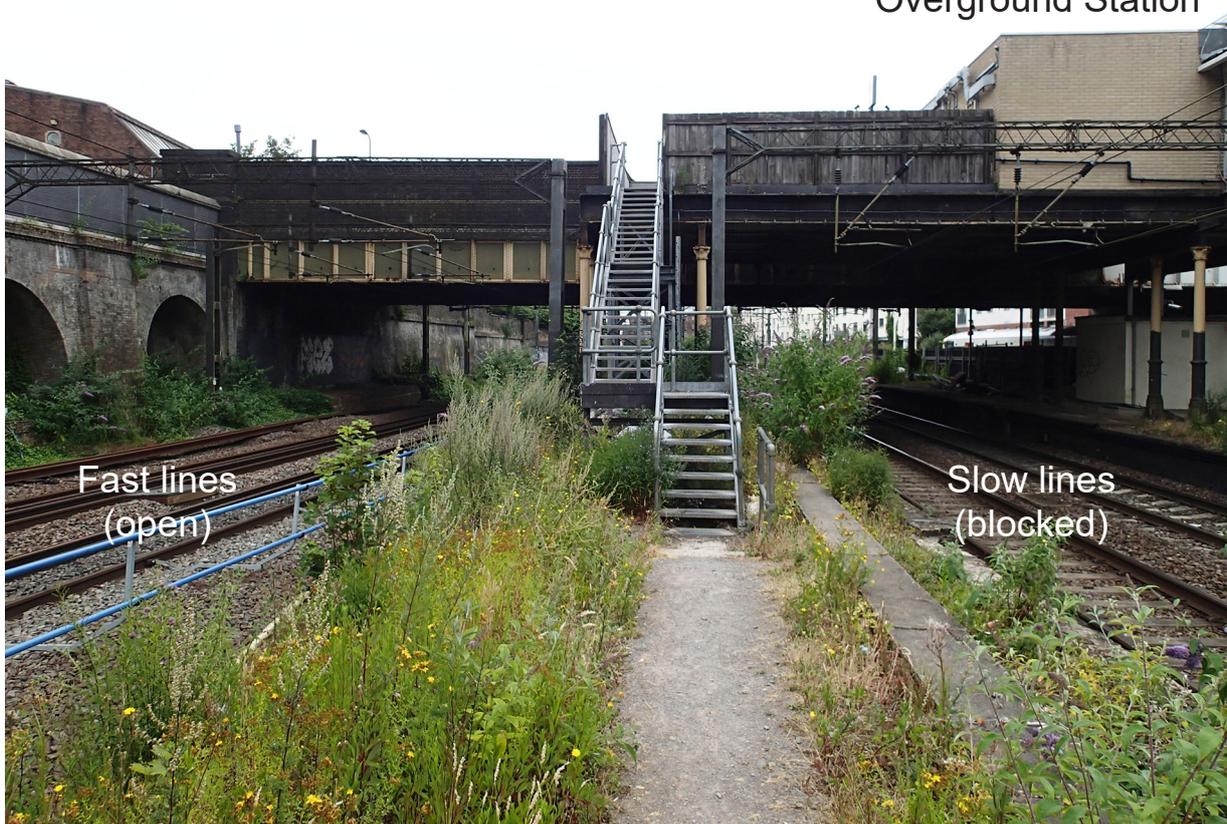
Figure 4: View of the access point stairs from the ten-foot

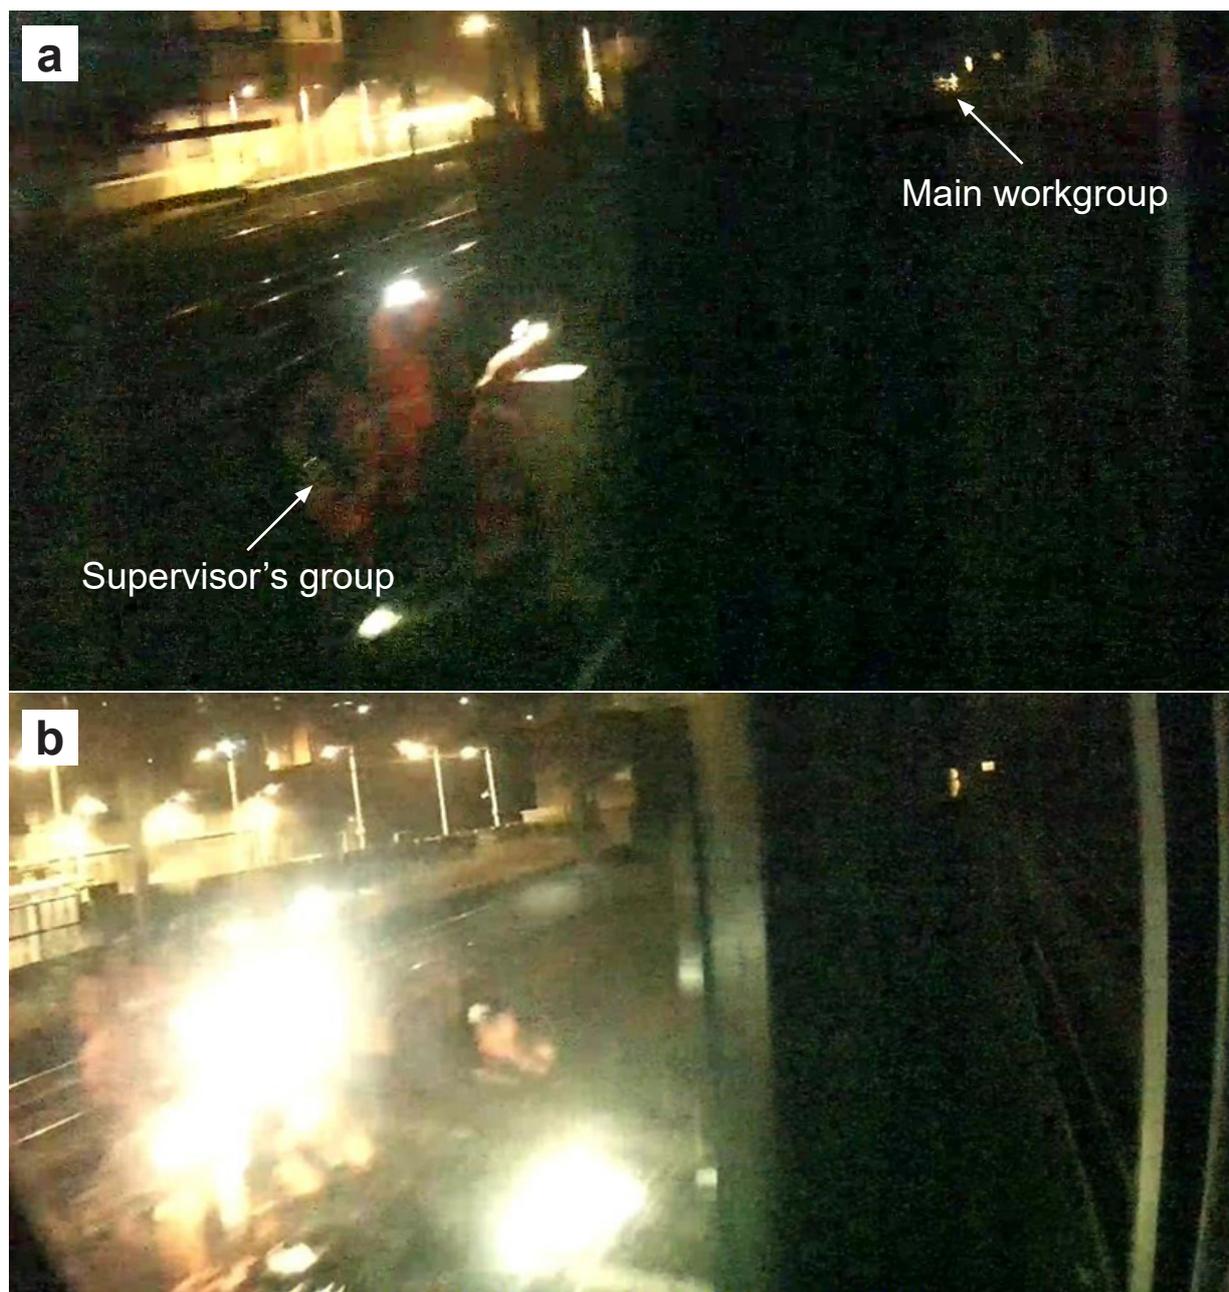
- 54 The train driver saw the supervisor and two staff alongside the line ahead, and then the main work group. He initially sounded the horn continuously for six seconds and then applied full service braking. Forward facing CCTV on the train shows that it passed the supervisor's group five seconds before it reached the main work group.

- 55 The main work group on the track heard the warning from the supervisor and the train horn and managed to remove the two trolley halves and move clear with approximately two seconds to spare. At least two members of the work group were on the up fast line as the train approached.

Figure 5: Forward Facing CCTV image taken a) five seconds before the train reached the main work group and as it was passing the supervisor and two staff; and b) as the train passed the main work group

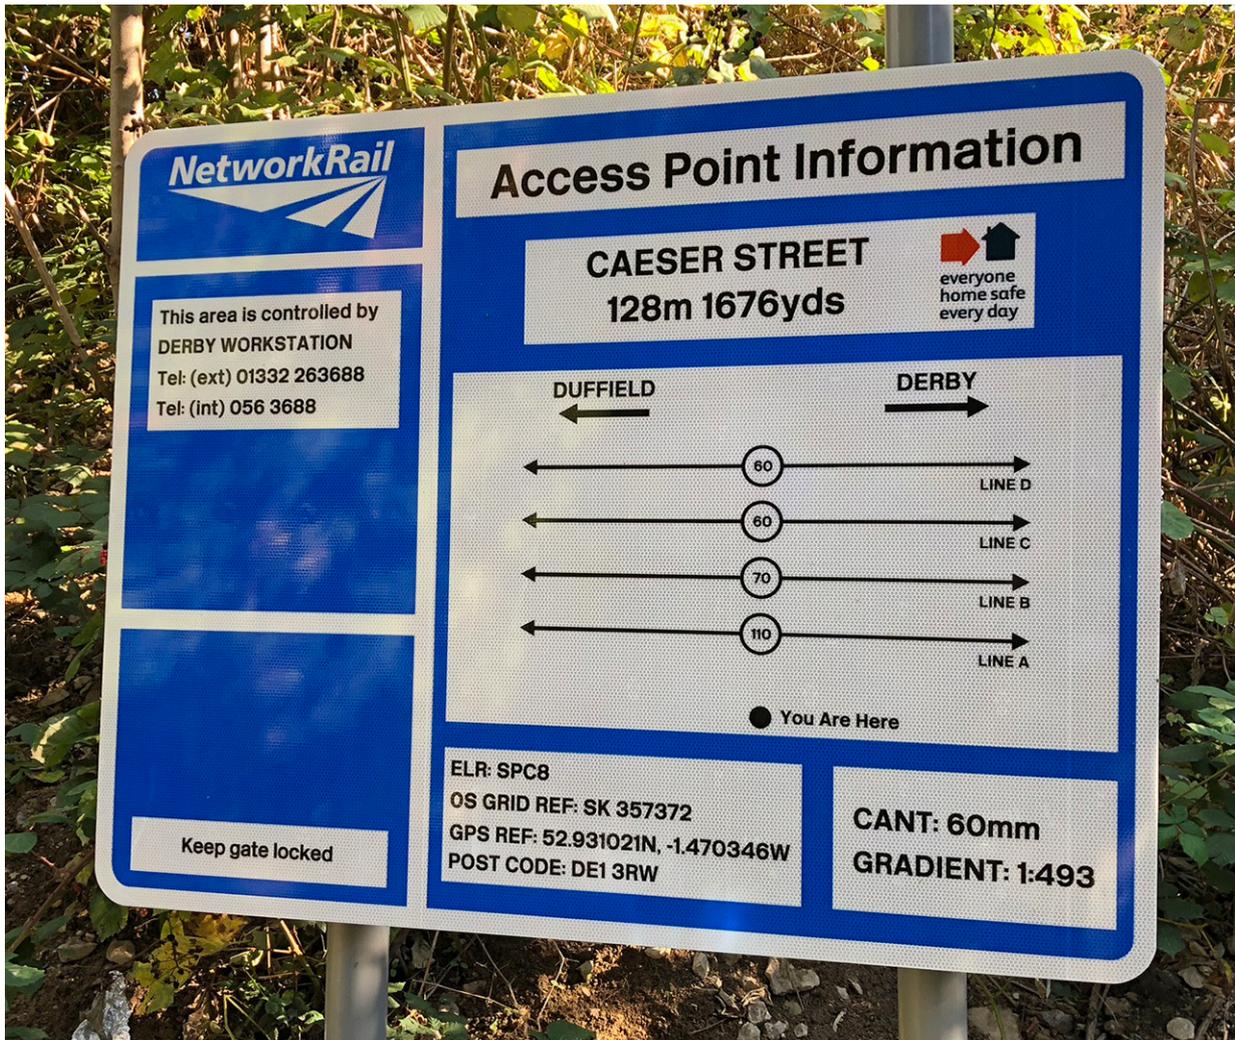
- 76 The staff on site had no visual indication of which lines were which. The RAIB investigation into a collision at Acton West ([RAIB report 15/2009](#)) recommended that Network Rail should provide track layout information at all access points (paragraph 103). Many Network Rail access points now include a sign which shows key information about the access, includes a diagram identifying the lines at the site and indicates where the reader is in relation to those lines (figure 6). If this signage had been available at South Hampstead, it is probable that the COSS and supervisor would have used it check the identity of the lines.

Figure 6: Example of Network Rail access point signage

77 There was no access point signage because this access point did not appear in the National Hazard Directory. This document contains details of hazards on the railway infrastructure, as well as the locations of authorised access points. The South Hampstead access point was well known and frequently used by local staff, and provided the only access to equipment rooms near the Primrose Hill tunnels. Network Rail has reported to the RAIB that the omission of this access point from the National Hazard Directory was due to an oversight that it was unaware of.

- amend its National Hazard Directory to include the access point alongside South Hampstead station; and
- provide access point signage to clearly identify each running line to staff using the access point.
