Failure of a throw bag rescue line during a capsized drill on an unnamed rowing boat Widnes, UK 24 March 2018

SUMMARY

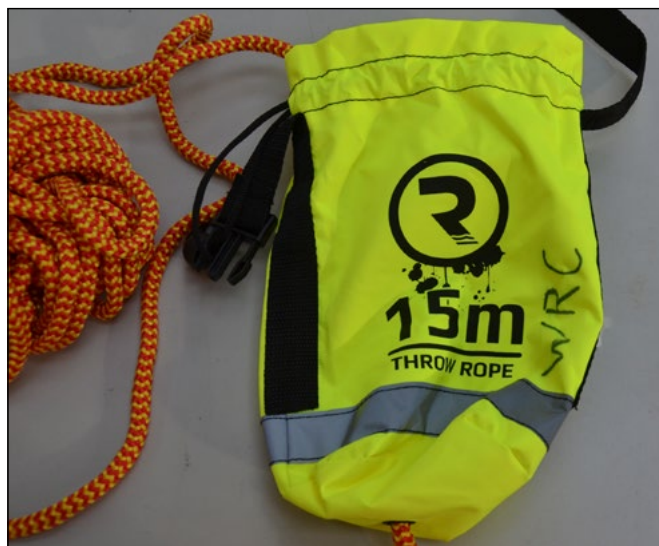
Figure 1: RIBER throw bag

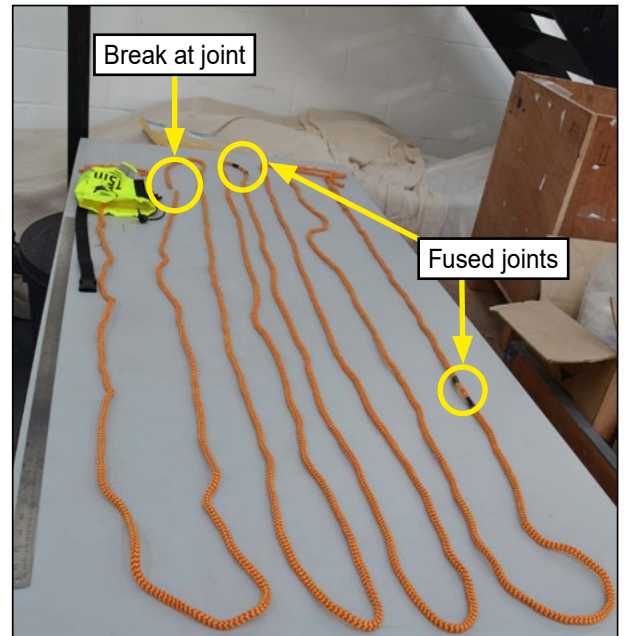
On close examination of the parted line, the safety advisor of the club identified that there were two joints in the line, one of which had parted. On checking four more throw bags that also belonged to the club, he found another rescue line with three joints (**Figure 2**). He promptly notified the manufacturer of the throw bag, Riber Products Limited (RIBER), and the national governing body for rowing in the UK, British Rowing. RIBER published news of the failed rescue lines on Facebook. British Rowing published a notice that included RIBER's Facebook notification in its March newsletter. RIBER identified two batches, totalling 471 throw bags, which potentially had the same problem and contacted its customers directly or through retailers. In response to the customer notification campaign, eight further defective throw bags were identified. In June 2018, the MAIB published a safety bulletin to disseminate the lessons learned from this incident and to seek information about similar incidents¹.

Figure 2: 15m rescue line with three joints

The throw bag rescue line that failed during the capsize drill conducted by WRC was made up of four pieces of rope thermally fused together. The laboratory test established that the joints could withstand only a twelfth of the load sustainable by an intact section of the line. It was therefore inevitable that the line would fail when a small load was applied to it during the drill.

- Introduced batch and serial numbers to uniquely identify its throw bags.
- Instructed its canoe suppliers to inspect each throw bag before dispatching them to the UK.
- Implemented a policy to inspect a randomly selected 10% of its throw bags imported into the UK.
