**ACCIDENT**

<b>Aircraft Type and Registration:</b>	Slingsby T61F Venture T Mk 2, G-BUGT	
<b>No &amp; Type of Engines:</b>	1 Rollason RS MK 2 piston engine	
<b>Year of Manufacture:</b>	1977 (Serial no: 1871)	
<b>Date &amp; Time (UTC):</b>	9 December 2018 at 1335 hrs	
<b>Location:</b>	Field near Rufforth Airfield, York	
<b>Type of Flight:</b>	Private	
<b>Persons on Board:</b>	Crew - 1	Passengers - None
<b>Injuries:</b>	Crew - None	Passengers - N/A
<b>Nature of Damage:</b>	Wings twisted and broken. One propeller blade damaged, minor damage to rear fuselage	
<b>Commander's Licence:</b>	National Private Pilot's Licence	
<b>Commander's Age:</b>	44 years	
<b>Commander's Flying Experience:</b>	106 hours (of which 80 were on type) Last 90 days - 10 hours Last 28 days - 2 hours	
<b>Information Source:</b>	Aircraft Accident Report Form submitted by the pilot and aircraft inspection report

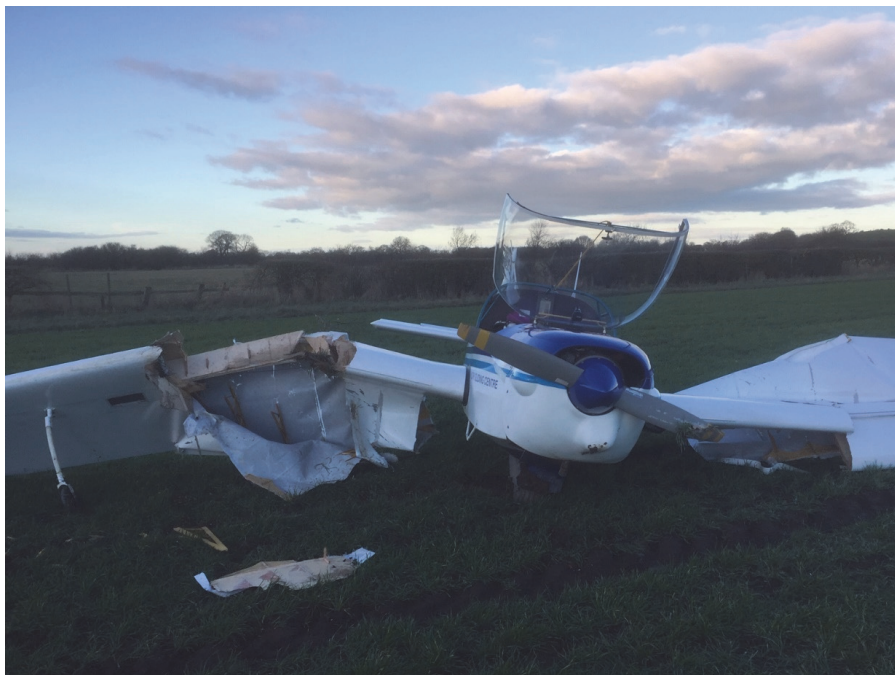
**Figure 2**

G-BUGT's departure from Runway 35 was delayed because the runway was occupied, and the pilot applied carburettor heat while waiting. When the runway was clear, the pilot lined up and applied full throttle without stopping. At approximately 150 to 200 ft, the pilot felt a complete loss of power and executed a forced landing. The aircraft touched down close to the field boundary (Figure 1). The pilot "attempted a hop" through a gap but the wings struck bushes (Figure 2). After stopping, the pilot noticed that the carburettor heat was still selected ON.

Inspection of the aircraft engine and associated systems revealed no faults which would explain the power loss. Tests of carburettor heat effectiveness on two other Slingsby Ventures indicated that full carburettor heat resulted in a drop of up to 600 rpm, and extended use in flight resulted in rough running and climb was not possible. The tests did not replicate a total loss of power. Full power was always restored when the carburettor heat was returned to cold.

G-BUGT after the accident

The pilot commented that he should have repeated the pre-takeoff checks immediately before takeoff, which would have revealed that the carburettor heat was on. Checking the rpm achieved during the takeoff roll may help to identify an engine that is not performing as required.
