Report on the investigation of the contact
and grounding of the ro-ro passenger ferry

Pride of Kent

Calais, France

10 December 2017

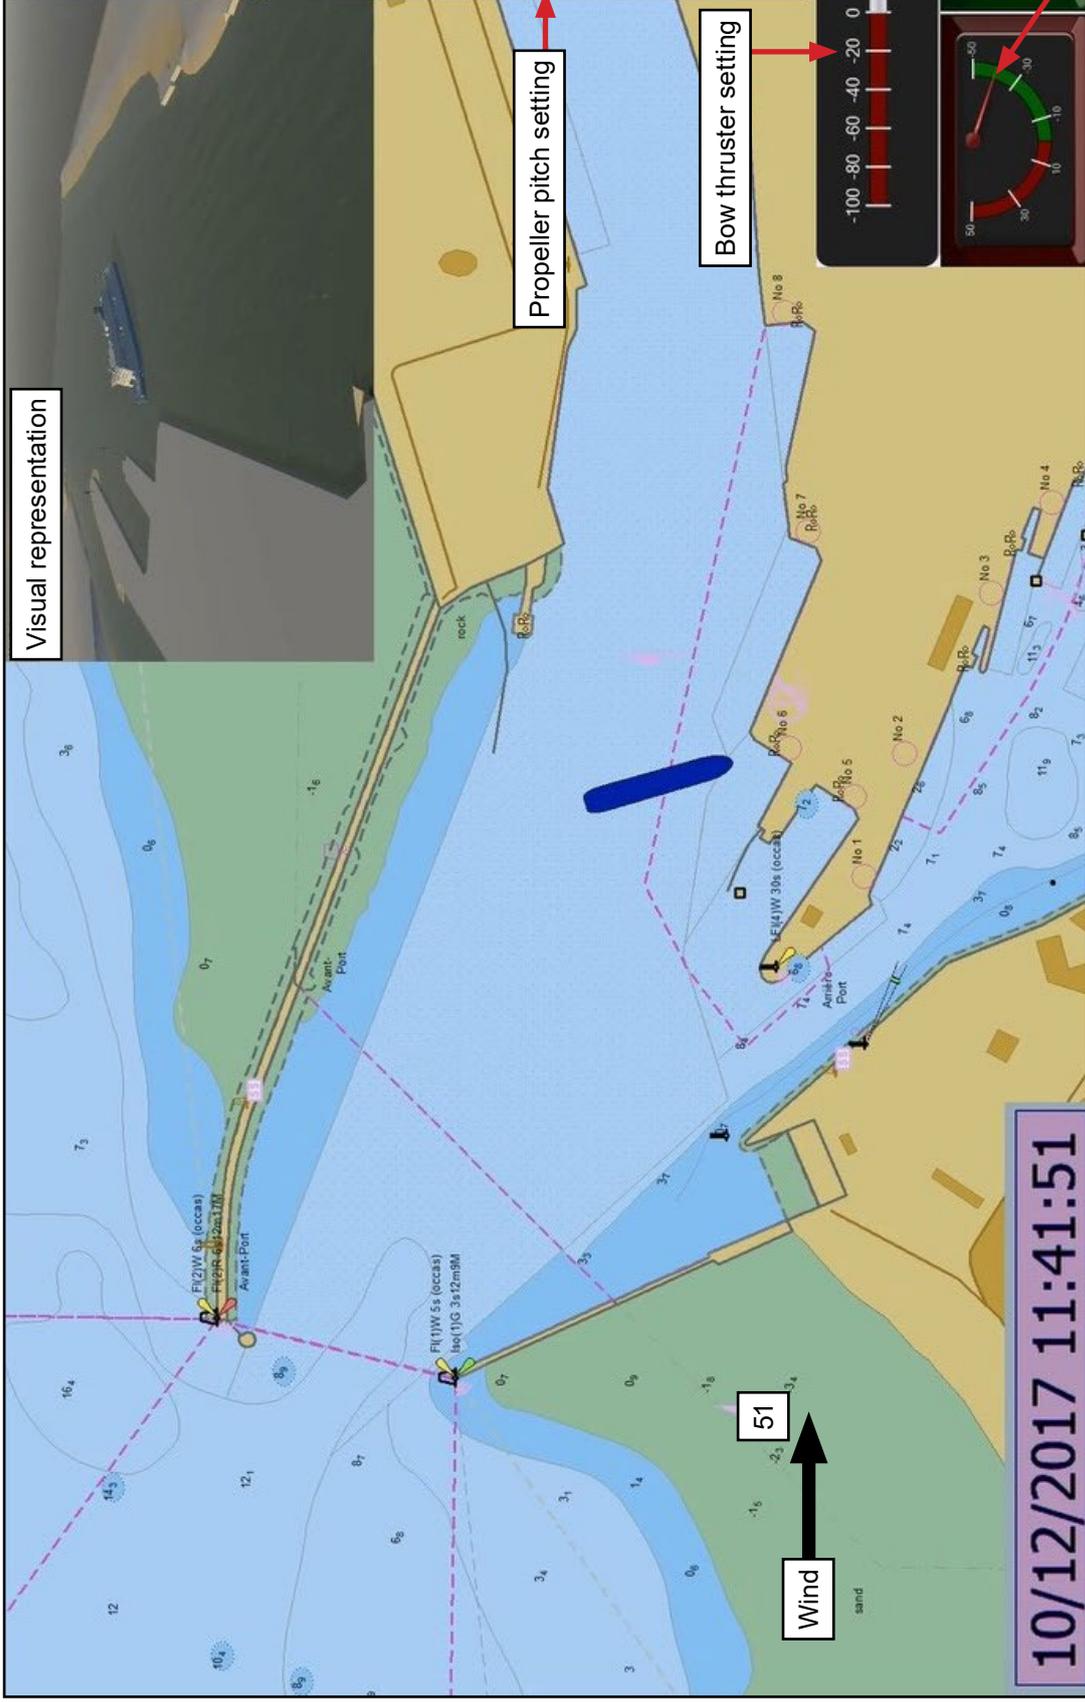
Figure 3: Vessel position at 11:41:51 – significant wind speed increase

By 1140, the mooring lines were clear and the stern had started to lift from the berth as intended. At 1141, the master manoeuvred the ferry astern, and then started to swing its bow to starboard (**Figure 3**). Seconds later, the wind speed increased to a steady 45kts, gusting to 55kts.

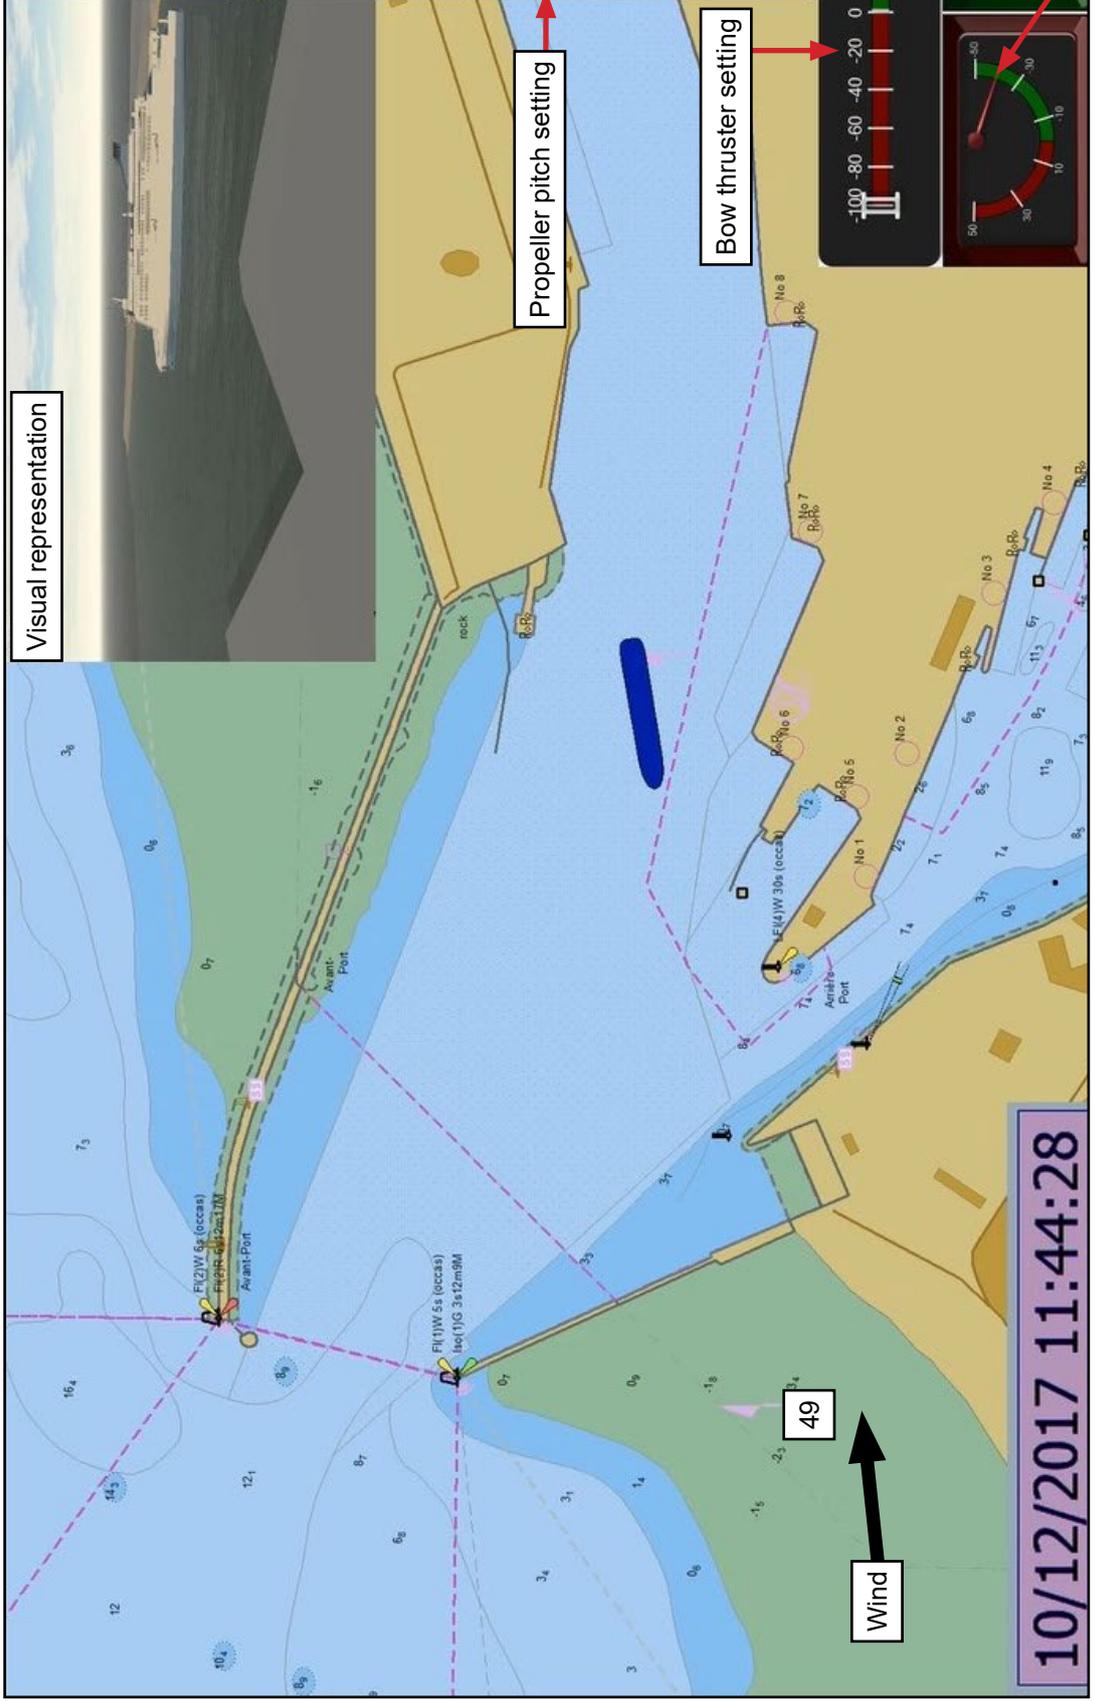
Figure 4: Vessel position at 11:44:28 – head to wind

Pride of Kent's master continued to turn the ferry using the No.2 bow thruster and main engines, and at 1144:28 it was heading into the wind (**Figure 4**). At this point, the master changed the thrust direction of the bow thruster from starboard to port in order to slow the rate of turn, which had reached 58°/min.

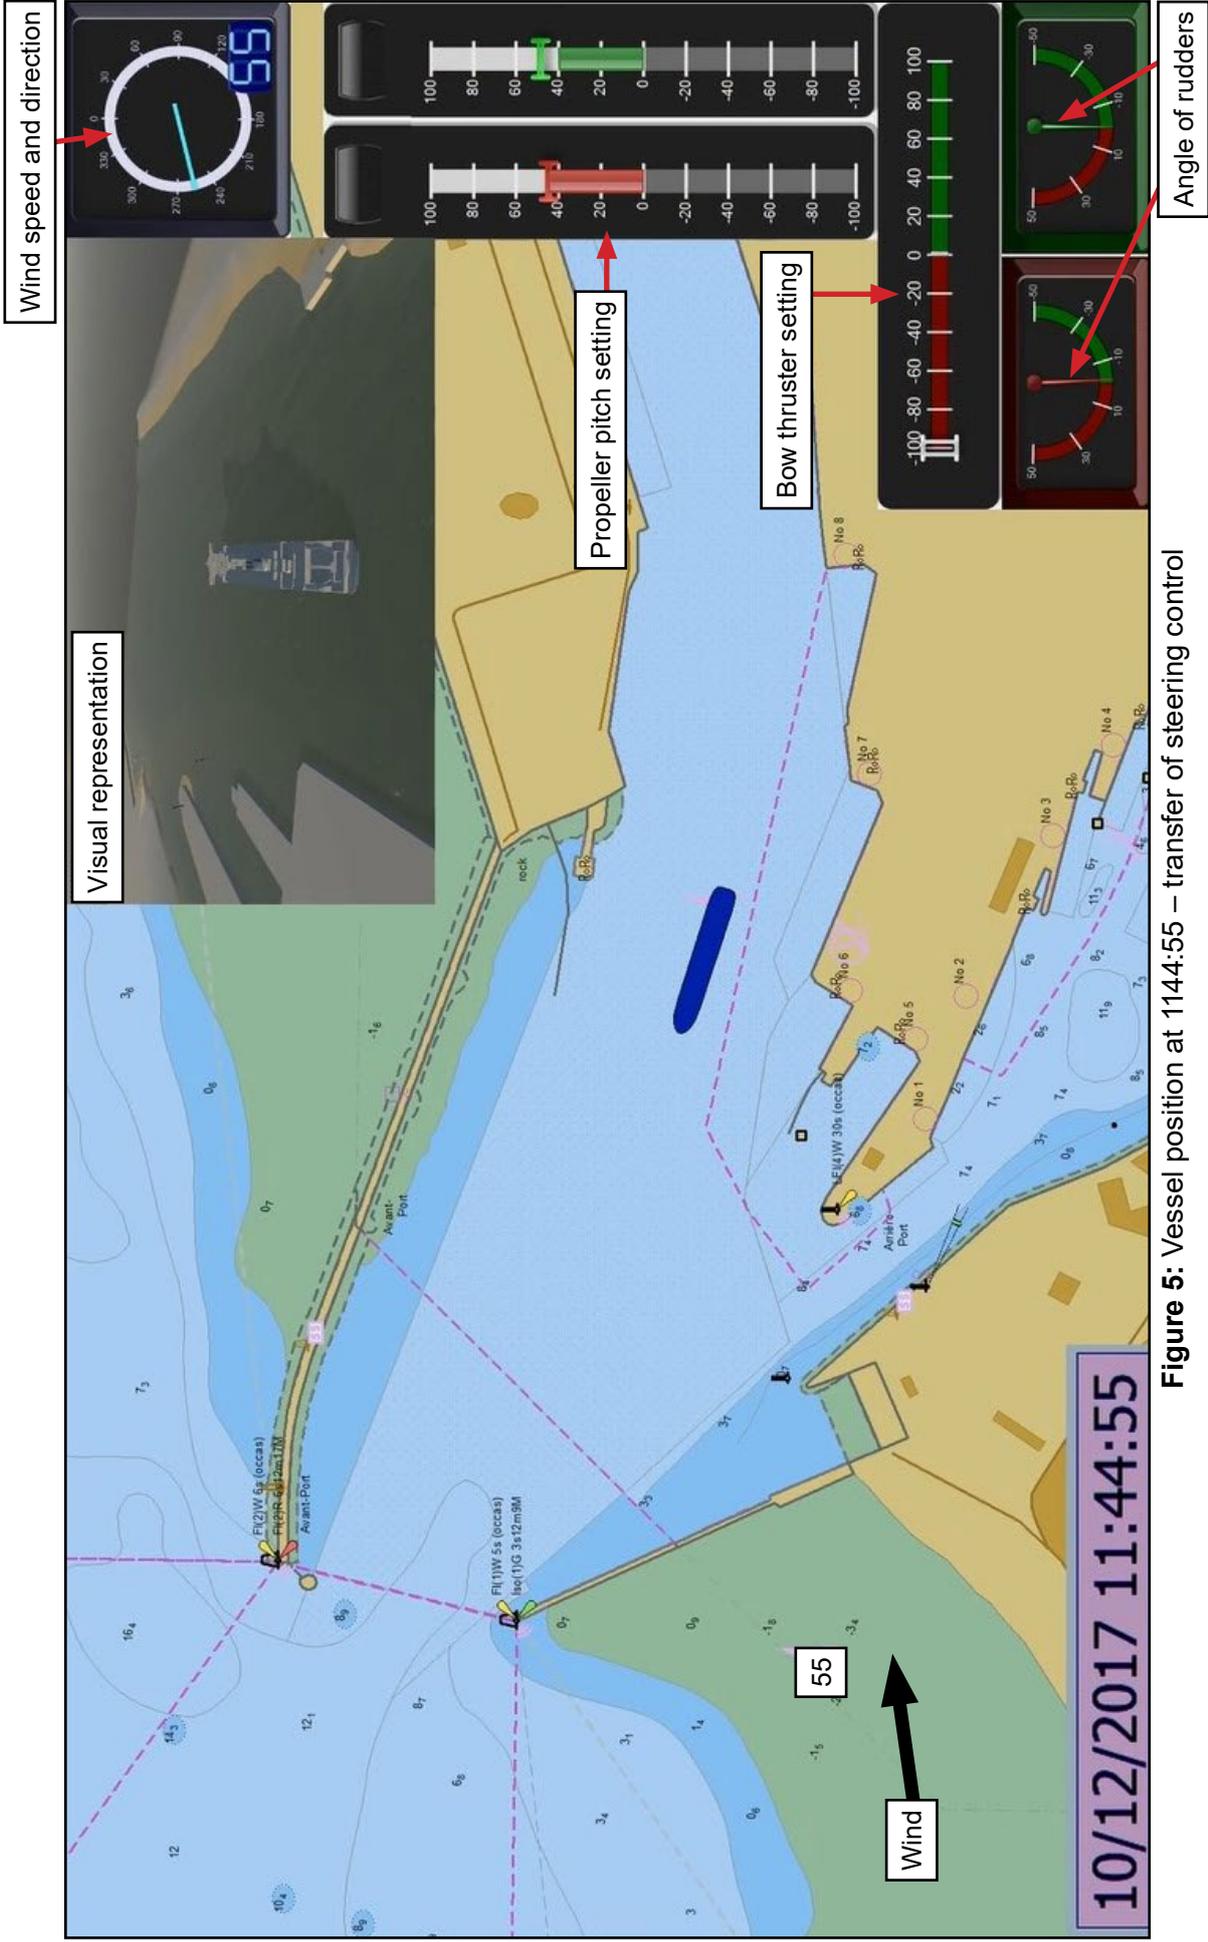
Figure 5: Vessel position at 1144:55 – transfer of steering control

At 1144:55, *Pride of Kent's* master put both rudders to amidships as the ferry's heading approached 289° (**Figure 5**). He then requested the helmsman to take steering control at the centre console and steer for the green light on the southern breakwater. The helmsman pressed the take-over button and moved the port (master) control lever⁴ (**Figure 6**) to port 40°. The starboard helm control lever remained at amidships.

About 16 seconds later, the master noticed the difference in the rudder positions and told the helmsman to synchronise the rudders. Accordingly, the helmsman pushed the 'synchronised' button on the centre console and the starboard rudder moved to 40° (to port) to match the port rudder. The master was now becoming concerned by the ferry's continuing turn to starboard, so he set the propeller pitch controls at 'full ahead' and instructed the helmsman to steer further to the south.

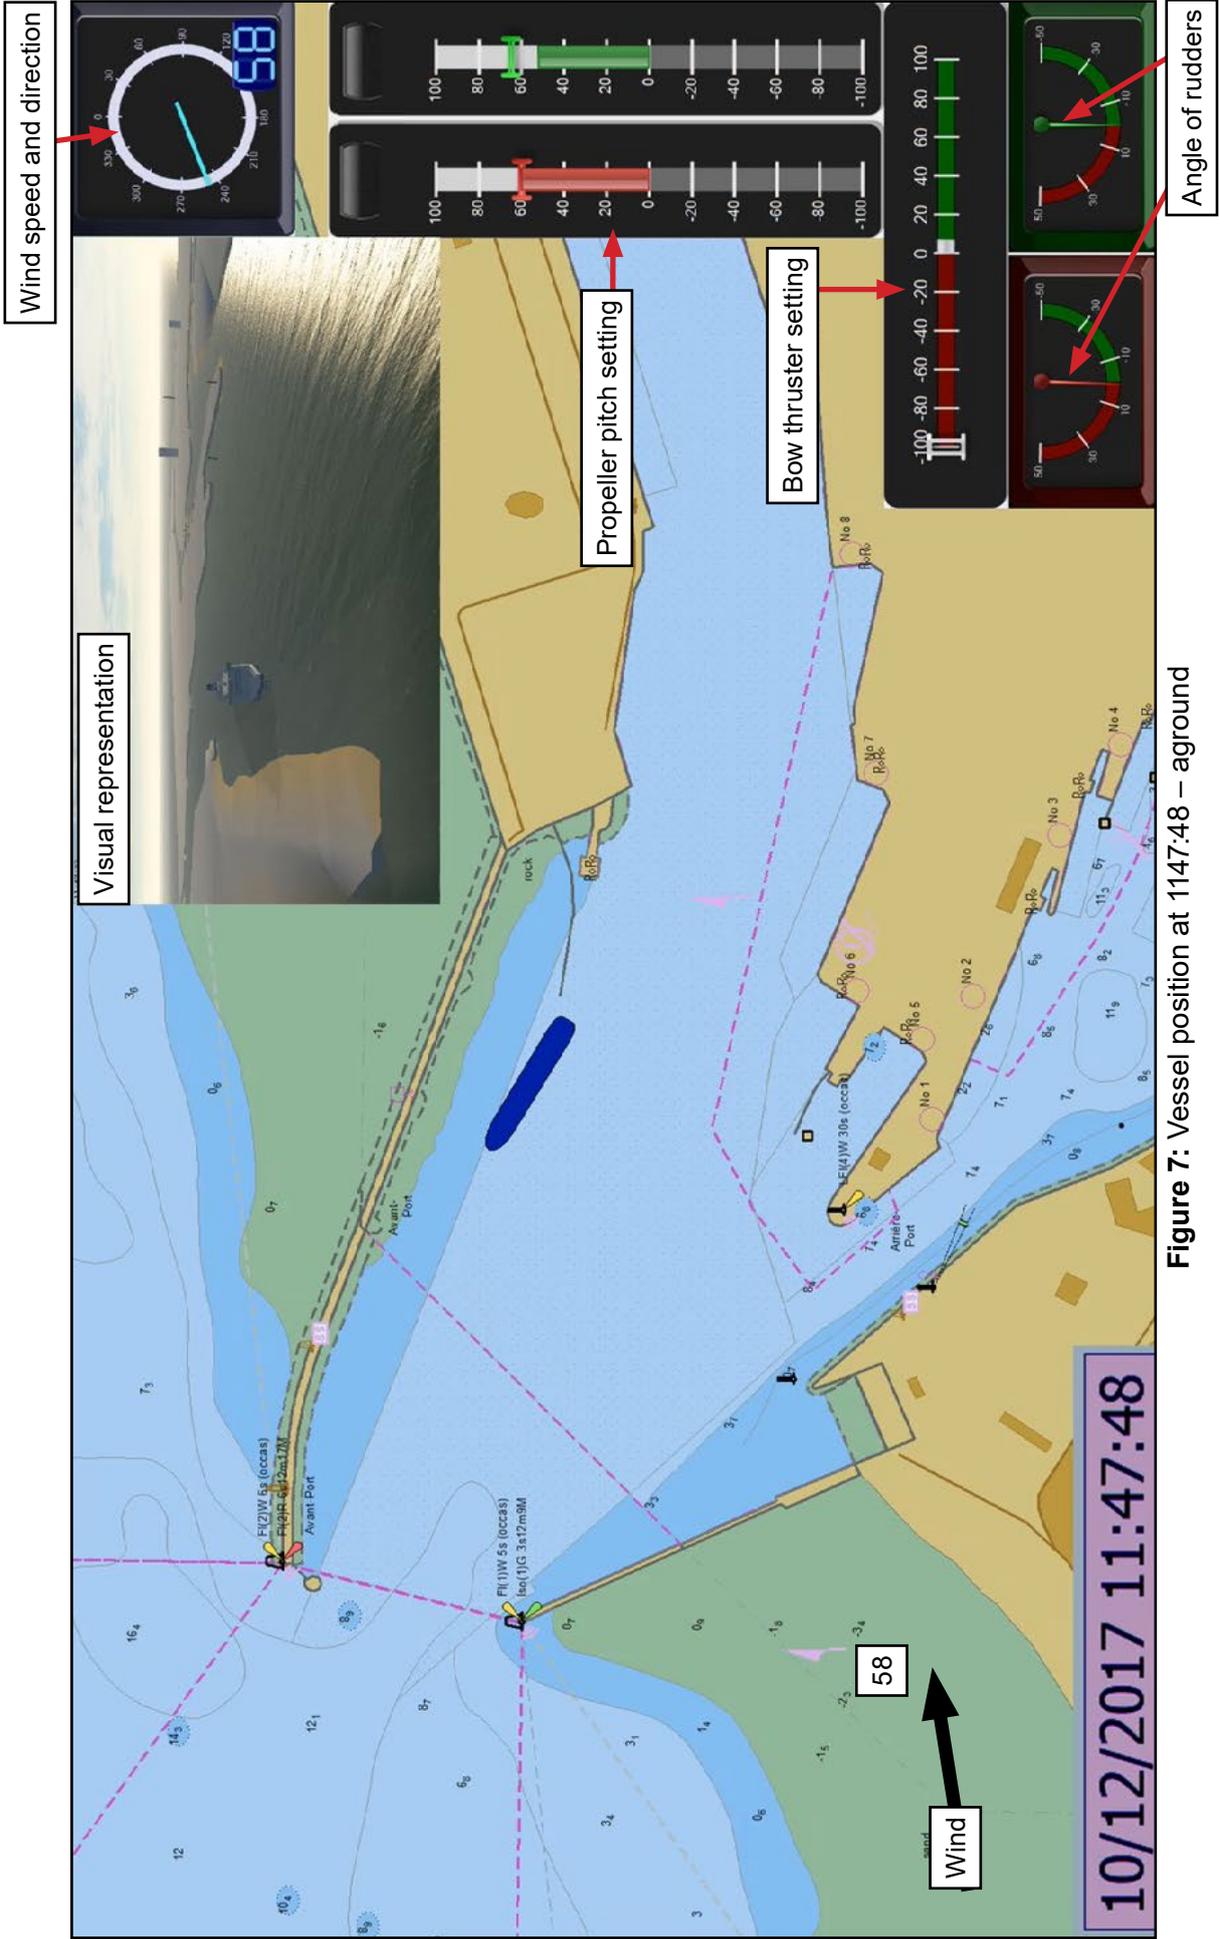
Figure 7: Vessel position at 1147:48 – aground

Pride of Kent continued to close T1 and, at 1146:14, the ferry's starboard side struck the jetty piles. The ferry moved ahead with the propellers still turning and the rudders full to port. About 20 seconds later, the starboard propeller shaft stopped on overload and the ferry then grounded in the shallow water to the west of the jetty (**Figure 7**). The wind was now gusting up to 70kts.

Pride of Kent was inspected by its crew and a Lloyd's Register surveyor. Damage to the starboard tail-shaft and propeller resulted in the ferry being taken out of service and dry docked in Dunkirk for repair. The walkway and piles on the T1 ro-ro berth were also damaged.

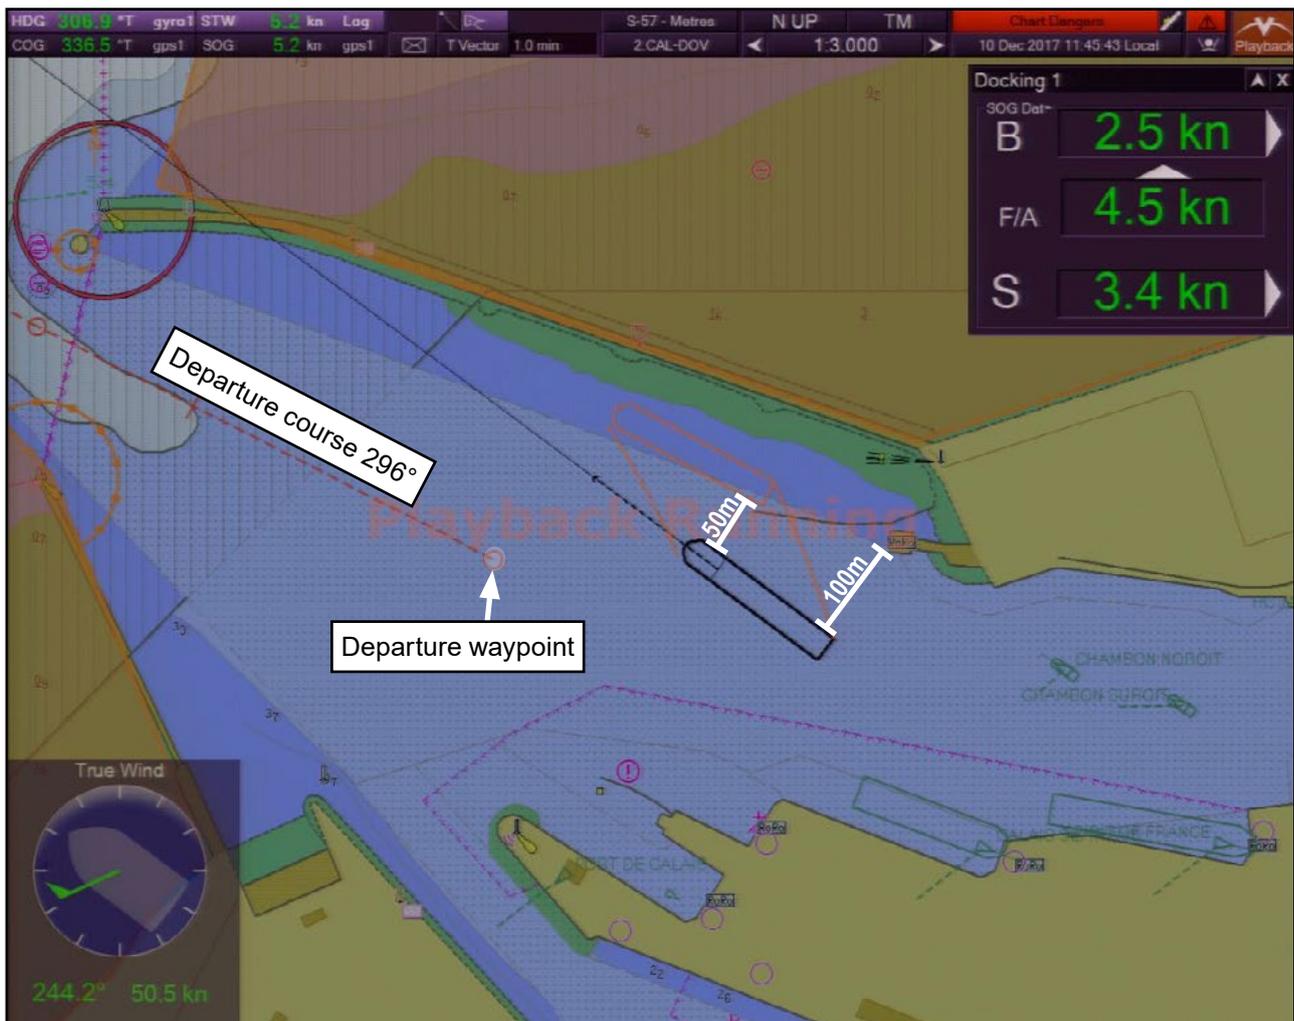
Figure 8: ECDIS playback screenshot at 1145:43 showing lateral speed and bow/stern clearances

Wind information based on data from *Pride of Kent's* anemometer is shown graphically at **Annex B**. **Figure 8** is a screen shot of the ferry's electronic chart display and information system (ECDIS) playback, which shows the intended route, position and heading shortly before grounding. It also shows the ferry's predicted position and heading.
