Ministry  
of Defence

## Defence Infrastructure Organisation

Ref: EIR/2017/13719

September 2014

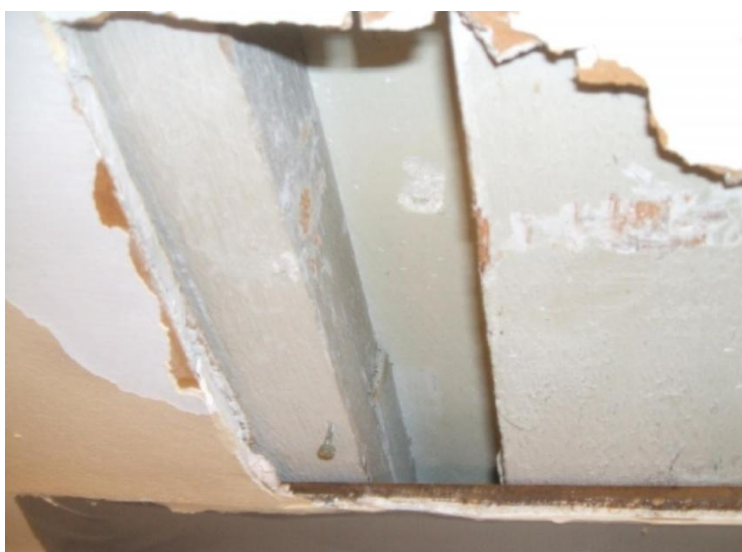
<b>Last Inspection Date</b>	-	03 Sep 2012	<b>Certificate N°</b>	-	BK30485
<b>Next Inspection Date</b>	-	03 Sep 2013	<b>Sample N°</b>	-	11
<b>Survey Type</b>	-	Refurbishment & Demolition Survey	<b>Photograph N°</b>	-	4650
<b>Position</b>	-	Sample Taken	<b>Location ID</b>	-	Loc19952

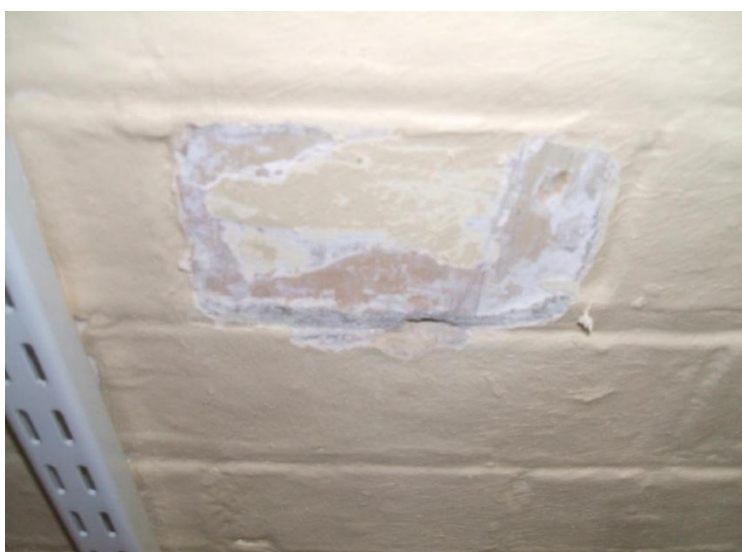
<b>Last Inspection Date</b>	-	03 Sep 2012	<b>Certificate N°</b>	-	BK30485
<b>Next Inspection Date</b>	-	03 Sep 2013	<b>Sample N°</b>	-	07
<b>Survey Type</b>	-	Refurbishment & Demolition Survey	<b>Photograph N°</b>	-	4645
<b>Position</b>	-	Sample Taken	<b>Location ID</b>	-	Loc19948

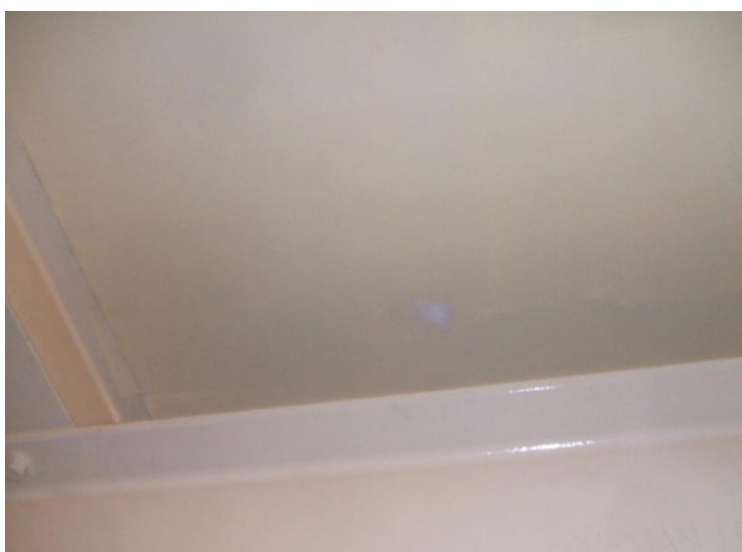
<b>Last Inspection Date</b>	-	03 Sep 2012	<b>Certificate N°</b>	-	BK30485
<b>Next Inspection Date</b>	-	03 Sep 2013	<b>Sample N°</b>	-	01
<b>Survey Type</b>	-	Refurbishment & Demolition Survey	<b>Photograph N°</b>	-	4639
<b>Position</b>	-	Sample Taken	<b>Location ID</b>	-	Loc19942

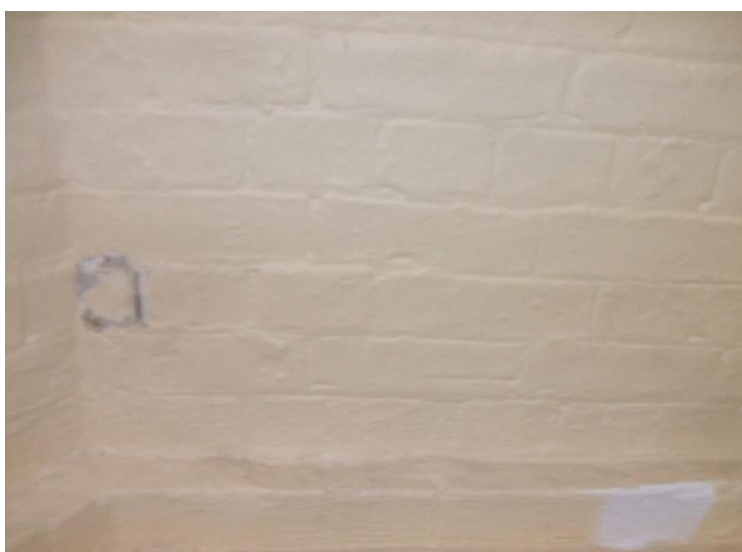
<b>Last Inspection Date</b>	-	03 Sep 2012	<b>Certificate N°</b>	-	BK30485
<b>Next Inspection Date</b>	-	03 Sep 2013	<b>Sample N°</b>	-	13
<b>Survey Type</b>	-	Refurbishment & Demolition Survey	<b>Photograph N°</b>	-	4652
<b>Position</b>	-	Sample Taken	<b>Location ID</b>	-	Loc19954

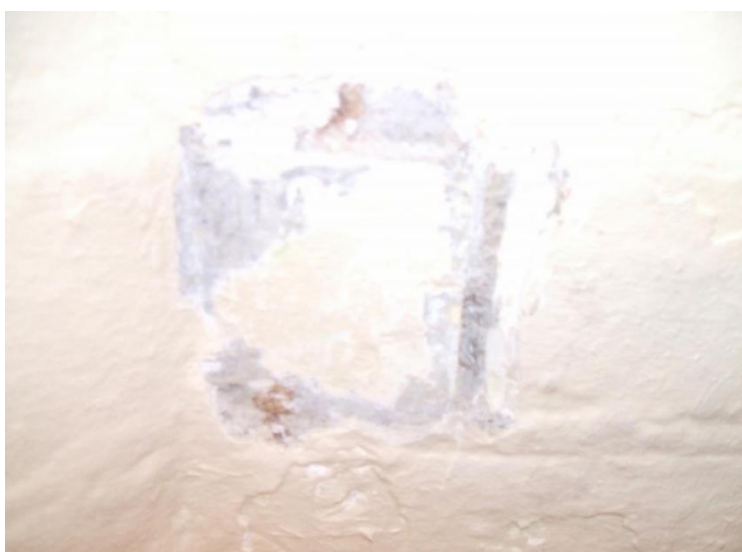
<b>Last Inspection Date</b>	-	03 Sep 2012	<b>Certificate N<sup>o</sup></b>	-	BK30485
<b>Next Inspection Date</b>	-	03 Sep 2013	<b>Sample N<sup>o</sup></b>	-	14
<b>Survey Type</b>	-	Refurbishment & Demolition Survey	<b>Photograph N<sup>o</sup></b>	-	4653
<b>Position</b>	-	Sample Taken	<b>Location ID</b>	-	Loc19955

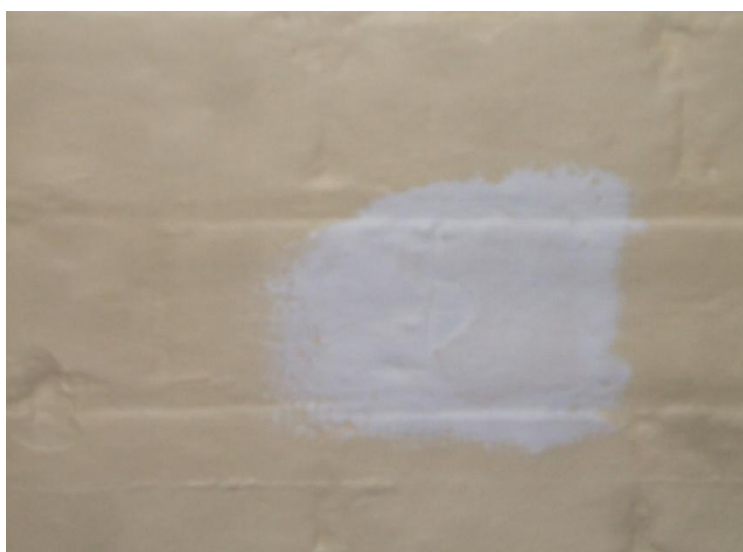
<b>Last Inspection Date</b>	-	03 Sep 2012	<b>Certificate N<sup>o</sup></b>	-	BK30485
<b>Next Inspection Date</b>	-	03 Sep 2013	<b>Sample N<sup>o</sup></b>	-	22
<b>Survey Type</b>	-	Refurbishment & Demolition Survey	<b>Photograph N<sup>o</sup></b>	-	4661
<b>Position</b>	-	Sample Taken	<b>Location ID</b>	-	Loc19963

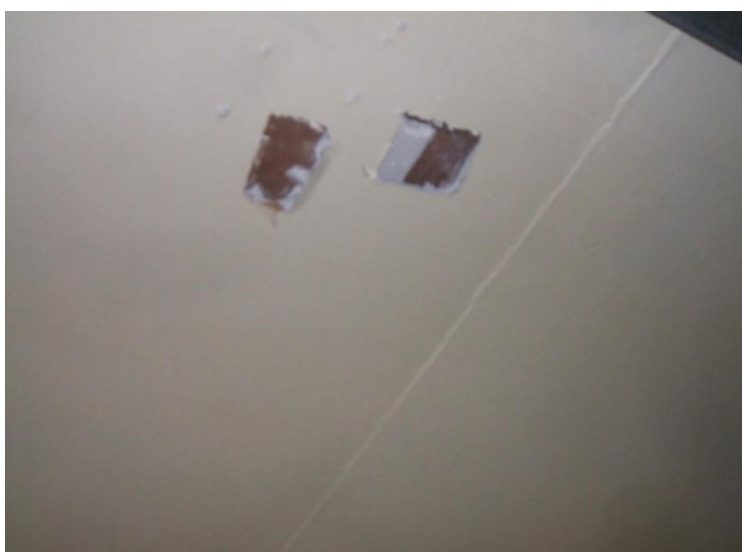
<b>Last Inspection Date</b>	-	03 Sep 2012	<b>Certificate N<sup>o</sup></b>	-	BK30485
<b>Next Inspection Date</b>	-	03 Sep 2013	<b>Sample N<sup>o</sup></b>	-	25
<b>Survey Type</b>	-	Refurbishment & Demolition Survey	<b>Photograph N<sup>o</sup></b>	-	4664
<b>Position</b>	-	Sample Taken	<b>Location ID</b>	-	Loc19966

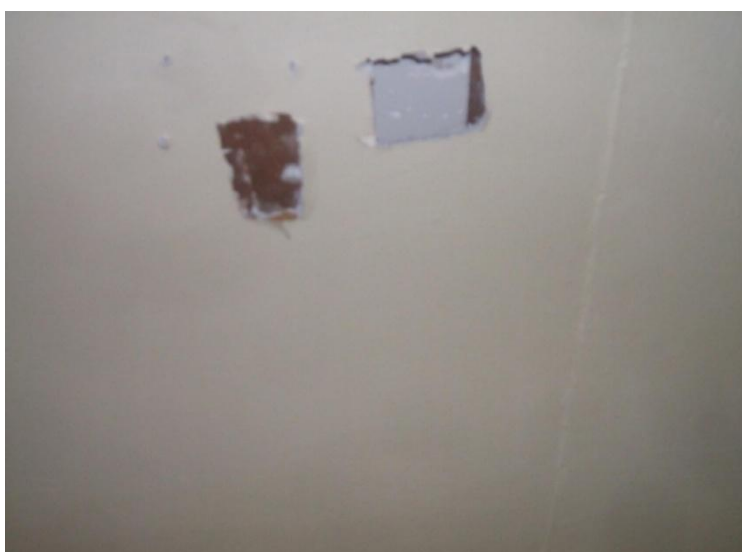
<b>Last Inspection Date</b>	-	03 Sep 2012	<b>Certificate N<sup>o</sup></b>	-	BK30485
<b>Next Inspection Date</b>	-	03 Sep 2013	<b>Sample N<sup>o</sup></b>	-	26
<b>Survey Type</b>	-	Refurbishment & Demolition Survey	<b>Photograph N<sup>o</sup></b>	-	4665
<b>Position</b>	-	Sample Taken	<b>Location ID</b>	-	Loc19967

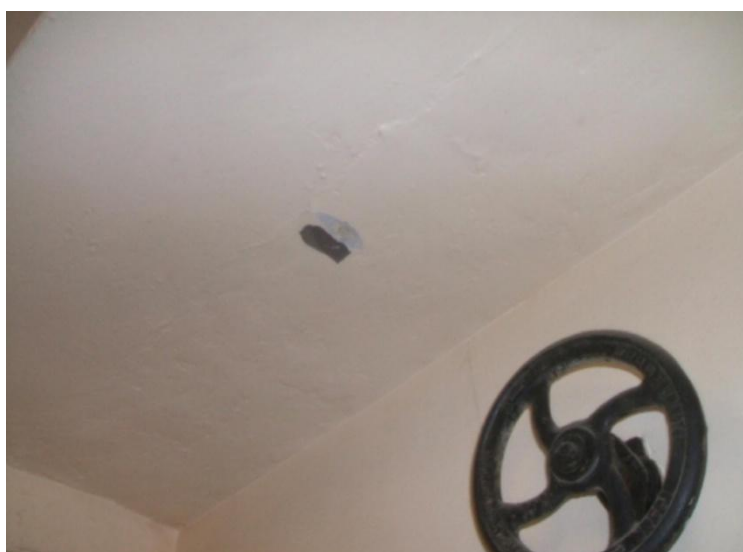
<b>Last Inspection Date</b>	-	03 Sep 2012	<b>Certificate N°</b>	-	BK30485
<b>Next Inspection Date</b>	-	03 Sep 2013	<b>Sample N°</b>	-	19
<b>Survey Type</b>	-	Refurbishment & Demolition Survey	<b>Photograph N°</b>	-	4658
<b>Position</b>	-	Sample Taken	<b>Location ID</b>	-	Loc19960

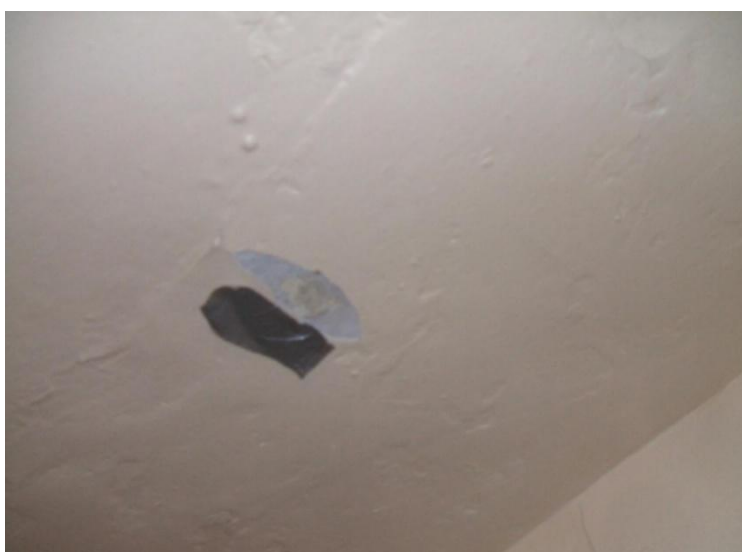
<b>Last Inspection Date</b>	-	03 Sep 2012	<b>Certificate N°</b>	-	BK30485
<b>Next Inspection Date</b>	-	03 Sep 2013	<b>Sample N°</b>	-	20
<b>Survey Type</b>	-	Refurbishment & Demolition Survey	<b>Photograph N°</b>	-	4659
<b>Position</b>	-	Sample Taken	<b>Location ID</b>	-	Loc19961

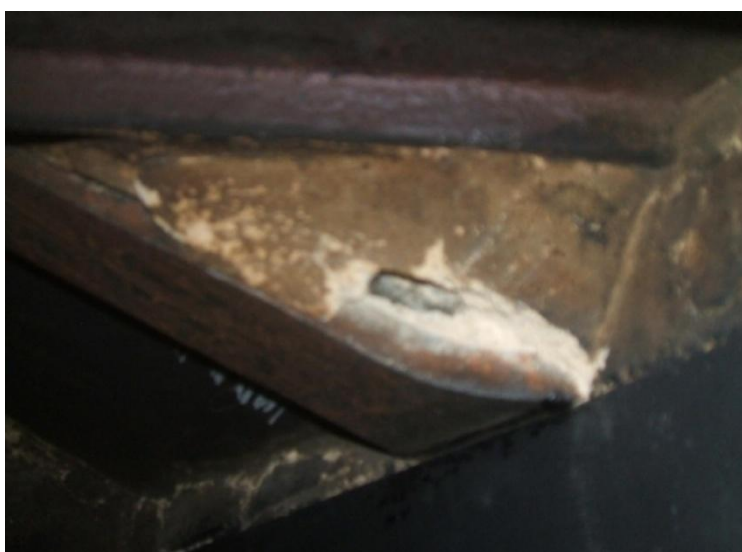
<b>Last Inspection Date</b>	-	03 Sep 2012	<b>Certificate N°</b>	-	BK30485
<b>Next Inspection Date</b>	-	03 Sep 2013	<b>Sample N°</b>	-	66
<b>Survey Type</b>	-	Refurbishment & Demolition Survey	<b>Photograph N°</b>	-	4705
<b>Position</b>	-	Internal	<b>Location ID</b>	-	Loc20007

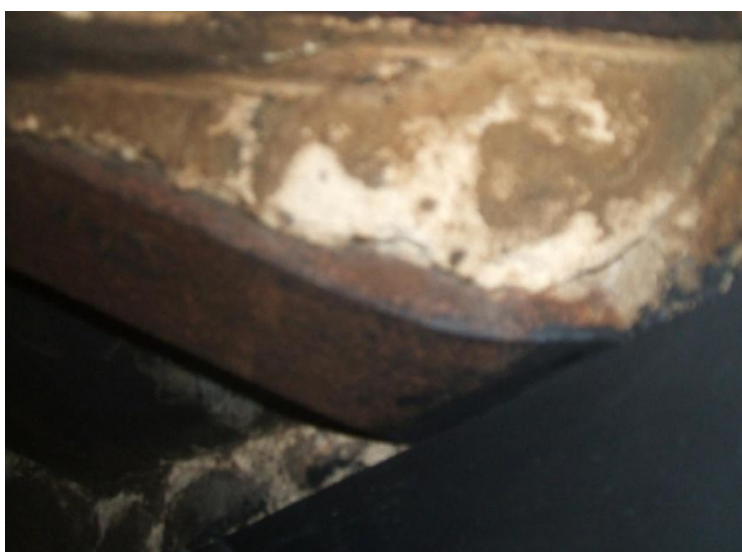
<b>Last Inspection Date</b>	-	03 Sep 2012	<b>Certificate N<sup>o</sup></b>	-	BK30485
<b>Next Inspection Date</b>	-	03 Sep 2013	<b>Sample N<sup>o</sup></b>	-	64
<b>Survey Type</b>	-	Refurbishment & Demolition Survey	<b>Photograph N<sup>o</sup></b>	-	4703
<b>Position</b>	-	Sample Taken	<b>Location ID</b>	-	Loc20005

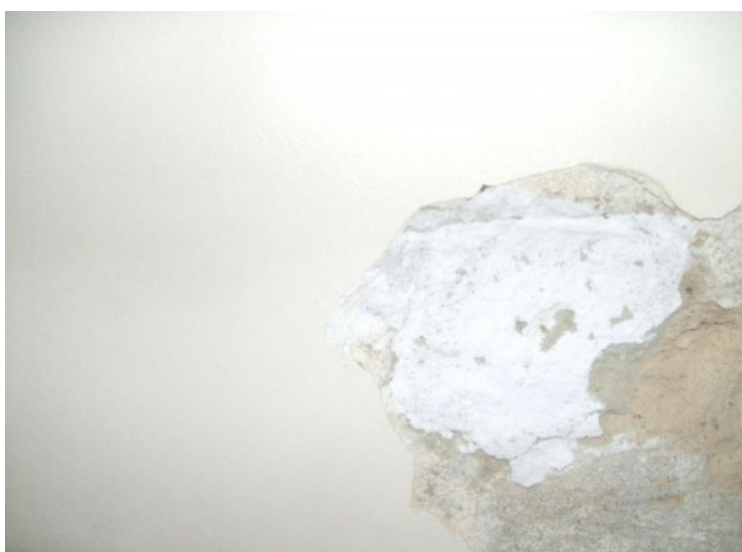
<b>Last Inspection Date</b>	-	03 Sep 2012	<b>Certificate N°</b>	-	BK30485
<b>Next Inspection Date</b>	-	03 Sep 2013	<b>Sample N°</b>	-	39
<b>Survey Type</b>	-	Refurbishment & Demolition Survey	<b>Photograph N°</b>	-	4675
<b>Position</b>	-	Sample Taken	<b>Location ID</b>	-	Loc19980

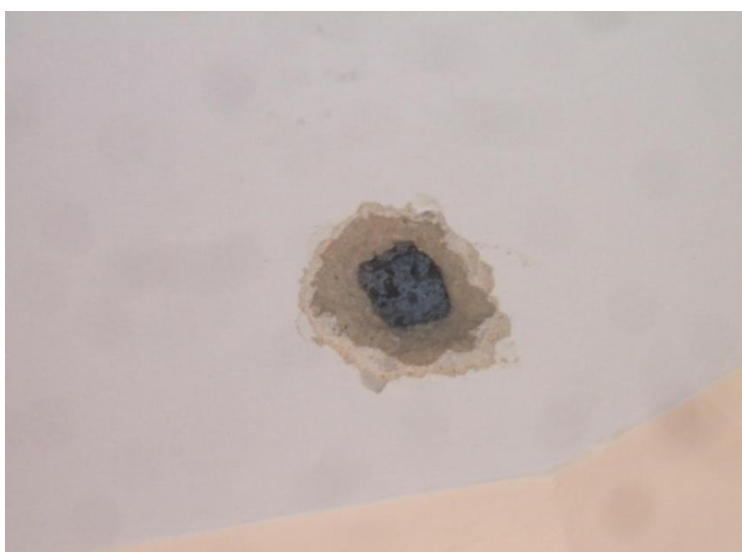
<b>Last Inspection Date</b>	-	03 Sep 2012	<b>Certificate N<sup>o</sup></b>	-	BK30485
<b>Next Inspection Date</b>	-	03 Sep 2013	<b>Sample N<sup>o</sup></b>	-	42
<b>Survey Type</b>	-	Refurbishment & Demolition Survey	<b>Photograph N<sup>o</sup></b>	-	4681
<b>Position</b>	-	Sample Taken	<b>Location ID</b>	-	Loc19983

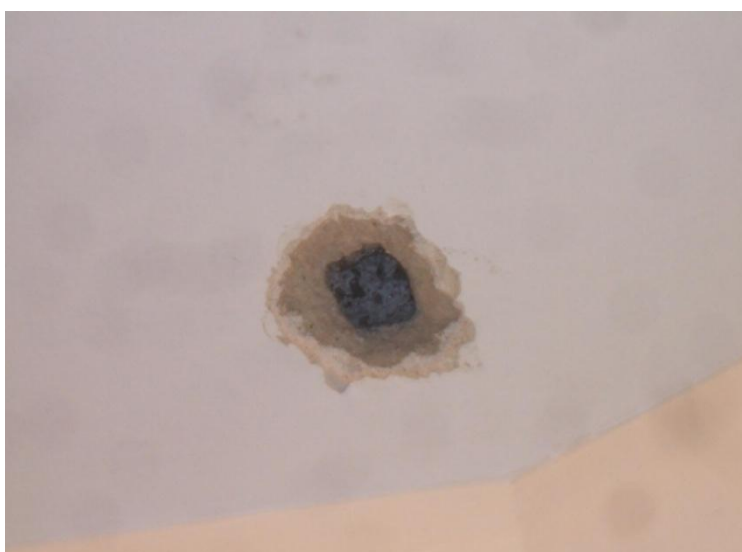
<b>Last Inspection Date</b>	-	03 Sep 2012	<b>Certificate N<sup>o</sup></b>	-	BK30485
<b>Next Inspection Date</b>	-	03 Sep 2013	<b>Sample N<sup>o</sup></b>	-	41
<b>Survey Type</b>	-	Refurbishment & Demolition Survey	<b>Photograph N<sup>o</sup></b>	-	4680
<b>Position</b>	-	Sample Taken	<b>Location ID</b>	-	Loc19982

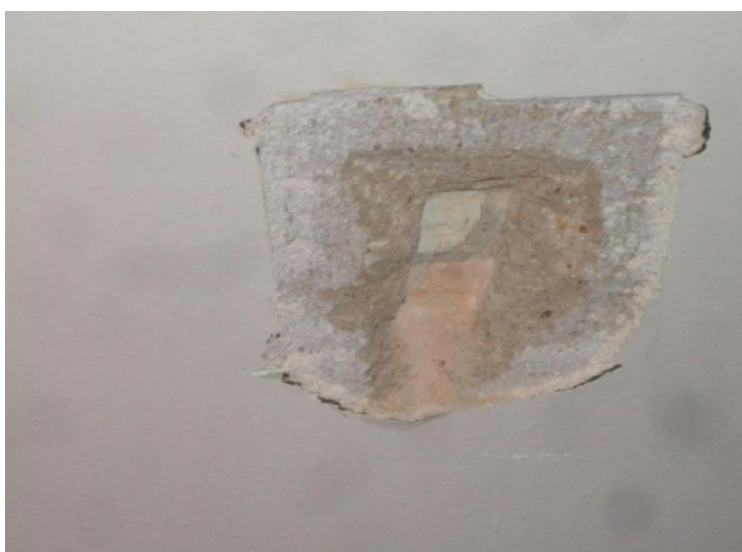
<b>Last Inspection Date</b>	-	03 Sep 2012	<b>Certificate N<sup>o</sup></b>	-	BK30485
<b>Next Inspection Date</b>	-	03 Sep 2013	<b>Sample N<sup>o</sup></b>	-	45
<b>Survey Type</b>	-	Refurbishment & Demolition Survey	<b>Photograph N<sup>o</sup></b>	-	4684
<b>Position</b>	-	Internal	<b>Location ID</b>	-	Loc19986

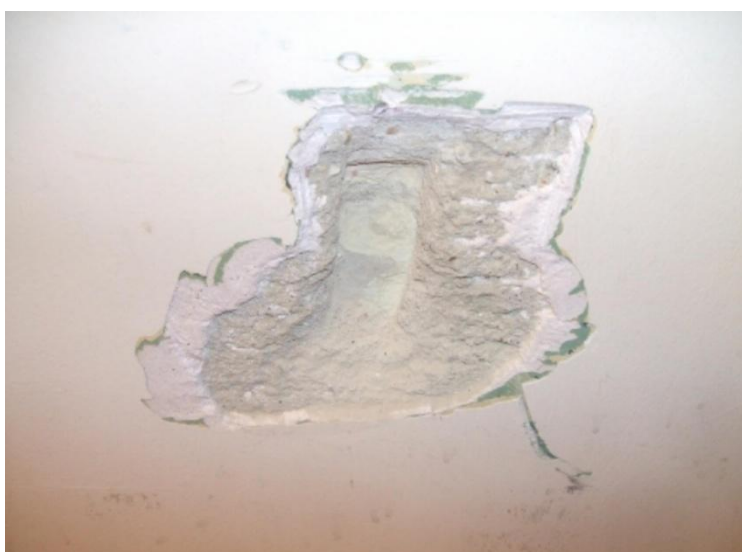
<b>Last Inspection Date</b>	-	03 Sep 2012	<b>Certificate N<sup>o</sup></b>	-	BK30485
<b>Next Inspection Date</b>	-	03 Sep 2013	<b>Sample N<sup>o</sup></b>	-	51
<b>Survey Type</b>	-	Refurbishment & Demolition Survey	<b>Photograph N<sup>o</sup></b>	-	4690
<b>Position</b>	-	Sample Taken	<b>Location ID</b>	-	Loc19992

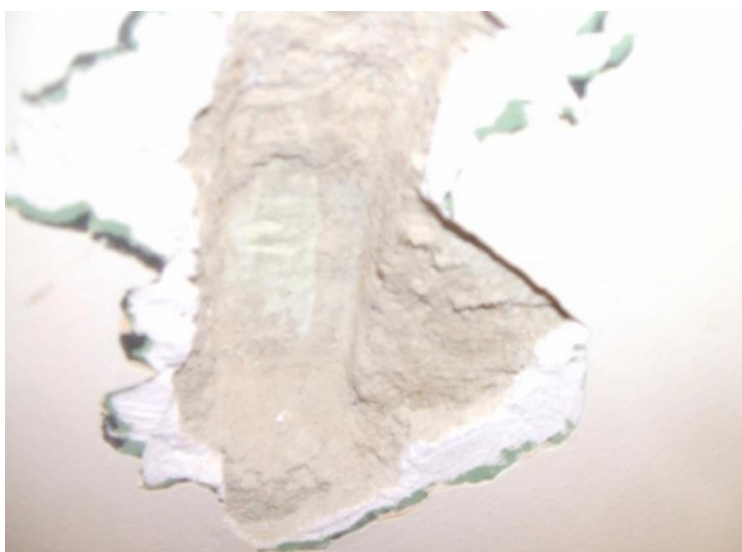
<b>Last Inspection Date</b>	-	03 Sep 2012	<b>Certificate N°</b>	-	BK30485
<b>Next Inspection Date</b>	-	03 Sep 2013	<b>Sample N°</b>	-	50
<b>Survey Type</b>	-	Refurbishment & Demolition Survey	<b>Photograph N°</b>	-	4689
<b>Position</b>	-	Sample Taken	<b>Location ID</b>	-	Loc19991

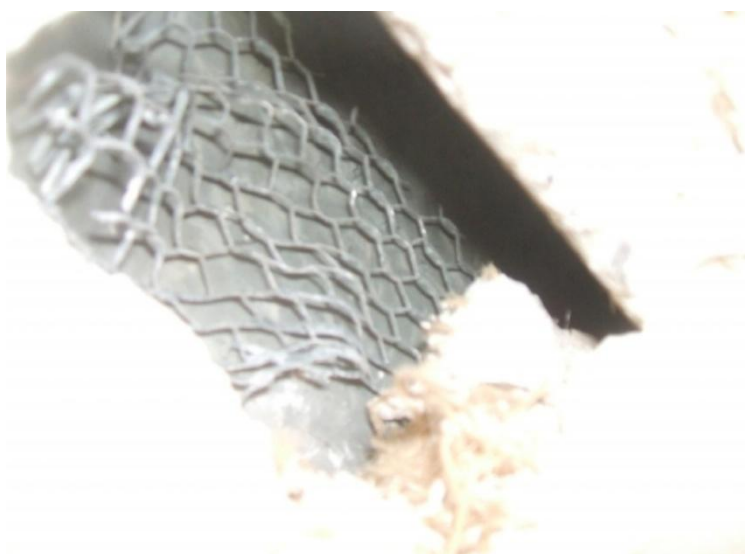
<b>Last Inspection Date</b>	-	03 Sep 2012	<b>Certificate N<sup>o</sup></b>	-	BK30485
<b>Next Inspection Date</b>	-	03 Sep 2013	<b>Sample N<sup>o</sup></b>	-	48
<b>Survey Type</b>	-	Refurbishment & Demolition Survey	<b>Photograph N<sup>o</sup></b>	-	4687
<b>Position</b>	-	Sample Taken	<b>Location ID</b>	-	Loc19989

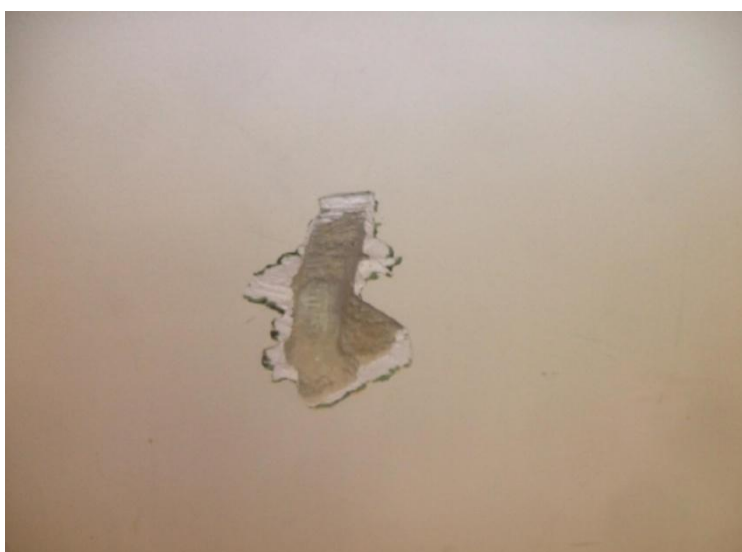
<b>Last Inspection Date</b>	-	03 Sep 2012	<b>Certificate N<sup>o</sup></b>	-	BK30485
<b>Next Inspection Date</b>	-	03 Sep 2013	<b>Sample N<sup>o</sup></b>	-	49
<b>Survey Type</b>	-	Refurbishment & Demolition Survey	<b>Photograph N<sup>o</sup></b>	-	4688
<b>Position</b>	-	Sample Taken	<b>Location ID</b>	-	Loc19990

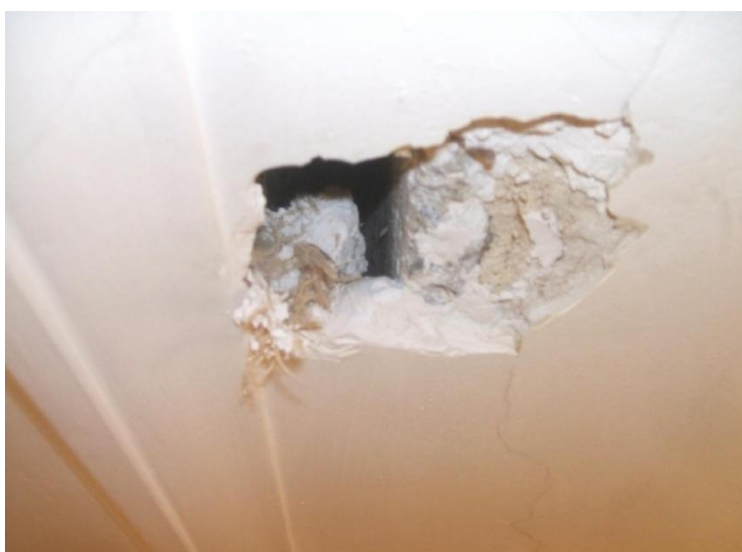
<b>Last Inspection Date</b>	-	03 Sep 2012	<b>Certificate N<sup>o</sup></b>	-	BK30485
<b>Next Inspection Date</b>	-	03 Sep 2013	<b>Sample N<sup>o</sup></b>	-	47
<b>Survey Type</b>	-	Refurbishment & Demolition Survey	<b>Photograph N<sup>o</sup></b>	-	4686
<b>Position</b>	-	Sample Taken	<b>Location ID</b>	-	Loc19988

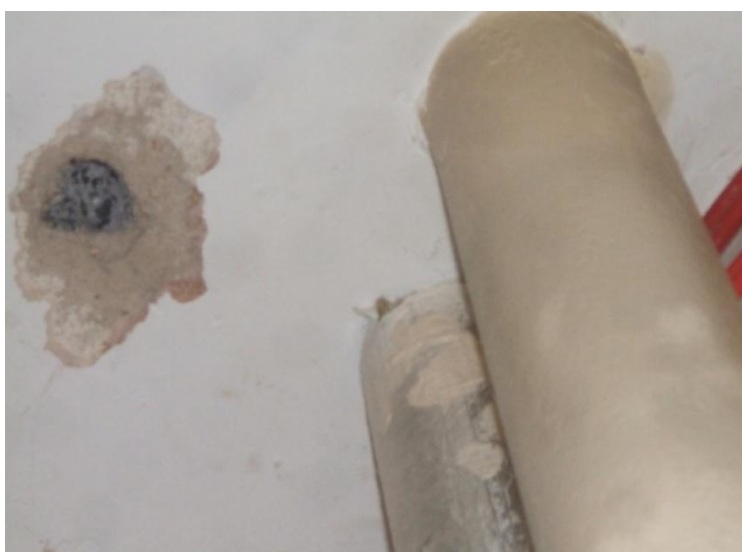
<b>Last Inspection Date</b>	-	03 Sep 2012	<b>Certificate N<sup>o</sup></b>	-	BK30485
<b>Next Inspection Date</b>	-	03 Sep 2013	<b>Sample N<sup>o</sup></b>	-	55
<b>Survey Type</b>	-	Refurbishment & Demolition Survey	<b>Photograph N<sup>o</sup></b>	-	4694
<b>Position</b>	-	Sample Taken	<b>Location ID</b>	-	Loc19996

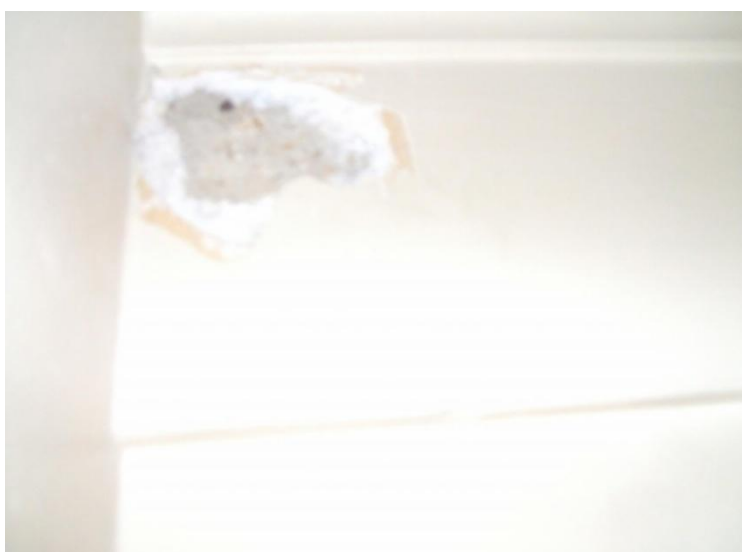
<b>Last Inspection Date</b>	-	03 Sep 2012	<b>Certificate N°</b>	-	BK30485
<b>Next Inspection Date</b>	-	03 Sep 2013	<b>Sample N°</b>	-	54
<b>Survey Type</b>	-	Refurbishment & Demolition Survey	<b>Photograph N°</b>	-	4693
<b>Position</b>	-	Sample Taken	<b>Location ID</b>	-	Loc19995

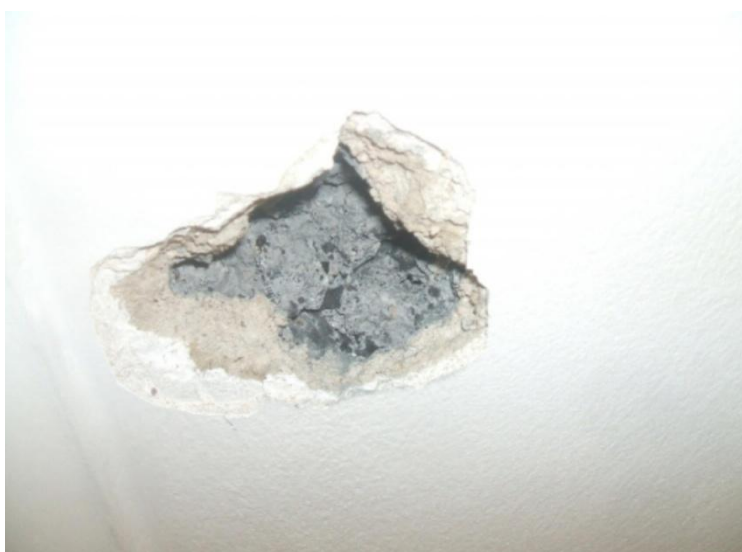
<b>Last Inspection Date</b>	-	03 Sep 2012	<b>Certificate N°</b>	-	BK30786
<b>Next Inspection Date</b>	-	03 Sep 2013	<b>Sample N°</b>	-	181
<b>Survey Type</b>	-	Refurbishment & Demolition Survey	<b>Photograph N°</b>	-	4902
<b>Position</b>	-	Sample Taken	<b>Location ID</b>	-	Loc20125

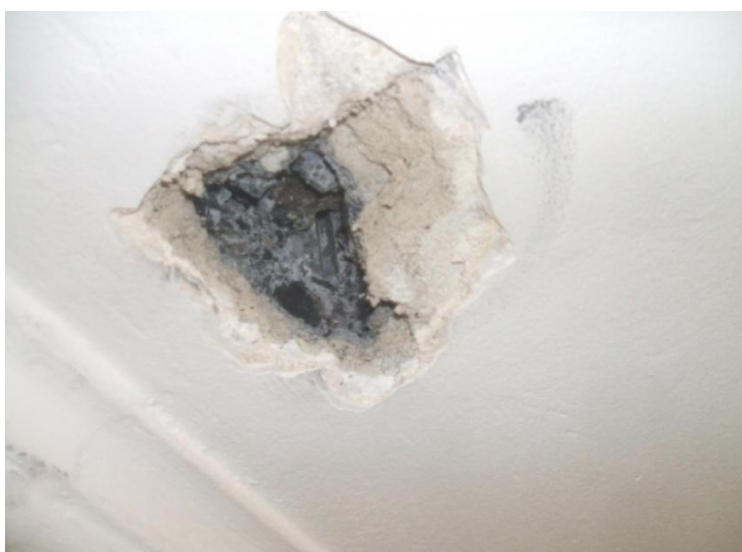
<b>Last Inspection Date</b>	-	03 Sep 2012	<b>Certificate N<sup>o</sup></b>	-	BK30786
<b>Next Inspection Date</b>	-	03 Sep 2013	<b>Sample N<sup>o</sup></b>	-	173
<b>Survey Type</b>	-	Refurbishment & Demolition Survey	<b>Photograph N<sup>o</sup></b>	-	4891
<b>Position</b>	-	Sample Taken	<b>Location ID</b>	-	Loc20117

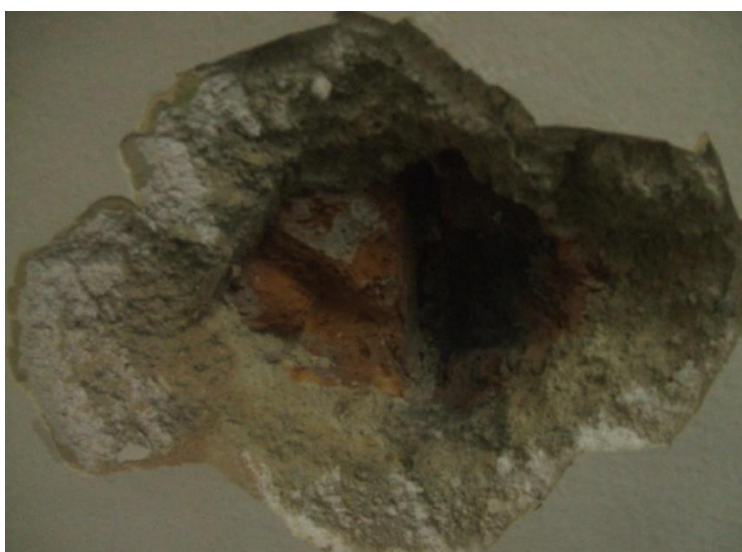
<b>Last Inspection Date</b>	-	03 Sep 2012	<b>Certificate N<sup>o</sup></b>	-	BK30786
<b>Next Inspection Date</b>	-	03 Sep 2013	<b>Sample N<sup>o</sup></b>	-	175
<b>Survey Type</b>	-	Refurbishment & Demolition Survey	<b>Photograph N<sup>o</sup></b>	-	4893
<b>Position</b>	-	Sample Taken	<b>Location ID</b>	-	Loc20119

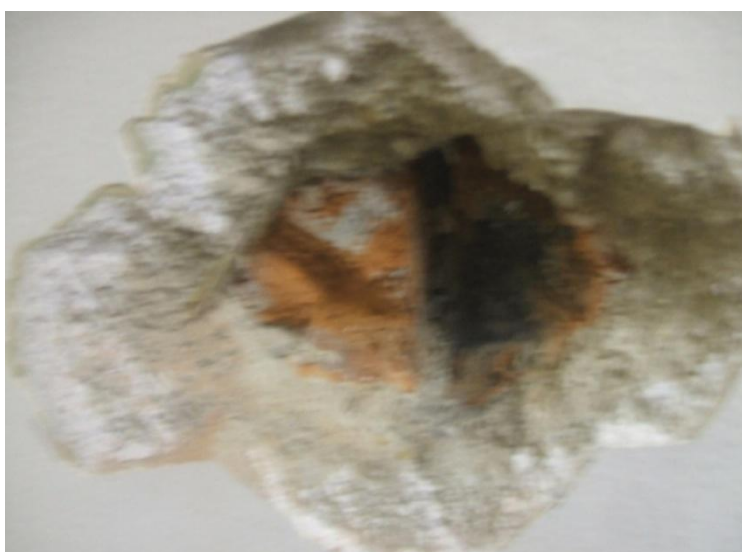
<b>Last Inspection Date</b>	-	03 Sep 2012	<b>Certificate N°</b>	-	BK30786
<b>Next Inspection Date</b>	-	03 Sep 2013	<b>Sample N°</b>	-	176
<b>Survey Type</b>	-	Refurbishment & Demolition Survey	<b>Photograph N°</b>	-	4894
<b>Position</b>	-	Sample Taken	<b>Location ID</b>	-	Loc20120

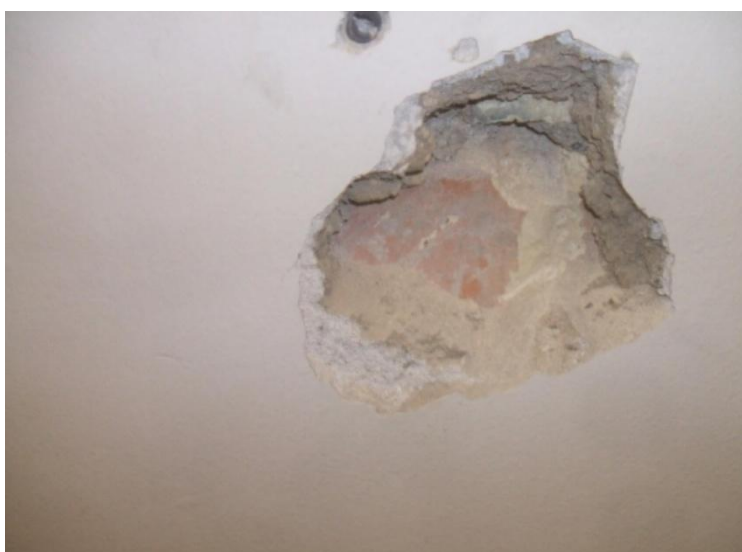
<b>Last Inspection Date</b>	-	03 Sep 2012	<b>Certificate N<sup>o</sup></b>	-	BK30786
<b>Next Inspection Date</b>	-	03 Sep 2013	<b>Sample N<sup>o</sup></b>	-	168
<b>Survey Type</b>	-	Refurbishment & Demolition Survey	<b>Photograph N<sup>o</sup></b>	-	4884
<b>Position</b>	-	Sample Taken	<b>Location ID</b>	-	Loc20112

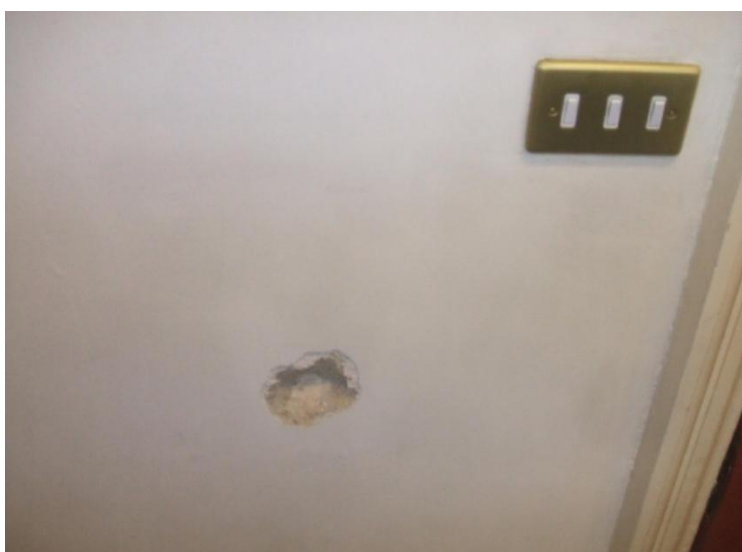
<b>Last Inspection Date</b>	-	03 Sep 2012	<b>Certificate N<sup>o</sup></b>	-	BK30786
<b>Next Inspection Date</b>	-	03 Sep 2013	<b>Sample N<sup>o</sup></b>	-	169
<b>Survey Type</b>	-	Refurbishment & Demolition Survey	<b>Photograph N<sup>o</sup></b>	-	4885
<b>Position</b>	-	Sample Taken	<b>Location ID</b>	-	Loc20113

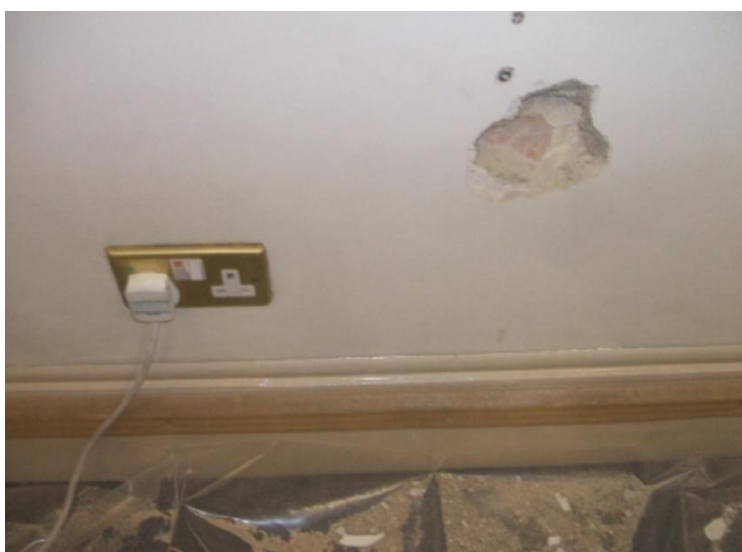
<b>Last Inspection Date</b>	-	03 Sep 2012	<b>Certificate N°</b>	-	BK30786
<b>Next Inspection Date</b>	-	03 Sep 2013	<b>Sample N°</b>	-	165
<b>Survey Type</b>	-	Refurbishment & Demolition Survey	<b>Photograph N°</b>	-	4883
<b>Position</b>	-	Sample Taken	<b>Location ID</b>	-	Loc20109

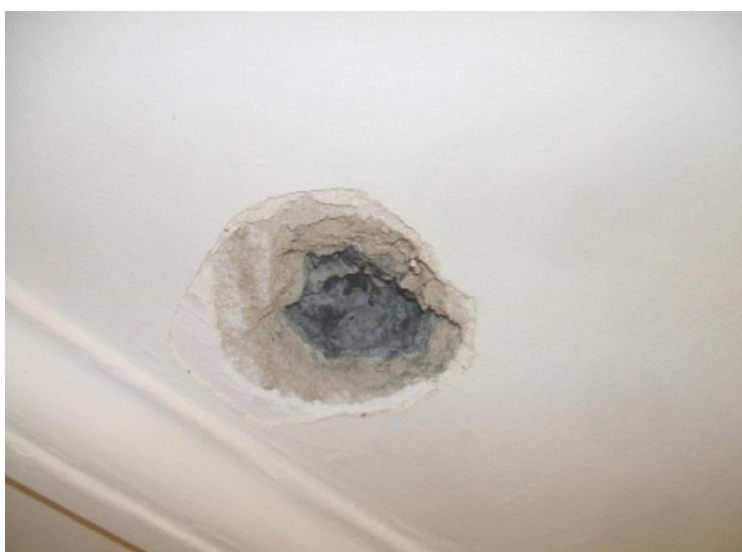
<b>Last Inspection Date</b>	-	03 Sep 2012	<b>Certificate N<sup>o</sup></b>	-	BK30786
<b>Next Inspection Date</b>	-	03 Sep 2013	<b>Sample N<sup>o</sup></b>	-	162
<b>Survey Type</b>	-	Refurbishment & Demolition Survey	<b>Photograph N<sup>o</sup></b>	-	4879
<b>Position</b>	-	Sample Taken	<b>Location ID</b>	-	Loc20106
