## Fire and Solar PV Systems – Investigations and Evidence

Prepared for: Malwina Gradecka and Yehuda Lethbridge, SICE, BEIS

Date: 11th May 2018

Report Number: P100874-1004 Issue 2.9

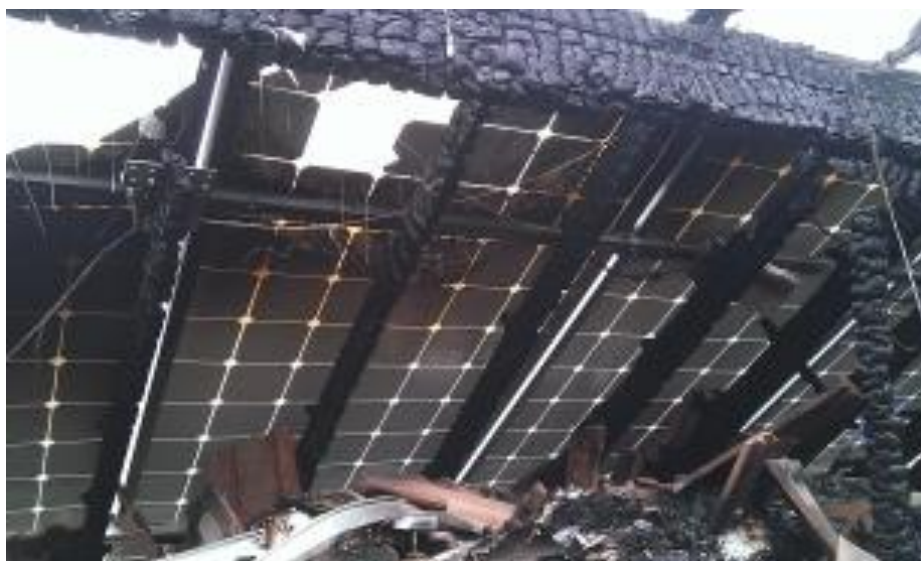
Figure 3: Example burnt-out roof with parts of the PV system intact.

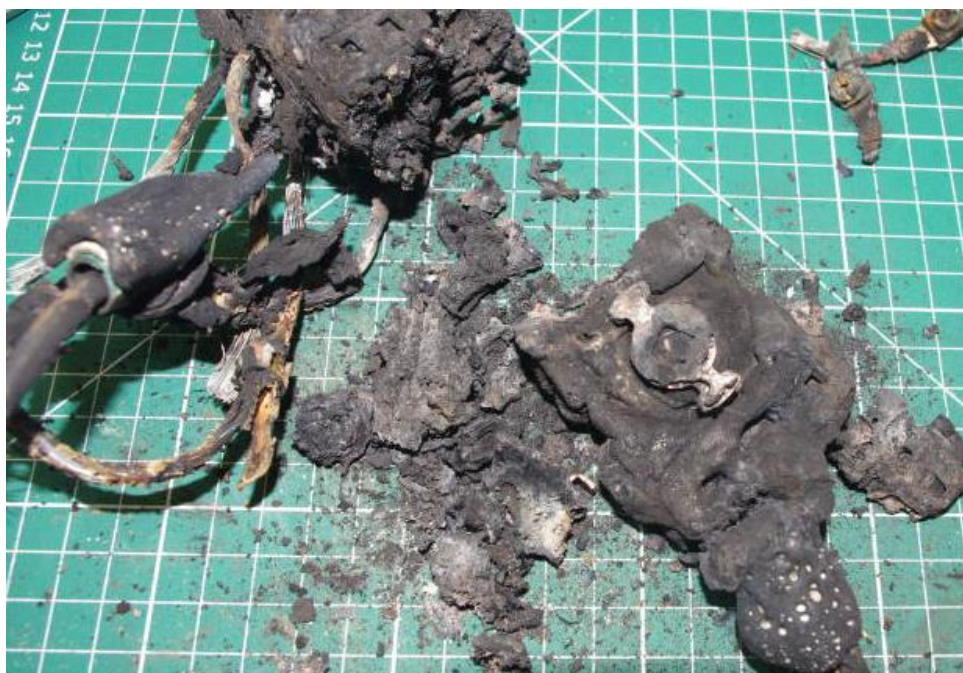
Figure 4: Remains of a DC isolator being disassembled and inspected in the laboratory  
(Photo courtesy of Fire Investigations (UK) LLP)

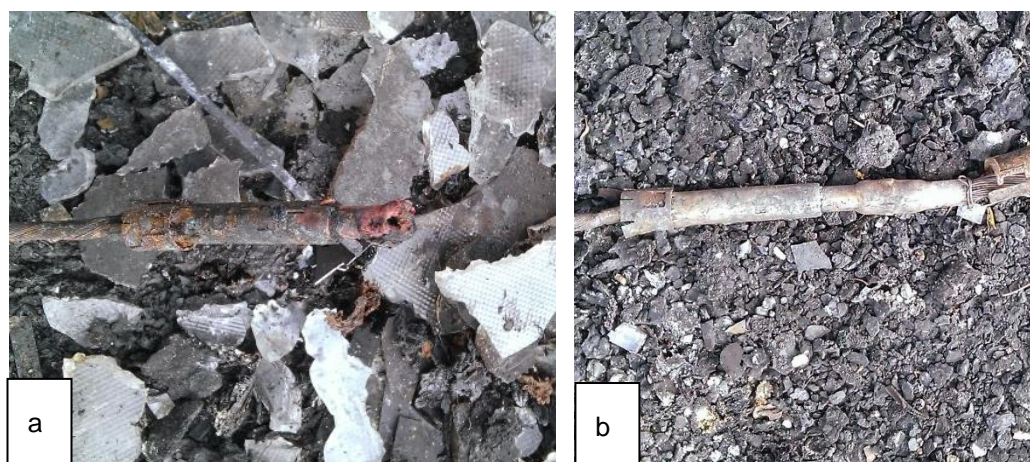
Figure 5: Remains of a DC connector ablated by arcing (a), and by contrast, a connector with contacts still intact and engaged, merely damaged by the surrounding fire (b). In both cases, the insulating body of the connector has been burnt off.

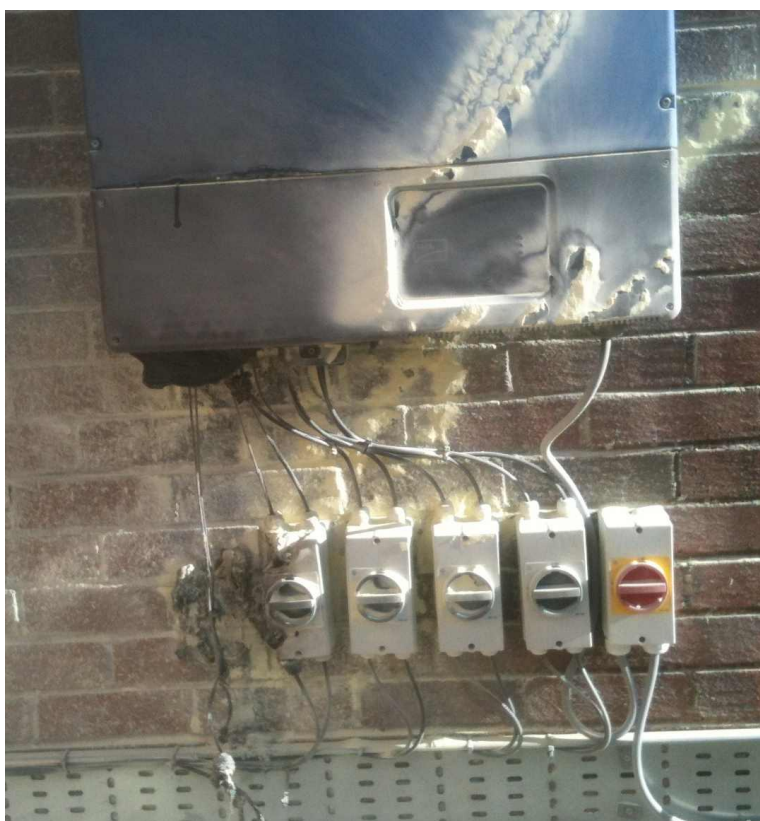
Figure 6: Localised fire in which the left hand DC isolator is completely missing, destroyed by a fire, with collateral damage to the adjacent isolator and inverter above.

In this case the evidence from the site and also the laboratory report (included in Appendix C) indicated that the isolators, which were mounted on an exposed exterior wall, were filling with water

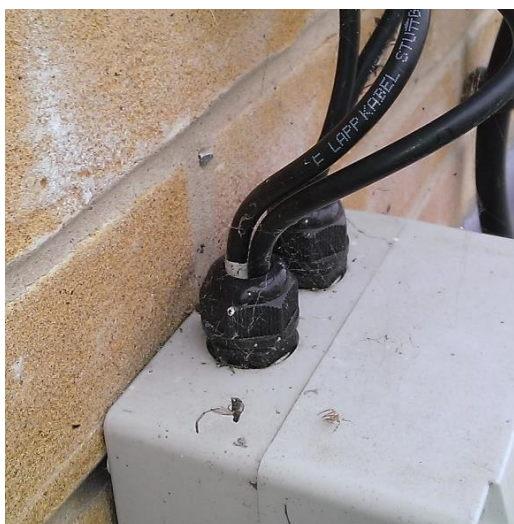
In 7, possibly 8, cases of poor installation, the result of the error was the ingress of water into the isolator casing, subsequently causing arcing. In several cases, this was caused by multiple cables being passed through a sealing gland designed to hold one cable. This issue is most acute when the gland is mounted on the upper surface of an isolator enclosure that is exposed to weather – see Figure 7.

Figure 7: More than one cable passing through an upward-facing sealing gland on a DC isolator enclosure mounted on an outside wall.

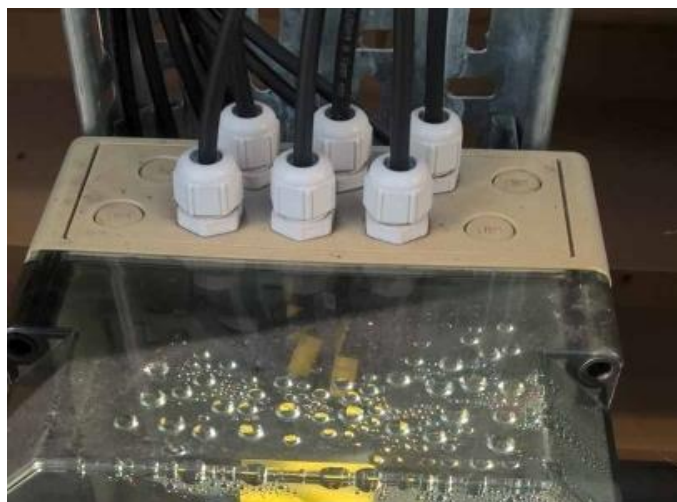
Even where one cable of the correct size passes through an upward-facing, exposed gland, water may penetrate the enclosure – this was the case for at least 2 incidents – see Figure 8.

Figure 8: Water can be seen inside this enclosure, even though only one cable passes through each gland.

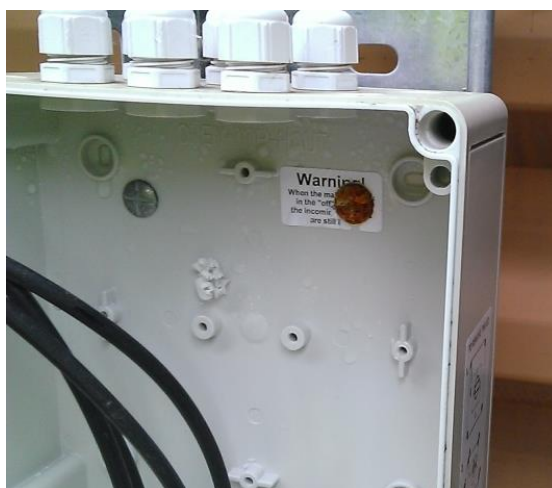
Another issue noted on 4 installations was the drilling of mounting holes through the back of enclosures designed to be weathertight (IP65). An example is shown in Figure 9. The hole on the top right-hand corner of the enclosure is outside of the weather seal and is designed to be used for a mounting screw without compromising the sealing. However, installers sometimes view drilling through the rear of the box as an easier option, most likely because of the types of screws they have to hand.

Figure 9: Rear of isolator enclosure drilled through for mounting screws. Note that the screw on the right hand side is rusty, indicating water ingress.

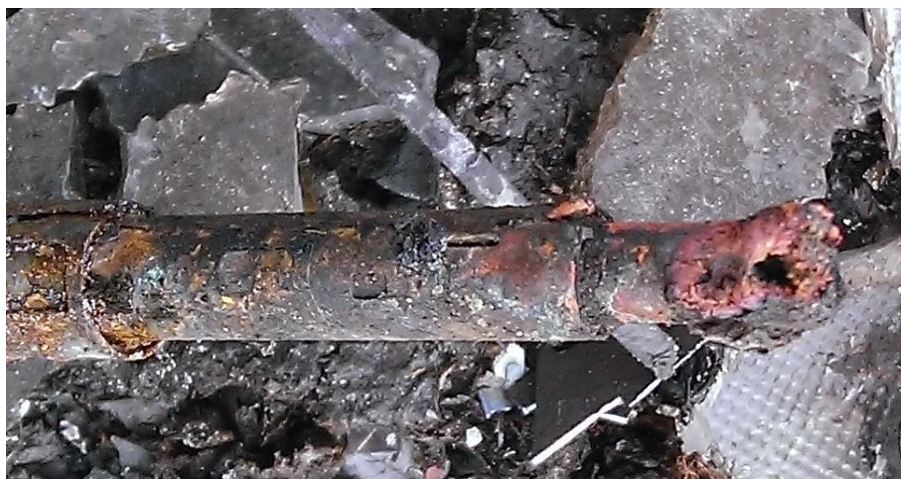
Figure 12: Example of DC connector contact that has been subject to electrical arcing. The right hand end has been melted.

The finding of such evidence does not necessarily mean that the component caused the fire, since the arcing may have occurred as a result of the fire. However, the experience of the investigating teams has been that the metal contacts of DC connectors tend to remain connected by frictional forces, even when the supporting plastic body has been burnt off – see Figure 5. Therefore, any DC connectors that have been subject to arcing should be suspected as a likely source of ignition.

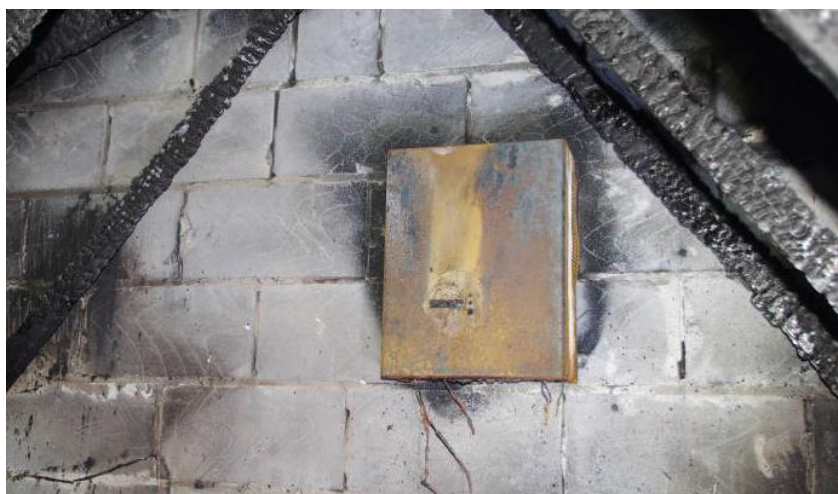
Figure 13: Inverter fire with clear burn patterns showing this as the source of the fire.

Further corroborating evidence may be that there were no isolators mounted nearby, or if there were, their conducting parts have not been subject to arcing or resistance heating, and no evidence of arcing at the inverter connectors.

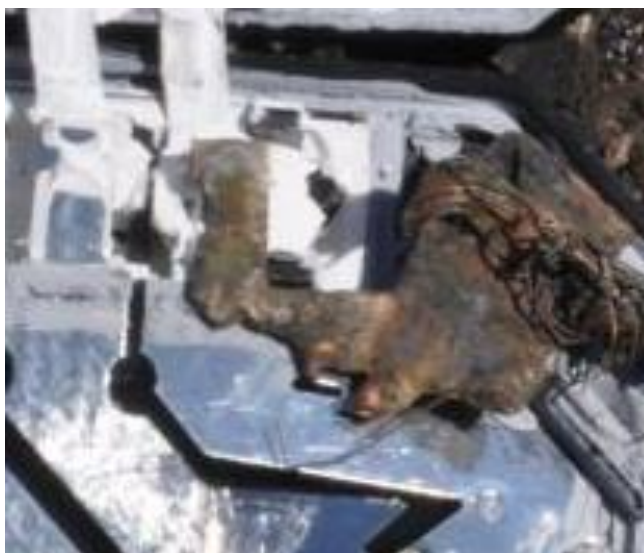
Figure 14: Damaged part of a PV module junction box laid over an identical undamaged component, showing where material has been ablated through arcing.

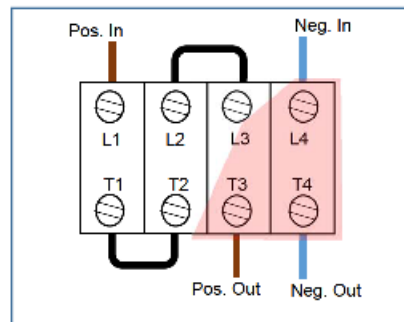
- 3.6. The fire damaged isolator enclosure (exhibit [REDACTED]) showed localised damage to the top right-hand corner, affecting the top, right-hand side and rear of the enclosure. The front of the enclosure was mostly undamaged. The four DC cables had been severed by electrical arcing activity within the enclosure. The switch mechanism showed the greatest fire damage to the bottom right-hand corner (highlighted in pink on Image 1).

Image 1: Schematic showing the configuration and terminal designation of the switch mechanism inside the DC Isolator.
