## Collision between the ro-ro passenger ferry *Red Falcon* and the motor cruiser *Phoenix* Thorn Channel, Southampton, England 29 September 2018

### SUMMARY

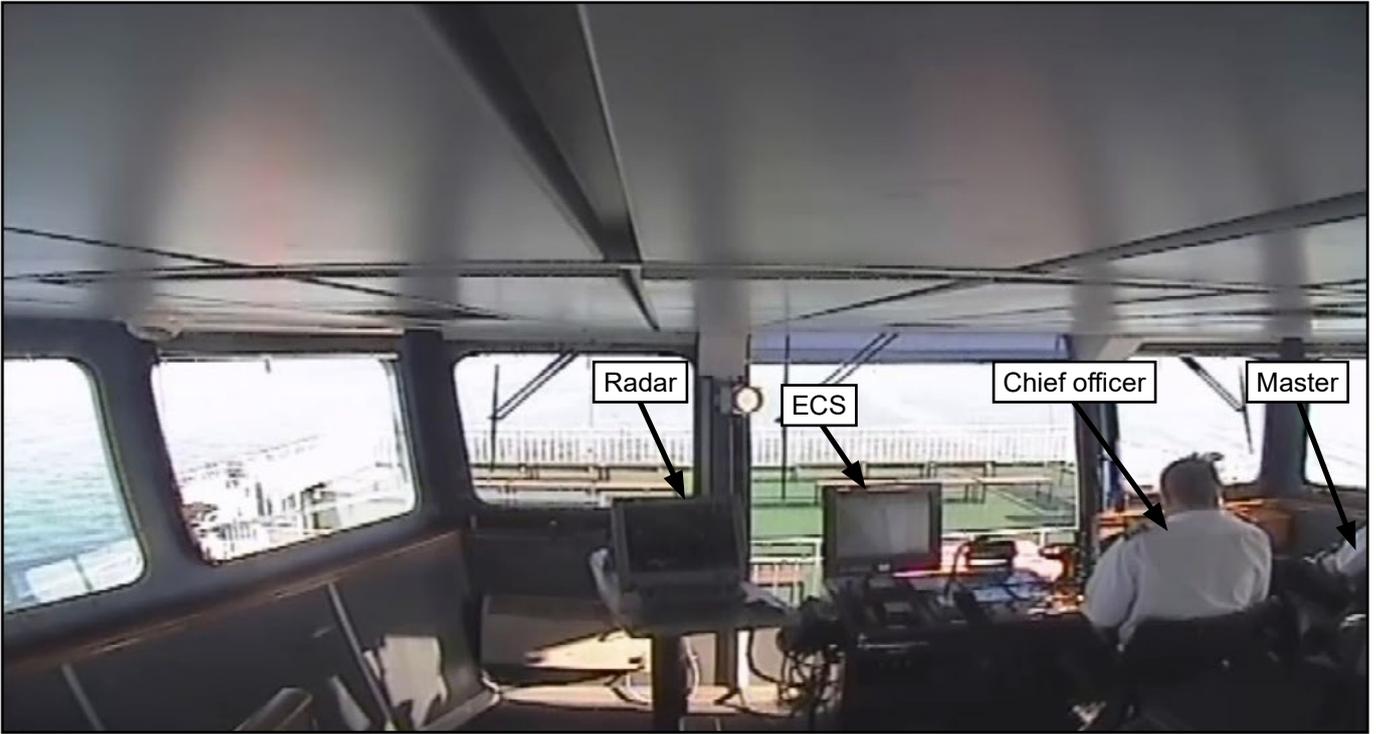
**Figure 2:** Red Falcon's bridge at 1627 (CCTV image)

At 1627, *Red Falcon*'s master called Southampton VTS<sup>2</sup> on VHF<sup>3</sup> channel 12 to advise that the ferry was passing the Hook buoy (**Figure 1**). The ferry was making good a course of 140° at 13.5 knots (kts)<sup>4</sup>. Meanwhile, the chief officer took over from the deckhand, and sat down behind the central propulsion control console. The master was seated on the starboard side of the bridge (**Figure 2**).

From the master and chief officer's seated positions, the shadow zone ahead was extended beyond 65m and the likelihood of Phoenix and its wake (Figure 4) being obscured by the window frames on the starboard side of the bridge (Figure 2) was also increased. In addition, both officers were unable to effectively monitor the radar display. Given the bridge layout and the adverse impact of the sun on effective visual lookout, it would have been appropriate for at least one of the bridge team to stand up and frequently check blind spots and the radar.

- The effectiveness of the lookout maintained on *Red Falcon's* bridge was reduced because the master and chief officer remained seated throughout the vessel's transit through the Solent, and did not lower the bridge window sun screens.

- From their seated positions, the master and chief officer could not monitor radar targets or check the blind arcs created by the bridge's window frames.

- Completed its own investigation report, which made recommendations connected with bridge manning, bridge watchkeeping procedures, the use of window blinds and the positioning of radar displays, which are intended to improve navigational watchkeeping practices.
- Issued a circular to all staff warning of the dangers of repetitive tasks and a fleet-wide letter regarding the conduct of navigation.

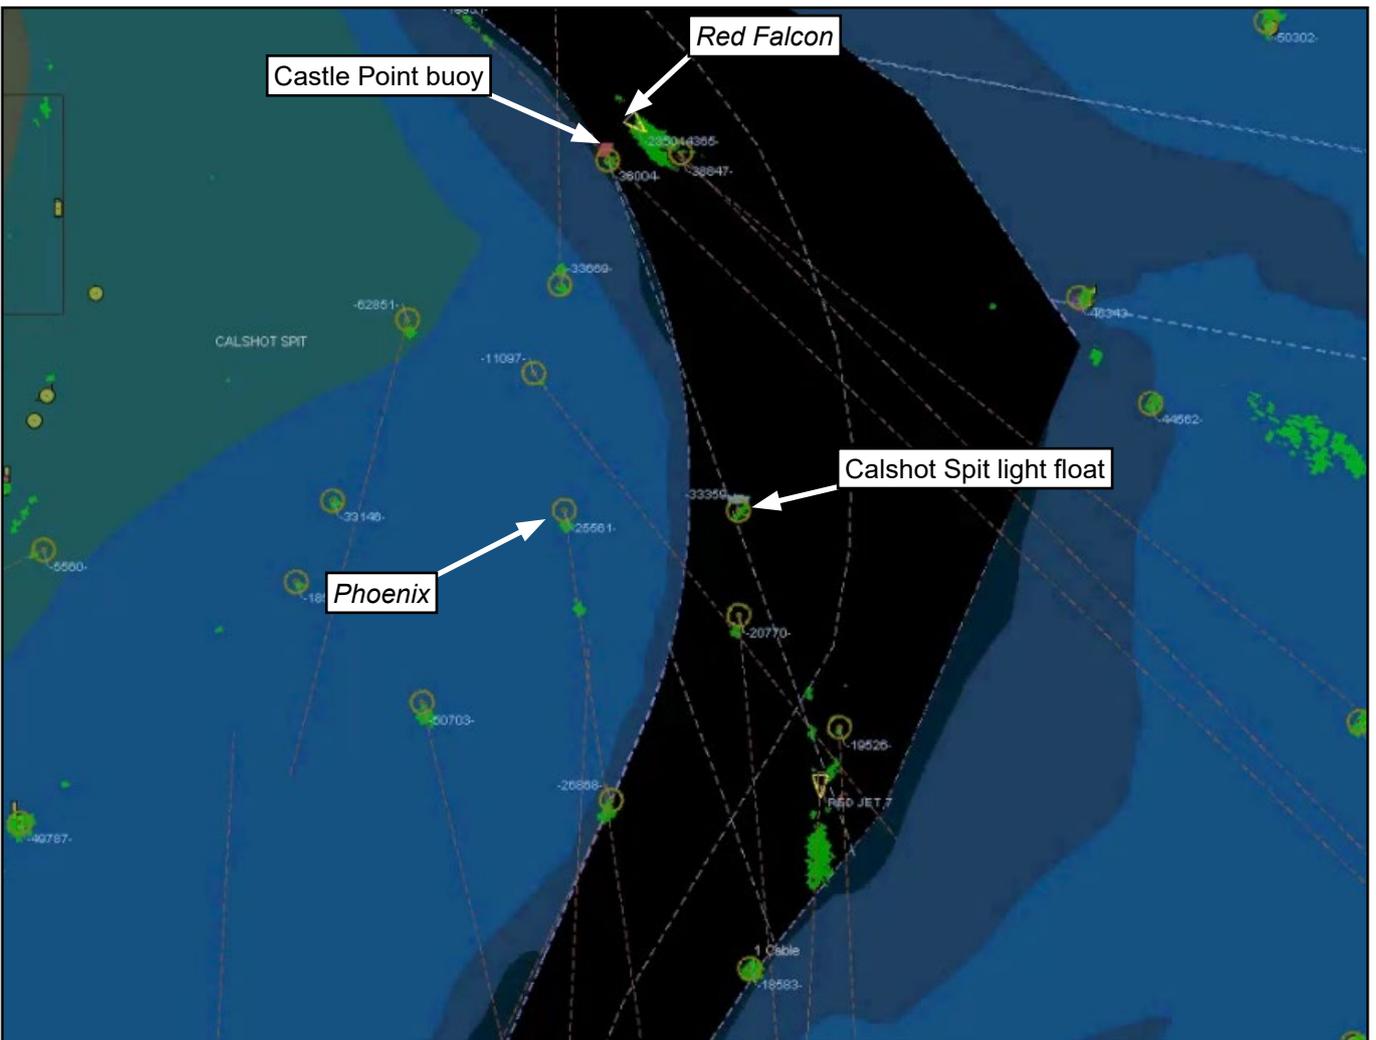
**Figure 3:** VTS radar at 1632

At 1632 *Red Falcon* passed to the east of Castle Point buoy (**Figure 3**) and an unknown motor cruiser passed down the ferry's starboard side. Moments later, the ferry commenced a slow turn to starboard into the Thorn Channel. During the turn, the master and chief officer discussed the fine weather and several small slow-moving recreational craft on the Calshot

Only a visual lookout was maintained on board *Red Falcon*, which was usual practice given the visibility and traffic density, and *Phoenix* was one of several small recreational craft on Calshot Spit Bank (**Figure 3**) that were discussed by the ferry's bridge team during the turn into the Thorn Channel. The master's assessment that none of these craft were of concern was probably based on their slow speed, that they were outside the main channel, and that the ferry would be steadying on its new heading for only a short period. He did not notice that *Phoenix*, which had seemingly briefly reduced speed between 1627 and 1632, was making good almost 8kts and was also entering the Thorn Channel. Consequently, as *Red Falcon* was steadied on about 216° at 1634:30, the bridge team's attention turned to the yacht on the ferry's port bow (**Figures 4 and 5**) that was impeding the next intended course alteration to the south. In addition to watching the yacht, the chief officer would also have been concentrating on steadying and keeping the ferry on its new heading.

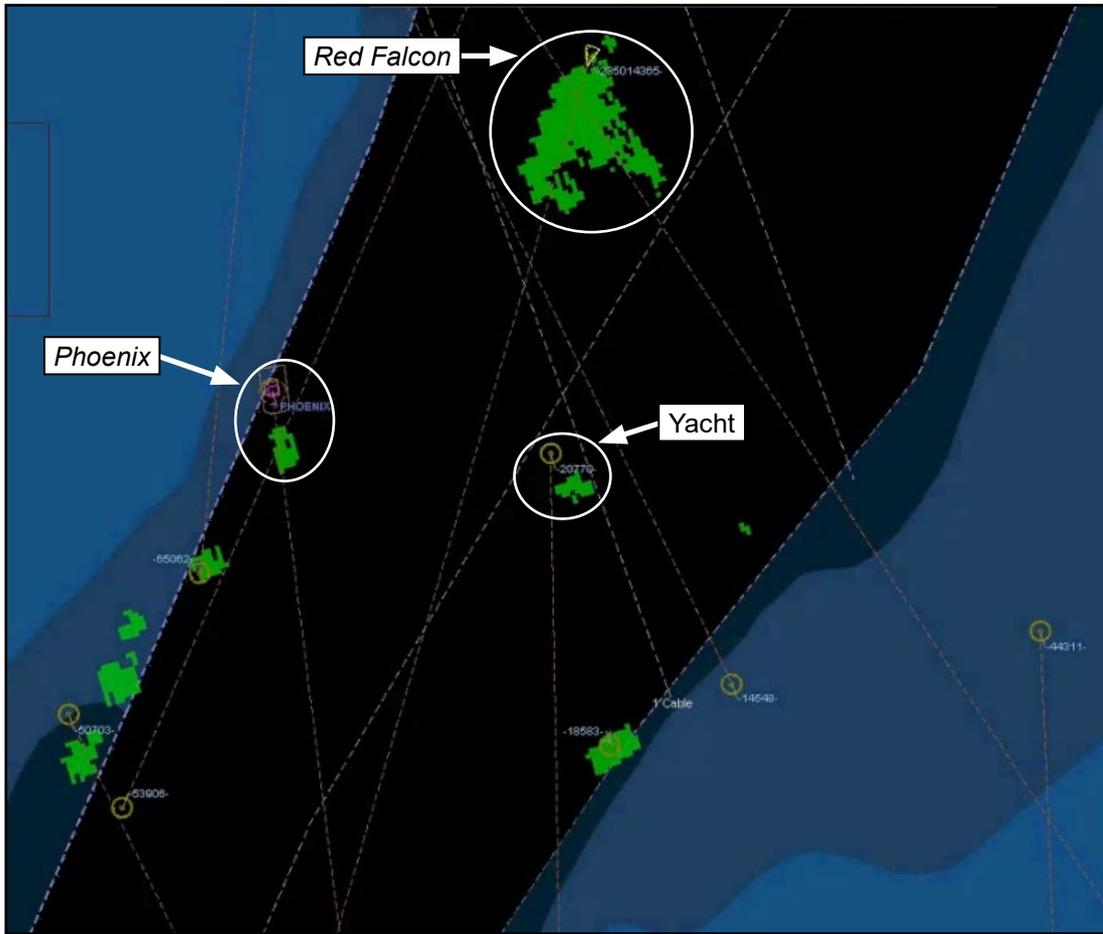
Figure 5: VTS radar at 1634.31

At 1634:30, *Red Falcon's* chief officer steadied the ferry in the Thorn Channel on a heading of about 216°. The bright sun was now about 25° off the starboard bow with significant glare being reflected off the water. However, the master, who was using sun shades over prescription glasses, intended that the ferry remain on this heading for only a very short period before turning to the south to pass west of the North Thorn buoy. He and the chief officer, both of whom remained seated, were aware of a yacht on the port bow (**Figures 4 and 5**) and decided not to turn to the south before the yacht was sufficiently clear down the ferry's port side.

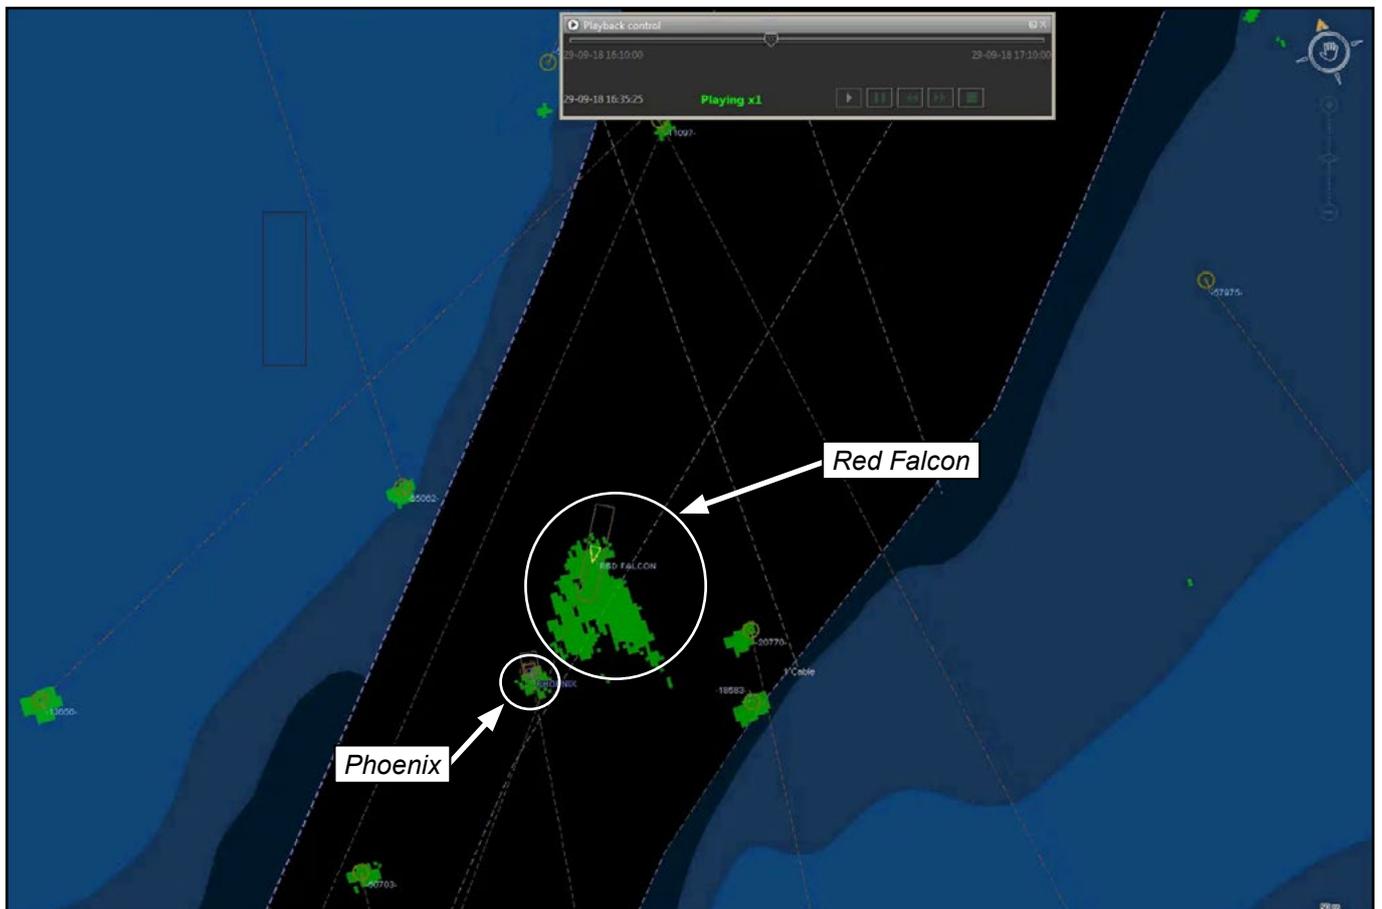
Figure 6: VTS radar image at 1635.25

At 1635:25, *Red Falcon* started to turn to port (**Figure 6**). Seconds later, the starboard side of the ferry's bow collided with *Phoenix's* port side. The motor cruiser was pinned against the ferry's bow for about 18 seconds during which time it was pushed over to starboard to an angle of approximately 40° (**Figure 7**).

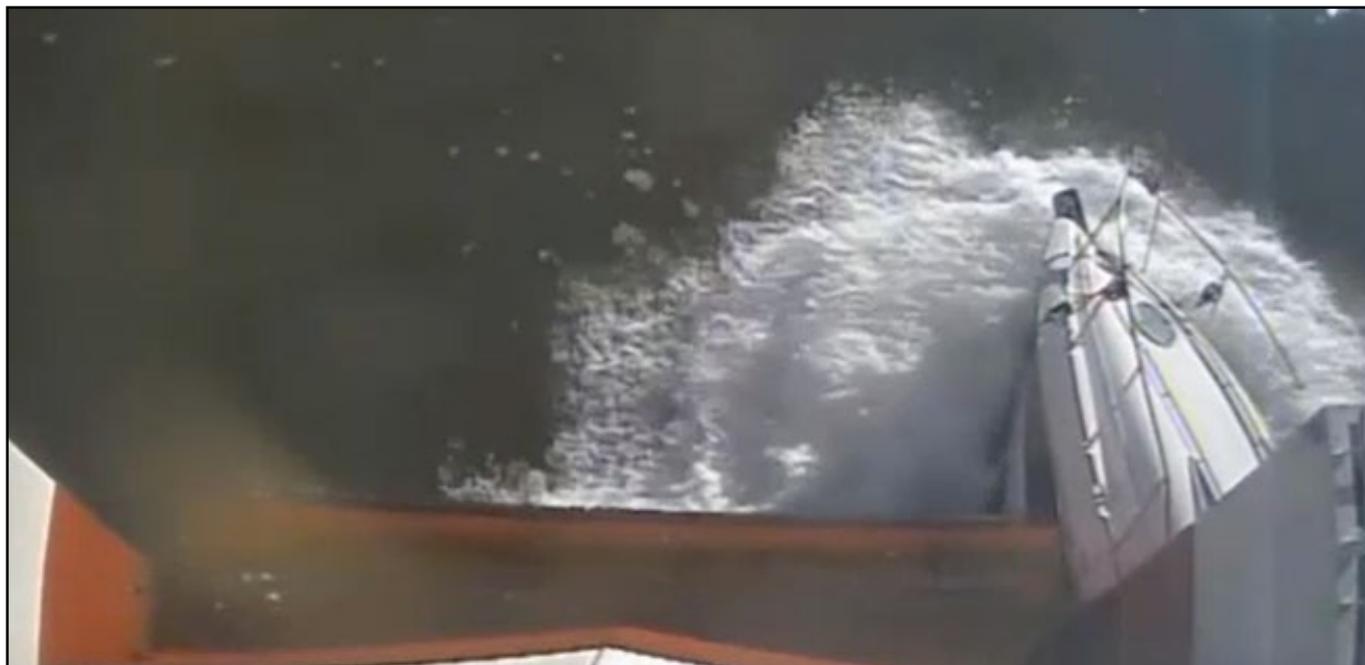
**Figure 7:** *Red Falcon* and *Phoenix* collision at 1635.41

At 1653, *Red Falcon* berthed at East Cowes where the master and chief officer reviewed the ferry's CCTV<sup>6</sup> recordings. Footage of the collision was found (**Figure 7**) and a check for damage identified marks and debris on the ship's forward belting. At 1715, the master informed Southampton VTS and Red Funnel's Head of Ferry Operations of the collision. The ferry then sailed for Southampton, where its master and chief officer were tested for drug and alcohol use on arrival. The test results were negative.

Damage to *Phoenix* included a 5m split in the hull to deck join, hull deformation, and detachment of sections of superstructure. The motor cruiser was declared a total constructive loss by its insurers. *Red Falcon* was not damaged.

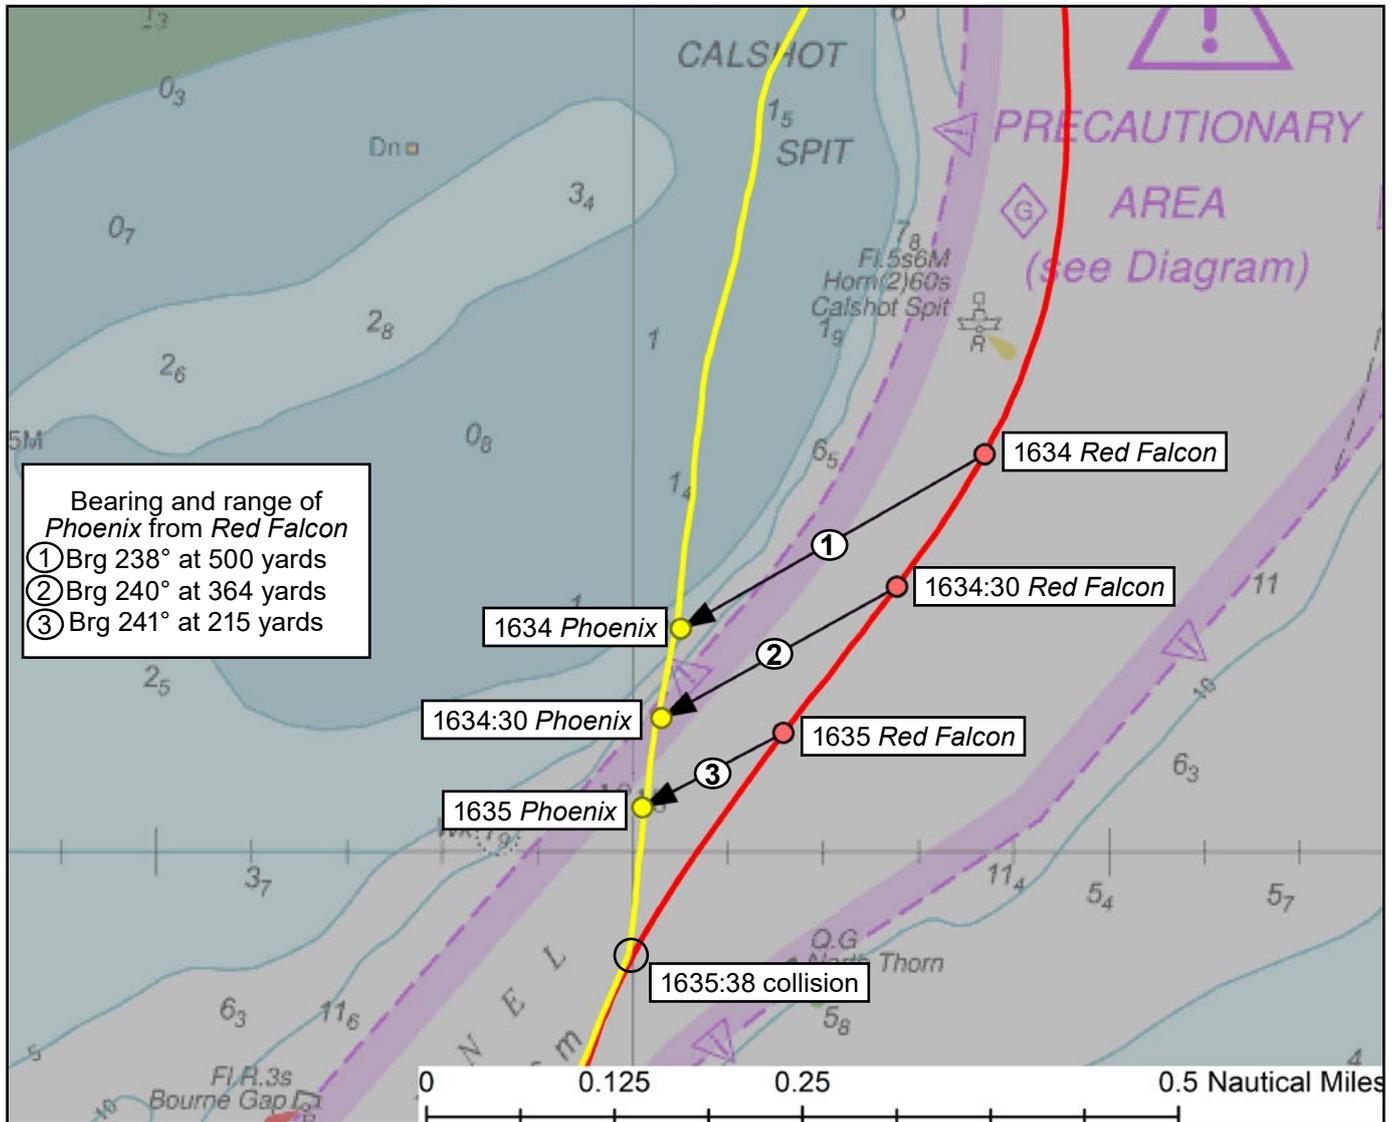
Figure 8: Red Falcon and Phoenix track history

Reconstruction of the tracks of *Red Falcon* and *Phoenix* in the Thorn Channel (**Figure 8**) shows that when the ferry steadied on a heading of about 216° at 1634:30, the motor cruiser had just entered the channel. The ferry was overtaking the motor cruiser, which was within 0.2nm on a bearing of 240°, with a speed advantage of about 6kts. The bearing of *Phoenix* from *Red Falcon* remained steady as the distance between the vessels reduced until the vessels collided at an angle of between 30° and 40°. No avoiding action was taken on board either vessel because *Red Falcon*'s master and chief officer were unaware of *Phoenix*, and the driver and other occupants of the motor cruiser were unaware of the ferry.

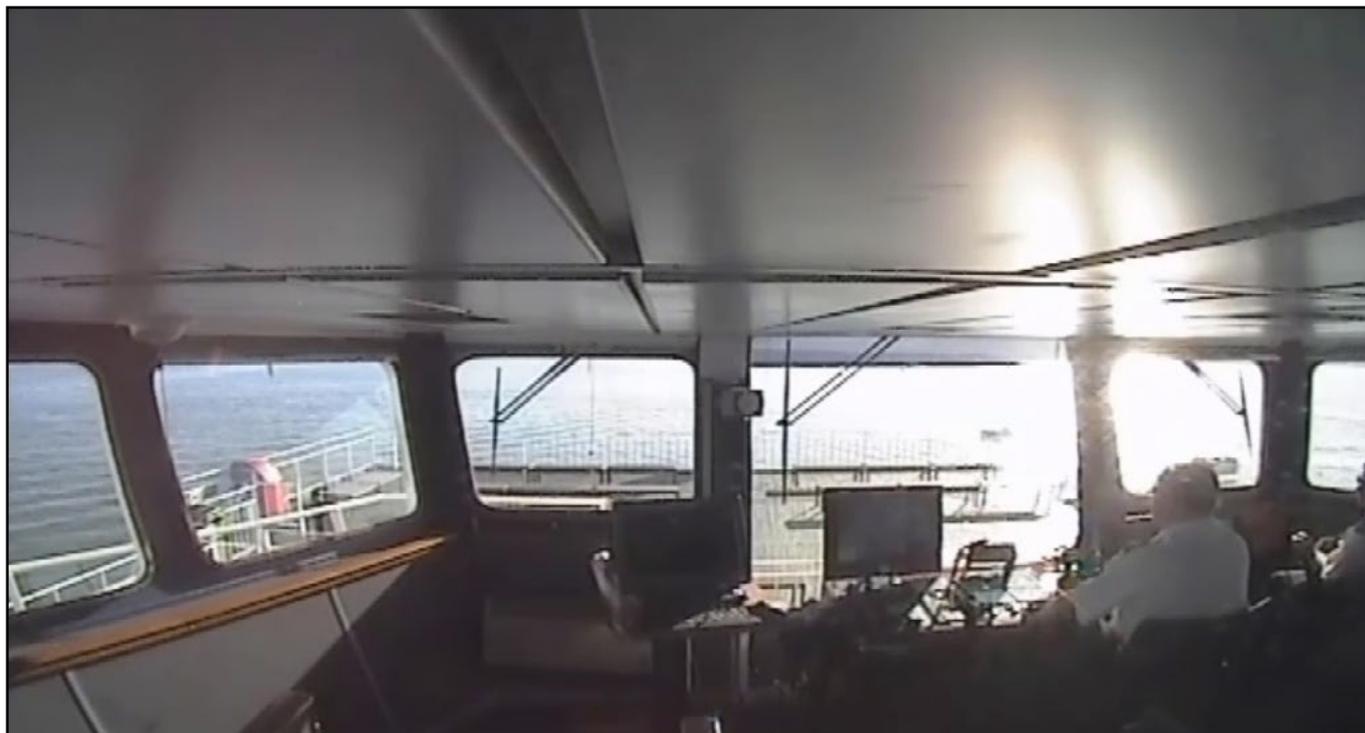
**Figure 9:** *Red Falcon's* bridge at 1635.07 (CCTV image)

Between 1634 and the collision just before 1636, not only was *Red Falcon*'s bridge team's focus largely to port, but also their view of *Phoenix* during this period was obscured by the sun's glare. The low sun (19°) was bearing 240° and therefore coincident with the bearing of *Phoenix* from *Red Falcon*. Although

the master wore sun shades over prescription spectacles, without the sun blinds, which were not used because of the imminent alteration of course to port, Phoenix would have been very difficult to see. Replay of the CCTV recordings indicated that Phoenix emerged from the sun's glare (Figure 9) only 14 seconds before it was lost from view as it entered the shadow zone ahead.

- *Red Falcon's* master and chief officer were focused on a yacht off the port bow, and the sun's glare on the starboard bow would have made *Phoenix* very difficult to see.
