Collision between the ro-ro passenger ferry *Red Falcon* and the motor cruiser *Phoenix* Thorn Channel, Southampton, England 29 September 2018

SUMMARY

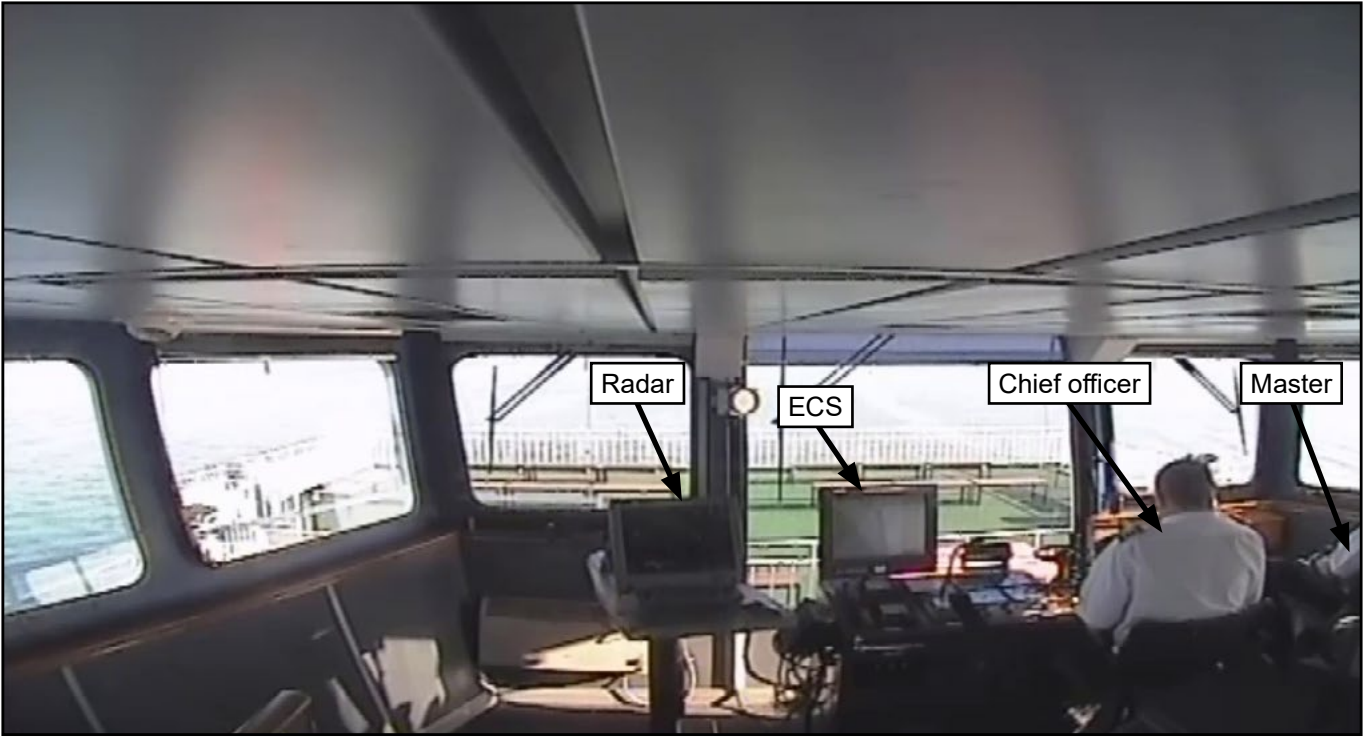
Figure 2: Red Falcon's bridge at 1627 (CCTV image)

At 1627, *Red Falcon*'s master called Southampton VTS² on VHF³ channel 12 to advise that the ferry was passing the Hook buoy (**Figure 1**). The ferry was making good a course of 140° at 13.5 knots (kts)⁴. Meanwhile, the chief officer took over from the deckhand, and sat down behind the central propulsion control console. The master was seated on the starboard side of the bridge (**Figure 2**).

From the master and chief officer's seated positions, the shadow zone ahead was extended beyond 65m and the likelihood of Phoenix and its wake (Figure 4) being obscured by the window frames on the starboard side of the bridge (Figure 2) was also increased. In addition, both officers were unable to effectively monitor the radar display. Given the bridge layout and the adverse impact of the sun on effective visual lookout, it would have been appropriate for at least one of the bridge team to stand up and frequently check blind spots and the radar.

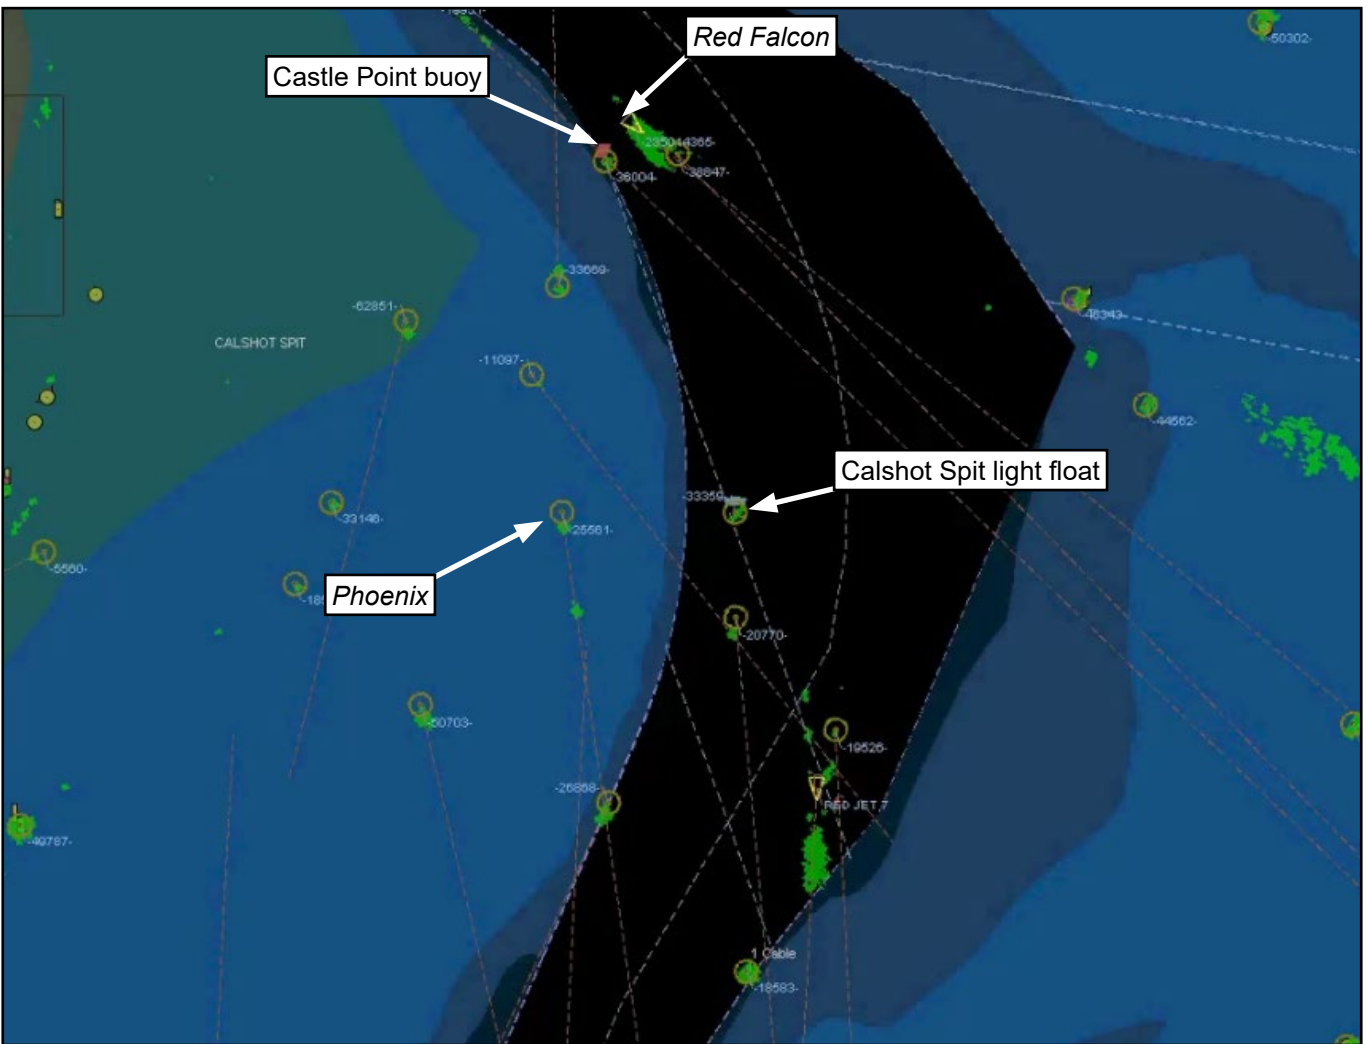
Figure 3: VTS radar at 1632

At 1632 *Red Falcon* passed to the east of Castle Point buoy (**Figure 3**) and an unknown motor cruiser passed down the ferry's starboard side. Moments later, the ferry commenced a slow turn to starboard into the Thorn Channel. During the turn, the master and chief officer discussed the fine weather and several small slow-moving recreational craft on the Calshot

Only a visual lookout was maintained on board *Red Falcon*, which was usual practice given the visibility and traffic density, and *Phoenix* was one of several small recreational craft on Calshot Spit Bank (**Figure 3**) that were discussed by the ferry's bridge team during the turn into the Thorn Channel. The master's assessment that none of these craft were of concern was probably based on their slow speed, that they were outside the main channel, and that the ferry would be steadying on its new heading for only a short period. He did not notice that *Phoenix*, which had seemingly briefly reduced speed between 1627 and 1632, was making good almost 8kts and was also entering the Thorn Channel. Consequently, as *Red Falcon* was steadied on about 216° at 1634:30, the bridge team's attention turned to the yacht on the ferry's port bow (**Figures 4 and 5**) that was impeding the next intended course alteration to the south. In addition to watching the yacht, the chief officer would also have been concentrating on steadying and keeping the ferry on its new heading.

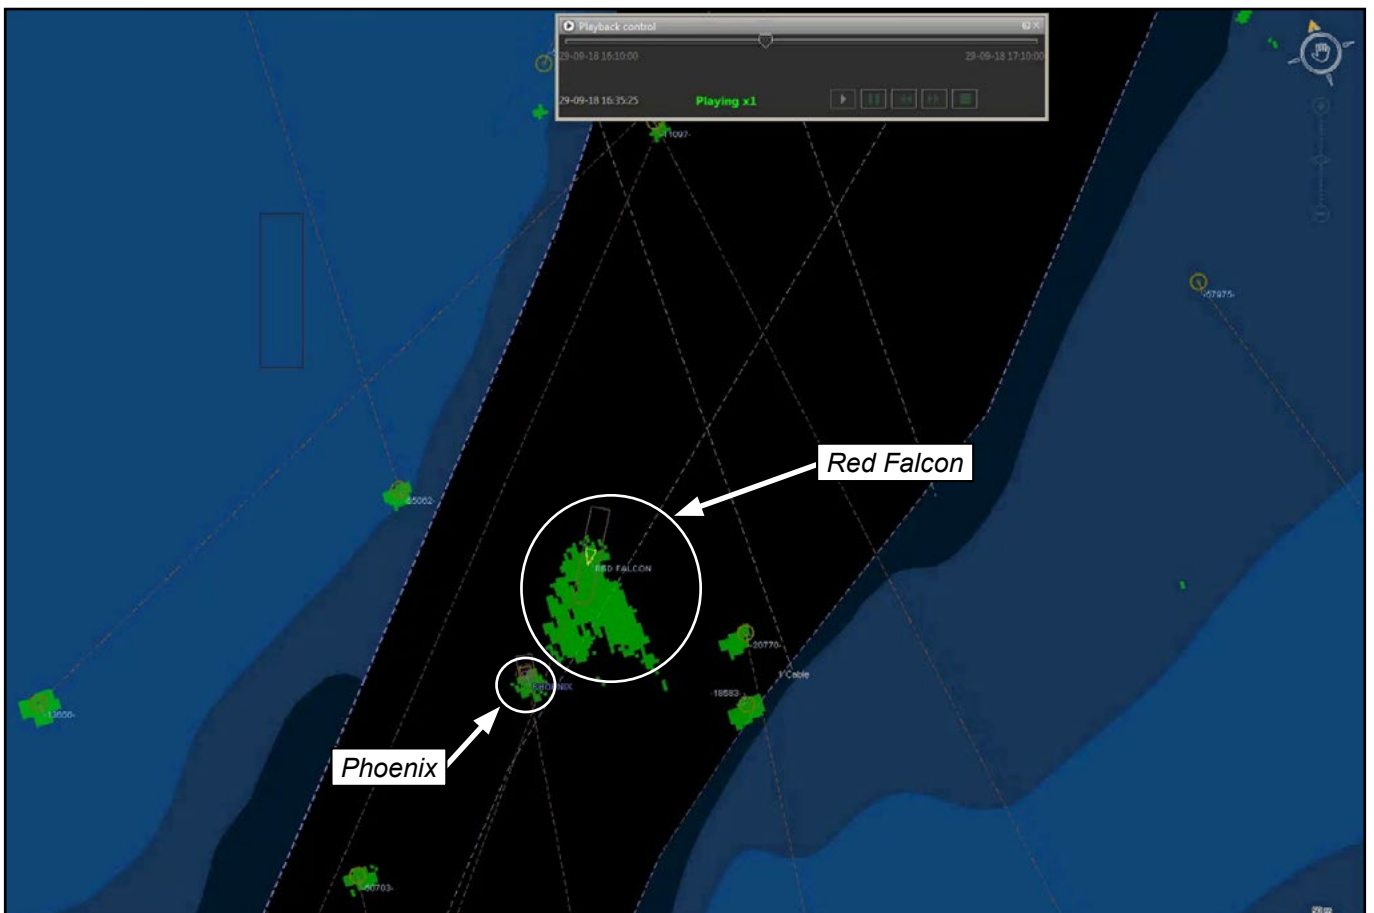
Figure 6: VTS radar image at 1635.25

At 1635:25, *Red Falcon* started to turn to port (**Figure 6**). Seconds later, the starboard side of the ferry's bow collided with *Phoenix's* port side. The motor cruiser was pinned against the ferry's bow for about 18 seconds during which time it was pushed over to starboard to an angle of approximately 40° (**Figure 7**).

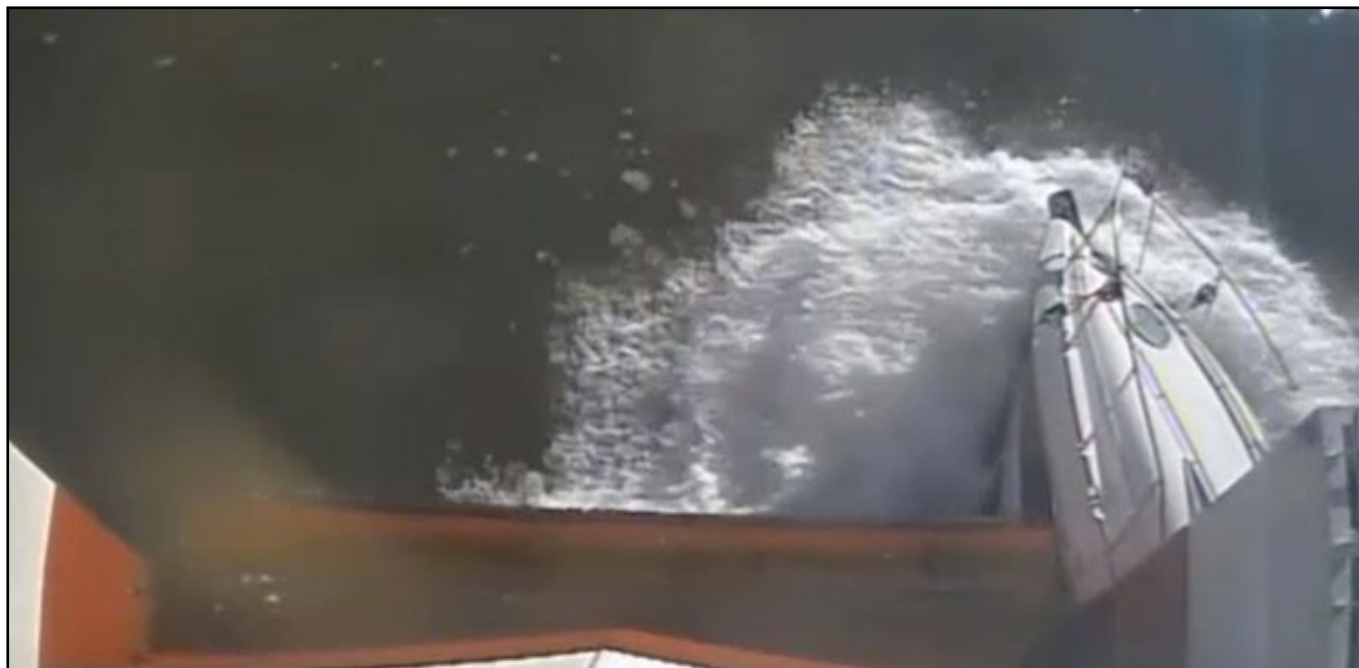
Figure 7: *Red Falcon* and *Phoenix* collision at 1635.41

At 1653, *Red Falcon* berthed at East Cowes where the master and chief officer reviewed the ferry's CCTV⁶ recordings. Footage of the collision was found (**Figure 7**) and a check for damage identified marks and debris on the ship's forward belting. At 1715, the master informed Southampton VTS and Red Funnel's Head of Ferry Operations of the collision. The ferry then sailed for Southampton, where its master and chief officer were tested for drug and alcohol use on arrival. The test results were negative.

Damage to *Phoenix* included a 5m split in the hull to deck join, hull deformation, and detachment of sections of superstructure. The motor cruiser was declared a total constructive loss by its insurers. *Red Falcon* was not damaged.

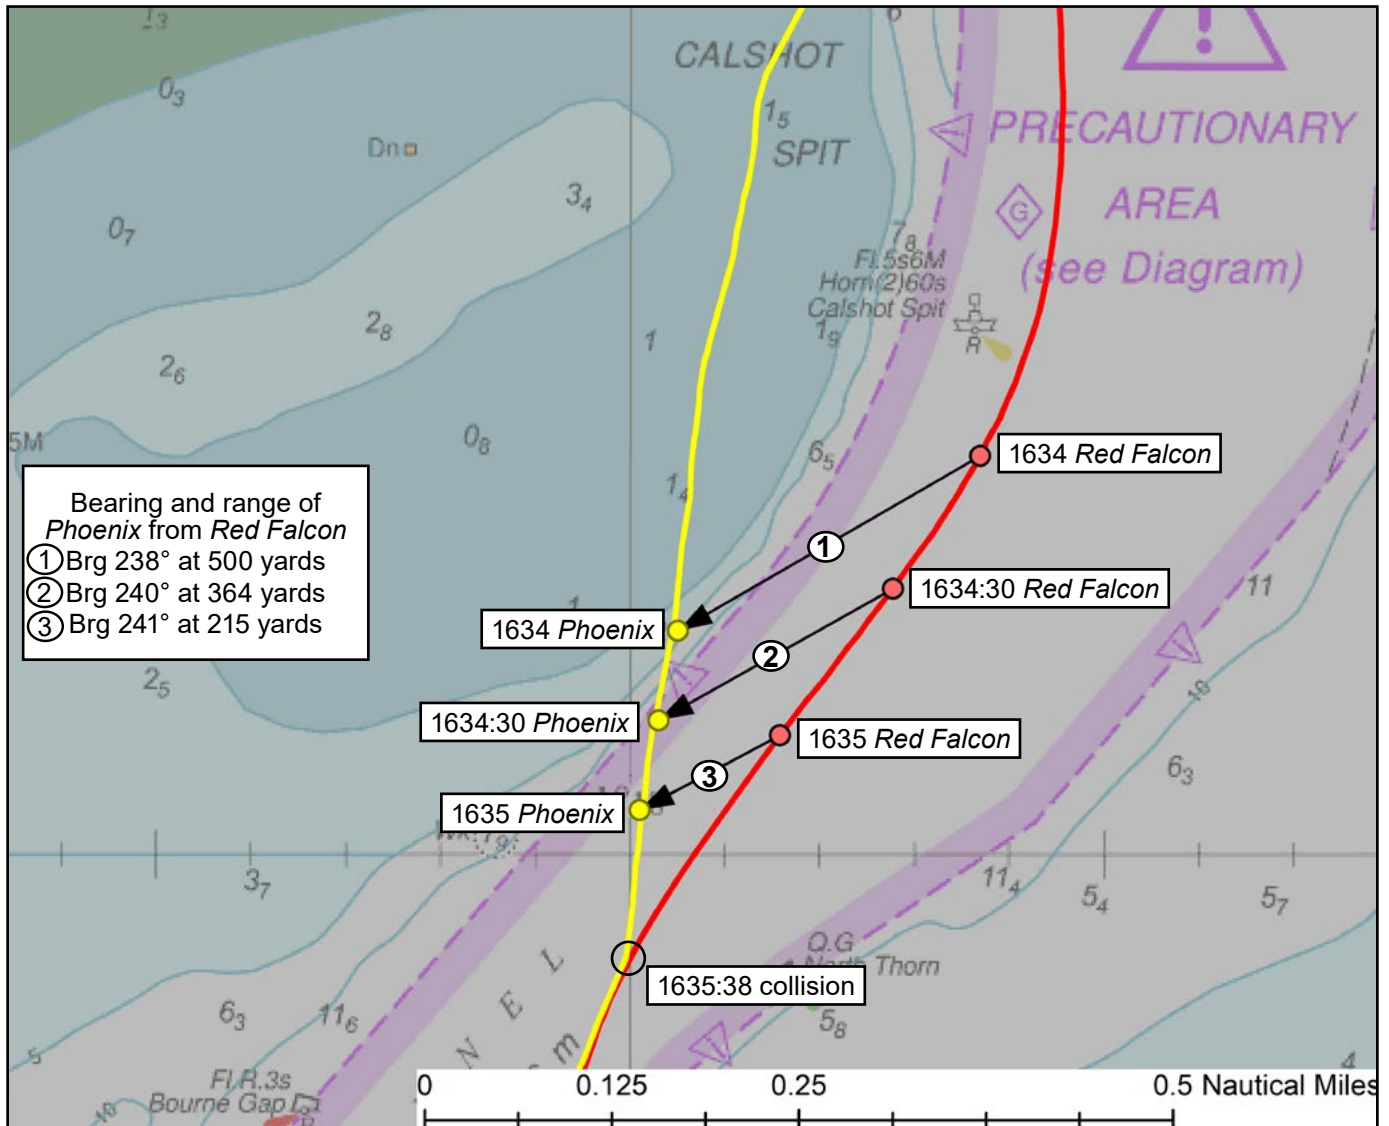
Figure 8: Red Falcon and Phoenix track history

Reconstruction of the tracks of *Red Falcon* and *Phoenix* in the Thorn Channel (**Figure 8**) shows that when the ferry steadied on a heading of about 216° at 1634:30, the motor cruiser had just entered the channel. The ferry was overtaking the motor cruiser, which was within 0.2nm on a bearing of 240°, with a speed advantage of about 6kts. The bearing of *Phoenix* from *Red Falcon* remained steady as the distance between the vessels reduced until the vessels collided at an angle of between 30° and 40°. No avoiding action was taken on board either vessel because *Red Falcon*'s master and chief officer were unaware of *Phoenix*, and the driver and other occupants of the motor cruiser were unaware of the ferry.

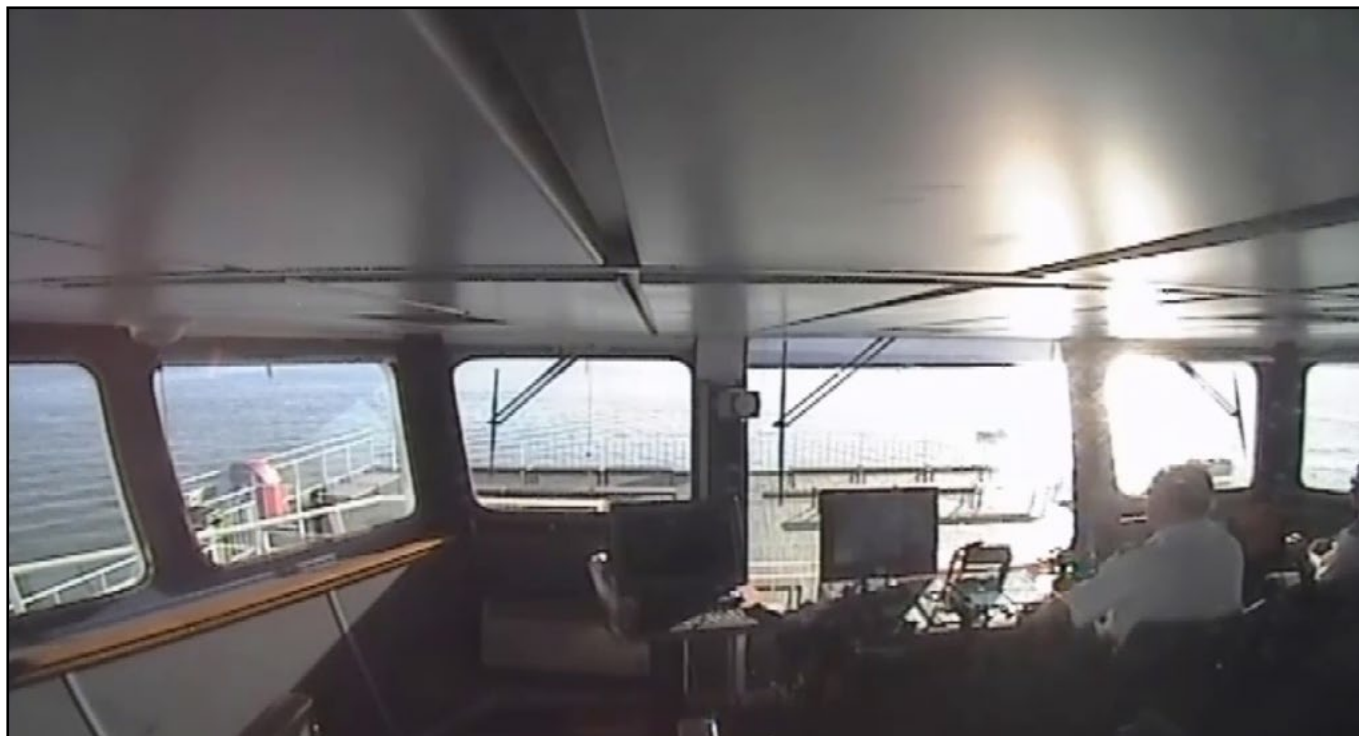
Figure 9: *Red Falcon's* bridge at 1635.07 (CCTV image)

the master wore sun shades over prescription spectacles, without the sun blinds, which were not used because of the imminent alteration of course to port, Phoenix would have been very difficult to see. Replay of the CCTV recordings indicated that Phoenix emerged from the sun's glare (Figure 9) only 14 seconds before it was lost from view as it entered the shadow zone ahead.
