Level crossing accident at Penrhyn, Ffestiniog Railway, 6 January 2019

Summary of the accident

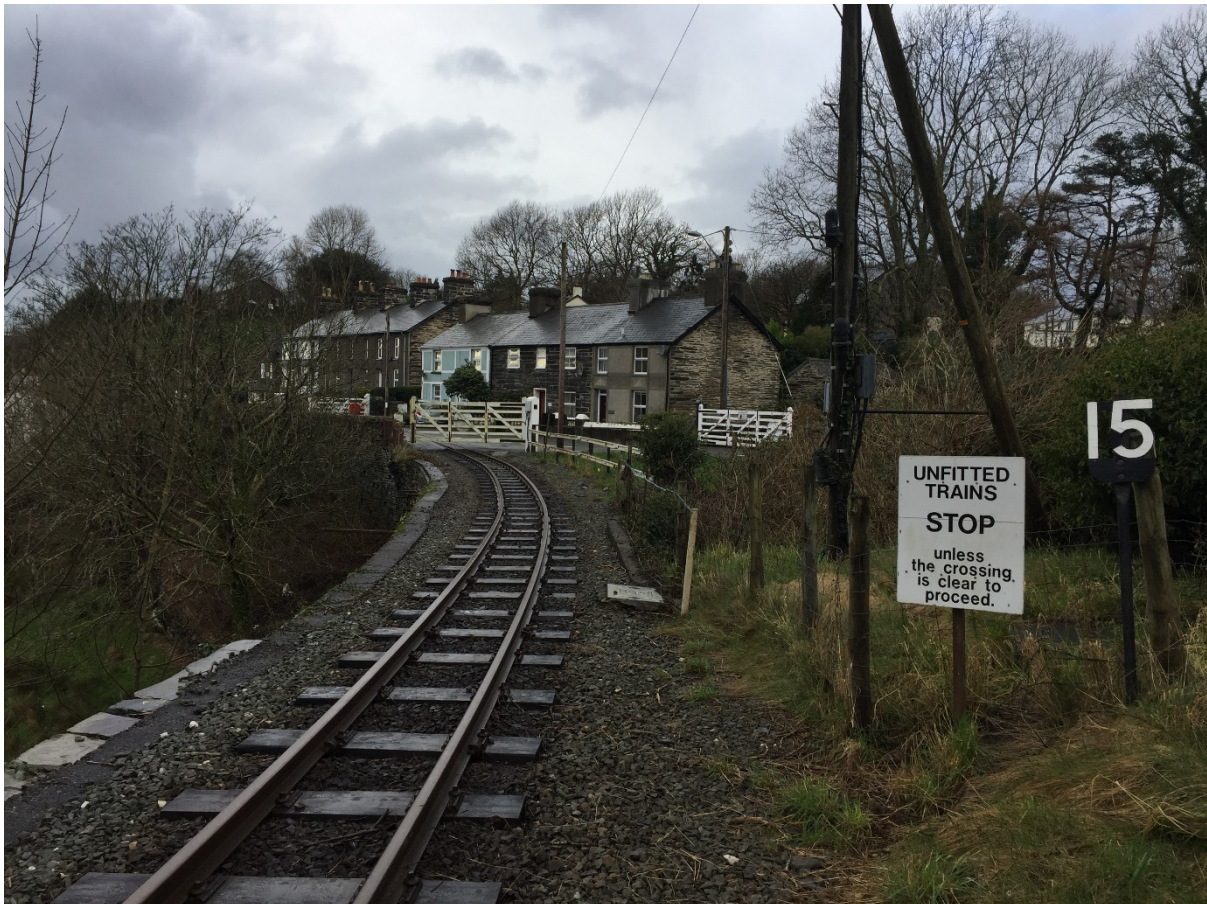
Figure 1: the approach to Penrhyn Level Crossing and the second stop board

The wheels of the locomotive locked approximately 15 metres before the crossing gates. The brakes of the van coupled to the locomotive were not applied until the last moment, and the rest of the train was not fitted with a continuous brake. Witness evidence indicates that the railhead was contaminated, probably with debris and road salt resulting from the spray thrown up by passing cars travelling over the crossing on the A4085.

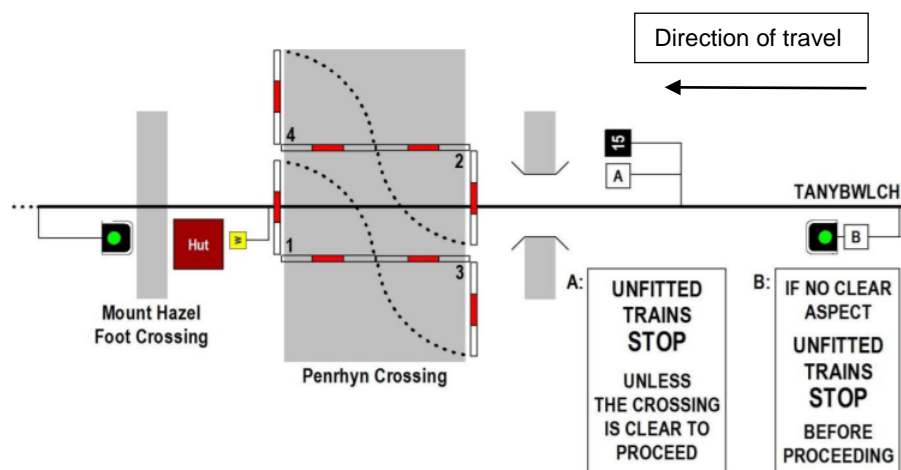
Instructions produced by the operating department of the Ffestiniog and Welsh Highland Railways, state that drivers of unfitted trains (trains without a continuous brake which can act on all the wheels of a train) approaching in the downhill (from Tan y Bwlch) direction must make their approach cautiously, prepared to stop at the crossing gate signal and associated stop board, which are approximately 120 metres from the crossing. If the signal is unlit (which was the case as passenger trains were not running on the railway at the time), the driver must stop at the signal and then proceed cautiously as far as the second stop board, 30 metres from the crossing. Unfitted trains must wait at the second stop board until the crossing has been closed to road traffic, in this instance by the train crew, and is clear for the train to proceed.

The driver stopped at the first stop board and then proceeded at walking pace, past the second stop board, with the intention of stopping close to the crossing gates. He stated that this was the custom and practice of the drivers who had trained him when he qualified as a driver in 2013, and, despite the local instruction in the operating procedures and the clear signage adjacent to the line, this was also his usual practice.

Figure 2: Extract from the Ffestiniog and Welsh Highland Railways Operating Department local instructions showing the placement and wording of the signs. Direction of travel shown for clarity.

There was a further incident in 2007 when a light engine ran into the gates, having been unable to stop due to the wheels locking. Railhead contamination was again cited as the cause. The local instruction for unfitted trains to stop at the second stop board has now been amended to also apply to light locomotives.
