Locomotive derailment at Doncaster, 21 December 2018

Summary of the accident

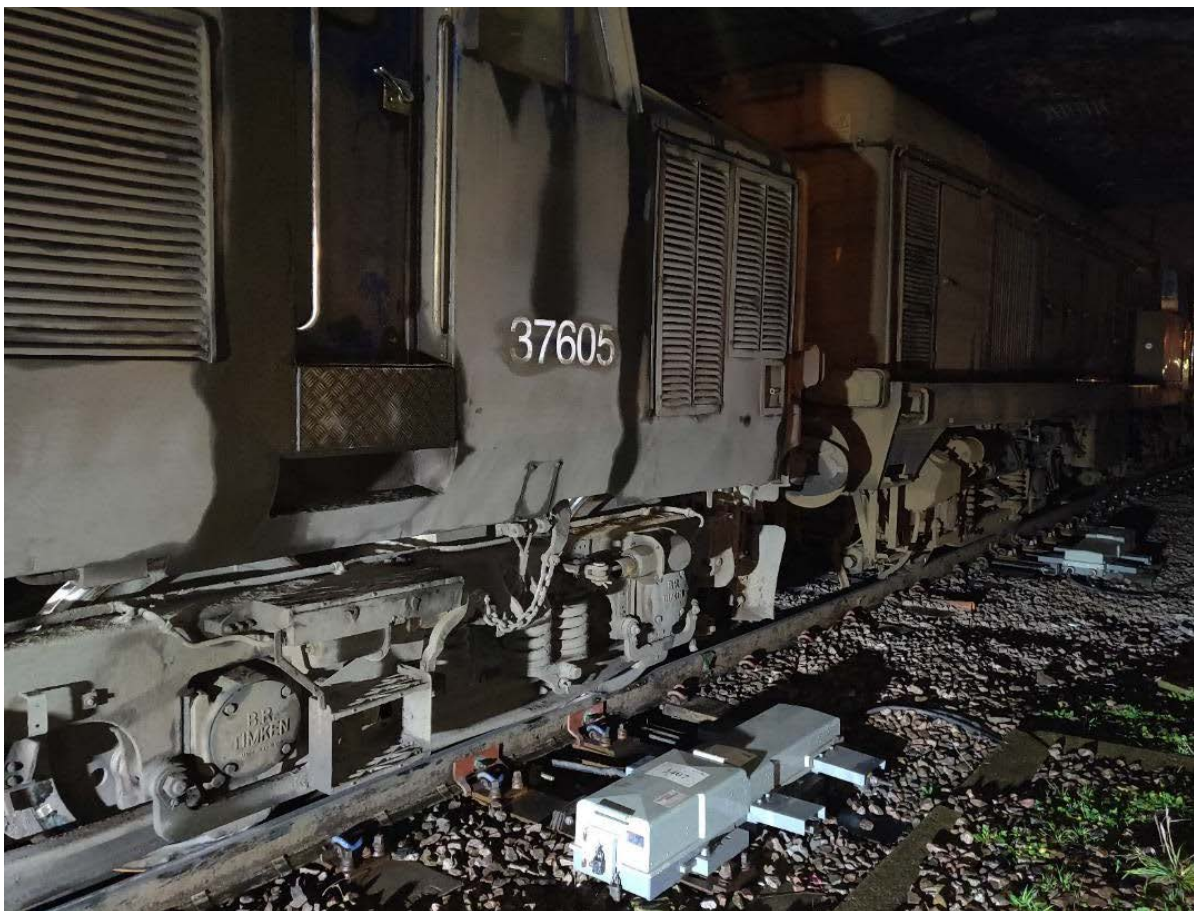
The Class 37 locomotive involved, with the second wheelset of its front bogie derailed

As the train negotiated the curve, the first two right-hand wheels of the leading bogie of the class 37 locomotive climbed the outside rail of the curve and derailed to the outside of the curve. The third wheelset on the leading bogie stayed on the rails until the bogie reached the crossing of a set of trailing points, at which point it also derailed.

The bogies of the class 37 locomotive each have three wheelsets, which increases the overall wheelbase compared to a two-axle bogie, and this is likely to have adversely affected the ability of the bogie to corner.

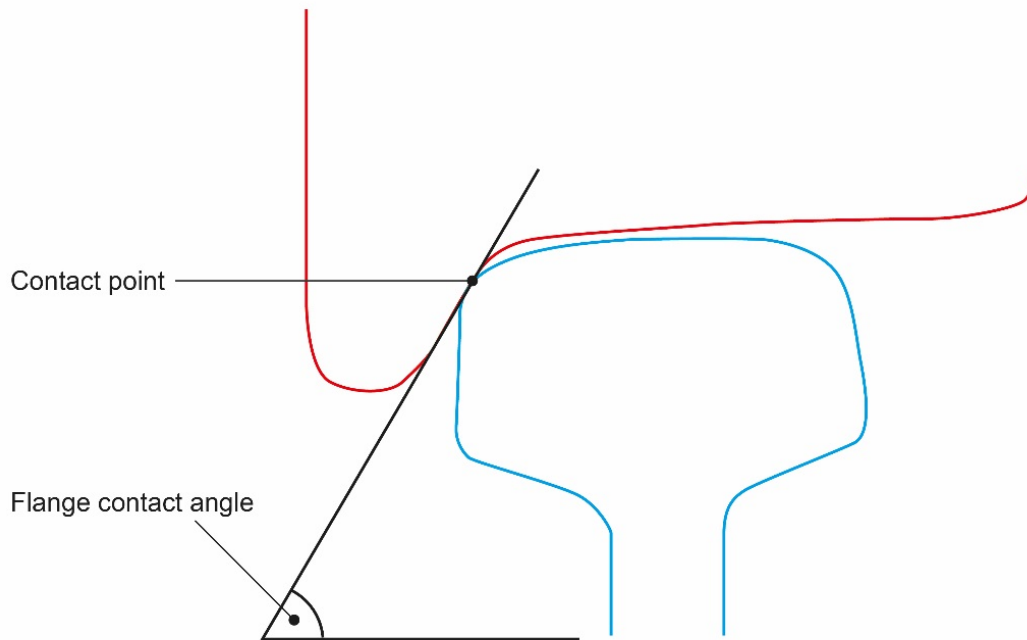
Derailements of this type, where the flange of a wheel climbs the outer rail of a curve, are complex and dependent on a number of factors. These include the lateral and vertical forces applied where the wheel flange contacts the rail, the flange contact angle (which depends on both the flange angle of the wheel and the profile of the rail), the level of friction between the wheel and rail and the presence or absence of a check rail. An adverse combination of some or all of these factors can lead to a derailment, and such a combination is likely to have been the cause of this derailment.

Representation of the flange contact angle as a wheel begins to climb the rail

The P1 wheel profile used on the class 37 locomotive is common across many older rail vehicles in the UK and has a designed flange angle of 62° . More modern wheel profiles (such as the P8 found on the class 66 locomotives) are designed with flange angles of between 68° and 70° . The shallower flange angle of a P1 profile increases the risk of derailment compared to a P8 profile, and as a result the P1 profile has less resistance to climbing the rail. As a P1 profile wears, the flange angle increases and hence the derailment risk decreases.
