Rail Accident Investigation Branch

Rail Accident Report

Passenger trapped and dragged at Notting Hill Gate station, 31 January 2018

Report 14/2018
September 2018

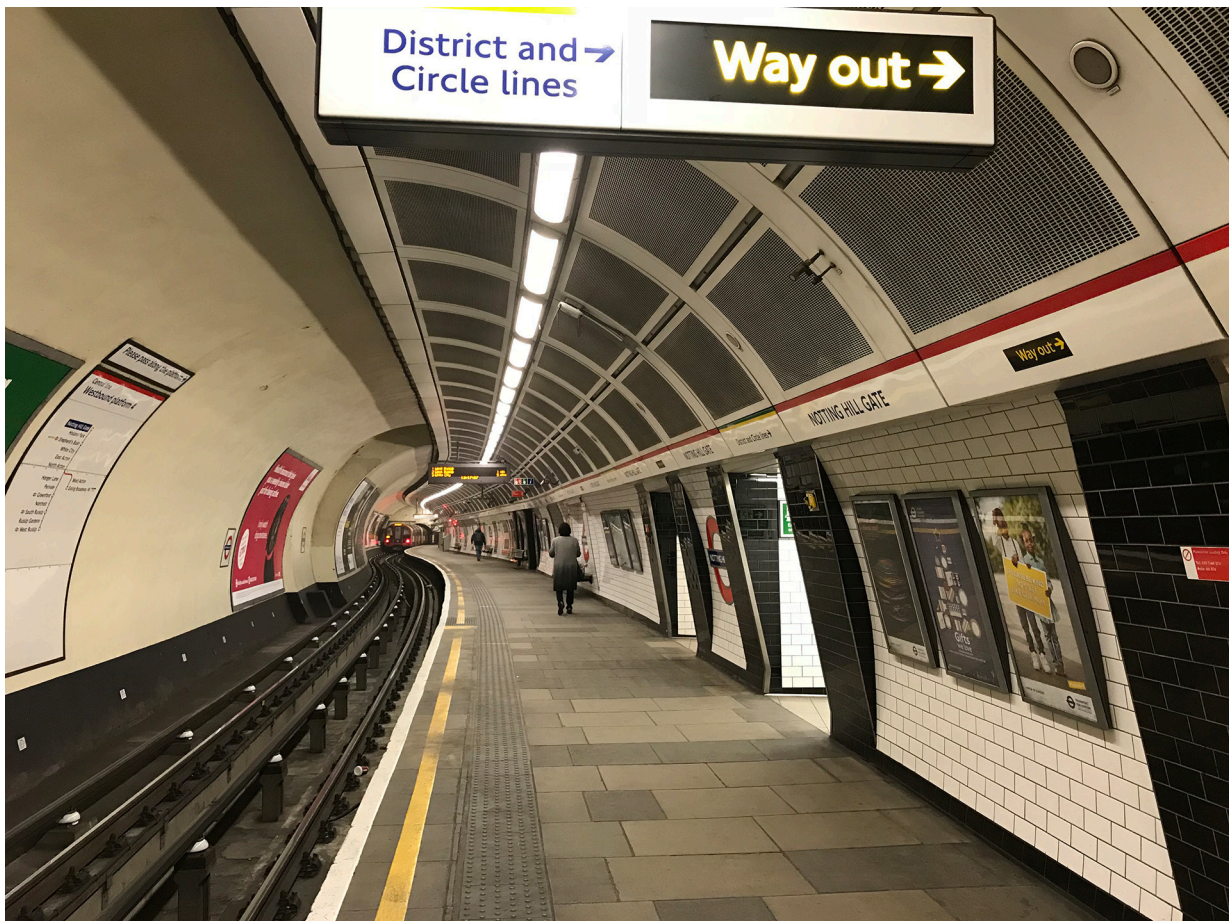
- 10 Platform 4 incorporates a reverse curve (ie an 'S' bend; figure 2) and, because of this, is classified by London Underground as a 'category A' platform. Category A platforms are defined as those where the train operator is unable to see the entire platform-train interface without mirrors or monitors. This means that platform staff are needed to assist with train despatch if the platform is busy or if the monitors are inoperative. At the time of the accident, the platform was not busy enough to warrant platform staff being needed.

Figure 2: View from the east (tailwall or rear) end of platform 4 at Notting Hill Gate facing west, showing the reverse curve

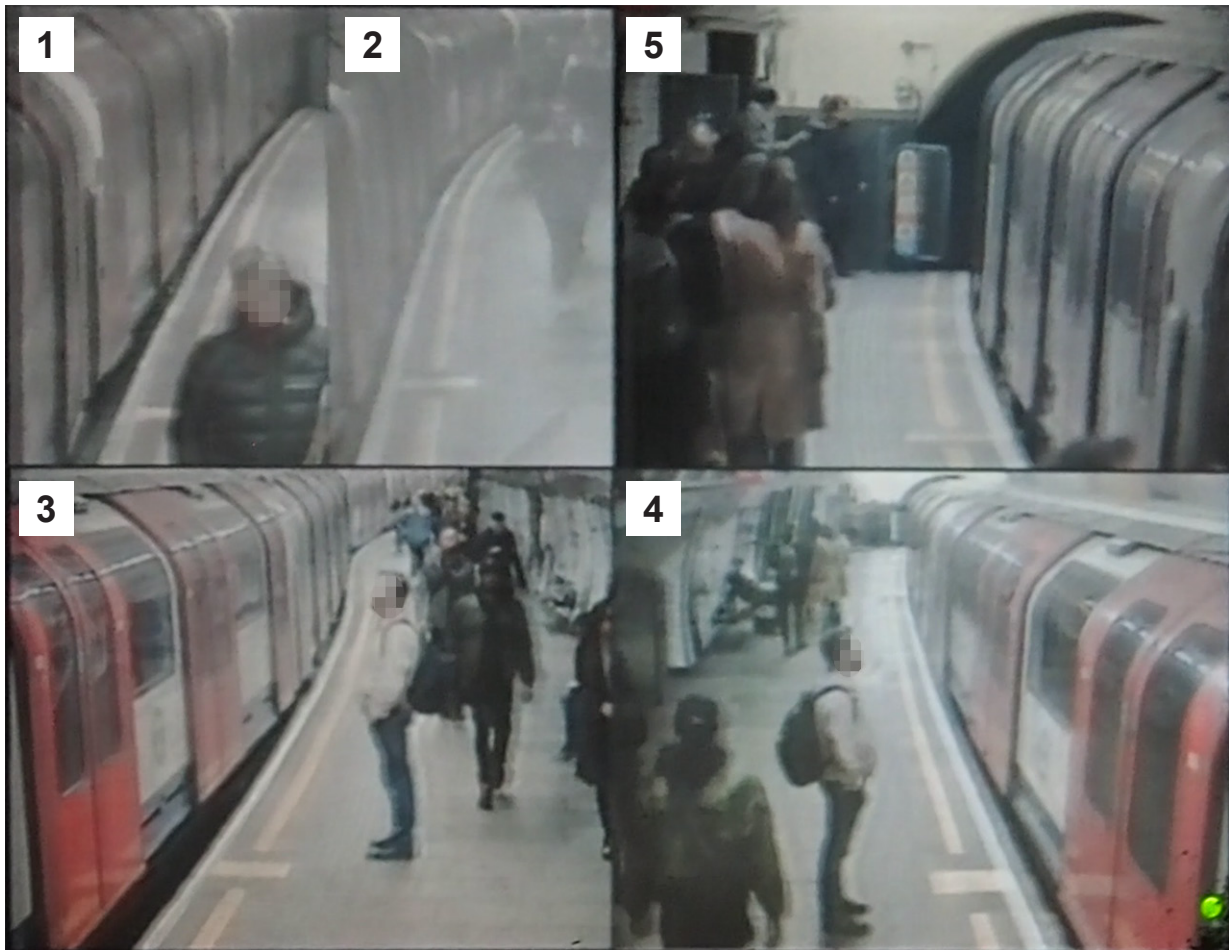
Figure 6: Arrangement of in-cab platform CCTV images at Notting Hill Gate platform 4 (numbers denote the ordering of images from front to rear of the train)

- 65 The investigation also examined the number and arrangement of images on the monitor, but the evidence is equivocal as to whether this could have affected the train operator's perception. LUL's current standard for platform-train interface CCTV sets out several requirements taking into account the visual information requirements of the train operator, which the Central line configuration does not meet (because it pre-dates that standard; paragraph 41). For instance, there should not be more than four images on a single screen, and the images from any cameras facing backwards should be inverted horizontally so as to display the platform side consistently across all images. Comparable standards for the mainline railway¹⁶ further require that all cameras should face in the same direction, and that the arrangement of images on the monitor should be logical and sequential (eg arranged so that they can be read in a Z-shape from top-left to bottom-right).

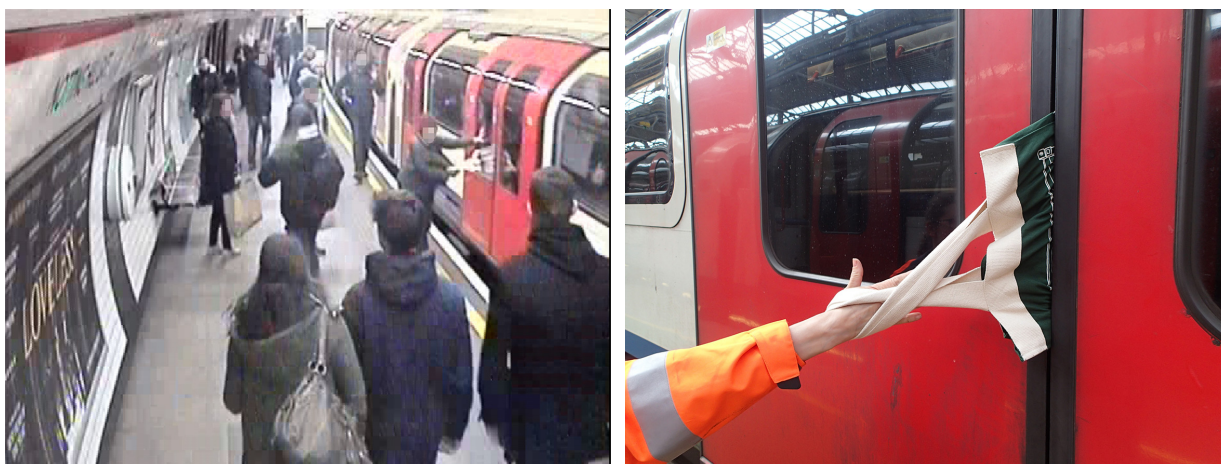
- 46 As the passenger led with her arm to try and board the train, her bag swung into the carriage, where the top of the bag became trapped in the closing doors (figure 7, left image). Witness evidence and station CCTV images suggest that the handles were twisted around her wrist. Tests conducted by the RAIB, using an identical bag and a 1992 stock train, showed that this would have made it very difficult to free herself (figure 7, right image). Because there were books and other belongings in the portion of the bag that was inside the train, it would also have been virtually impossible to pull the bag out of the doors.

Figure 7: Image from station security camera (left) and RAIB reconstruction (right) showing the bag trapped in the doors

- 1 *The intent of this recommendation is to reduce the risk of a train departing with something trapped in the doors, by improving the detection of small objects by the train's door systems.*

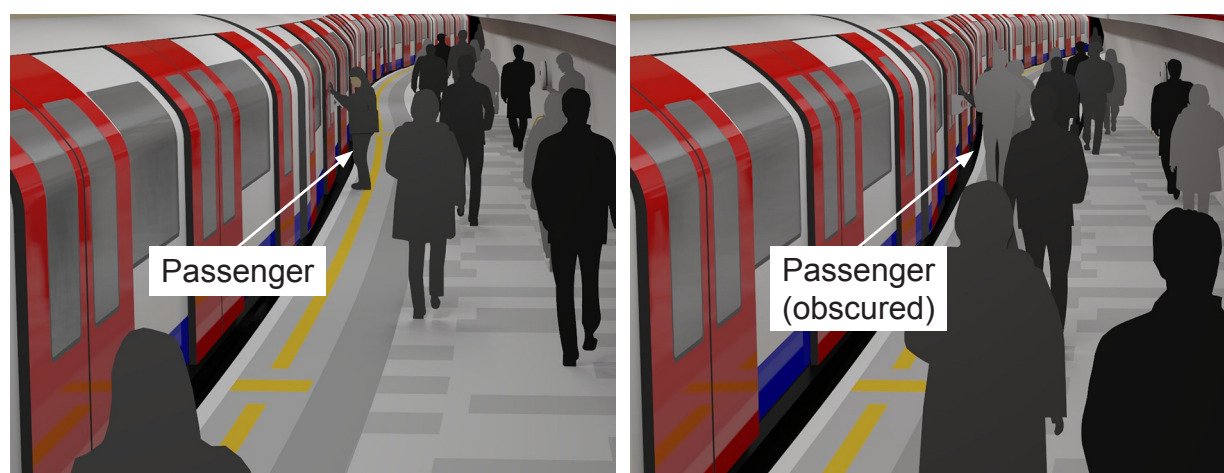
- 64 It is also possible that the view of the passenger was obscured by other people on the platform at the moment when the train departed. Because the in-cab monitor images are not recorded, the RAIB created a virtual model of the perspective from the relevant camera based on a site survey and reconstruction, as well as images that were recorded from station security cameras. The model shows that, at the time the train departed, there was a person on each side of the passenger, potentially blocking the train operator's view of her. However, about seven seconds before departure, when the train operator initially tried to start the train (paragraph 26), there was a clear view of the passenger (figure 8).

Figure 8: Virtual model of the perspective from the relevant platform-train interface camera showing the view seven seconds before departure (left image) and one second before departure (right image). NB: these represent the image that would have been displayed in the lower-left quadrant of the train operator's in-cab monitor.

- 3 *The intent of this recommendation is to optimise the views presented on in-cab CCTV monitors in order to minimise the possibility of a train operator being unaware of problems at the platform-train interface.*
