SAFETY FLYER TO THE FISHING INDUSTRY

Fishing vessel *Laura Jane* (SE80) capsized with the loss of one life

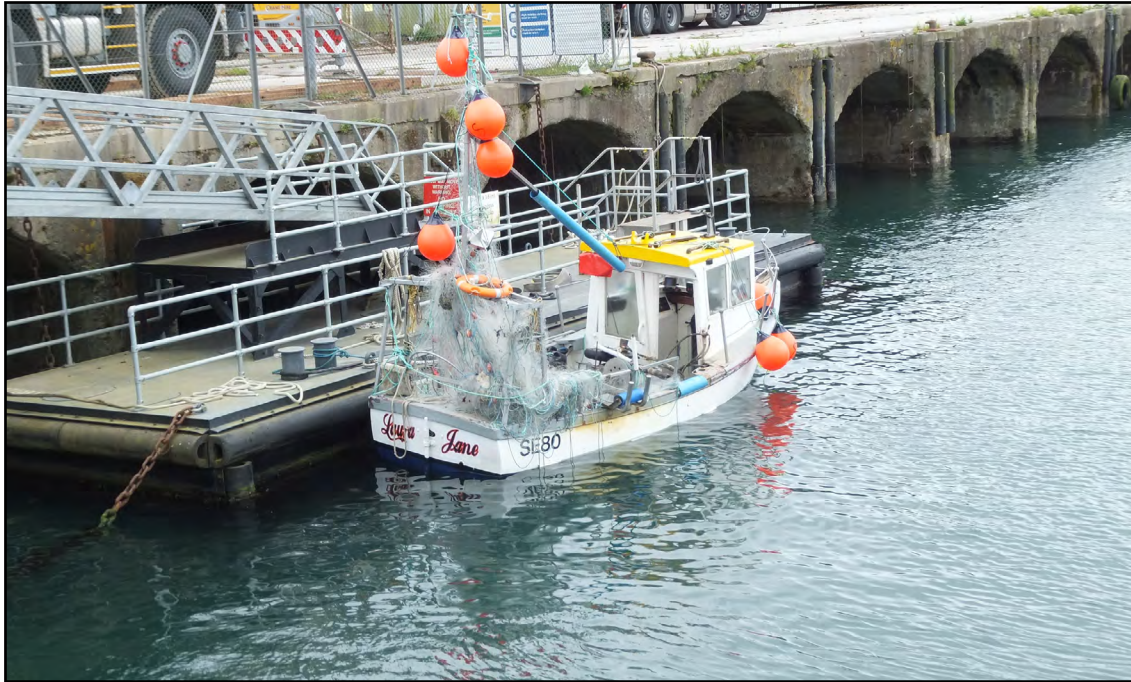
Fishing vessel *Laura Jane*

- The weight of the fishing gear on *Laura Jane* reduced its freeboard to the extent that water entered the vessel through its freeing ports, causing it to capsize.
- In 2012, the Maritime and Coastguard Agency (MCA) had inspected and categorized *Laura Jane* as a decked vessel without knowledge of its freeboard. During its next inspection in 2016, *Laura Jane* was recategorised as an open vessel because it did not meet the recommended minimum freeboard for a decked vessel. Despite the recategorisation, the vessel's freeing ports were allowed to remain.

- The existence of freeing ports on an open vessel went unchallenged during subsequent MCA inspections of *Laura Jane* due, in part, to a misinterpretation by surveyors as to what was required to be inspected.
- The skipper had not completed the mandatory Safety Awareness and Risk Assessment training course or any stability awareness training.

1. Open fishing boats are not permitted to have freeing ports. A low freeboard significantly reduces the stability reserve of small vessels, increasing the risk of capsize.
2. Any vessel will capsize if overloaded. It is important to recognise the safe loading limits of the vessel and never to load it beyond these limits.
3. It is the owner and skipper's responsibility to maintain the seaworthiness and safety of their vessel.
4. Owners are advised to assess the stability of their vessels in accordance with MSN 1871(F), MGN 503(F) and MGN 526(F), and display stability guidance notice (Wolfson Guidance Mark) in a prominent place in the wheelhouse as well as on either side on the hull.
