# Near miss with track workers at Sundon, Bedfordshire, 12 December 2018

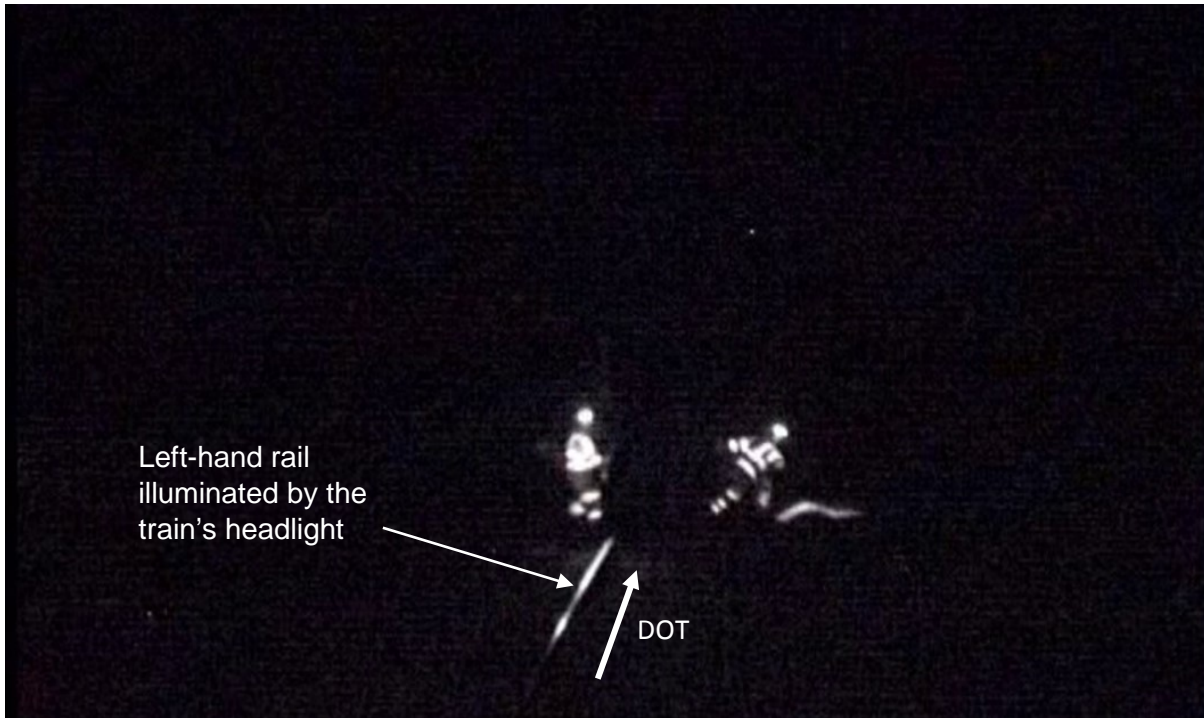
At around 23:50 hrs on the night of 12 December 2018, two track workers narrowly avoided being struck by an express passenger train that was travelling at about 100 mph (161 km/h) on the Midland Main Line near the village of Sundon, Bedfordshire. The track workers quickly moved clear to avoid being struck, having been alerted to the train's approach when the driver sounded the warning horn.

Forward-facing CCTV fitted to the train shows that the track workers were clear of the train's path less than two seconds before it passed them. Although nobody was physically injured, both track workers and the train driver were left shocked.

Forward-facing CCTV image showing track workers taking avoiding action less than two seconds before the train passed them (image courtesy of East Midlands Trains)

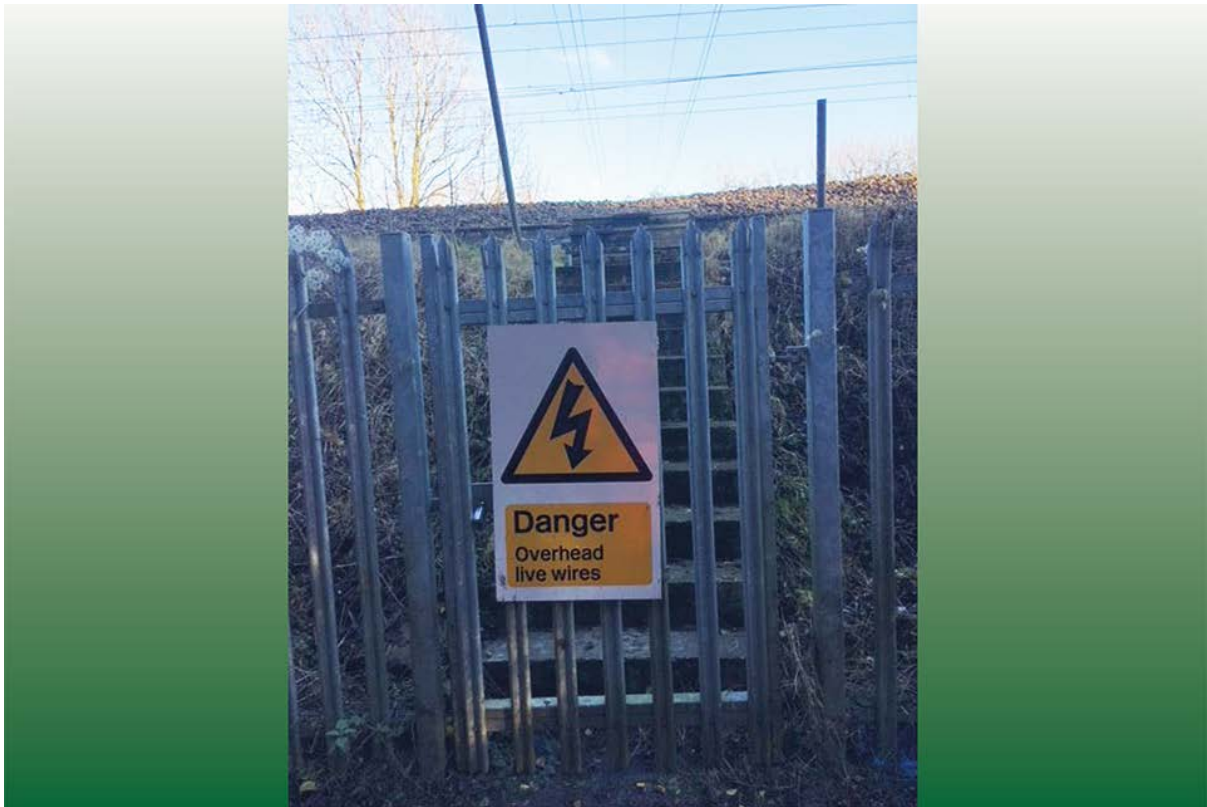
After driving for a further 600 metres, they came across another gated access point. This was at Water End Lane, but there was no signage at the access point stating this or giving the layout of the tracks at this location. The COSS again checked his paperwork and this time found the structures listed on his paperwork included one he could see near the access point.

The COSS and earthing assistant had been briefed at Legrave station at a location on the up slow line side of the railway. Neither realised that during the car journey from Legrave to Sundon they had driven underneath the railway and so both believed they were at an access point adjacent to the up slow line. However they were actually alongside the down fast line.

**The access point used by the track workers (image courtesy of Network Rail)**

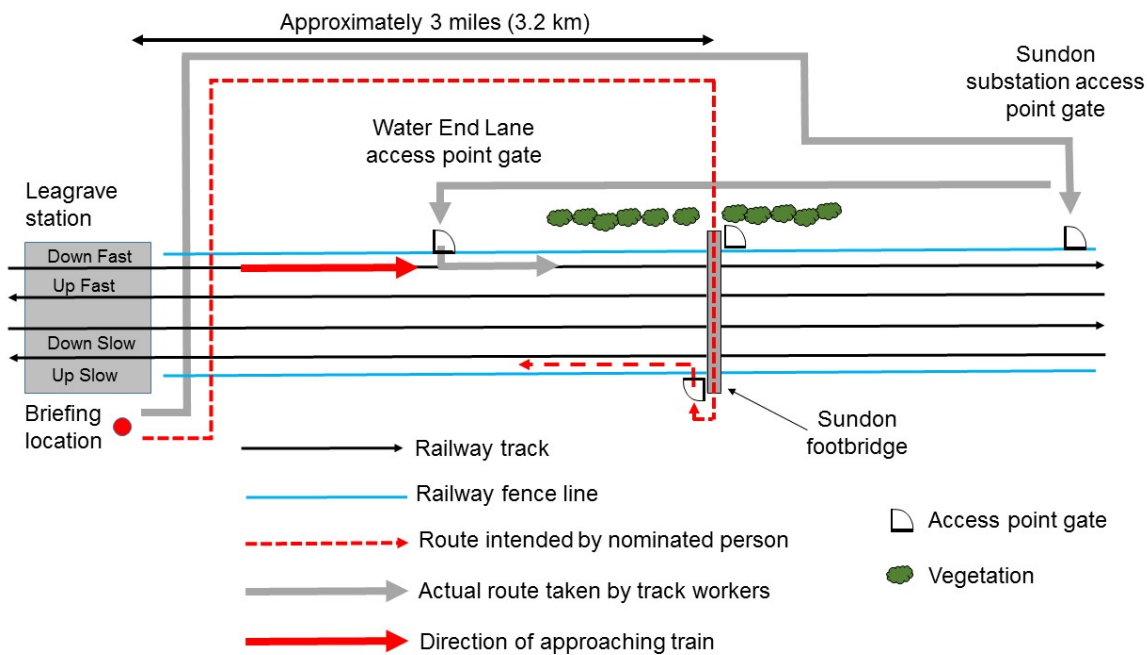
The COSS then phoned the nominated person to say they had reached the access point. The nominated person told them they could start work and that when through the access point gate they should turn left; crossing the footbridge was not mentioned. Following this phone call, the COSS and earthing assistant unlocked the gate, turned left and began walking along the nearest railway line to locate the first structure listed on the paperwork. They believed they were walking along the up slow line, which was closed to trains, but they were actually walking in the opposite direction along the down fast line which was open to train movements at up to 125 mph (201 km/h).

**Map showing intended route and actual route taken by the track workers**

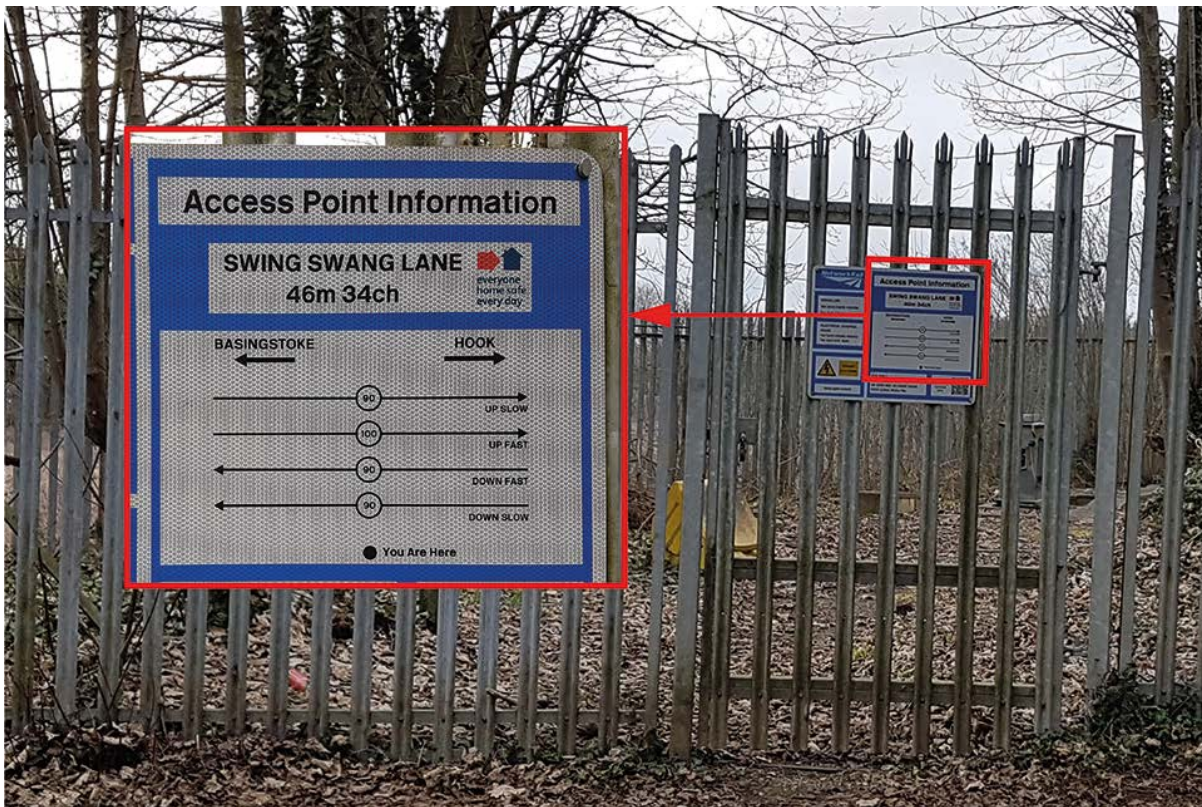
An example of access point information signage (as fitted near Basingstoke)

'develop and implement a programme for the provision of track layout information signage at all railway access points, showing mileages, line names and directions and other key items of local railway information, as appropriate'.
