SS Richard Montgomery Survey Report 2016

Maritime and Coastguard Agency
January 2019

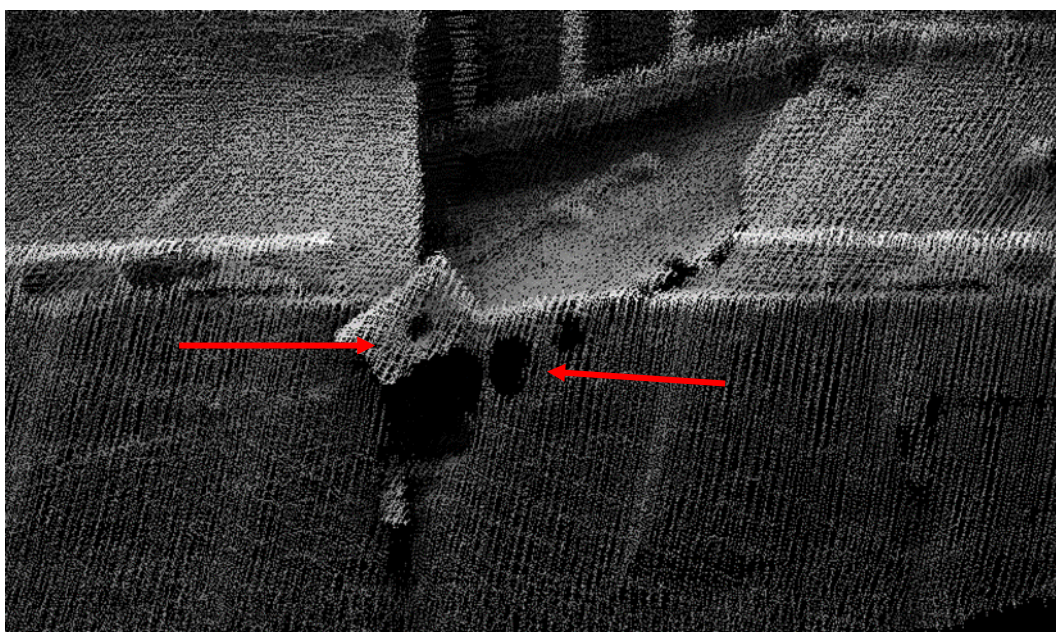
4.5.1 Key Area 1 (Feature ID04) is a crack in the hull located on the port side of the forward section of the wreck adjacent to hold 2. This crack has been known in the survey data since at least the 1970s and may have occurred at the time the vessel sank. Comparison with point cloud datasets from 2014 and 2015 suggests that changes have occurred in this location. The ship's gunnel, which originally bridged across the top of the crack, has fractured and slumped. The gunnel section now appears to be attached only to the section aft of the crack and hangs over the side below deck level. There is also evidence of an increase in the size of the crack in both the horizontal and vertical directions by up to 0.5m.

4.5.2 Comparisons of the datasets also suggests that there has been an increase in the size of the small holes on the aft side of the crack, measuring 0.1 to 0.2m across (these holes were considered to be part of the crack feature in the 2015 survey). The deck plating above has also cracked close to where the hull crack meets the deck level. The crack also appears to be spreading down below the broken gunnel as there is a strip devoid of soundings. However, the area that is devoid of soundings may be due to acoustic shadowing caused by an outward protruding flap of hull.

Fig. 3 Broken gunnel and holes in hull, port side, Hold 2

Table 3. Dimensions of crack in hull (ID04)		
Dataset	Height (m)	Width (m)
2014	3.3	2.2
2015	3.4	2.1
2016	3.9	2.4

6.7 The crack in the hull at Key Area 1 is closely linked with the collapse of the hold 2 deck plating. This has also shown some changes to the size of the holes (0.2m) and the spreading of these holes toward the fractured deck plate.

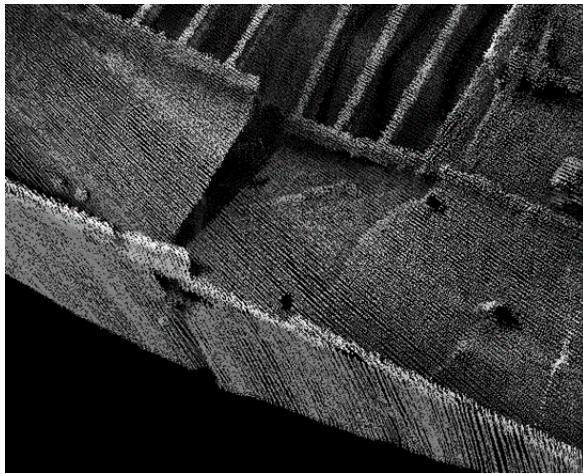
4.6.1 The collapsed deck plating on the port side of hold 2 consists of an area of deck that has shown gradual subsidence over a long period of time. The results of the 2016 survey also indicate that further subsidence has taken place.

Fig. 4 2015 data showing the collapsed deck plating at Hold 2.

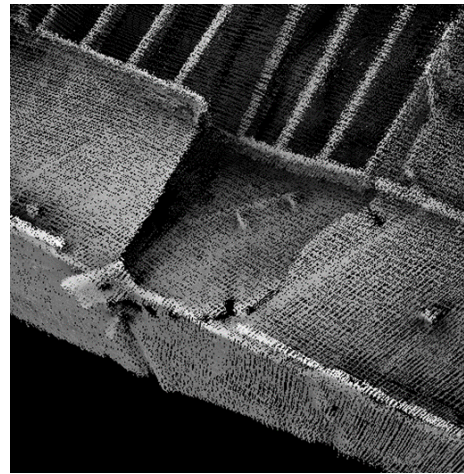
4.6.2 Comparison of the 2015 data against the 2016 data shows that further changes have occurred in this area. A new fracture is present on the aft side of the previously collapsed hold decking. Surface difference analysis confirms that the deck has collapsed further on the forward end by 0.35m, whilst the aft end has risen by 0.30m where the fracture is located. The forward end of the collapsed deck appears to be resting on the material within the hold.

Fig. 5 2016 data showing the collapsed deck plating at Hold 2

Table 4. Comparison of Collapsed Deck Depths			
Dataset	Depth	Magnitude of Collapse (m) from original deck level*	Collapse since last survey (m)
2014	5.8	1.7	
2015	6.0	1.9	0.2
2016	6.35	2.25	0.35

6.6 The key finding in the analysis of the 2016 data set was the continued fracturing of the deck plate at Key Area 2. The deck plating has continued to collapse (by 0.35m), the deck plate has fractured and some holes noted in the hull plating adjacent to this feature have increased in size by 0.2m. The gunnel has broken off and now slumps over the side below deck level.

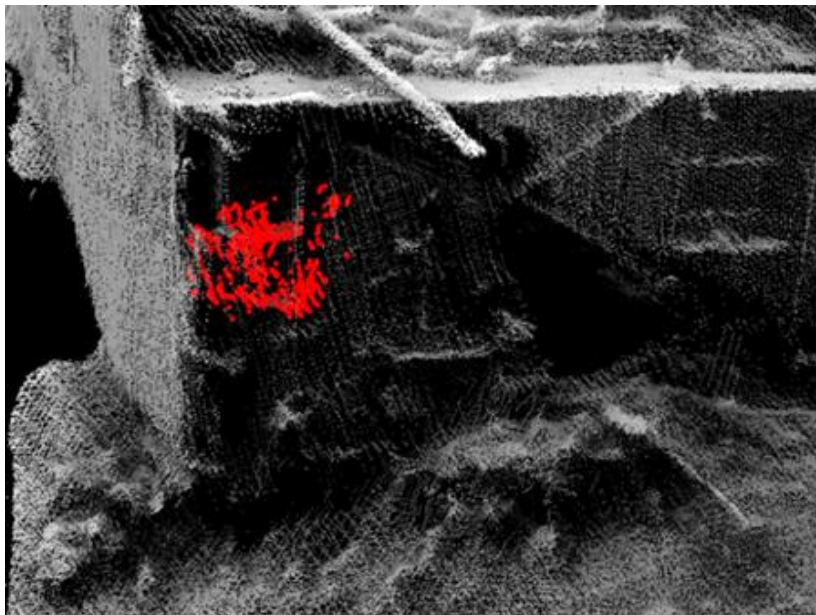
4.7.1 At the aft end of the forward section, the bulkhead between Hold 3 and the engine room is still in place and is providing containment for the contents of Hold 3. Although the bulkhead remains intact, apertures can be seen in successive survey data, in particular, an aperture on the port side. This aperture is clearly visible in the 2016 dataset. A CARIS profile shows very good correlation between the data sets. The dimensions of the aperture have remained consistent across the datasets from the previous three years, no changes have been noted.

4.7.2 Whilst the hold cargo can be seen through the aperture, the exact oblique sonar angle required for good internal ensonification was not achieved. This may be because of the state of tide or beam sector angle during that pass. The shoalest depth recorded of the internal cargo was 8m below CD compared to 7.04m in 2015. It is not possible to ascertain whether this represents a decrease in the amount of cargo visible or whether the area was not fully ensonified. No change was noted in the debris field at the foot of Hold 3, which suggests that this change is related to data collection rather than an actual change in the wreck.

Fig. 6 Hold cargo data points, aft of Hold 3, 2016 data

6.11 At Key Area 3, the aperture at the aft of the forward section was surveyed with good clarity and no changes have been noted to the opening. The cargo inside was ensonified but not to the same level as the 2015 survey. This is because of the tidal state and the angle of the MBES beam achieved through the opening.

4.7.3 For future surveys, it is recommended that flex mode on the Reson 7125 should be used. This compresses all the beams into a very narrow sector and, by varying the distance from the hold 3 aperture to the sonar head, this should allow for better angles of acoustic signal propagation.

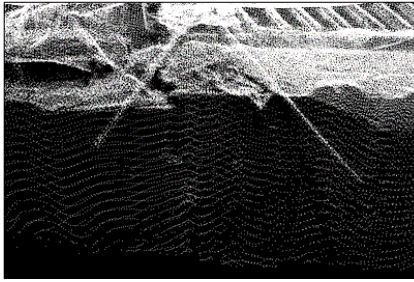
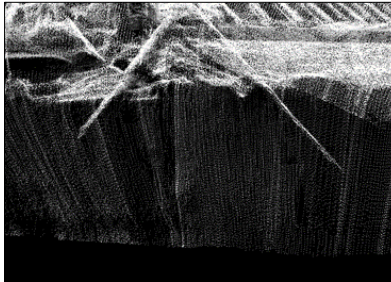
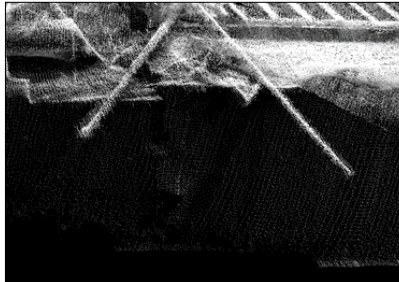
4.8.1 The split in the hull is located on the starboard side of the aft section of the wreck, adjacent to the mizzen mast. An initial visual inspection of the point cloud data shows little change in the split in the hull over the last three years of survey, although the feature is difficult to visualise due to the slightly differing beam pattern affecting the visual characteristics. Using a surface difference plot and CARIS profiles, it is clear that no significant change has occurred. The split in the hull appears to be the same with data points inside the hull visible in the survey data.

4.8.2 Cross profiles show part of the hull plate protruding at lower depth, which has remained the same throughout the last three surveys. A slightly better match between the 2016 and 2014 data rather than the 2016 and 2015 data is identified as a positional discrepancy in the dataset. Surface difference analysis shows a slightly raised deck level in the 2016 data when compared to the 2015 survey. This difference has been attributed to varying densities of data over the complex deck structures. The 2016 point-cloud data

indicates that there is a gap below the protruding hull plate. This is believed to be acoustic blanking caused by the protruding plate.

Fig. 7 Key Area 4 2014

Fig. 8 Key Area 4 2015

Fig. 9 Key Area 4 2016

6.10 At Key Area 4, the splitting of the hull has not shown any evidence of deterioration when compared with previous datasets.

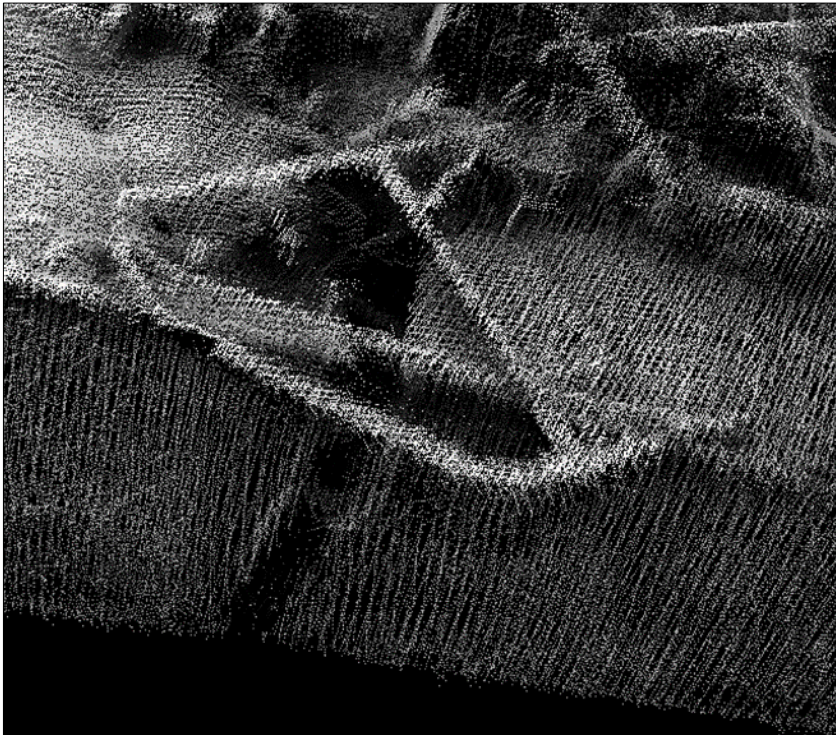
4.9.1 Area 5 is a split in deck and hull on the port side of the aft section of the wreck. It is associated with the split on the starboard side at the same area (Key Area 4). This split appears to have remained stable throughout the past three years of survey. Cross profiles along the deck show that the collapsed deck plate is in the same position with good positional correlation between the three surveys. Cross profiles through the hull show the assumed sediment within the hold, which has been ensonified through the crack in the deck above. This material has not been highlighted in previous surveys, but the sediment appears to be in a similar position to preceding surveys, arranged in an even manner with several peaks.

Fig. 10 Key Area 5 showing no change

6.9 At Key Area 5, the split in the deck and hull remains in the same state of deterioration but the contents inside the crack have been ensonified in greater detail than in previous surveys. This assumed sediment accumulation is well structured, indicating bedform features.

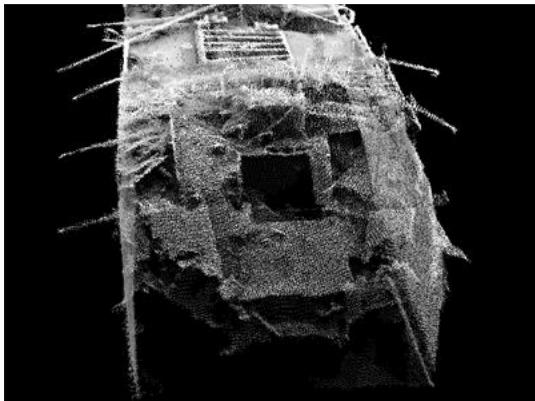
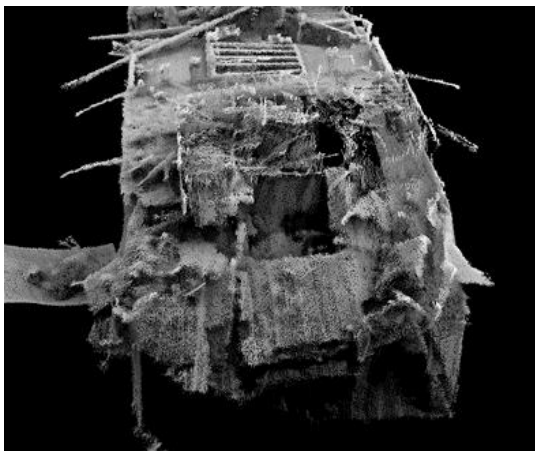
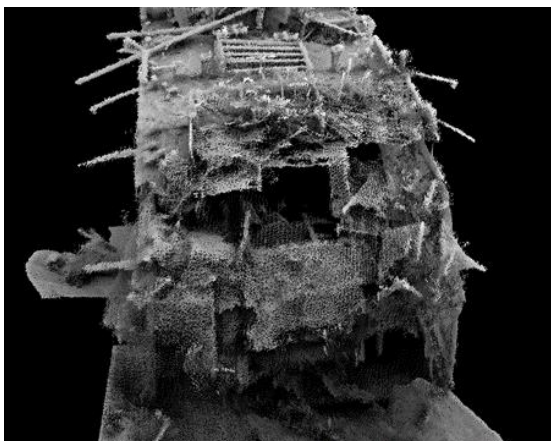
4.10.1 Key Area 6 encompasses the collapsing bridge deck/superstructure at the forward end of the aft section. This superstructure overhangs the main hull structure of the aft section of the wreck and was unsupported. This area of the wreck showed significant degradation in the previous surveys between 2014 and 2015. The 2016 survey data indicates that, whilst there has been some change, it is not of the same magnitude seen in the previous survey results. There is only one area of change, on the aft section starboard side upper deck level. Changes of less than 1m are noted to some of the previously protruding deck plates.

Fig. 11 Area 6, bridge deck, 2014

Fig. 12 Area 6, bridge deck, 2015

Fig. 13 Area 6, bridge deck, 2016

6.8 The 2015 survey showed deterioration of the large superstructure area on the forward end of the aft section of the wreck which encompasses the boiler room casing, the collapsed boat deck, the remains of the bridge deck and the accommodation block. Following the collapse seen between the 2014 and 2015 surveys, this area has remained reasonably stable with one further area of subsidence noted on the starboard boat deck where several of the previously overhanging sheets of metal have now broken free. Differences of less than 1m are noted on the difference plot and consist of smaller sheets of decking subsiding.

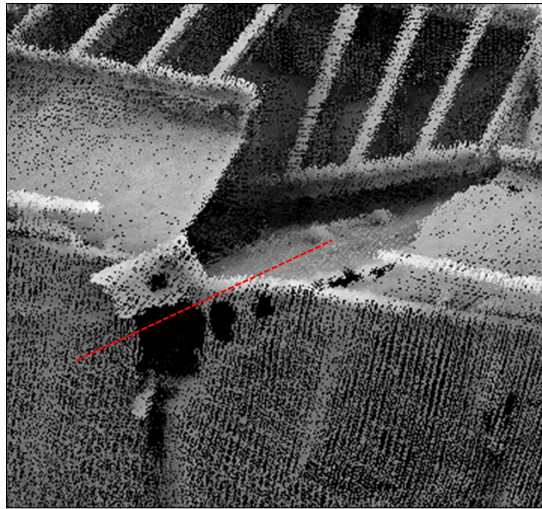
4.11.2 ID07 – Break in Gunnel. The break in the gunnel is located adjacent to Hold 2 on the port side of the forward section. This section of the gunnel has now almost broken off completely. This feature is closely linked to the collapsing deck plate at hold 2 (ID08) which has also shown movement (see above). The collapsing deck plate is thought to have caused the gunnel to break away and it is now only attached by the aft section, slumping over the side of the vessel.

Fig. 14 break in gunnel at Hold 2

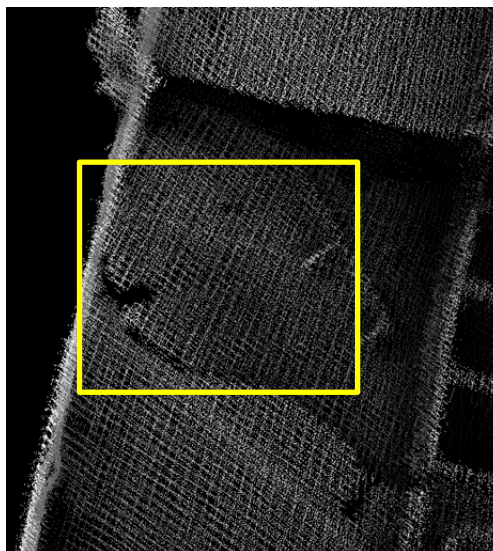
4.11.3 ID13 – Holes in Deck Plating – The holes in the deck plating are located adjacent to hold 2 on the forward section of the wreck. The holes were seen in the 2016 survey, with change noted to the larger of the holes. The deck has fractured at the site of the previous holes and the entire deck plating has moved. This progression has occurred gradually, as seen throughout the yearly surveys and these holes have served as good indicators of the ongoing degradation of this area.

Fig. 15 Holes in deck plating at Hold 2

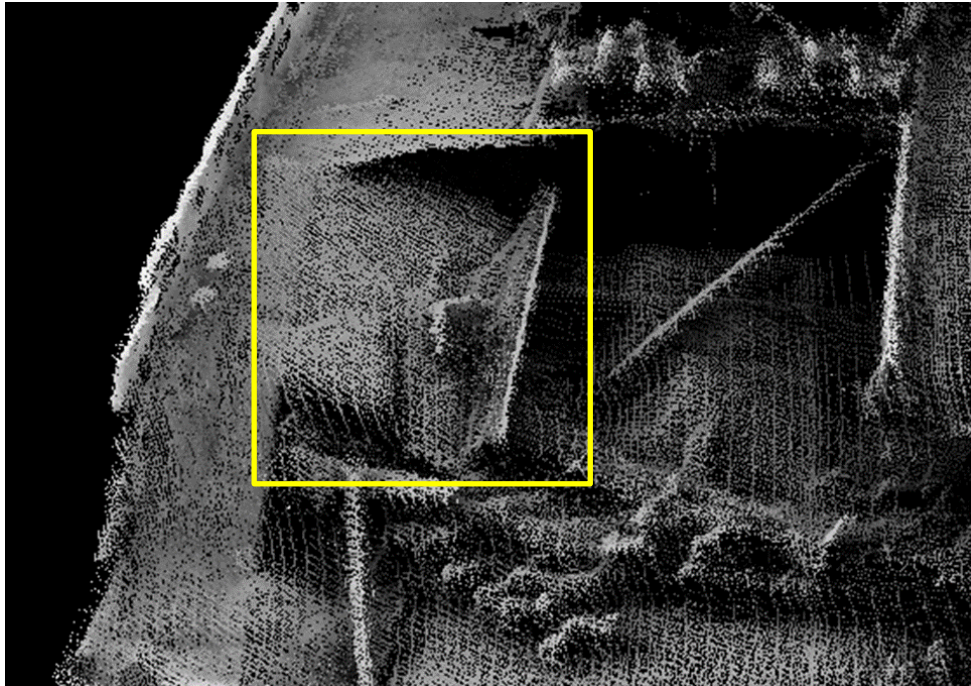
Fig. 16 Hold 3

4.11.4 ID15 – Collapse of Deck and Hatch Coaming - The deck hatch and coaming features are located on the aft end of the forward section of the SSRM and form part of the hatch opening of Hold 3 which was damaged at the time of the sinking as the ship broke in two. The deck and hatch coaming has remained in the same condition since the 2015 survey. Surface difference shows little or no change along the main deck area, with a slight rise of 0.15m in level towards the hatch coaming. This change is attributed to a denser dataset in 2016 which has delineated the hatch coaming with more definition.

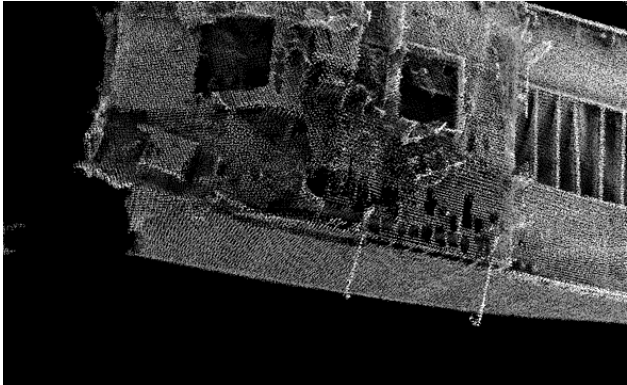
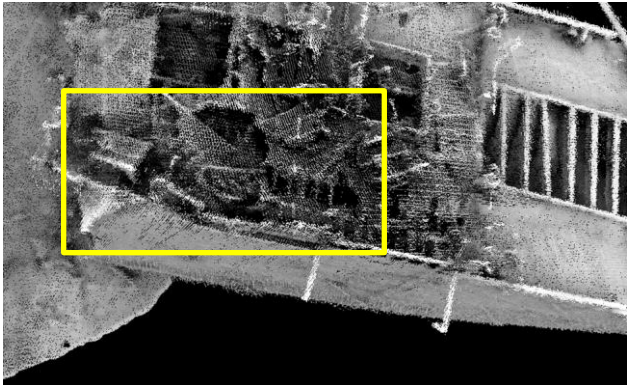
4.11.7 ID28 – Collapsing Boat Deck – This is part of the same overall structure as Key Area 6 and is a complex area of collapsing superstructure at the forward end of the aft

section of the wreck. Since around 2014, this has been a dynamic region in terms of subsidence and degradation. However, a difference plot over the collapsing port boat deck shows that this area has remained relatively stable between 2015 and 2016 with only minor point source changes in height to the finer superstructure, possibly due to varying densities of data on vertical structures. A longitudinal profile through the area shows little or no change when compared to the 2015 survey, although some change can be seen when compared to the 2014 survey.

Fig. 17 Superstructure, aft section of the wreck, 2014 data

Fig. 18 Superstructure, aft section of the wreck, 2016 data

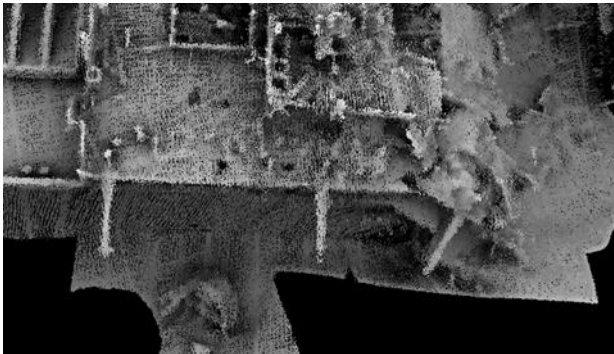
4.11.8 ID29 – Boat Deck Missing Above Walkway – This ID feature is on the starboard side of the collapsing superstructure, on the aft section of the wreck and, along with ID28 above, it is located in a dynamic region of the wreck in terms of subsidence and degradation. The boat deck was last listed as present in the 2012 survey and between the 2014 and 2015 surveys the area subsided and dropped towards the seabed. In the 2016 survey data, there is evidence of further subsidence. The magnitude of this subsidence is smaller than was previously seen, with changes of approximately 1m noted. These changes are predominantly to the sheets of overhanging deck plating which are gradually collapsing towards the seabed.

Fig. 19 ID29, missing section of boat deck, 2016 data

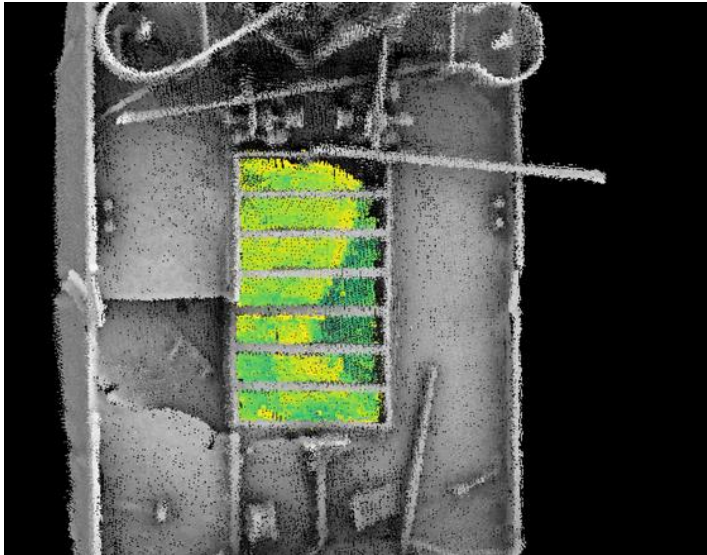
4.11.9 ID30 & 31 – Lower Hold Cover, Hold 2 – These ID features relate to holes in, and the collapse of the lower hold cover at Hold 2. The lower hold cover was noted in survey data prior to 2010 but, since then, yearly sediment build-up has obscured this hatch. Due to the large aperture in the upper hold, MBES data is obtainable through the hatch which allows a comparison of sediment build up between surveys. Between the 2015 and 2016 surveys there has been a general accumulation of sediments with up to 0.35m deposited within the hatch with a higher ridge of sediment orientated through the centre of the hatch to the northeast.

Fig. 20 Sediment accretion in Hold 2

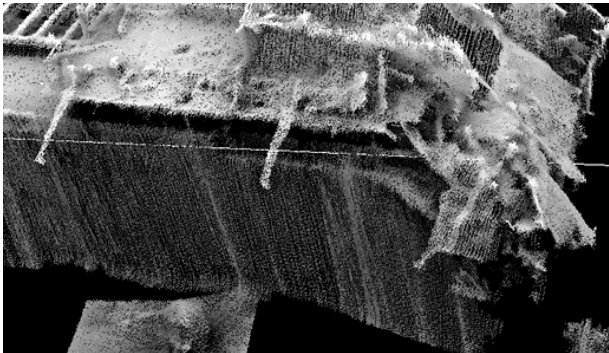
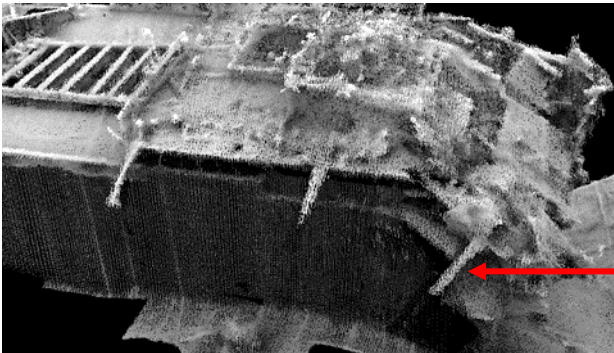
4.11.11 ID79 – Lifeboat Davit – This lifeboat davit is situated in the highly dynamic region of the starboard forward side of the aft section. A sheet of decking that was resting on the davit has now broken off and the davit arm has changed orientation and is now pointing further aft.

Fig. 21 ID79 covered by deck plating in 2015

Fig. 22 ID79 uncovered in 2016

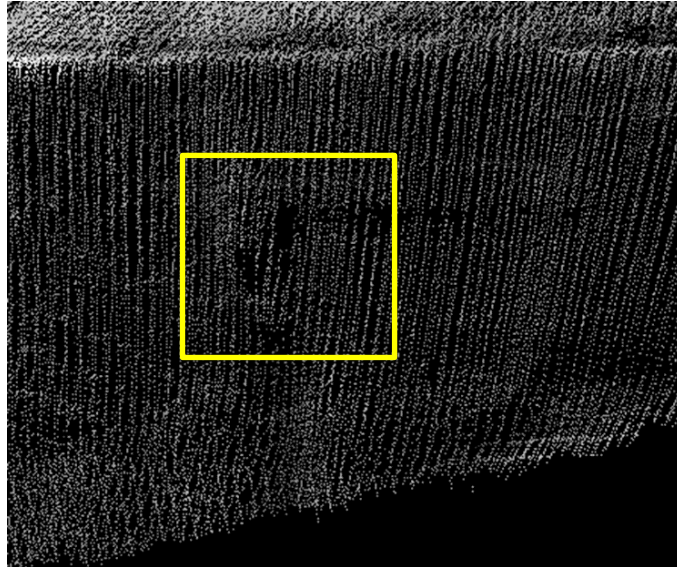
4.11.12 ID11 – Hole in Hull Plating – This hole in the hull plating is situated adjacent to hold 2 on the forward section of the wreck. In analysing three years of point cloud data it is evident that a change has occurred in this area and now a larger hole exists in this buckled section of the hull. Although difficult to measure precisely due to the point cloud data distribution, it appears to have opened by 0.2-0.3m. This section is in close proximity to the aft of hold 2, which has also experienced hull buckling and associated holes.

Fig. 23 Holes in hull plating, Hold 2

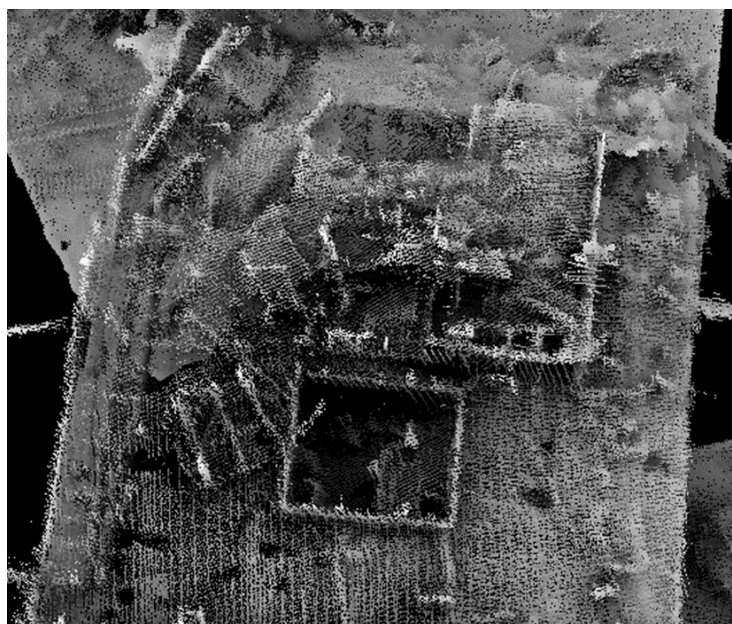
4.11.13 ID49 – Gunnery Officer's Cabin – The gunnery officer's cabin is located on the aft section of the wreck along the centreline towards the forward end. It consists of an open box type structure, which has undergone considerable degradation. Comparison of the datasets is difficult due to the varying amounts of data acquired each year, with data gaps present in all datasets. A direct comparison was achieved at the forward end of the gunnery cabin, with data from all three surveys present. The CARIS profile shows that, since the 2015 survey, the height of the cabin structure has decreased by up to 1.5m.

Fig. 24 Looking down on the area of the gunnery officer's cabin

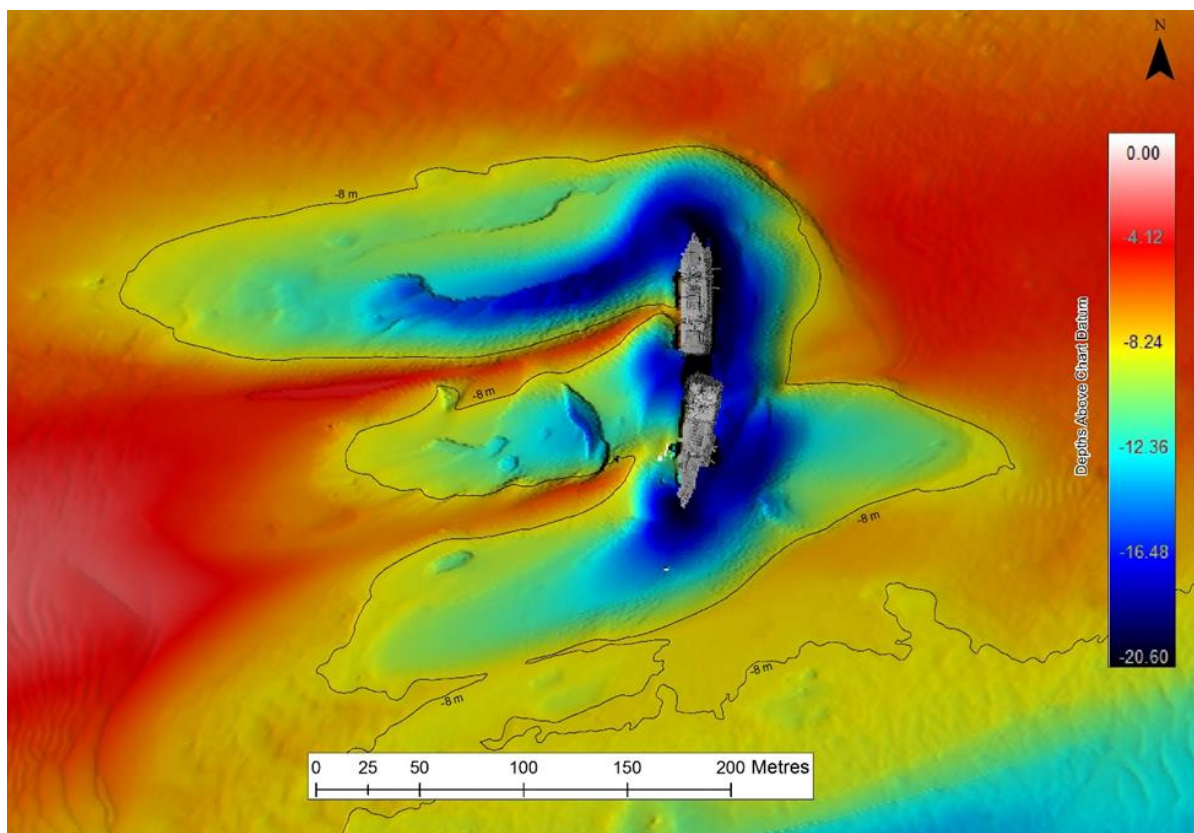
5.1.7 The image below highlights the prominent scouring around the SSRM area. The scour extends out from all sides of the wreck but is more prominent in an east to west direction extending out up to 200m from the wreck structure. The difference plots show that the prominent scour has increased further to the northeast of the forward section of the wreck where up to 0.7m difference is experienced.

Fig. 31 2016 overview of the prominent scouring around the wreck
