Report on the investigation of the
fatal man overboard from the UK registered yacht
CV30
approximately 1500nm west of Fremantle, Australia
on 18 November 2017

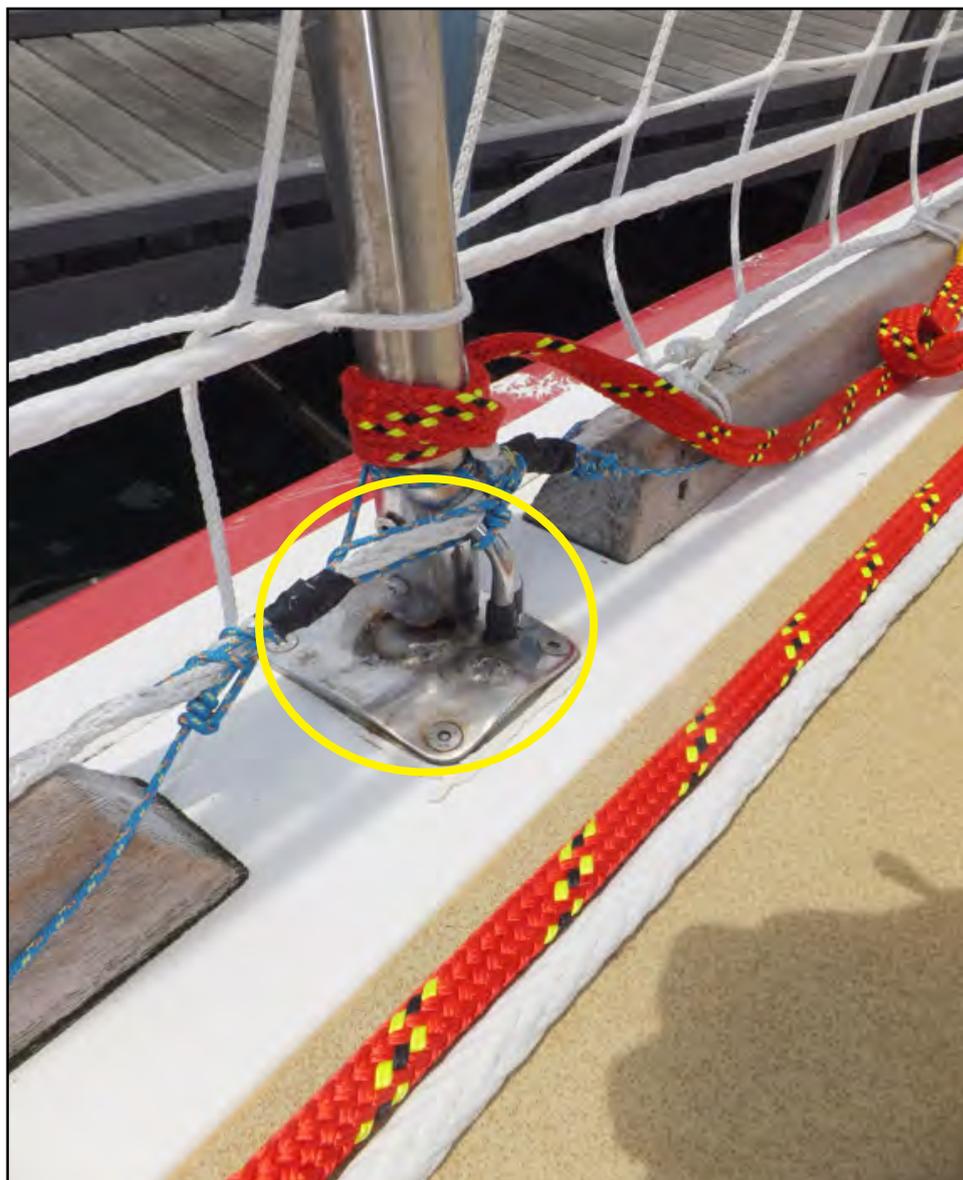
Overnight into 4 November, during the very rough sea conditions, damage was sustained to the forward two starboard stanchion bases, which supported the guardrails. This occurred when the yankee headsail, which had been stowed on deck, broke free of its sail ties. A wave washed the sail up against the starboard guardrail and the weight of water behind the sail caused the stanchion bases to fracture at the weld joint with the base plate (**Figure 1**). When the wind eased during the morning, additional high modulus polyethylene (HMPE) lines were rigged and winched on tight as a temporary repair (**Figure 2**) and the skipper minimised work on the foredeck in rough weather, particularly when the damaged guardrail was on the leeward side.

Figure 1: Starboard stanchion base failure in situ

A closer inspection of the failed forward two starboard stanchion bases identified that they had suffered significant distortion and had been re-welded previously following a similar failure in the 15-16 Race (**Figure 17**). No replacements were available in Fremantle, so the stanchion bases were repaired again before the start of Leg 4 of the Race.

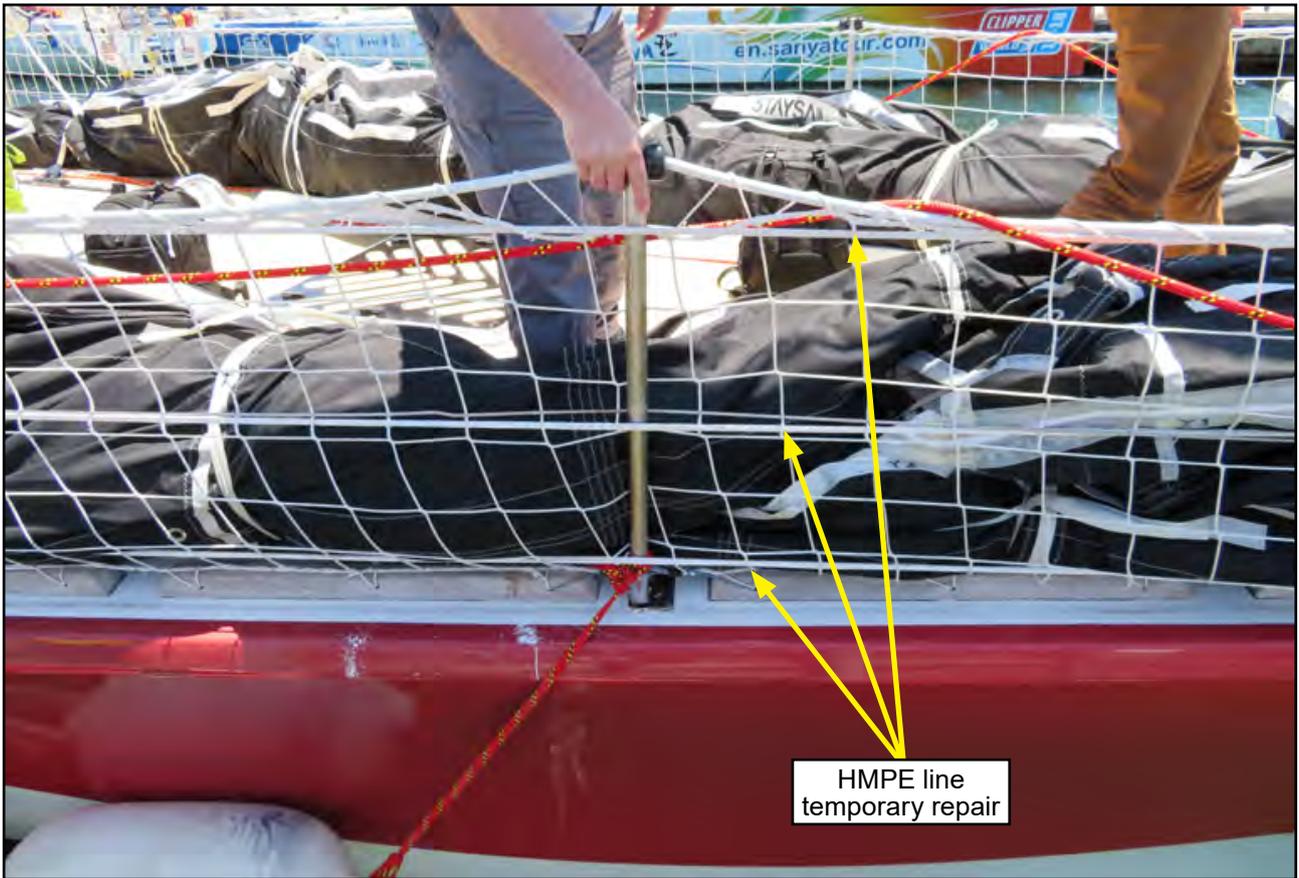
Figure 2: HMPE line temporary repair of guardrail

On inspection of the guardrails in Fremantle, three rows of HMPE line were found weaved through the starboard guardrail netting and secured between the pulpit and the shroud rigging to provide additional support in way of the two stanchion bases that had fractured. However, the two stanchions whose bases had fractured were free to move at their base and, compared to the port guardrail, the upper guardrail dipped lower between the stanchions, was further outboard and had greater lateral movement.

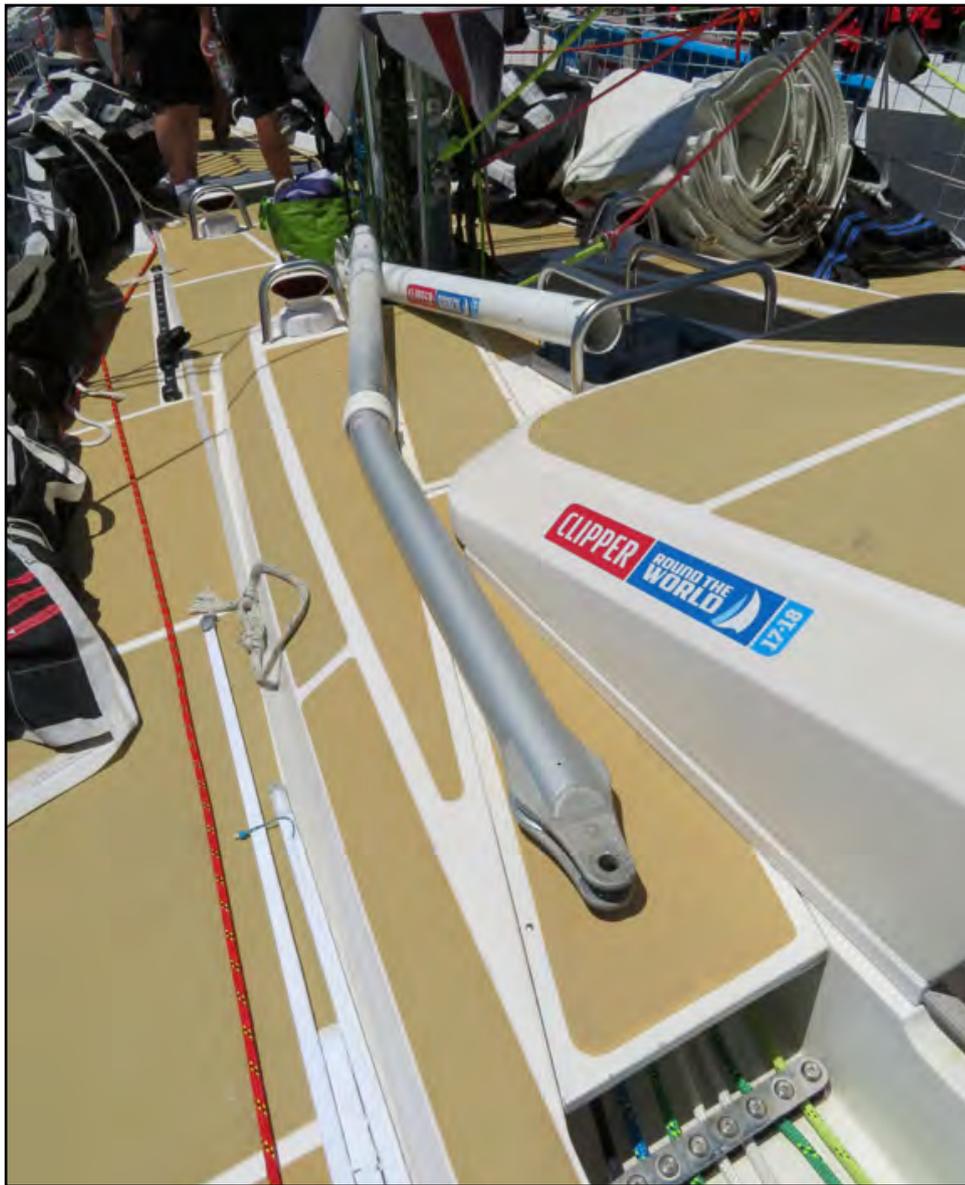
On 8 November, CV30 suffered further damage, including the breaking of two mainsail battens and the vang strut (**Figure 3**). The latter occurred when a crew member mistakenly winched on the vang rather than the outhaul, compressing the vang strut and buckling it (**Figure 4**). The vang strut was removed and a kicker rigged to enable the mainsail leech tension to be controlled. On the same day, the watch leader for Jack watch fell from his bunk, injuring his hand, resulting in him being confined below deck on light duties. Simon Speirs therefore resumed his previous role of watch leader.

Figure 4: Buckled vang strut

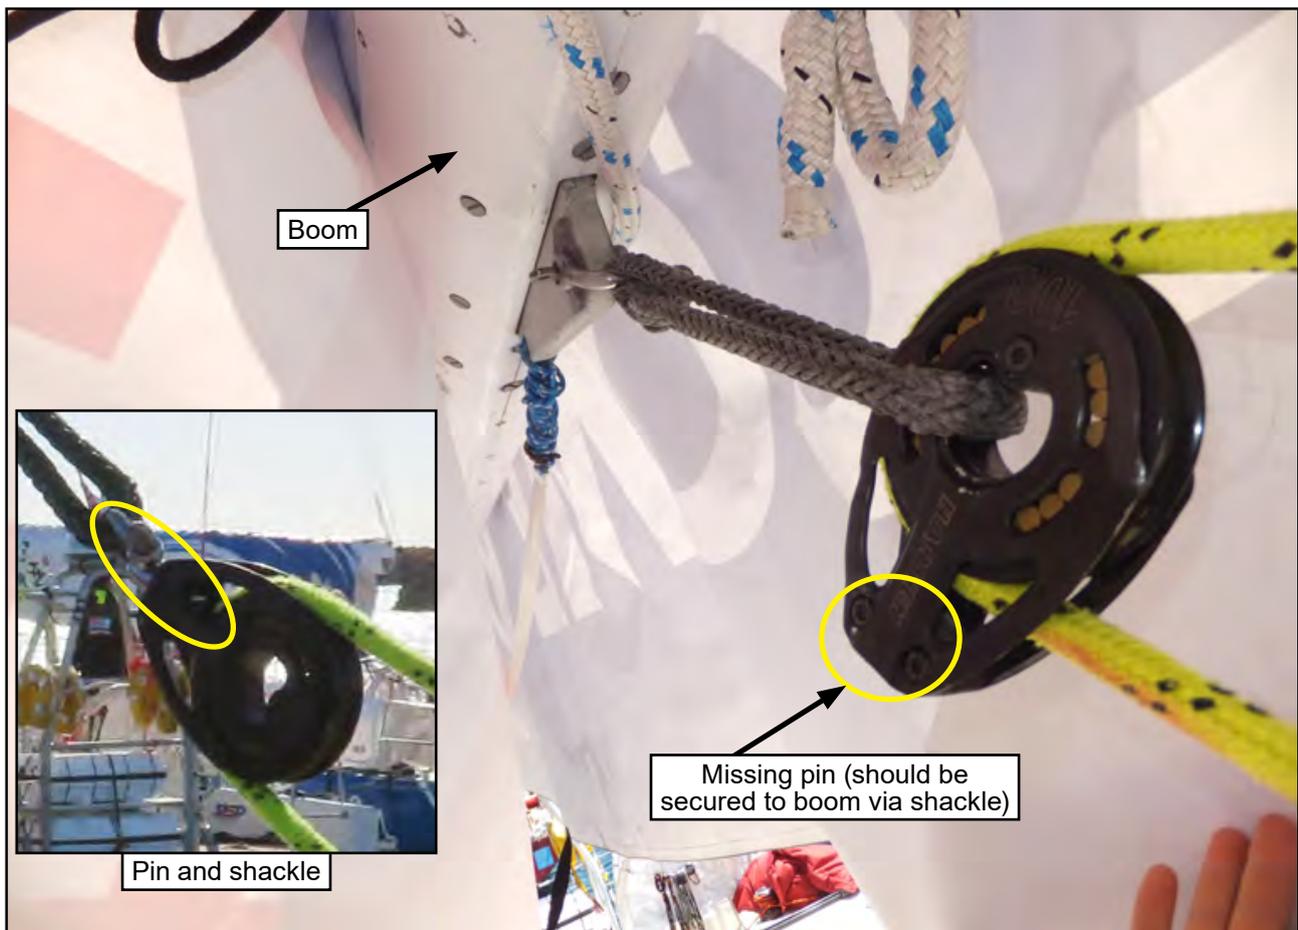
Although the preventers held during the gybe, the block attaching the kicker to the boom parted (**Figure 8**), resulting in the boom rising and all leech tension being lost. The mainsail filled with the wind on the wrong side, slowing the yacht down. The action of two crew in the cockpit in easing the preventers allowed the mainsail to be centred, but the sheet and mainsail then thrashed about until one of the crew managed to crawl under the traveller to tend the main sheet.

Figure 8: Parted kicker block (with temporary lashing to the boom)

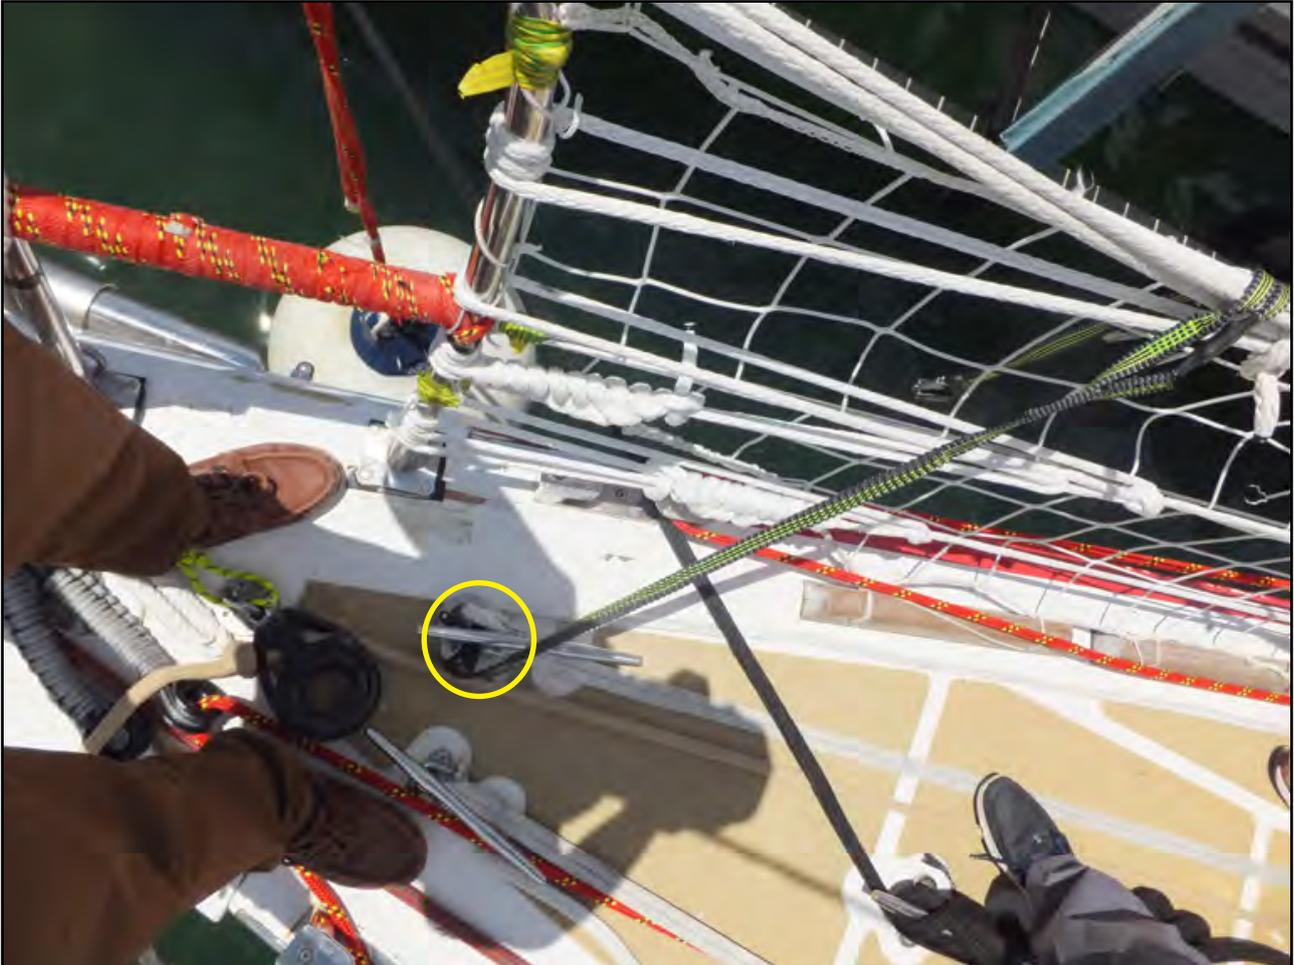
The MAIB investigation concluded that the combined effect of Simon's tether length and the hooking point location resulted in him being dragged alongside the yacht, preventing his recovery. It also concluded that Simon's tether hook became caught under the starboard forward mooring cleat, resulting in the hook being loaded laterally, distorting and releasing. On 9 January 2018, the MAIB issued Safety Bulletin 1/2018 regarding the dangers of lateral loading of tether hooks, and recommended that the method used to anchor the end of the tether to the yacht should be arranged to ensure that the tether hook cannot become entangled with deck fittings or other equipment. Further recommendations are made in respect of reviewing and amending international standards for tethers and jackstays.

Figure 9: Reconstruction showing tether hook caught under bow cleat, as observed by bowman

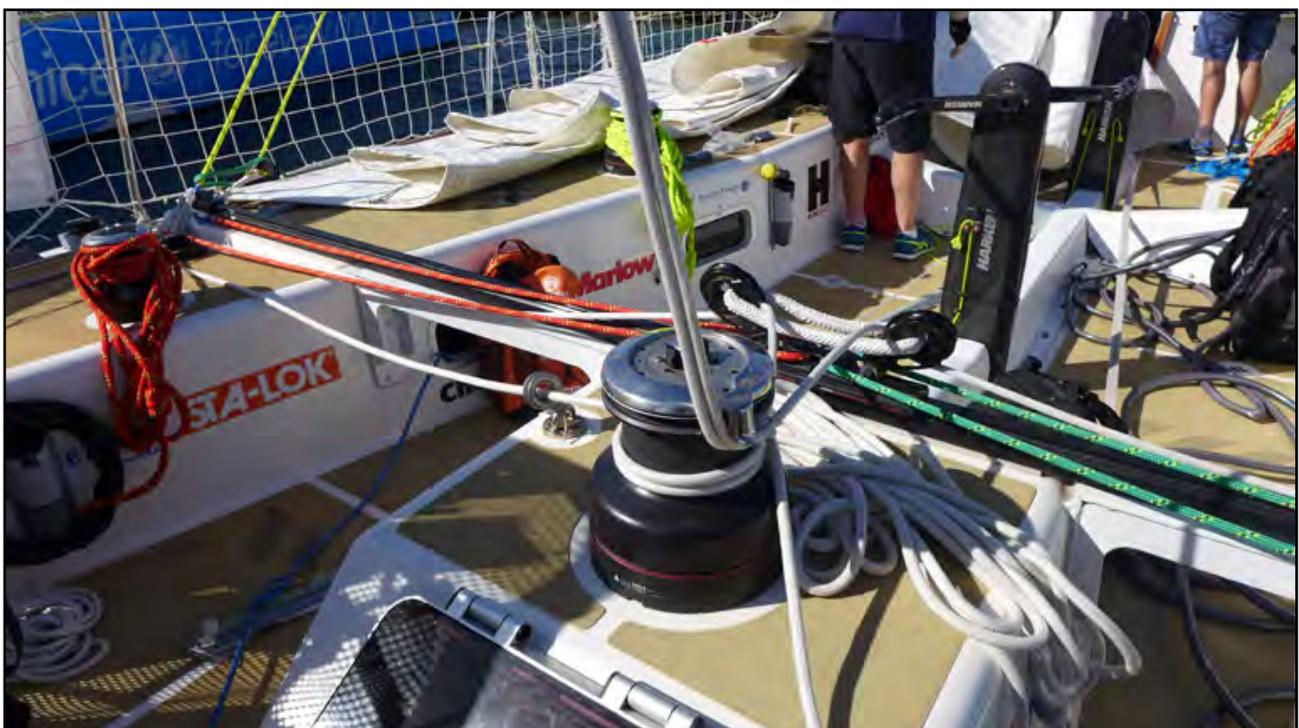
The skipper employed a combination of tacks, when able to, and gybes to approach Simon in the water (**Figure 10**). During one gybe the main sheet became caught around the main sheet winch and ripped off the self-tailing mechanism (**Figure 12**). Additionally, one of the blocks for the main sheet traveller broke. These factors combined to make trimming the mainsail more difficult.

Figure 12: Reconstruction of mainsheet caught around self-tailing winch

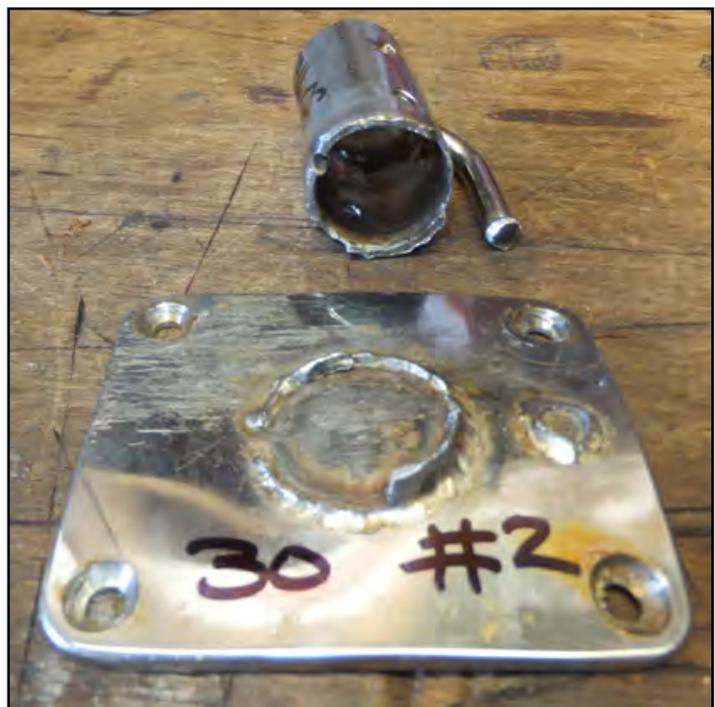
Figure 17: Fractured stanchion base

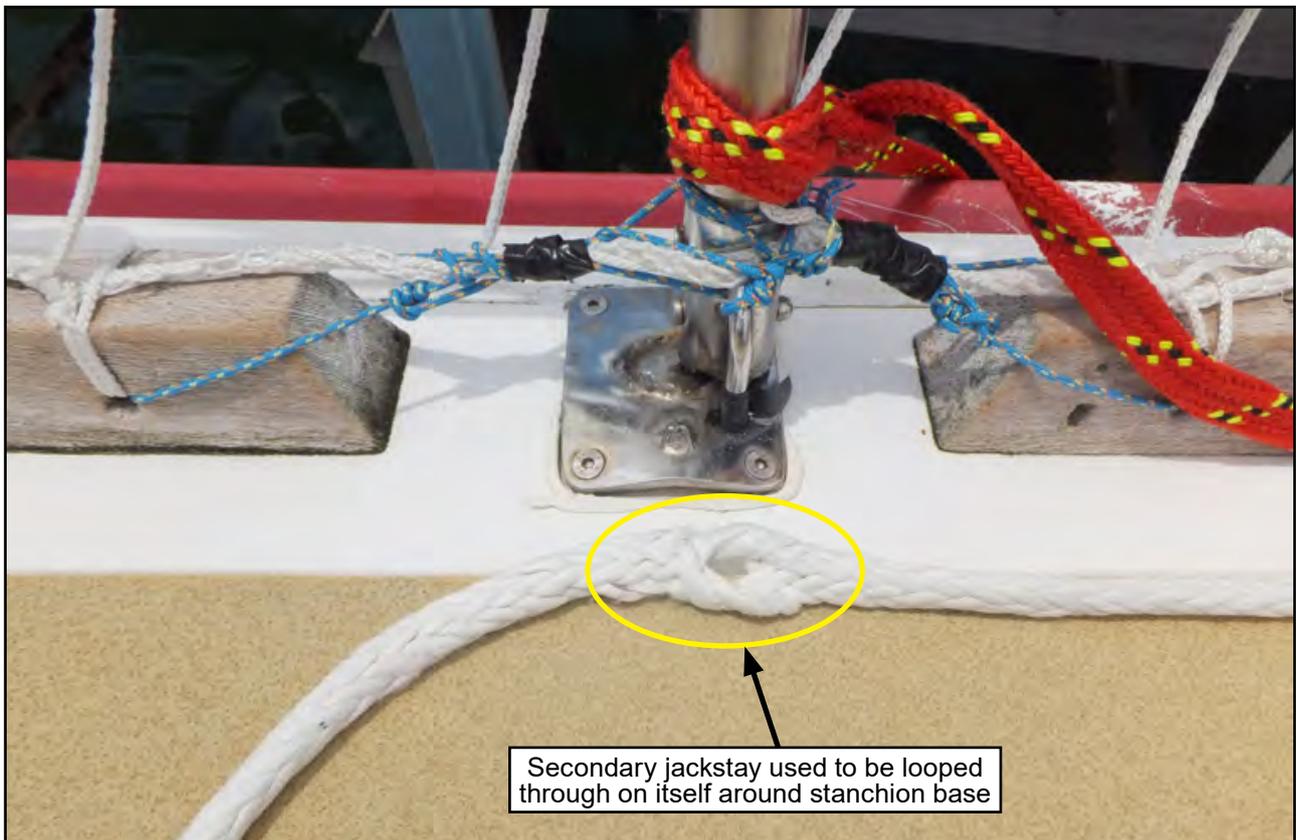
The failure of the forward two starboard stanchion bases (**Figure 22**) on 4 November released and introduced additional slack into the starboard side secondary jackstay (**Figure 23**).

Figure 22: Starboard secondary jackstay free from stanchion base

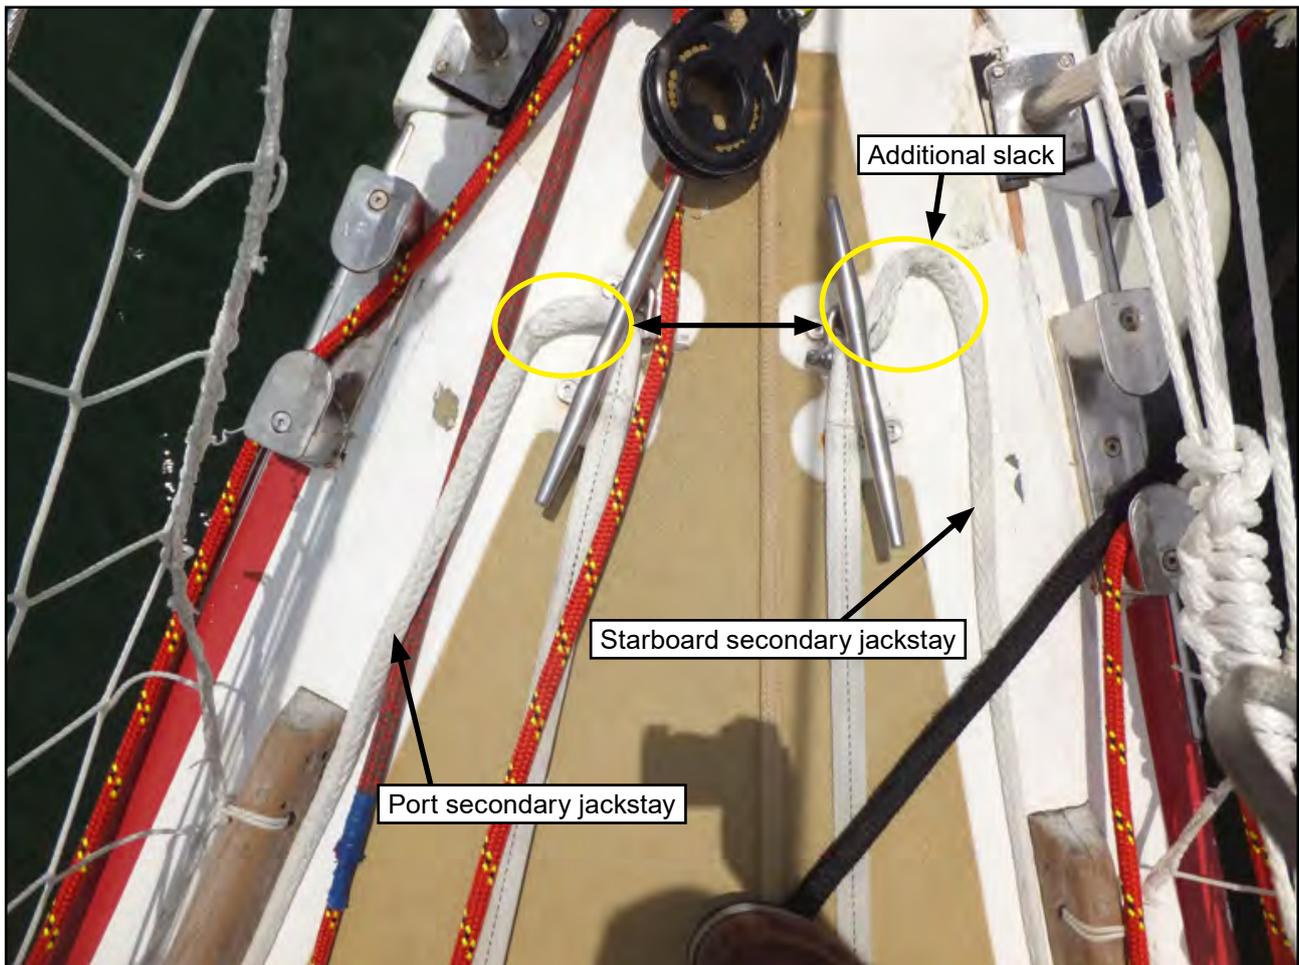
Figure 23: Starboard secondary jackstay showing additional slack compared with port secondary jackstay

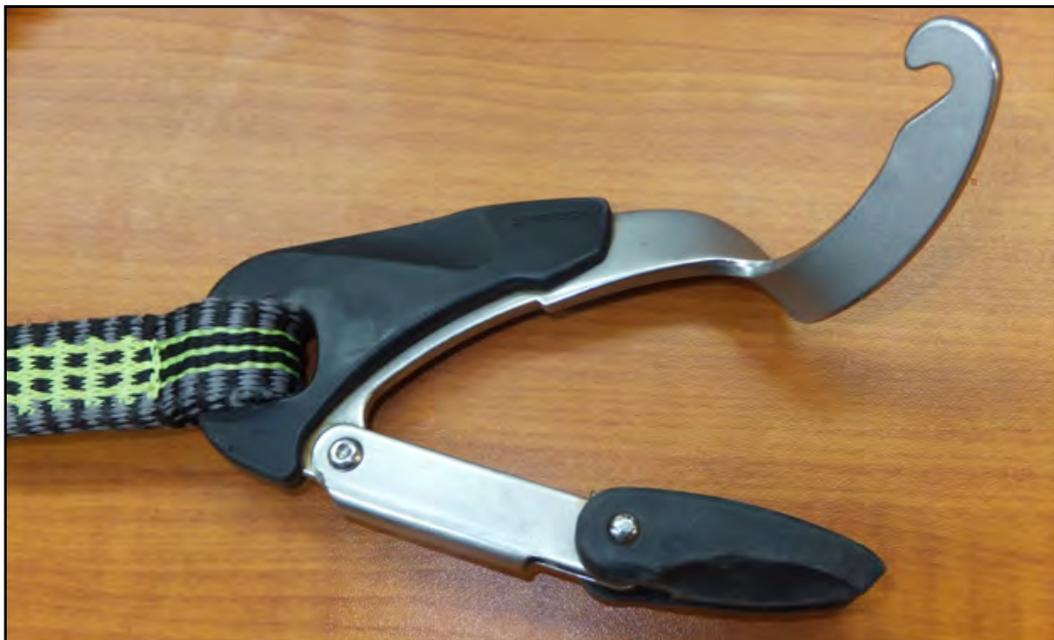
- The hook had been distorted and bent over 90° (**Figure 26**).
- The hook gate had 1-2mm of play compared with an undamaged gate.
- There was no sign of impression damage to the hook apart from one small indentation (**Figure 27**).
- The spring of the gate still functioned.

Figure 26: Distorted tether hook

Spinlock conducted tests shortly after the accident using its test rig. With the hook restrained to a 90 degree deflection from normal alignment it was possible to replicate similar distortion to that seen in the hook after the accident at loads of less than 500kg.

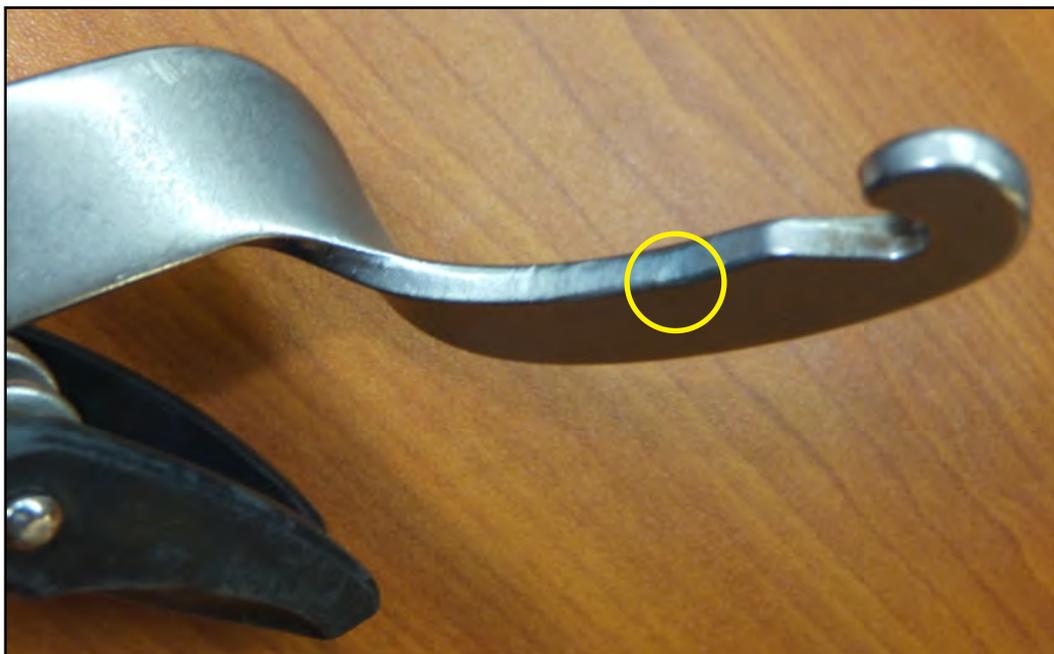
Figure 27: Distorted tether hook small indentation (circled)

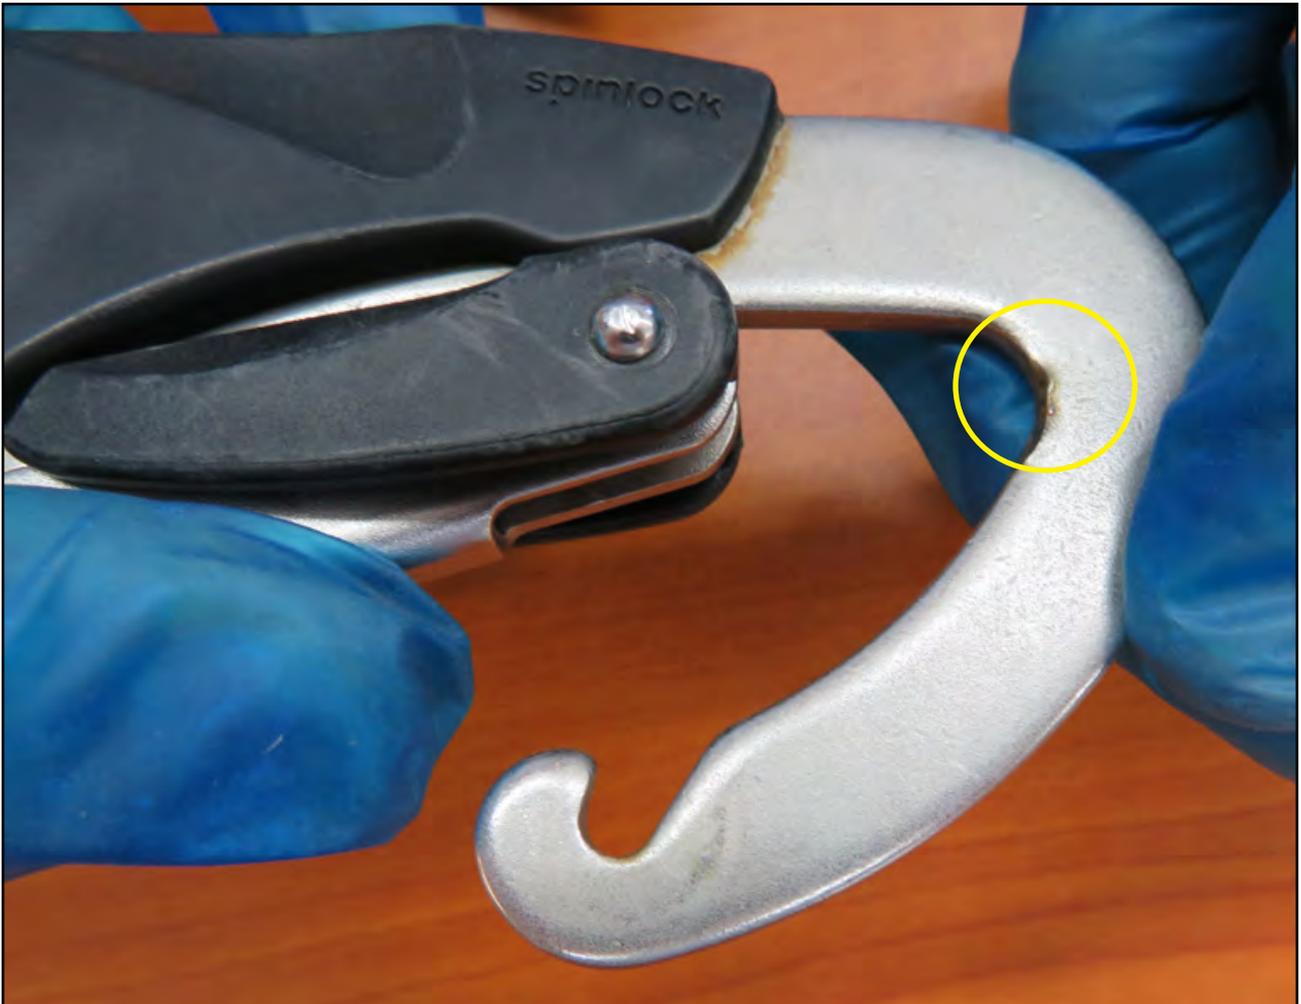
- The hook functioned correctly.
- There was a slight notch at the loading point of the hook (**Figure 28**).

Figure 28: Tether hook secured to harness notching

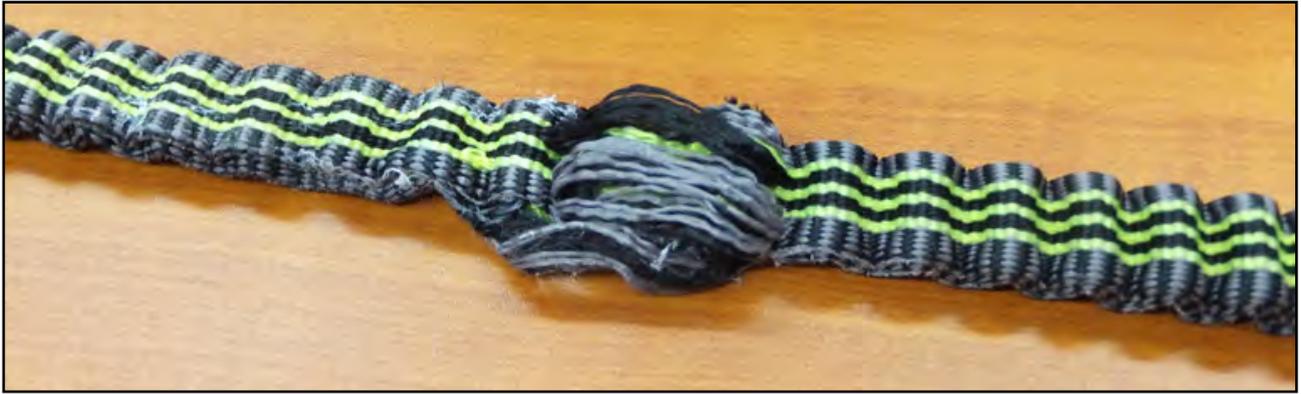
Figure 29: Frayed elasticated section of long tether

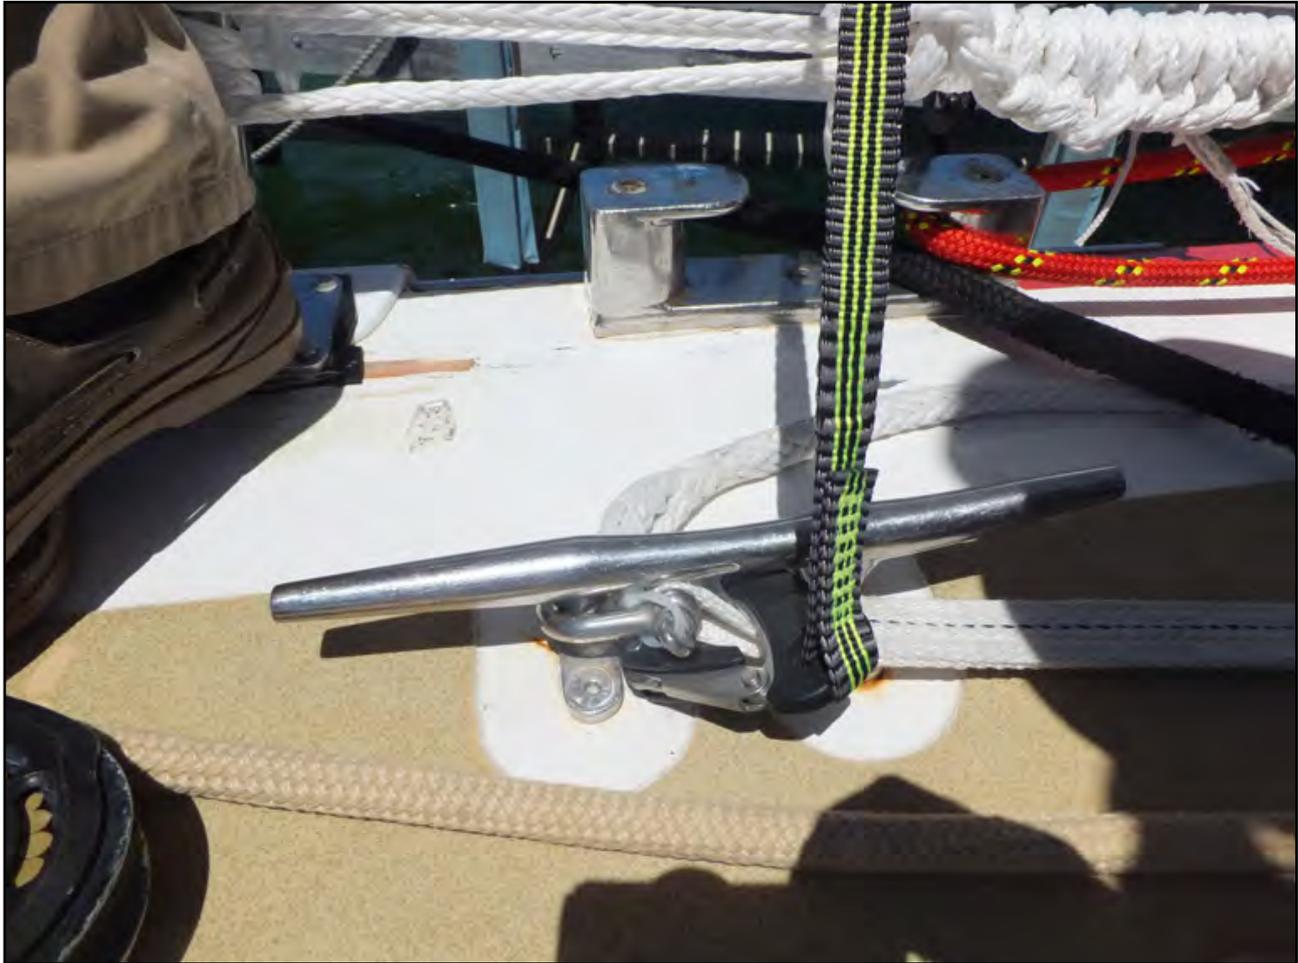
Figure 32: Tether hook caught under cleat attached to primary jackstay

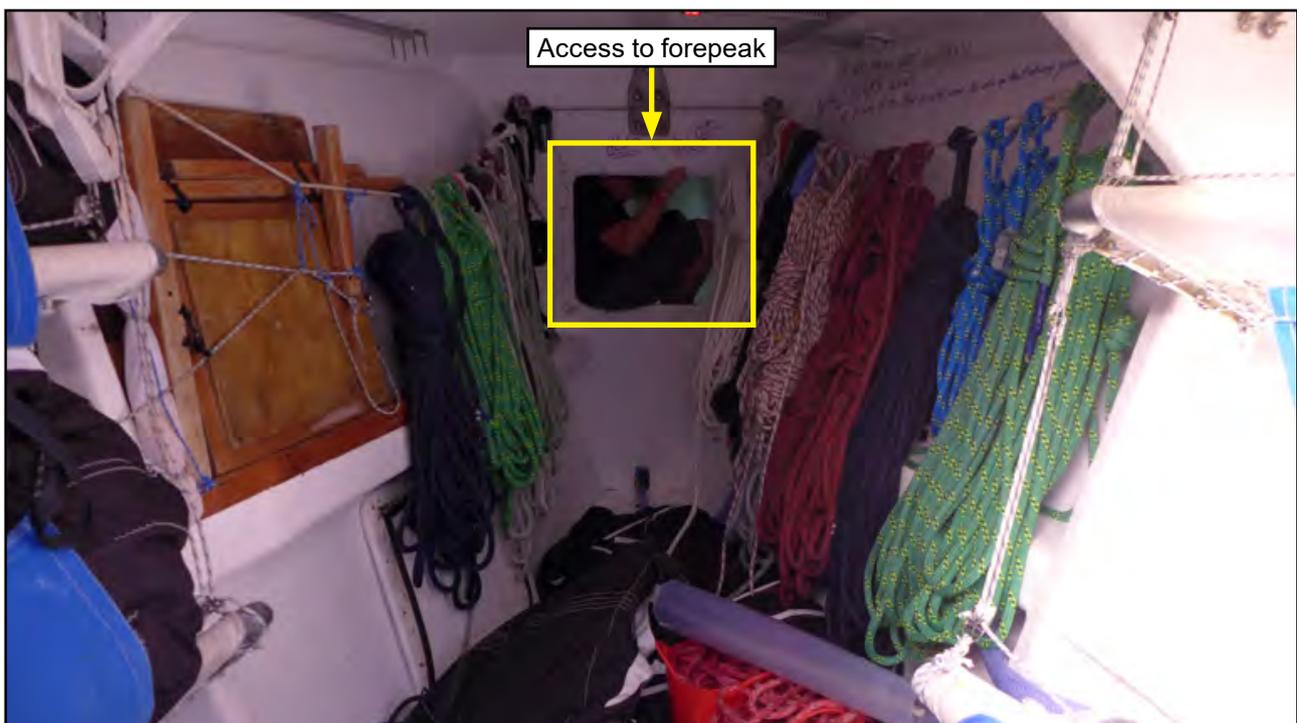
The lazarette leak was partially addressed by the Clipper Ventures maintenance team in Punta del Este. The forepeak space leak, however, could not be resolved, so a manual bilge pump was fitted in the sail locker with its own discharge overboard during the stopover in Cape Town to facilitate pumping out the forepeak space.

Figure 36: Access to forepeak via bolted hatch

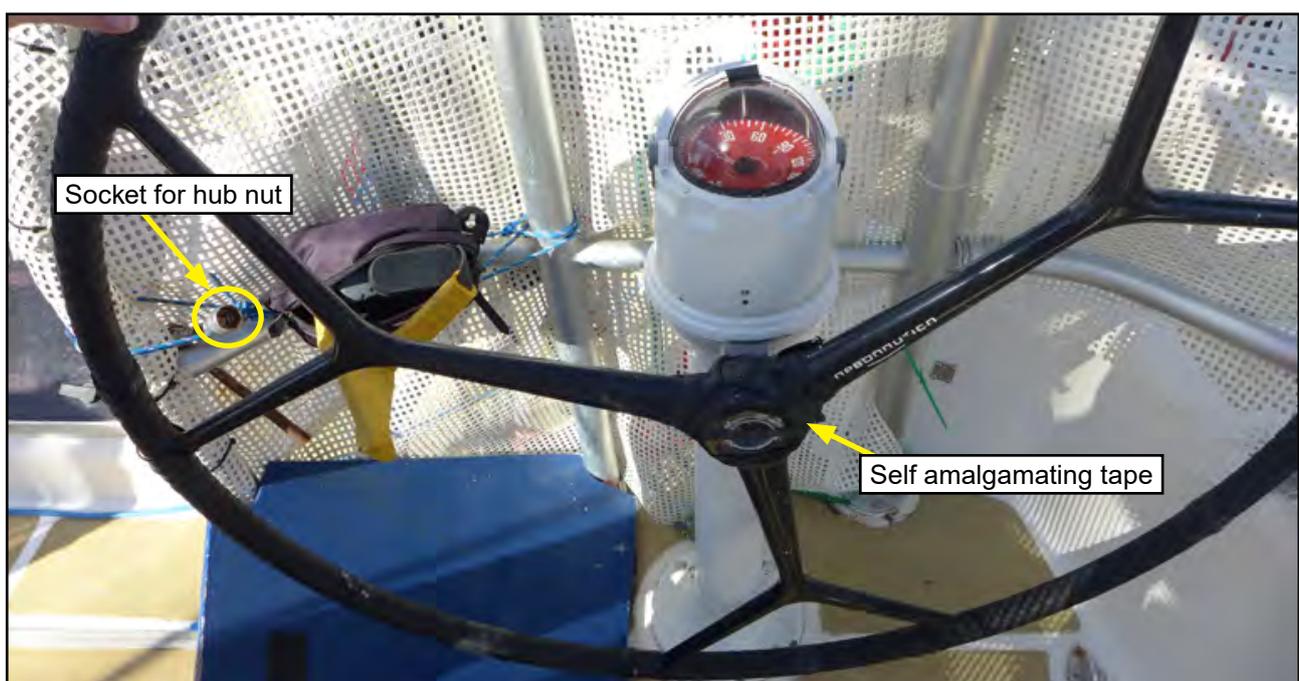
During leg 2 the starboard wheel developed a significant amount of play, and a socket wrench was placed next to it to enable the hub nut to be tightened at regular intervals (**Figure 37**). There was a common issue of worn keyways in wheel bosses, which immersed during the early stages of the 17-18 Race. Clipper Ventures was aware of the issue and was completing repairs as parts became available at stopovers. Due to a lack of available parts, only a temporary repair was possible to CV30's starboard wheel but as the port wheel was functional and the emergency steering backup was unaffected, CV30 was considered safe by Clipper Ventures to

Figure 37: Starboard wheel temporary repair with socket spanner accessible to tighten hub nut

continue to race. A week or so into leg 3 the play in the starboard wheel was again significant, so although the crew made attempts to repair the wheel it was decided that all helming would be conducted from the port wheel. This imposed visibility restrictions on the person helming when the yacht was sailing on a starboard tack.
