# Rail Accident Report

**Collision between a train and utility vehicle at  
Dollands Moor freight yard, Kent  
4 September 2018**

Report 05/2019  
June 2019

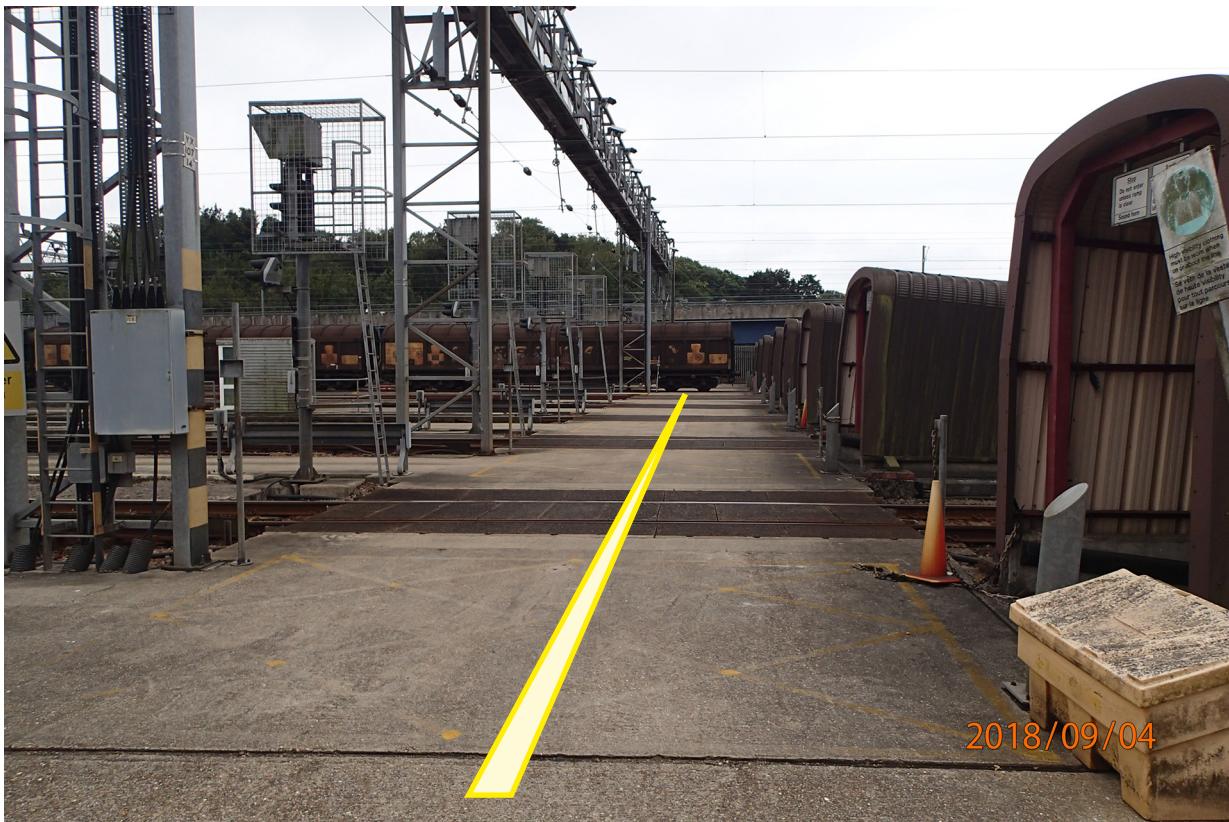
Figure 6: View looking south across the west end level crossing with subway ramps on the right. The path of the buggy is shown. A train is visible on siding 2.

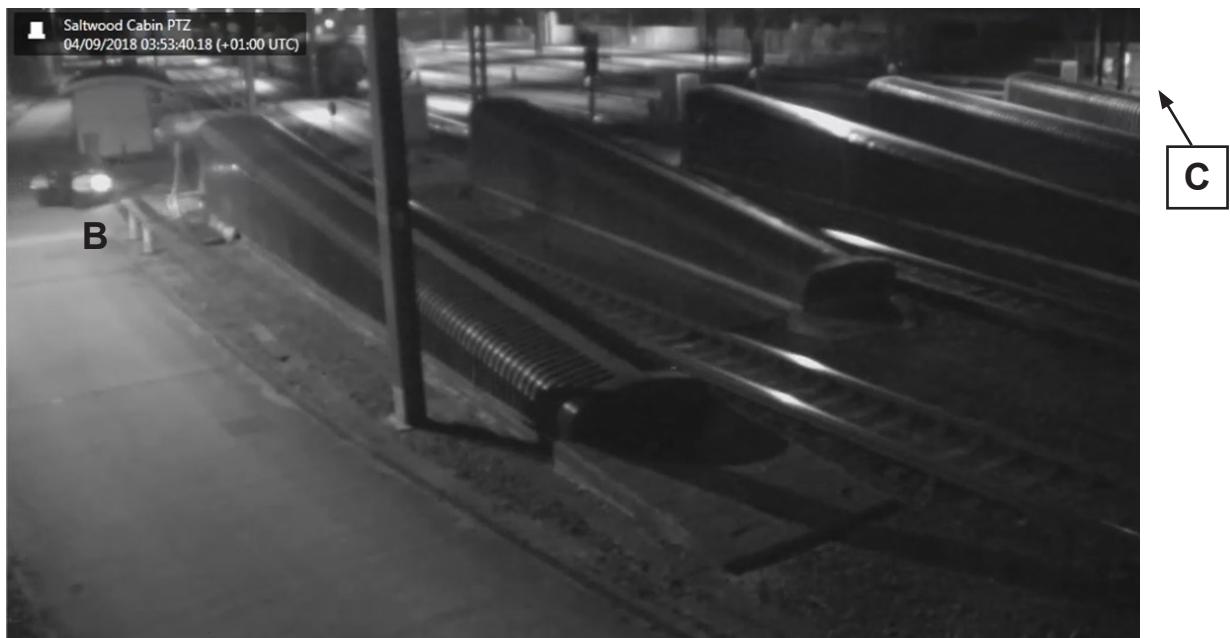
Figure 10: CCTV still image showing ramps and west end level crossing. Locations B and C are as marked on figure 8. The buggy is visible at location B, approaching the west end level crossing. The collision occurred just outside of the camera's field of view at location C.

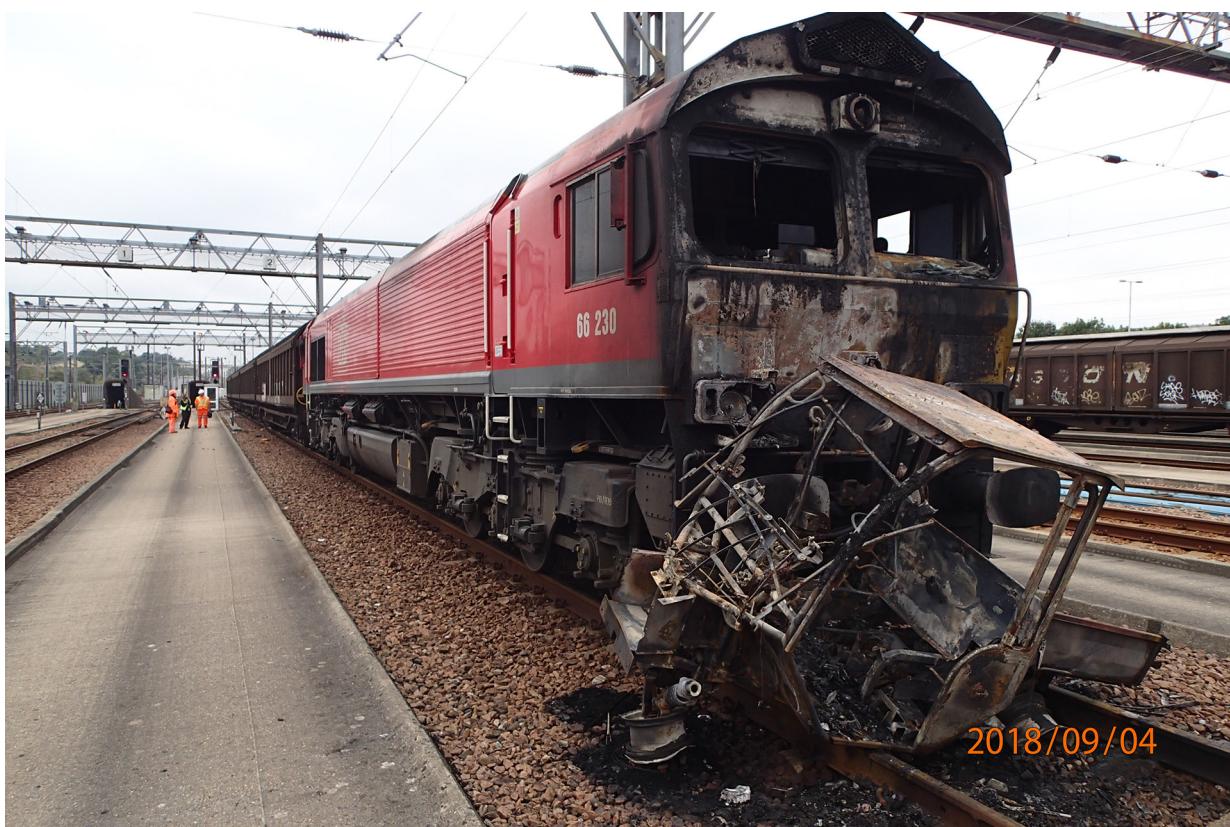
- 41 As the train was approaching the level crossing, the driver saw the buggy obstructing the line ahead and, at 03:39:41 hrs, applied the brake when the train was about 50 metres from the level crossing. He did not sound the train's horn. Immediately before the collision, he saw a person in orange overalls sitting in the buggy, who appeared to be reading a document and then looked up at the last moment before attempting to dive out.
- 42 The train travelled about 102 metres beyond the crossing before stopping 16 seconds after the collision. The buggy was pushed along the track by the train; creating sparks which ignited petrol spilt from the buggy's fuel tank as the train slowed down. The train driver left the cab immediately and before a significant fire took hold (figure 11); he was uninjured.

Figure 11: Image of locomotive and damaged buggy following accident. Concrete walkways run between each siding and are used for the inspection of trains.

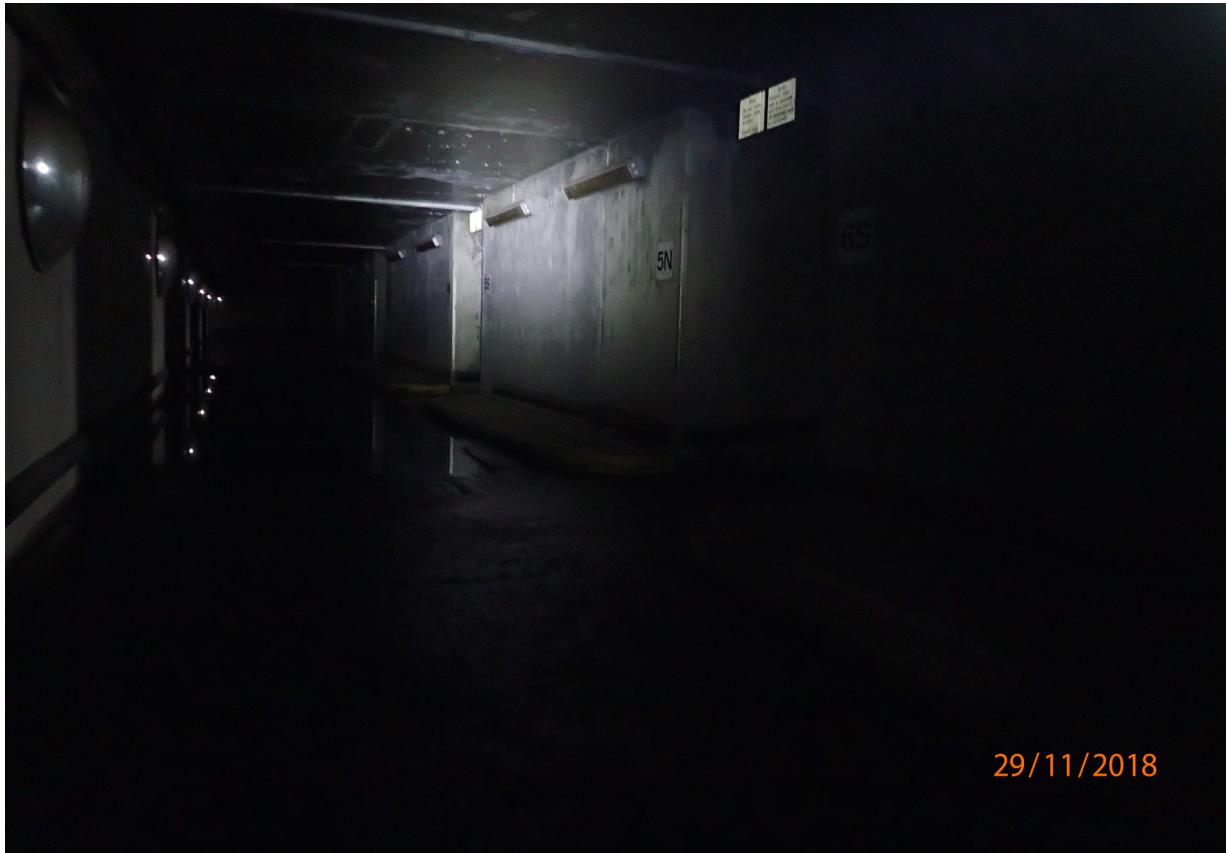
- 71 Use of the east end subway was problematic as it was often damp and, although the buggies had lights, the subway's internal lighting had failed (figure 12). It is not clear when these lights stopped working, but it pre-dated the arrival of the new group of shunters in 2014. There is no evidence that any maintenance reports were submitted requesting repair of the subway lighting between 2014 and 2018.

Figure 12: internal view of unlit east end subway in November 2018. The photograph was taken by torchlight.

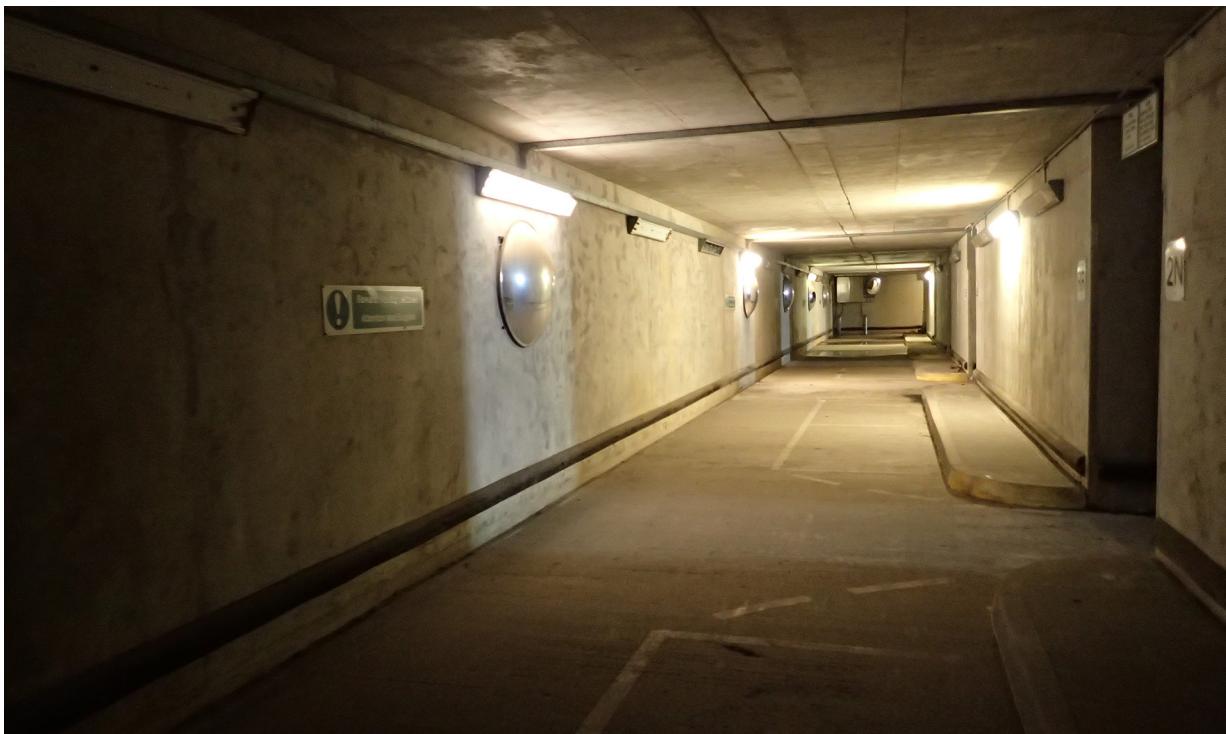
- 74 Although the condition of the west end subway was considered sufficiently poor to justify discontinuing its use in 2008 (paragraph 67), the RAIB found it was reasonably dry and most of its internal lighting was working in September 2018 (figure 13).

Figure 13: internal view of out of use west end subway with some working lighting, shown immediately after the accident in September 2018

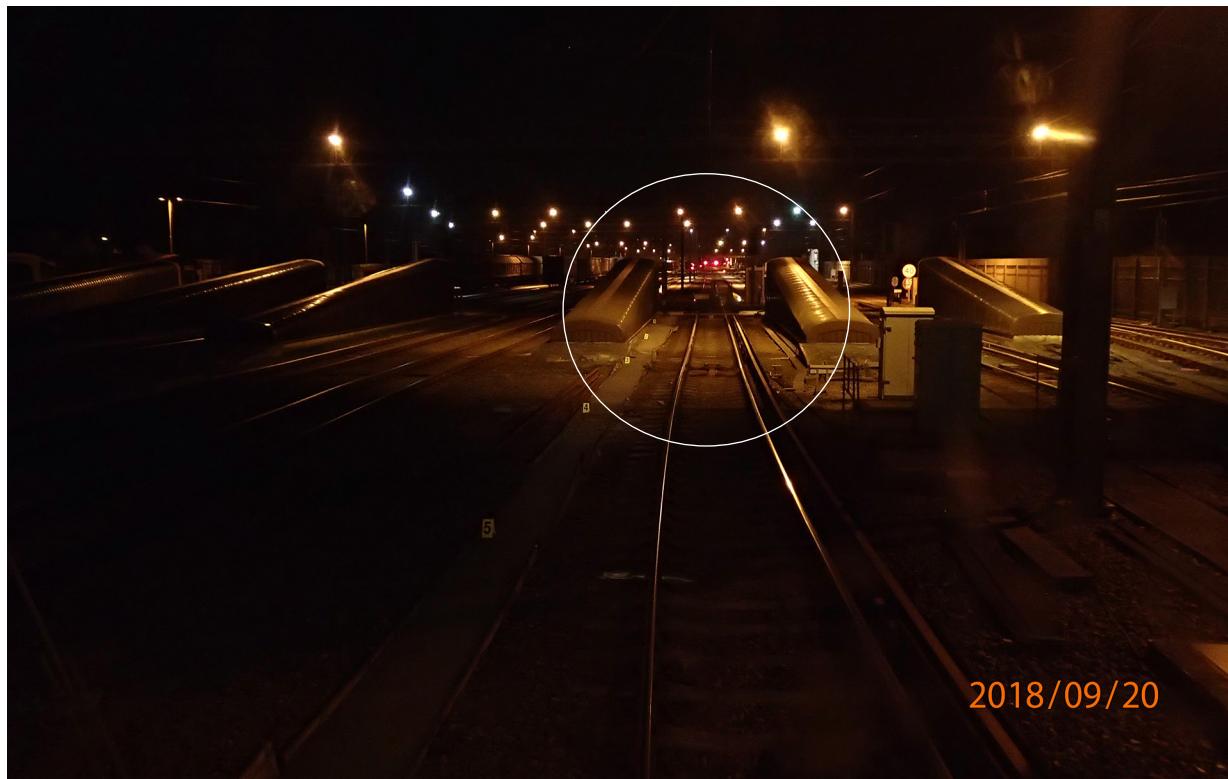
- 82 The buggy was not distinctly visible before it was illuminated by the train's headlights because its yellow bodywork meant it was a similar colour to pools of light reflected off the ground from the sodium floodlighting. This effect is illustrated by a photograph taken from the cab of a stationary locomotive during the reconstruction of the accident (figure 14). The reconstruction showed that the defective right-hand headlight had no significant effect on the conspicuity of the buggy viewed from an approaching train.

- 83 The petrol powered buggies, introduced in 2014, were equipped with front and rear driving lights which were designed to work only when the engine was running. They were not equipped with hazard lights, flashing beacons, reflective strips or other features to increase their conspicuity.
- 84 Network Rail document RT3170<sup>15</sup> indicates that it is good practice for road vehicles to show hazard warning lights when on or near the line. DB Cargo has informed the RAIB that it requires vehicles in other yards (eg reach-stackers in container-handling depots) to have an orange flashing beacon. The Health and Safety Executive (HSE) publication 'A guide to workplace transport safety'<sup>16</sup> states:

Figure 14: reconstructed view of a buggy on the level crossing showing a train driver's view 60 m from the crossing. Note that the right-hand headlight (ie on the side nearest the train) was unlit.
