Fatality resulting from the inversion of a craft with a retractable keel following a capsizing

June 2019

MAIB SAFETY BULLETIN 2/2019

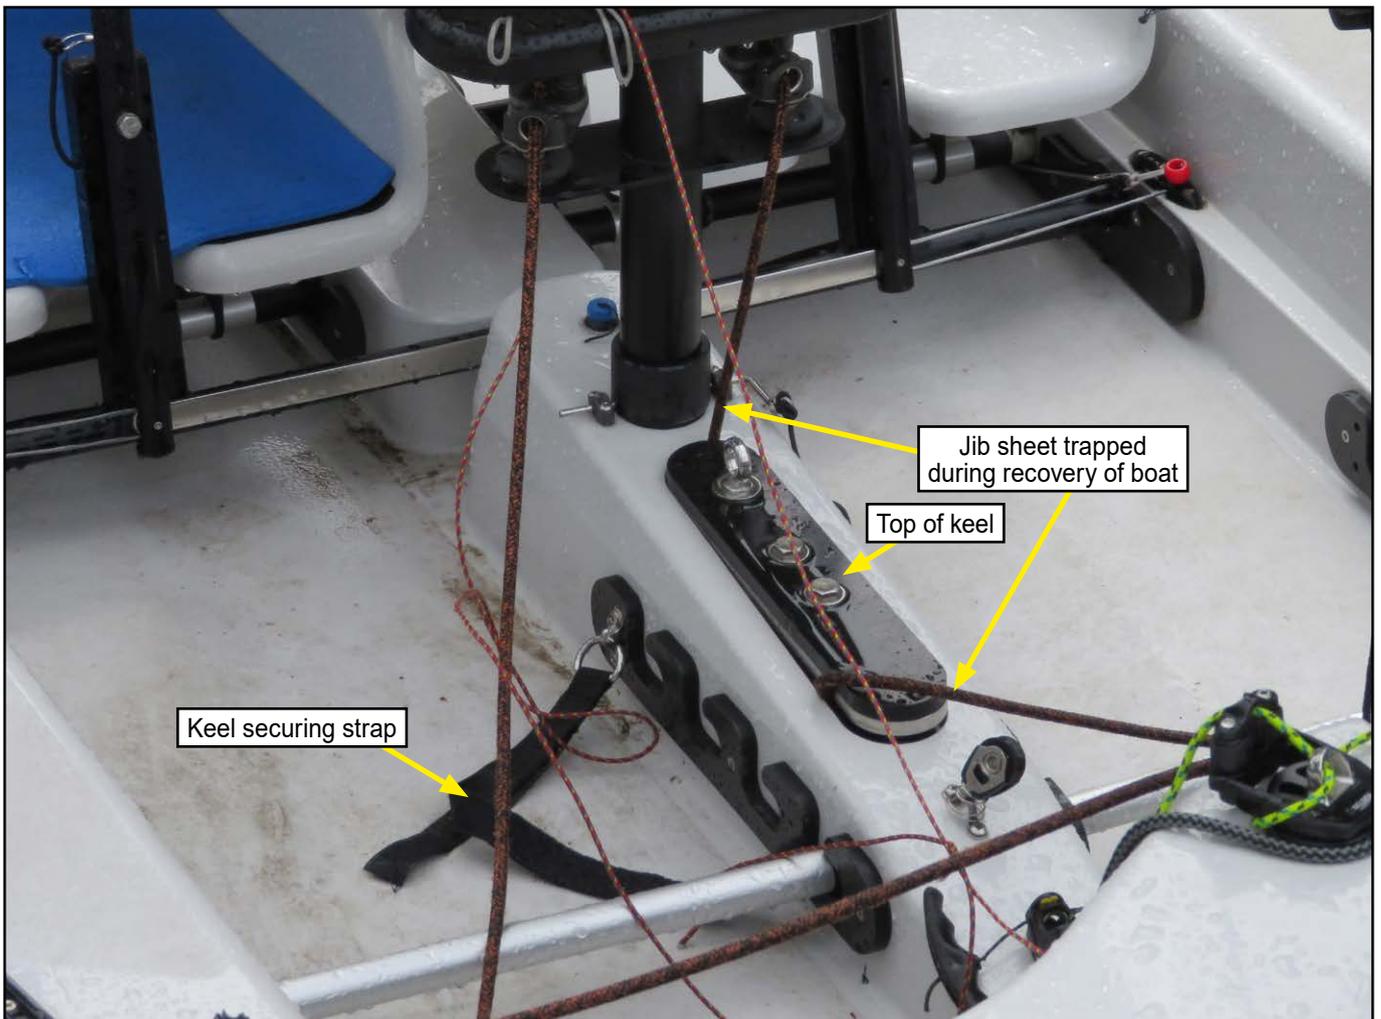
The post-accident inspection of the boat, together with photographic evidence from the day, has identified that the restraining device for the keel, a Velcro™ strap, designed to secure the keel in the lowered position, was not in place (**Figure 1**).

Figure 1: Showing top of the keel with the restraint not in place

RS Sailing has contacted all registered owners of RS Venture Connect boats, reiterating the instructions regarding the importance of ensuring the keel securing strap is correctly fitted prior to use.

- Prior to use, checks should be made to ensure the manufacturer's instructions regarding the securing of the keel or weighted centreboard have been followed.
- Their procedures and drills for recovering a capsized boat include the scenario where the keel or centreboard has retracted from its 'lowered' position.

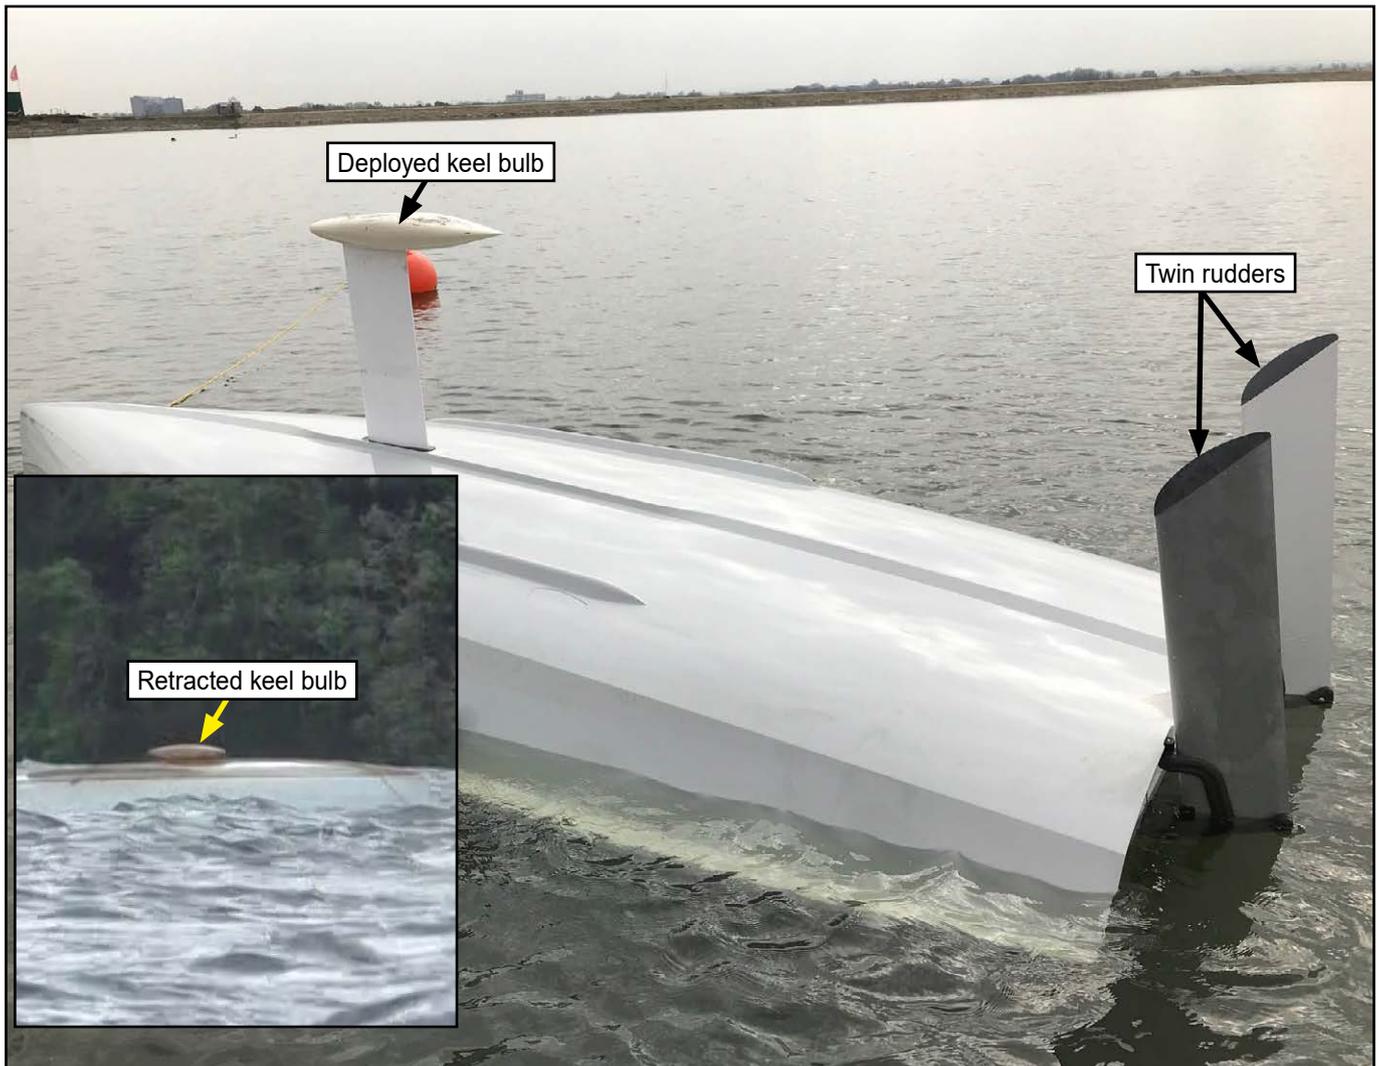
In the windy conditions on the day, the boat was knocked down and heeled to such an extent that the keel slipped in its housing, retracting entirely. **Figure 2** shows the boat fully inverted with the lead bulb keel fully deployed, with an inset showing the boat inverted and the keel retracted. During the capsize the assistant instructor was able to swim clear but the disabled crewman became trapped under the inverted hull. The safety boat crew saw the accident and attended the scene quickly, but had difficulty righting the boat and so were unable to reach the crewman in sufficient time to effect a successful rescue.

Figure 2: Inverted boat with a fully deployed keel bulb (Inset: the keel bulb hard up against the inverted hull)

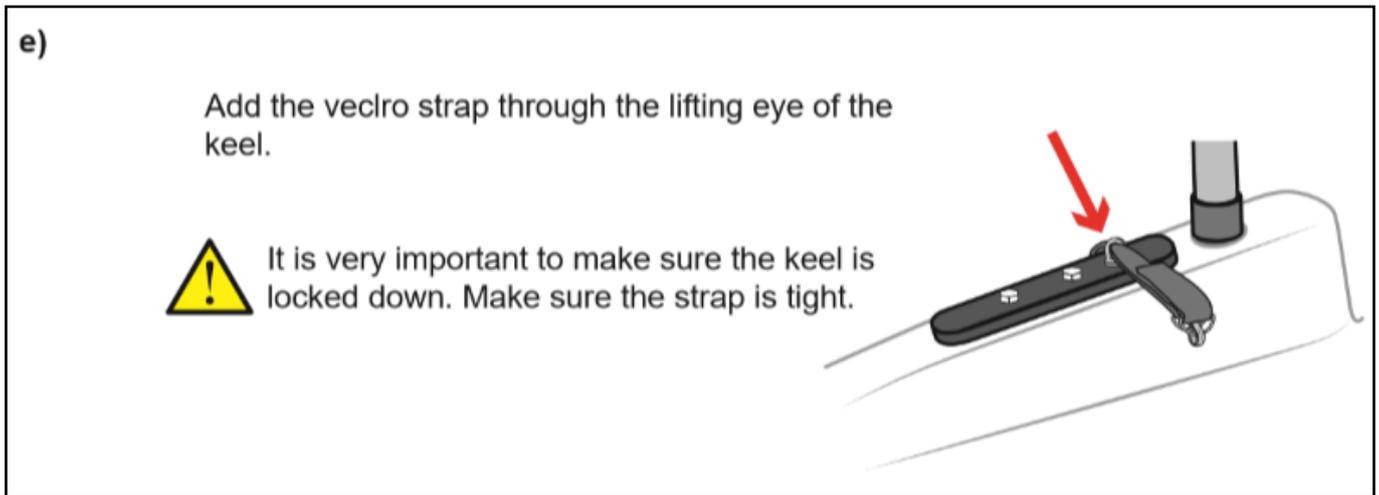
The importance of securing the retractable keel was highlighted in the manufacturer's rigging guide for the boat (**Figure 3**). However, this accident demonstrates that some users may not be aware of how critical this is.

Figure 3: Extract from the manufacturer's rigging guide
