General Inspection Report for River Great Stour (Old) (/M20//87.80//)
 (Authorised)

Structure Key	5958	Agent Name	A-One +
Commissioned	01/01/1957	O.S. Grid Ref East/North	601630 / 143450
Bridge Type	Highway Underbridge		
Length	14.80	Number of Spans	1
Date Inspected	30/09/2016	Overall Condition	Fair
Weather	Clear and dry		
Inspected by			
Authorised by			
Authorisation date	16/11/2016		
Method of Inspection	The structure was inspected on foot		
Equipment Used	Camera		
Parts of Structure Not Inspected	Foundations

River Great Stour (Old) underbridge is a single span insitu reinforced concrete structure. The structure has a span of 14.80m and a width of 32.90m and carries the M20 motorway over the River Great Stour and a cycletrack. The South edge of the bridge is a separate structure: River Great Stour (New) (#12433).

This inspection indicated that River Great Stour (Old) was in fair condition on the day of inspection.

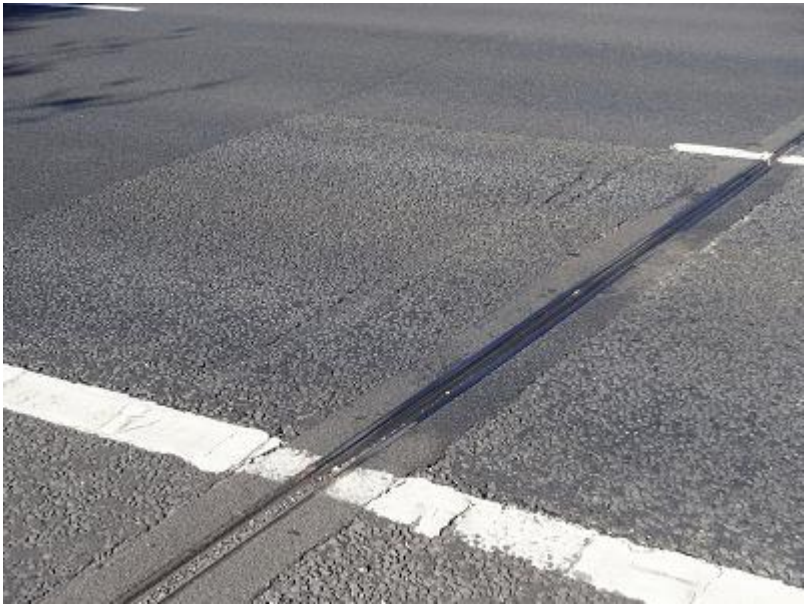
Components	Deck 1 - M20 LB Carriageway (Lane 3 - HS)	
Defect Type	CrCo - Cracked	
Extent	SC - Defect present in 5% to not more than 20% of area or length of element	
Severity	D2 - Minor: Defect is unlikely to be causing damage to the element or structure now or unlikely to do so in the near future	
Priority	Low	
Comments	There is transverse cracking of the surfacing parallel to the West expansion joint in the London bound carriageway across lane 1. (No action required at present)	
Cause	Other	Certainty Low

Comment on Cause	The cracking may be occurring over the beginning of the upstand for the expansion joint. This may have induced additional stresses in the pavement due to limited flexure of reduced surface thickness.	
	Cracking to the London bound surfacing

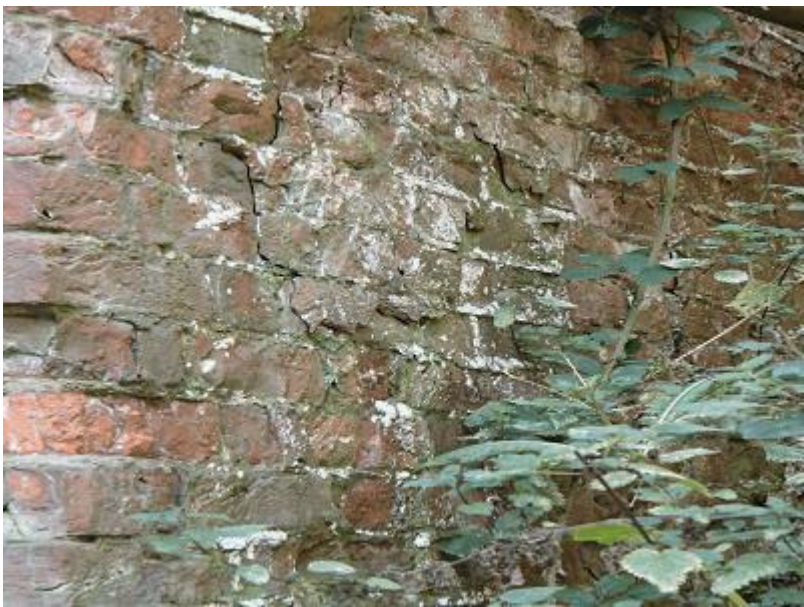
Comment on Cause	
Components	East Abutment - Northeast Wingwall, West Abutment - Northwest Wingwall
Defect Type	Sp - Spalled area
Extent	SE - Defect present in over 50% of area or length of element
Severity	D2 - Minor: Defect is unlikely to be causing damage to the element or structure now or unlikely to do so in the near future
Priority	Low
Comments	The Northern wingwalls both have areas of significant brickwork and mortar loss. The extent of the loss is unlikely to cause further problems at present. (No action required at present)
Cause	Other Certainty Medium

Comment on Cause	The brickwork is old (1957) and has been exposed to the weather throughout its life. The loss of brickwork might be attributable to frost damage as the brickwork appears saturated.
	Spalling area of brickwork to the Northwest wingwall

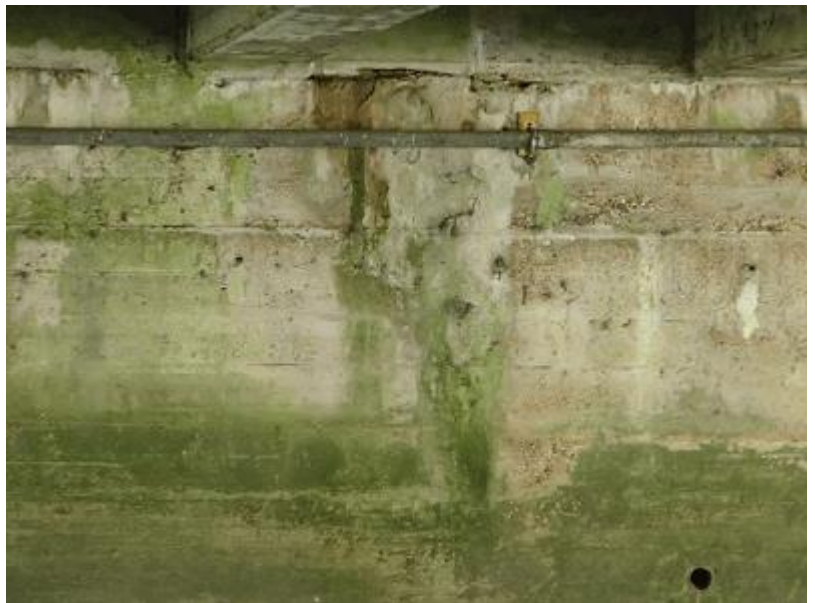
Components	East Abutment - East Abutment	
Defect Type	Cr - Crack of uncertain origin or a combination of causes

Extent	SD - Defect present in 20% to not more than 50% of area or length of element	
Severity	D2 - Minor: Defect is unlikely to be causing damage to the element or structure now or unlikely to do so in the near future	
Priority	Low	
Comments	The East abutment has numerous cracks with large amounts of leachate. A majority of the cracks and leachate appear to be horizontal along construction joints, however a few are vertical in nature with limited leaching.	
Cause	Unable to Determine	Certainty High
Comment on Cause

Possible rust staining to the East abutment (South deck)

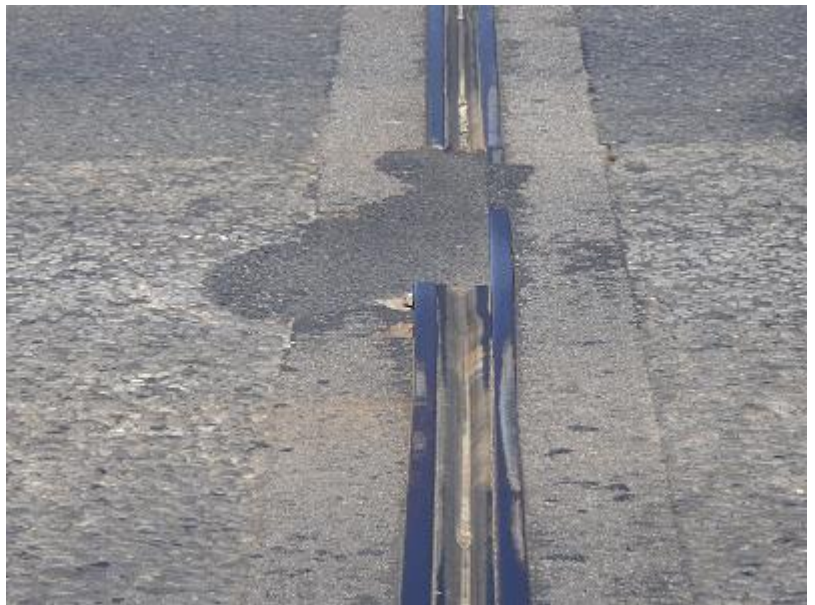
The East expansion joint across lane 2 of the London bound carriageway had failed. A section of rail had already been removed, however the nosing was breaking up and the rail section was loose and vibrating in the off-side wheel track. This was reported to the NCC for removal.

Components	Deck 1 - East Joint	
Defect Type	FrCo - Broken or fractured

Extent	SC - Defect present in 5% to not more than 20% of area or length of element	
Severity	D5 - Defect is causing element to be non-functional	
Priority	Medium	
Comments	The East expansion joint has failed across the offside wheel track of lane 1. The nosing has broken out around the reinforcement and the edge of the rail is close to the wheel track of lane 1.	
Cause	Anchorage Failure	Certainty Medium
Comment on Cause

Failed joint across lane 1

Maintenance Object	Expansion Joint	Maintenance Action	Repair
Origin of Work	Not Specified		
Estimated Cost	£20,000	Recomm. Action Date	01/04/2018
Comments	Break out any additional areas of failed nosing and/or damaged rail and replace the damaged sections.

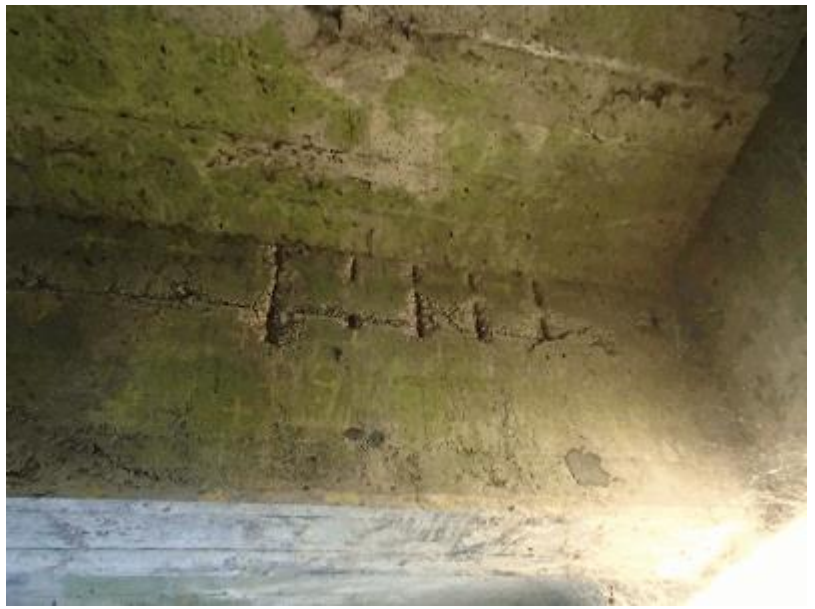
Components	South Deck: Beams - Beam 19 (South), South Deck: Beams - Beam 17, South Deck: Beams - Beam 18, Overlay Deck: Central Beams - Beam 11	
Defect Type	Sp - Spalled area

Extent	SC - Defect present in 5% to not more than 20% of area or length of element	
Severity	D3S - Moderate: Defect may present a danger to the public in the near future	
Priority	Medium	
Comments	There are numerous areas of delaminated and spalled concrete to beams 11, 17, 18 & 19. Some of these areas have extensive areas of exposed reinforcement.	
Cause	Unable to Determine	Certainty High
Comment on Cause	The original cause of the delamination and spalling is not known. It is possible that cracking allowed water ingress and subsequent corrosion of the reinforcement but this could not be confirmed.

Exposed reinforcement to South deck beam

Maintenance Object	Concrete Deck	Maintenance Action	Repair
Estimated Cost	£30,000	Recomm. Action Date	01/04/2018
Priority Category	2	Risk Score	93
Comments	Carry out concrete repairs to the affected areas of the South deck soffit. (07442)		
Maintenance Object	Abutment	Maintenance Action	Repair
Estimated Cost	£1,500	Recomm. Action Date	01/04/2010
Priority Category	3	Risk Score	25
Comments	Break out loose concrete and repair with a suitable repair mortar the area of spalling to the bearing plinth.

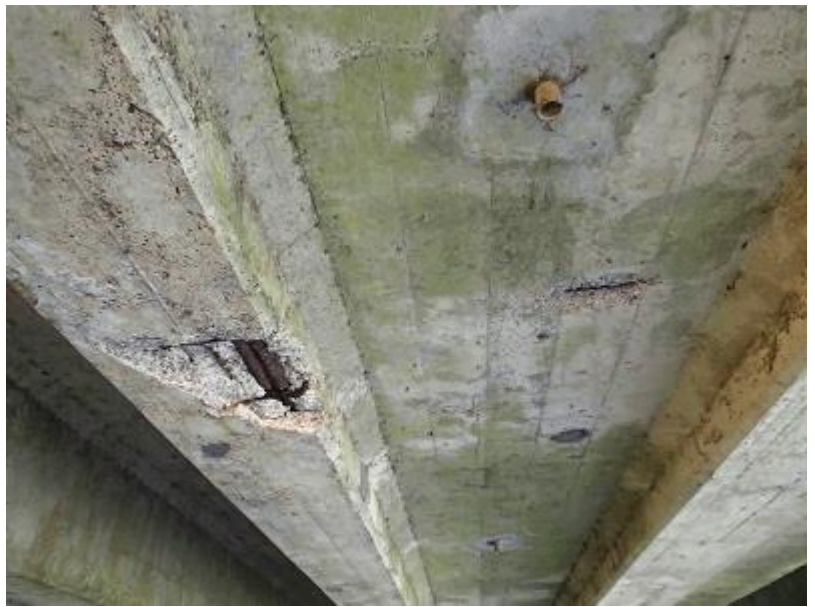
Exposed reinforcement to South deck beam and soffit

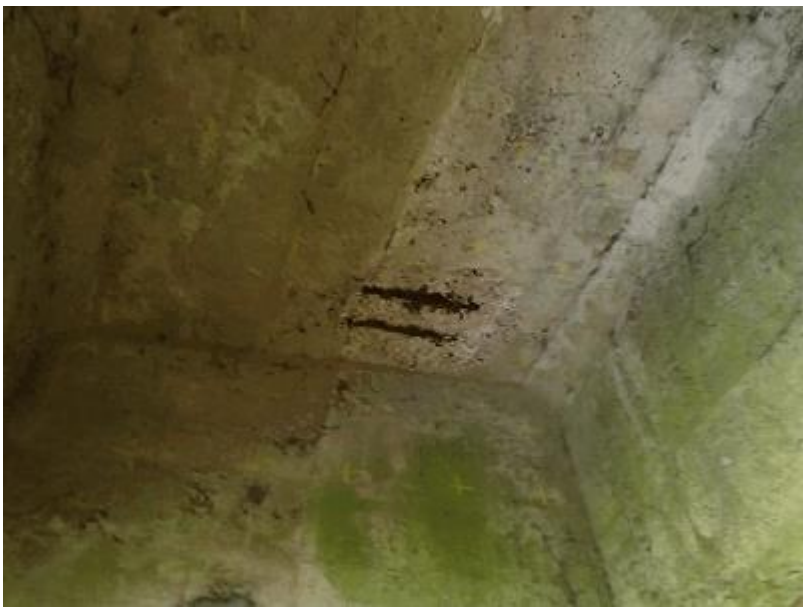
Extent	SB - Defect present in not more than 5% of area or length of element	
Severity	A2 - Defect in low tolerability condition	
Priority	Low	
Comments	There are various areas of graffiti to the beams of the structure.	
Components	Deck 1 - South Deck: Slab	
Defect Type	Sp - Spalled area

Extent	SC - Defect present in 5% to not more than 20% of area or length of element	
Severity	D2 - Minor: Defect is unlikely to be causing damage to the element or structure now or unlikely to do so in the near future	
Priority	Low	
Comments	Several areas of spalled concrete and exposed reinforcement to the slab soffit adj to beam 17 & 18.	
	Spalled concrete from the South deck soffit
