General Inspection Report for River Great Stour (Old) (/M20//87.80//)

Structure Key	5958	Agent Name	A-One +
Commissioned	01/01/1957	O.S. Grid Ref East/North	601630 / 143450
Bridge Type	Highway Underbridge		
Length	14.80	Number of Spans	1
Date Inspected	05/09/2018	Overall Condition	Fair
Weather	Dry; Cloudy; Warm 15 Degrees Celsius		
Inspected by			
Authorised by			
Authorisation date	11/01/2019		
Method of Inspection	On foot		
Equipment Used	PPE; Inspection Kit; Camera		
Parts of Structure Not Inspected	Foundations, waterproofing and other buried elements.

River Great Stour (Old) underbridge is a single span insitu reinforced concrete structure. The structure has a span of 14.80m and a width of 32.90m and carries the M20 motorway over the River Great Stour and a cycletrack. The South edge of the bridge is a separate structure: River Great Stour (New) (#12433).

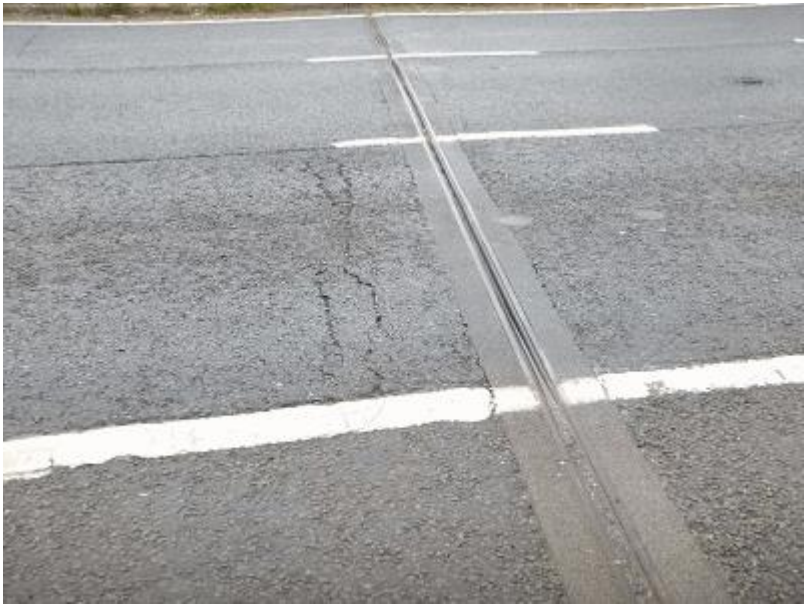
Components	Deck 1 - M20 LB Carriageway (Lane 3 - HS)	
Defect Type	CrCo - Cracked	
Extent	SC - Defect present in 5% to not more than 20% of area or length of element	
Severity	D2 - Minor: Defect is unlikely to be causing damage to the element or structure now or unlikely to do so in the near future	
Priority	Low	
Comments	There is transverse cracking of the surfacing parallel to the West expansion joint in the London bound carriageway across lane 1. (No action required at present)	
Cause	Other	Certainty Low

Comment on Cause	The cracking may be occurring over the beginning of the upstand for the expansion joint. This may have induced additional stresses in the pavement due to limited flexure of reduced surface thickness.	
	General view showing cracking to surfacing adjacent to the expansion joint.

Maintenance Object	Expansion Joint	Maintenance Action	Repair
Origin of Work	Not Specified		
Estimated Cost	£45,000	Recomm. Action Date	01/04/2021
Priority Category	3	Risk Score	82
Comments	Carry out replacement of the East Type 6 expansion joint, London bound. Consider combining with resurfacing to address the potholes.

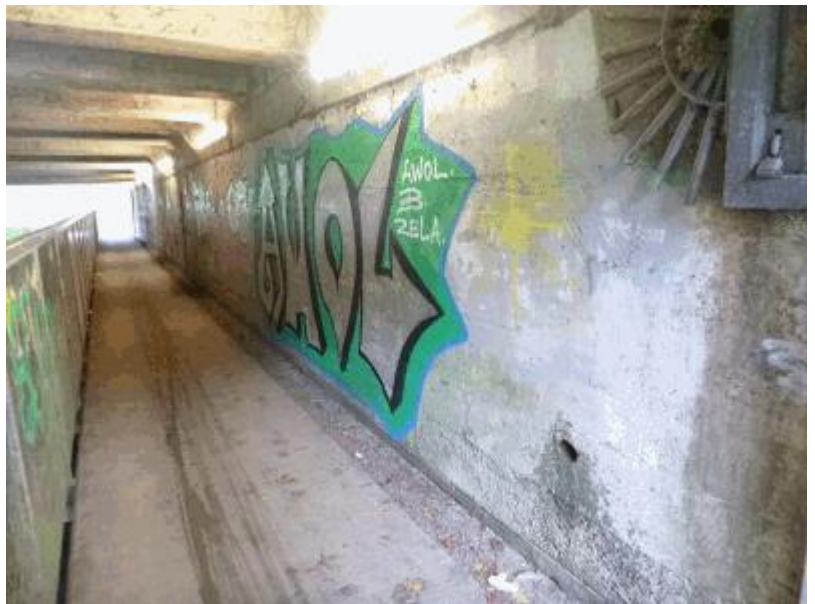
Components	West Abutment - West Abutment	
Defect Type	Graf - Graffiti	
Extent	SD - Defect present in 20% to not more than 50% of area or length of element	
Severity	A2 - Defect in low tolerability condition	
Priority	Low	
Comments	There are large areas of graffiti on the West abutment of the structure.	
Cause	Vandal Action	Certainty High
Comment on Cause	Vandalism

1. General view showing graffiti to the west abutment looking from the north end.

Comments Clean graffiti from the structure.

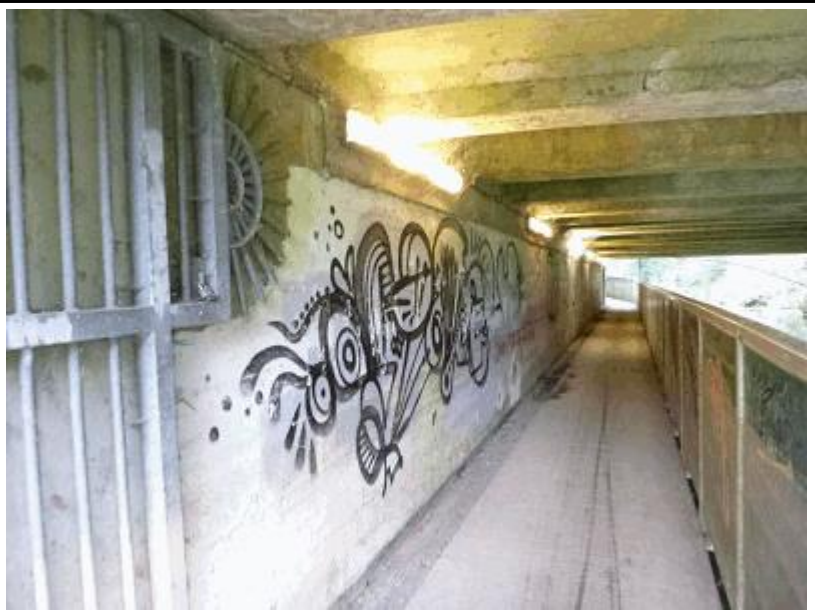
2. General view showing graffiti to the west abutment looking from the south end

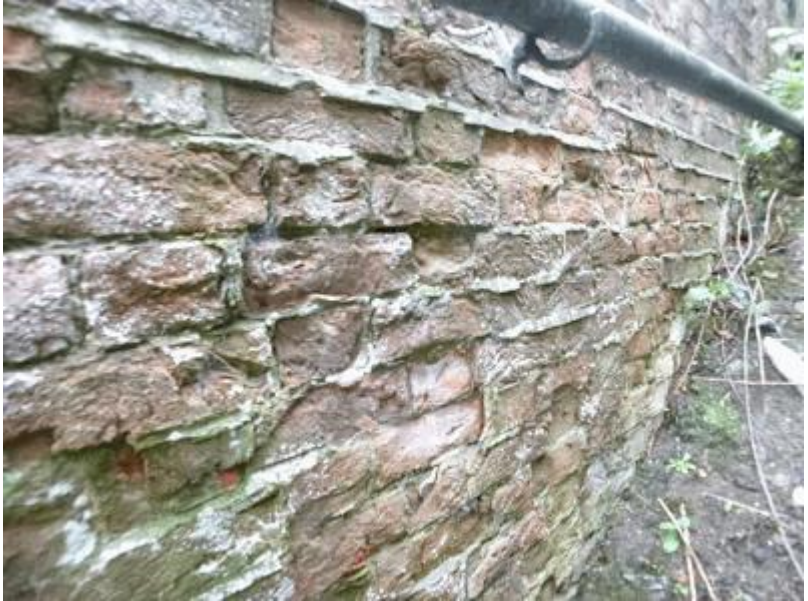
Components	East Abutment - Northeast Wingwall, West Abutment - Northwest Wingwall	
Defect Type	Sp - Spalled area	
Extent	SE - Defect present in over 50% of area or length of element	
Severity	D2 - Minor: Defect is unlikely to be causing damage to the element or structure now or unlikely to do so in the near future	
Priority	Low	
Comments	The Northern wingwalls both have areas of significant brickwork and mortar loss. The extent of the loss is unlikely to cause further problems at present. (No action required at present)	
Cause	Freeze Thaw Action	Certainty Medium

Comment on Cause	The brickwork is old (1957) and has been exposed to the weather throughout its life. The loss of brickwork might be attributable to frost damage as the brickwork appears saturated.	
	General view showing spalling brickwork and mortar loss to the wingwall.

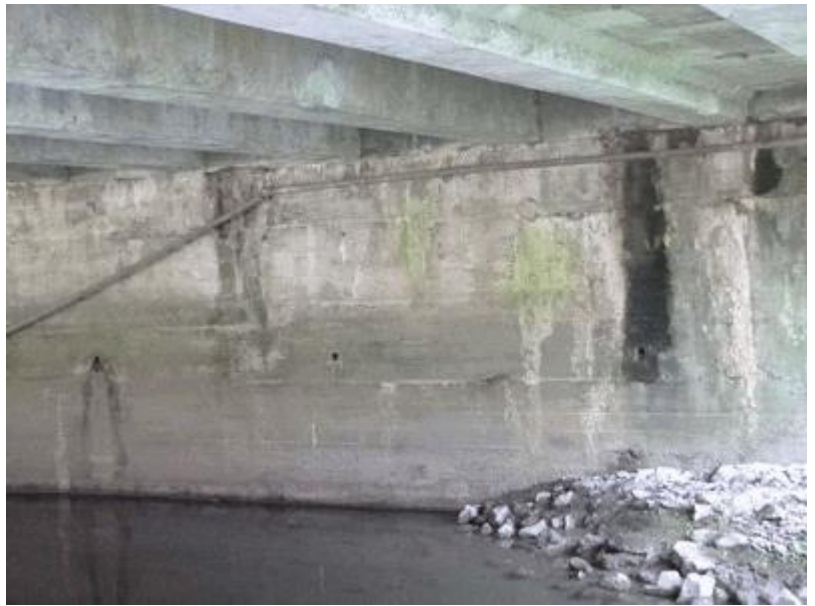
Extent	SD - Defect present in 20% to not more than 50% of area or length of element	
Severity	D2 - Minor: Defect is unlikely to be causing damage to the element or structure now or unlikely to do so in the near future	
Priority	Low	
Comments	The East abutment has numerous cracks with large amounts of leachate. A majority of the cracks and leachate appear to be horizontal along construction joints, however a few are vertical in nature with limited leaching.	
Cause	Unable to Determine	Certainty High

General view showing cracking with leachates to the east abutment.

Maintenance Object	Concrete Deck	Maintenance Action	Repair
Estimated Cost	£30,000	Recomm. Action Date	01/04/2020
Priority Category	2	Risk Score	93
Comments	Carry out concrete repairs to the affected areas of the South deck soffit. (07442)		
Maintenance Object	Trench	Maintenance Action	Repair
Estimated Cost	£750	Recomm. Action Date	01/04/2020
Priority Category	2	Risk Score	87
Comments	Supply and install new paving stones to the North verge.		
Maintenance Object	Abutment	Maintenance Action	Repair
Estimated Cost	£1,500	Recomm. Action Date	01/04/2010
Priority Category	3	Risk Score	25
Comments	Break out loose concrete and repair with a suitable repair mortar the area of spalling to the bearing plinth.		
Maintenance Object	Abutment	Maintenance Action	Repair
Estimated Cost	£10,000	Recomm. Action Date	01/04/2020
Priority Category	3	Risk Score	12
Comments	Carry out concrete repairs to the East abutment as identified in the 2013-14 concrete repair study. (07442)

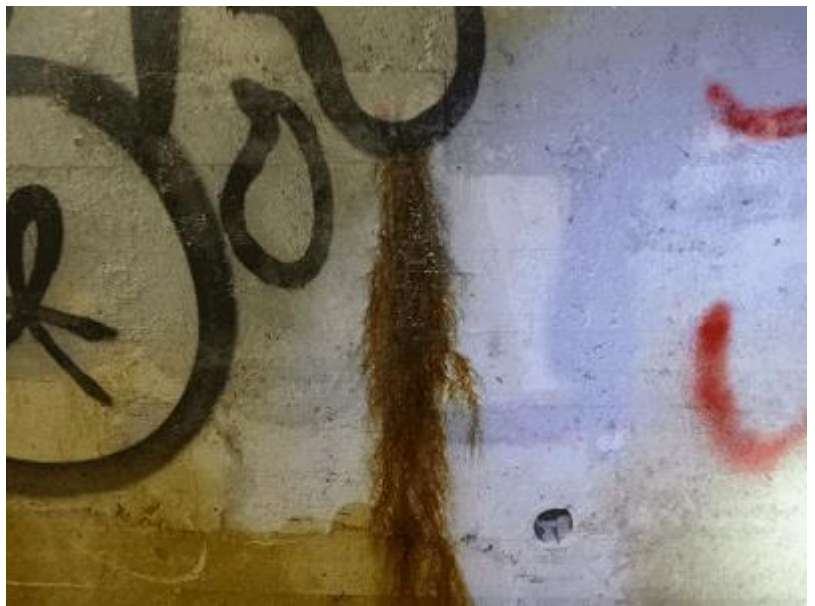
Components	West Abutment - West Abutment
Defect Type	Cr - Crack of uncertain origin or a combination of causes
Extent	SC - Defect present in 5% to not more than 20% of area or length of element
Severity	D2 - Minor: Defect is unlikely to be causing damage to the element or structure now or unlikely to do so in the near future
Priority	Low
Comments	The West abutment has hairline cracks in isolated areas along its length with some exhibiting leaching and rust staining. (No action required at present)

General view showing crack with rust staining to the west abutment.

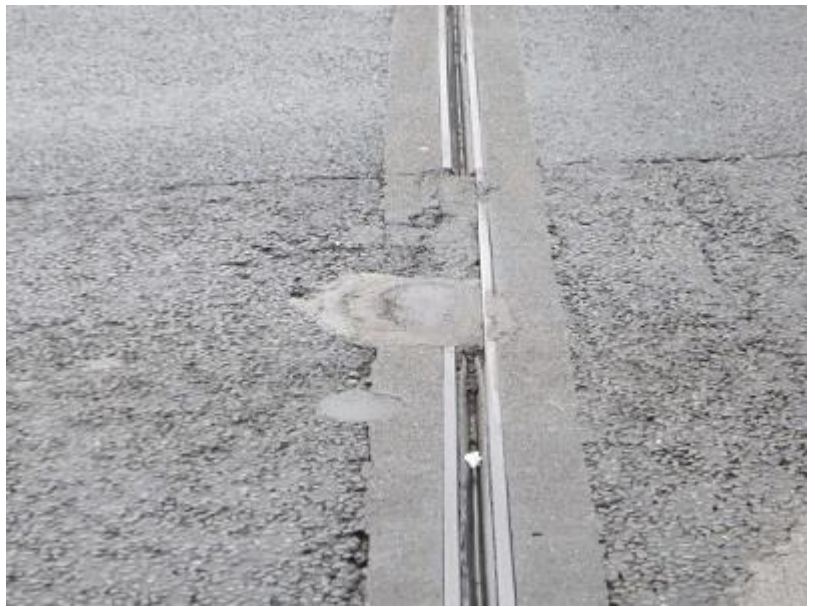
Components	Deck 1 - East Joint		
Defect Type	FrCo - Broken or fractured		
Extent	SC - Defect present in 5% to not more than 20% of area or length of element		
Severity	D4 - Severe: Defect is clearly causing damage to element or structure		
Priority	Medium		
Comments	The East expansion joint has failed across the offside wheel track of lane 1. The nosing has broken out around the reinforcement and the edge of the rail is close to the wheel track of lane 1. A section of rail has been removed.		
Cause	Anchorage Failure	Certainty	Medium
Comment on Cause

General view showing expansion joint to lane 1 has failed.

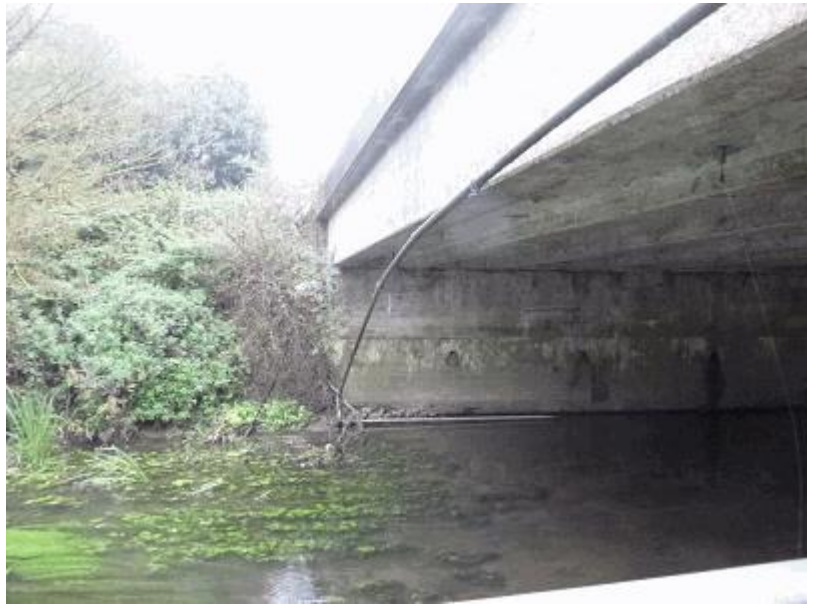
Extent	SC - Defect present in 5% to not more than 20% of area or length of element	
Severity	D2 - Minor: Defect is unlikely to be causing damage to the element or structure now or unlikely to do so in the near future	
Priority	Low	
Comments	The service conduit/pipe fixed to the North face of the deck is loose at the East end and on the abutment. The section over the pedestrian/cycle path has been made safe with a tie to the parapet.

1. General view showing that the service conduit/pipe is disconnected from deck north face and abutment.

Comments The conduit has been removed subsequent to the inspection.

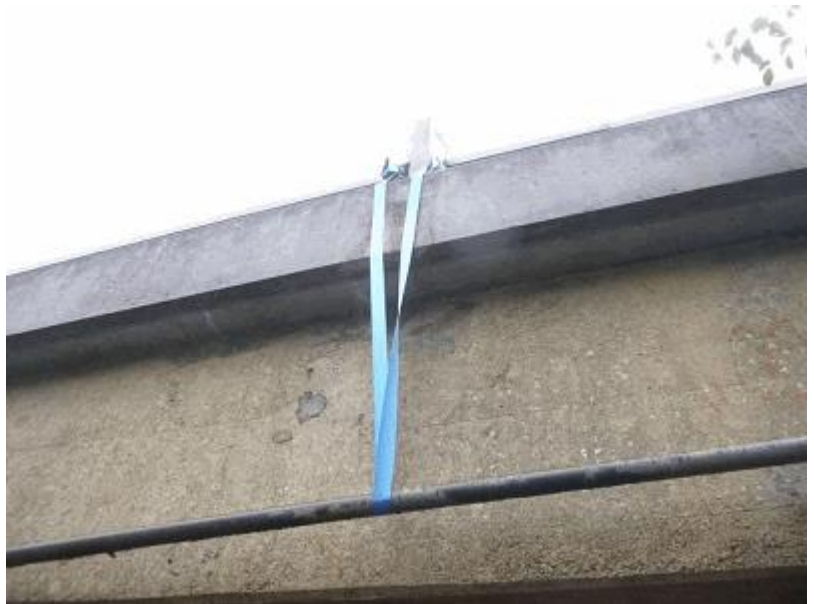
2. General view showing loose service conduit/pipe retain by strapping to parapet post.

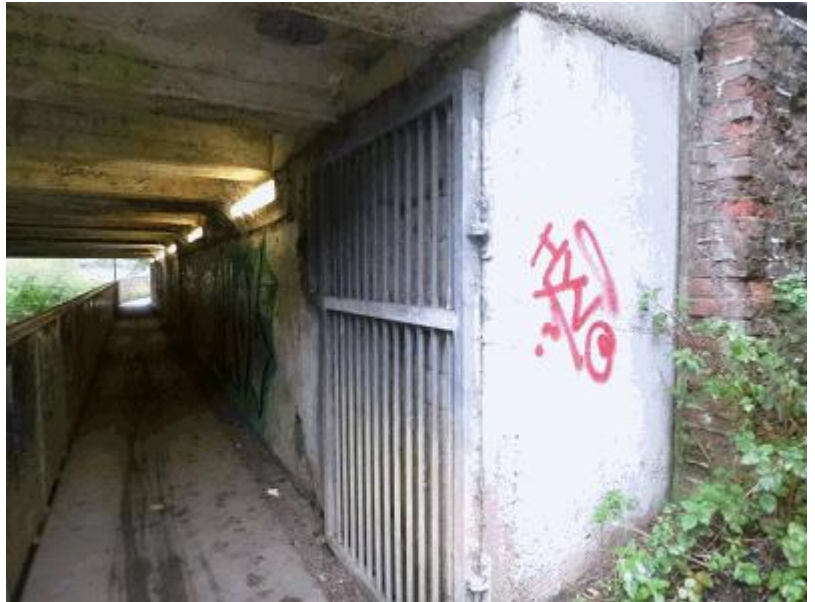
Extent	SB - Defect present in not more than 5% of area or length of element
Severity	D2 - Minor: Defect is unlikely to be causing damage to the element or structure now or unlikely to do so in the near future
Priority	Low
Comments	The central light unit afixed to the West abutment is non-functional. (Delete defect, lighting units are now functional)

General view showing lighting units to the west abutment are functional.

Maintenance Object	General	Maintenance Action	Change Status
Origin of Work	Routine Inspection		
Comments	Delete defect, lighting units are now functional.

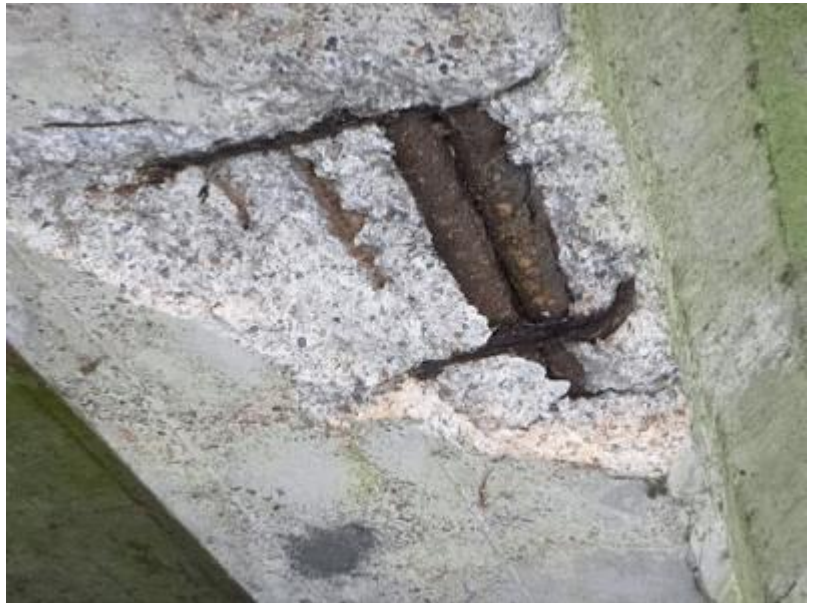
Extent	SC - Defect present in 5% to not more than 20% of area or length of element	
Severity	D3 - Moderate: Defect is probably causing damage to element or structure, or is likely to do so in the near future	
Priority	Medium	
Comments	There are numerous areas of delaminated and spalled concrete to beams 11, 17, 18 & 19. Some of these areas have extensive areas of exposed reinforcement.	
Cause	Unable to Determine	Certainty High
Comment on Cause	The original cause of the delamination and spalling is not known. It is possible that cracking allowed water ingress and subsequent corrosion of the reinforcement but this could not be confirmed.

2. General view showing spalling and exposed reinforcement to soffit of beam 18 (south) (2).

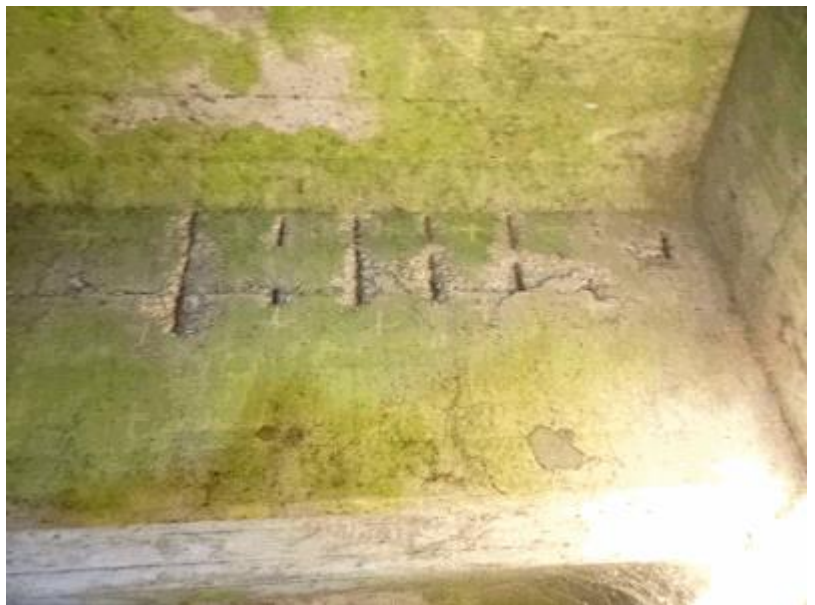
3. General view showing exposed reinforcement to fascia of beam 18 (south).

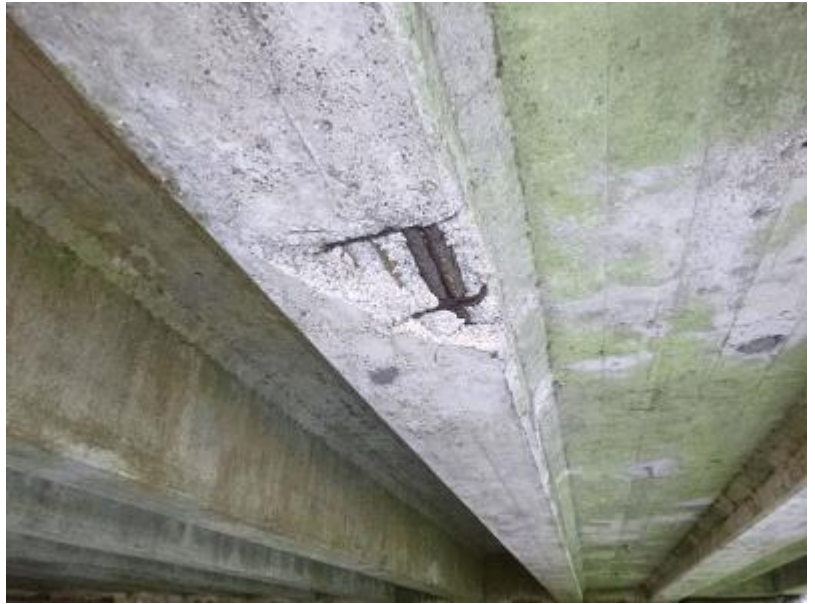
1. General view showing spalling and exposed reinforcement to soffit of beam 18 (south) (1).

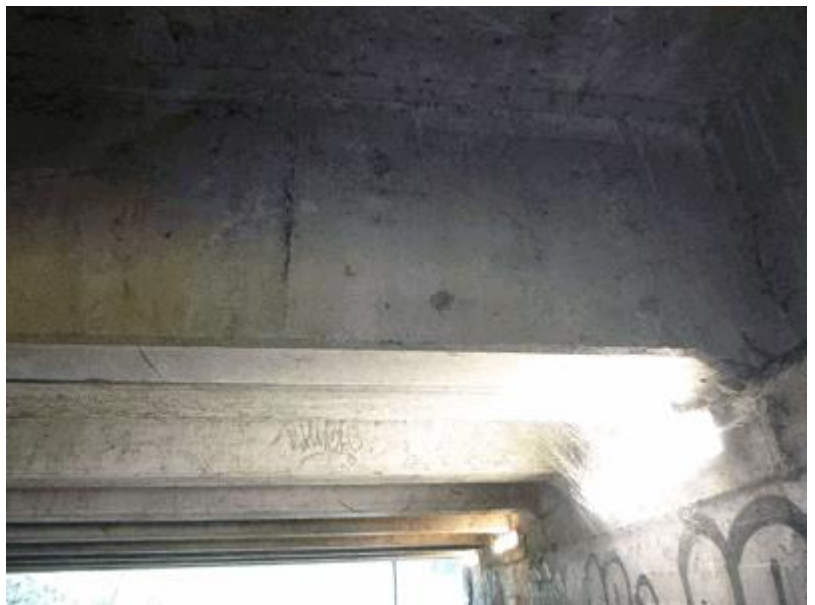
Comments There are various areas of graffiti to the beams of the structure.

2. General view showing graffiti to the deck beam.

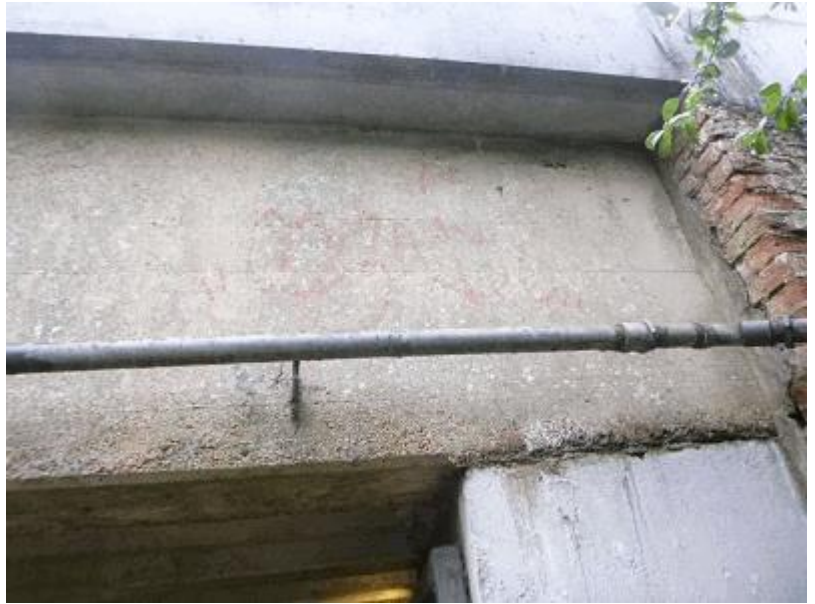
1. General view showing graffiti to the fascia beam at west end.

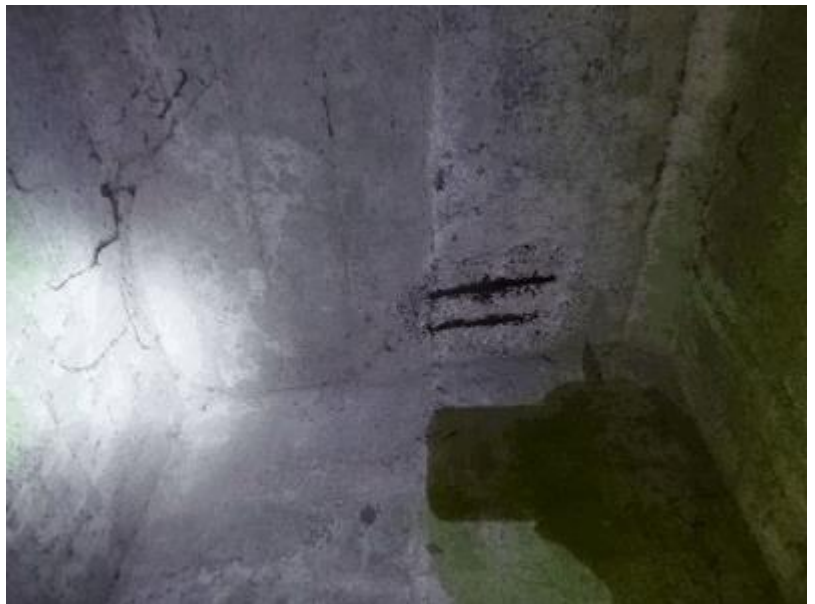
Components	Deck 1 - South Deck: Slab
Defect Type	Sp - Spalled area
Extent	SC - Defect present in 5% to not more than 20% of area or length of element
Severity	D2 - Minor: Defect is unlikely to be causing damage to the element or structure now or unlikely to do so in the near future
Priority	Low
Comments	Several areas of spalled concrete and exposed reinforcement to the slab soffit adj to beam 17 & 18.

General view showing spalled and exposed reinforcement to south deck soffit.

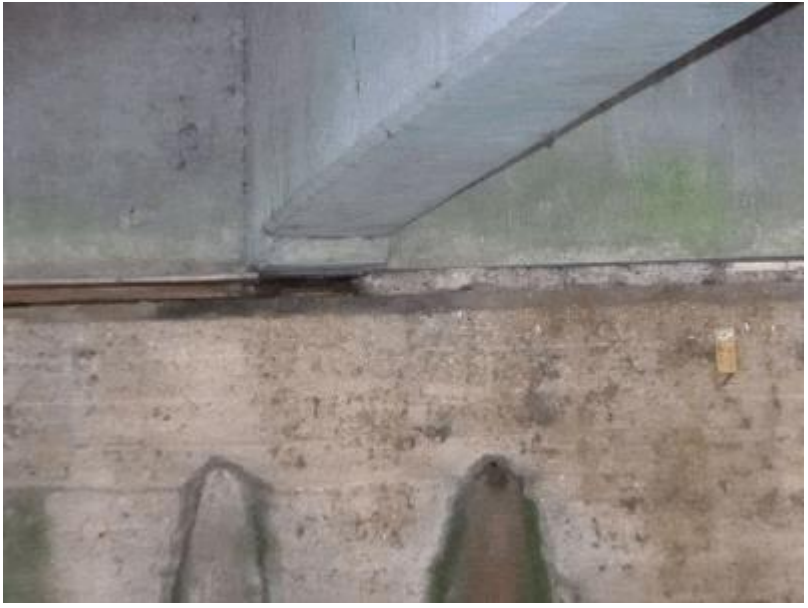
Components	East Abutment - East Abutment Bearings (Central Gap), West Abutment - West Abutment Bearings (Central Beams)
Defect Type	RCo - Rusty/Corroded
Extent	SC - Defect present in 5% to not more than 20% of area or length of element
Severity	D2 - Minor: Defect is unlikely to be causing damage to the element or structure now or unlikely to do so in the near future
Priority	Low
Comments	There is minor surface corrosion to the bearings of the central beams. The corrosion is not considered significant at present. (No action required at present)
	<p>General view showing surface corrosion to bearings of the central beams.</p>

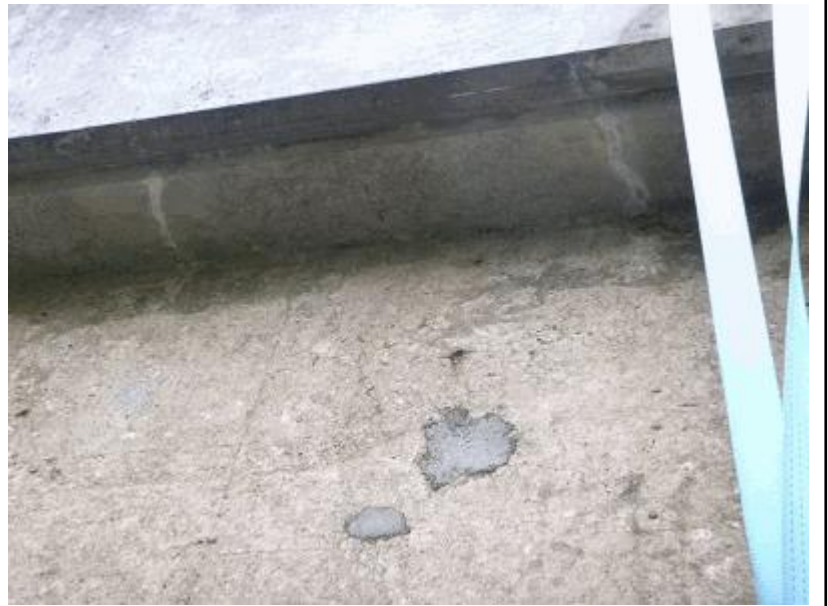
Priority	Low
Comments	Hairline cracking was identified to the underside of the deck slab at the North edge. The cracking is at semi-regular intervals with no significant leaching. (No action required at present)

General view showing cracking to the underside of the deck slab at north edge.
