SAFETY FLYER TO THE FISHING INDUSTRY

Fatal man overboard from the tender of *Fram of Shieldaig* in Loch Torridon off Ardhessaig, Scotland on 7 August 2018

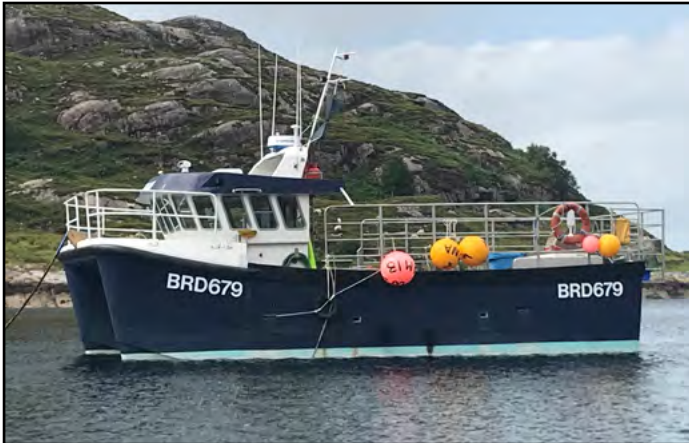
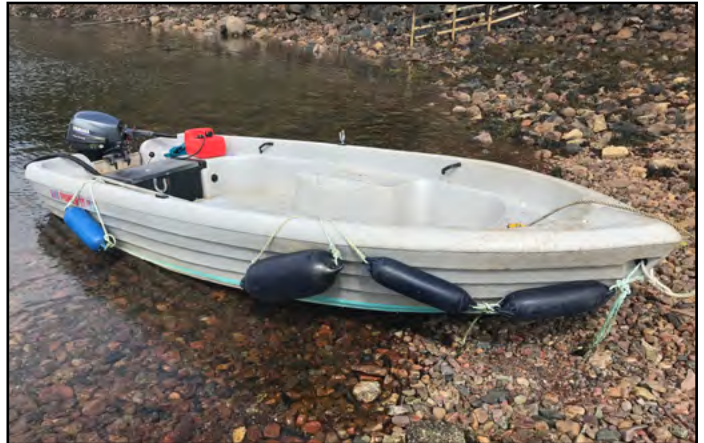
At approximately 0800 on 7 August 2018, a deckhand from the fishing vessel *Fram of Shieldaig* (*Fram*), entered the water while manoeuvring the vessel's tender.

The skipper, who was alone on board *Fram*, saw the tender approaching the vessel's stern and moved to the port side to take its painter from the deckhand. After a few moments, when the tender had not drawn alongside as expected, the skipper looked over the side and saw the deckhand was floating motionless in the water between *Fram* and the tender, which was drifting away with its engine at tick-over.

The evidence indicated that the deckhand struck his head and was knocked unconscious as he fell into the water. As a result, the MAIB investigation concluded that he drowned because he was not wearing a lifejacket when he entered the water and the skipper was unable to recover him on board on his own. Regular manoverboard drills had not been carried out and therefore the difficulties involved in the recovery of an unconscious person by a single rescuer had not been identified.
