Fall from height on board from freight ferry *Seatruck Pace* with loss of one life in Liverpool 17 December 2018

SUMMARY

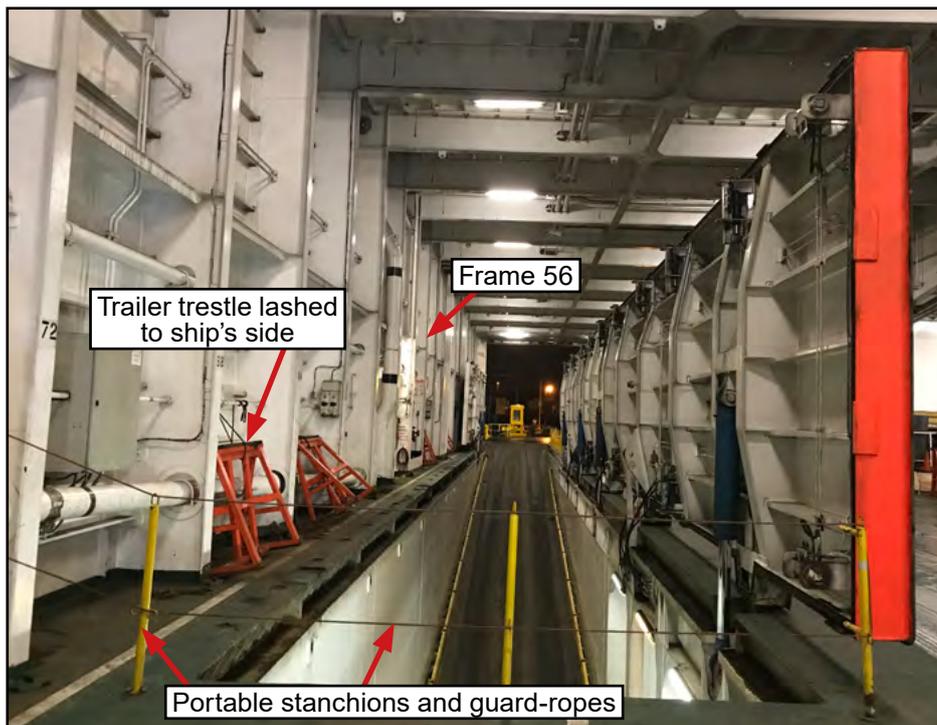
Figure 2: Hatch opening and ramp

When closed, the hatch cover formed part of the main vehicle deck and onto which semi-trailers were loaded. When open, portable stanchions and guard-ropes were rigged along the forward edge of the open hatch (**Figure 2**) and along the inboard edge opposite to the aft hatch cover section (**Figure 3**) to protect crew from falling onto the ramp below. When discharging, the assistant bosun's duties included the rigging of the forward stanchions and guard-ropes.

Portable stanchions provided for use along the outboard edge of the open hatch were not routinely used (**Figure 4**). The deck between the starboard ship's side and the hatch edge adjacent to the forward and middle hatch cover sections was 90cm wide. It contained a re-fuelling point, a fire hose and hydrant, the emergency control panel for the hatch covers' hydraulics, and trestles, none of which the crew were required to access when the hatch cover was open. It was usual practice for the trestles to be placed parallel to the ship's side and secured with rope lashings (**Figure 2**) before the hatch covers were opened.

To have fallen over the outboard edge of the open hatch on the main vehicle deck in way of Frame 56, the assistant bosun must have passed through the temporary rope and stanchion barrier at its forward end and then moved 12m aft, along the 90cm wide deck (**Figure 2**). It is only possible to speculate on why the assistant bosun entered this hazardous area.

- Reminded its masters of the dangers of bypassing safety control measures and prompted them to review the safety of deck openings.
- Provided safety chains, fittings and warning signs for use on the temporary barriers rigged on the main vehicle decks of its ferries.

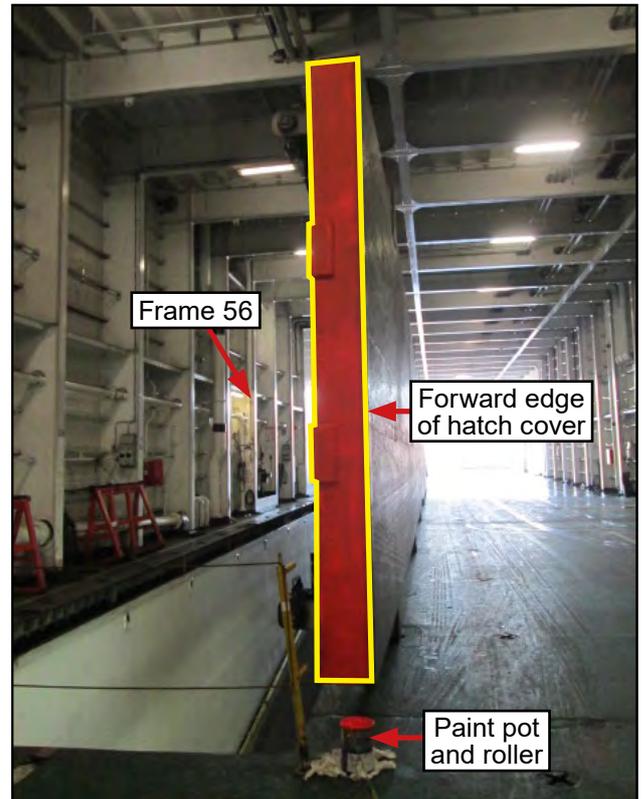
Figure 1: Hatch opening and cover (forward)

At 0810, two ordinary seamen passed the assistant bosun, Roman Giersz, as they walked aft on the main vehicle deck towards the cargo office. The assistant bosun had not attended the meeting and was preparing to paint the forward edge of the hatch cover. He had with him a pot of orange paint, a short-handled paint roller and a rag (**Figure 1**).

At about 0820, crew in the cargo office and the two ordinary seamen in the lower hold heard a loud crash on the ramp and hurried to investigate. The assistant bosun was found lying on the inboard side of the ramp in line with Frame 56 (**Figures 1, 2 and 3**), with a trestle lying on its side and across the lower part of his right leg. The assistant bosun was on his back with his feet towards the lower end of the ramp, 12m from the forward end of the hatch opening above. The second officer immediately raised the alarm and went to the ferry's hospital to collect the medical kit.

The assistant bosun was found on the inboard side of the 3.5m wide permanent ramp, adjacent to Frame 56 (**Figures 1, 2 and 3**), but access to the hatch above was blocked on the inboard (port) side by the open hatch cover and protected on the forward edge by the guard ropes. The forward end of the hatch opening was 12m away. Therefore, the assistant bosun could only have fallen onto the ramp from the outboard (starboard) edge of the hatch opening, which was not protected along its length. The vertical distance from the main vehicle deck to the ramp at Frame 56 was 4.5m. It cannot be determined whether the assistant bosun's medical condition was contributory to his fall.

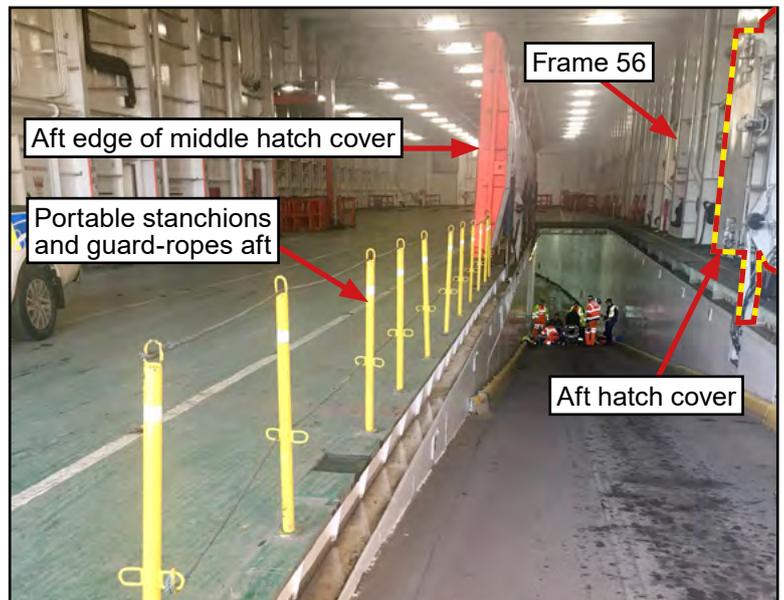
Figure 3: Paramedics on scene

At 0845, an ambulance with three paramedics arrived on board *Seatruck Pace*, escorted by a Port of Liverpool police vehicle. The paramedics treated the assistant bosun where he was lying (**Figure 3**),

Access to the lower hold was via a 3.5m wide permanent ramp through a hatch on the starboard side of the main vehicle deck. The hatch cover was divided into three sections along its length, with the forward and middle sections hinged on the inboard side of the hatch and the aft section hinged on the outboard side (**Figure 3**).

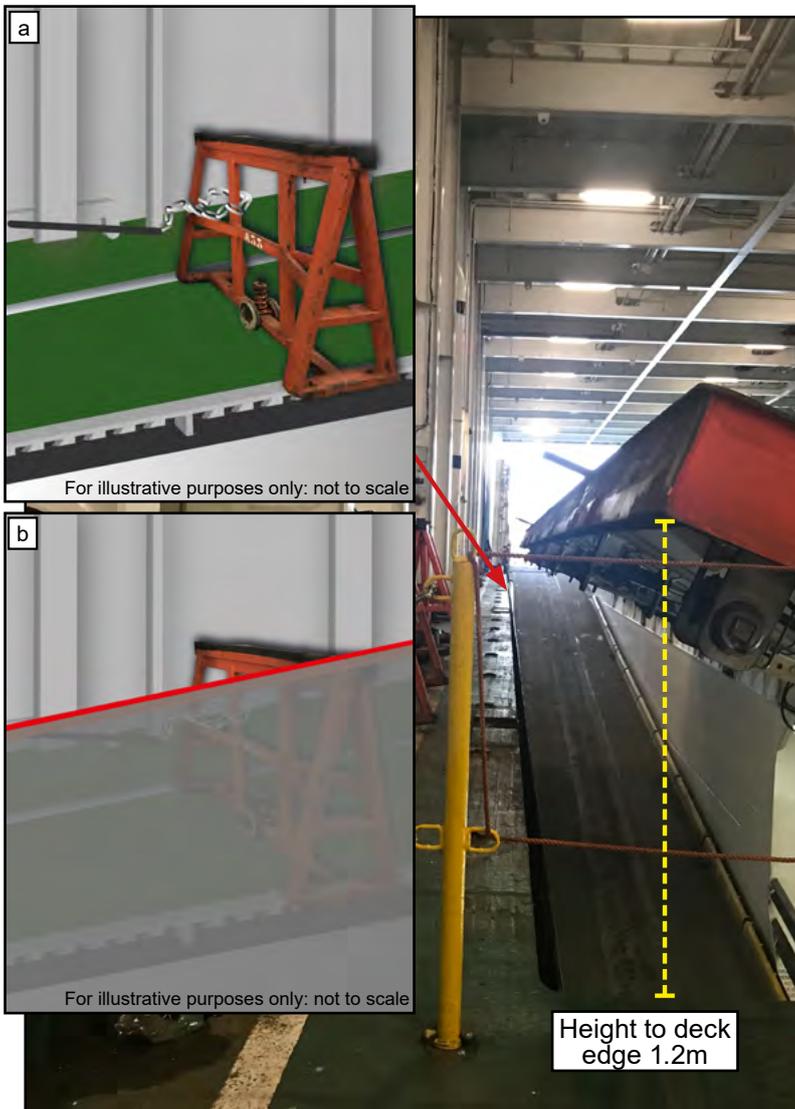
Figure 5: Open hatch cover (illustration a: approximate position of trestle overhanging hatch edge and illustration b: hatch cover resting on trestle)

Work on the hatch cover had last been undertaken on Saturday 15 December 2018 (2 days before the accident), when *Seatruck Pace* was in Dublin. After cargo discharge, the hatch cover was left open and the bosun and an AB positioned a trestle perpendicular to the ferry's starboard side, so that part of the trestle was overhanging the hatch edge. The outboard end of the trestle was secured to pipes on the ferry's side with a chain and hook arrangement. The forward section of the hatch cover was then lowered until it rested on the trestle (**Figure 5**). The trestle was placed as a precautionary measure and was intended to support the hatch cover in the event of hydraulic failure.

With the forward section of the hatch cover resting on the trestle, the AB removed rust from its outboard edge with a chipping hammer and an angle grinder. An OS then primed the prepared areas. Meanwhile, the assistant bosun cleaned the vertical forward and aft edges of the middle and aft hatch covers, which

remained fully open. The work was not authorised by a PTW, none of the ratings wore a safety harness, and portable stanchions and guard-ropes were not rigged along the side of the exposed edge.

A similar attitude to safety was evident among *Seatruck Pace*'s crew during the earlier hatch cover maintenance on 15 December. On that occasion, the crew involved had accessed the hatch cover's outboard edge from the outboard side of the vehicle deck using a trestle to support the cover at a convenient height, rather than tower scaffolding, which was in use in the lower hold, or a mobile elevated platform, which was not on board at the time. The use of a trestle was an unusual practice that was not included in the ferry's generic risk assessments. However, a specific, task-based risk assessment, which could have identified the hazards involved and mitigation measures to be taken, was not completed. Instead, the risk of the AB and the OS falling through the 1.2m gap between the hatch cover and the hatch opening (**Figure 5**) was accepted, and mitigation measures such as the rigging of an additional temporary safety barrier along the outboard edge of the hatch opening, or the wearing of safety harnesses, were not considered.

- Engaged HSE consultants with the aim of forming a safety culture steering group and implementing the HSE's Safety Climate Tool.
- Undertaken to revise the SMS to highlight that specific items of equipment should only be used for their intended purpose, e.g. trailer trestles should only be used to support trailers.
