Report detailing the testing of an HPL rainscreen cladding system tested in accordance with the requirement as described in British Standard 8414

CUSTOMER TEST REPORT

BS 8414-1-2015+A1-2017 Test Report

Report Reference: 101856.002

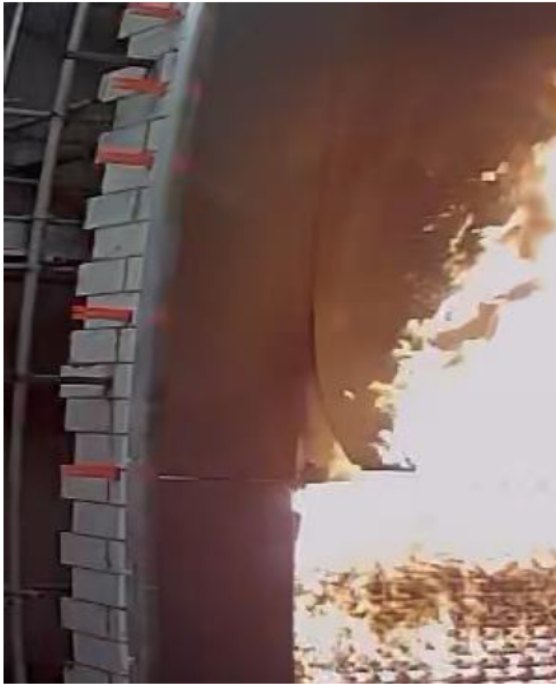
10.50	Damage to surface of panels 2 & 3.
11.30	Damage to surface of panels 10 & 13.
12.00	Bottom edge of panels 7 and 8 starts to curve up. (See Figure 9)

Figure 9 – Panel 7 curing upwards
(approximately 18 minutes after ignition)

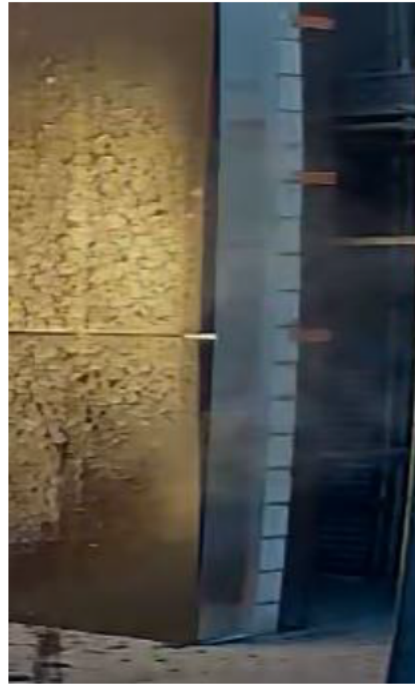
15.20	Right hand edge of panels 10 and 13 starts to curve inwards toward the fire. (See Figure 10)
15.50	Bottom edge Panels 7 and 8 damaged/fallen away so the insulation is visible from front face.

Figure 10 – Panel 10 and 13 curing inwards
(approximately 22 minutes after ignition)

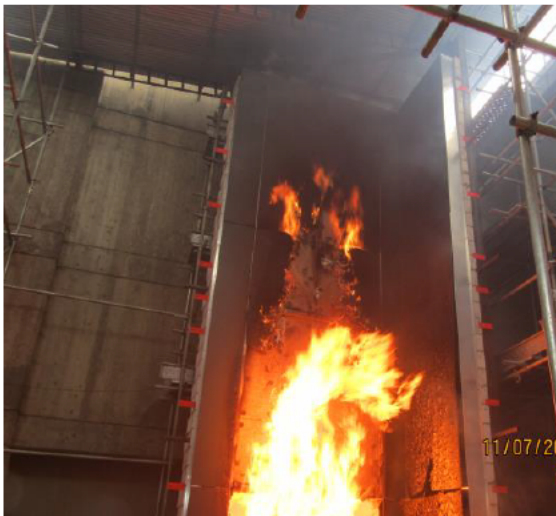
26.00	Panel 2 and 3 burning independently. (See Figure 11)
26.50	Panel 10 starts to split apart near base. (See Figure 12)
27.50	Panel 10 burning independently.

Figure 11 – Panels 2 and 3 independently
burning (approximately 26 minutes after
ignition)

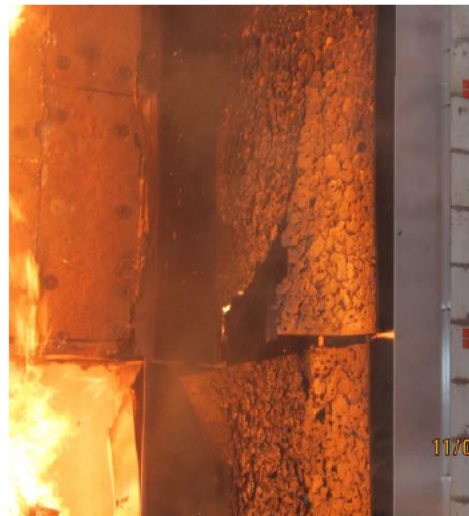
Figure 12 – Split in panel 10 (approximately 27
minutes after ignition)

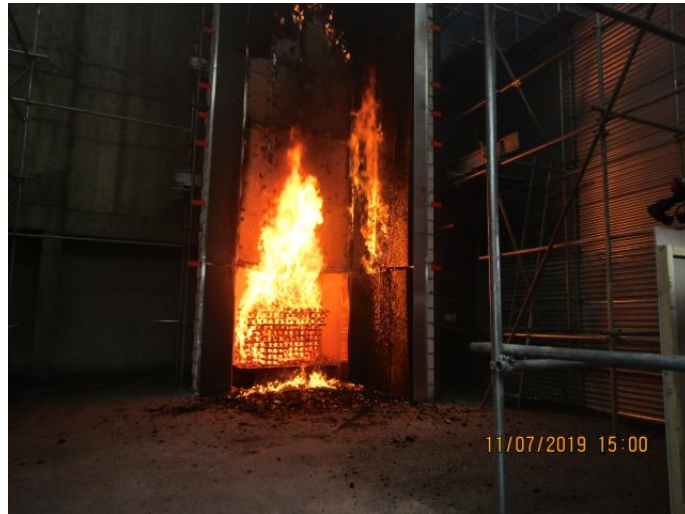
Figure 13 – Test wall and debris in front of wall prior to extinguishment of the crib. (29 minutes 50 seconds from ignition)

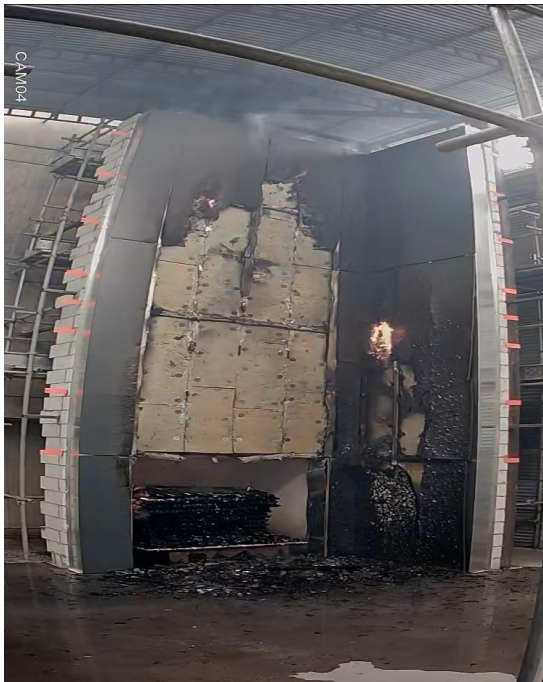
30.30	Crib extinguished by applying water from remote monitor and in-chamber suppression system.
Post crib extinguishment	Flames continue to burn on panels 2, 3 and 10. (See Figure 14)
41.20	Open flaming on panel 10 appears to have ceased, although some smouldering continues.
41.50	Open flaming on panel 2 appears to have ceased, although some smouldering continues.
48.50	Open flaming on panel 3 appears to have ceased, although some smouldering continues.
58.20	Flames become visible from behind panel 13. (See Figure 15)
60.00	Test ended, residual burning near panel 13 extinguished. Face of test wall doused down as smoke was still issuing from top of test wall.

Figure 14 – Residual burning on panels 2, 3 and 10 following extinguishment of the crib

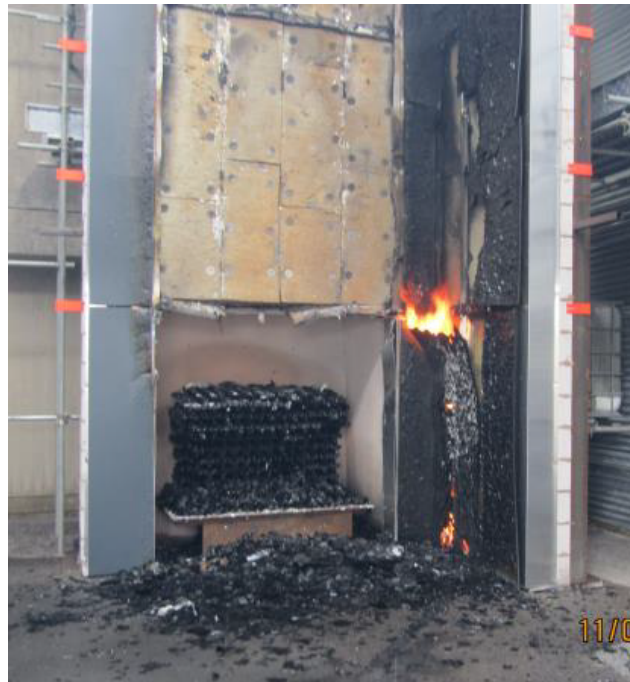
Figure 15 – Flames on panel 13 immediately before test end

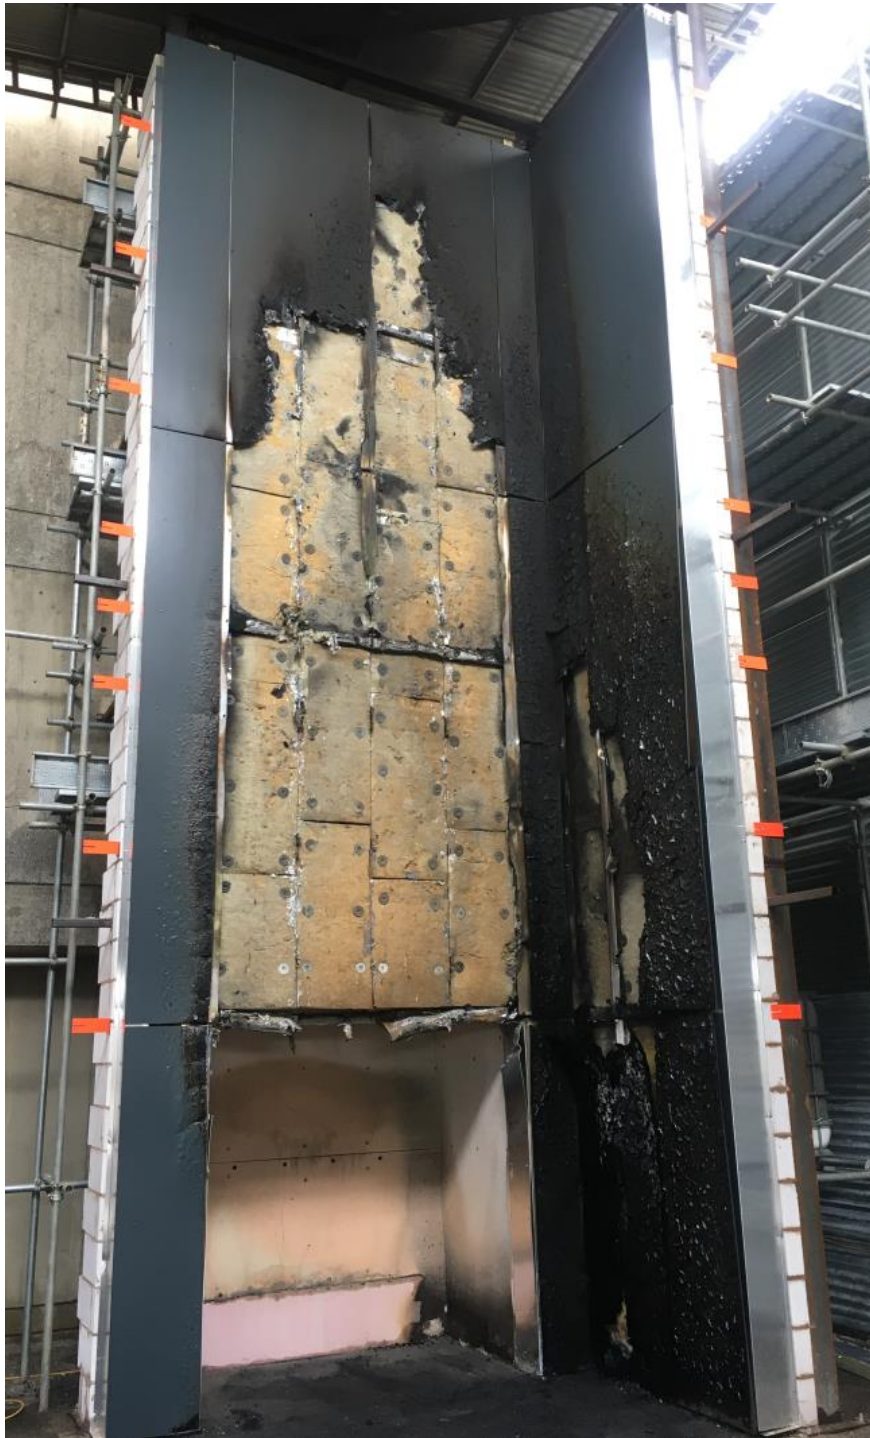
Figure 20 – Front face of system post test

- All panels were damaged or partially damaged. See Figure 20, Figure 21 and Figure 22.
- On the main wall the worst damaged area was directly above the combustion chamber. Approximately 50% (by area) of the panels had been consumed or become detached from the system.
- On the return wall the worst damaged areas were adjacent to and directly above the combustion chamber. Approximately 15% by area of the panels had been consumed or become detached from the system.
- On the return wall near the base, the panels had warped, resulting in the outside edge curling in towards the combustion chamber.

- Where the rainscreen had been consumed/fallen away from the system, the majority of exposed aluminium rails were missing. See Figure 20.
- In areas where the rainscreen was still present, the rails remained intact although slightly warped in places.

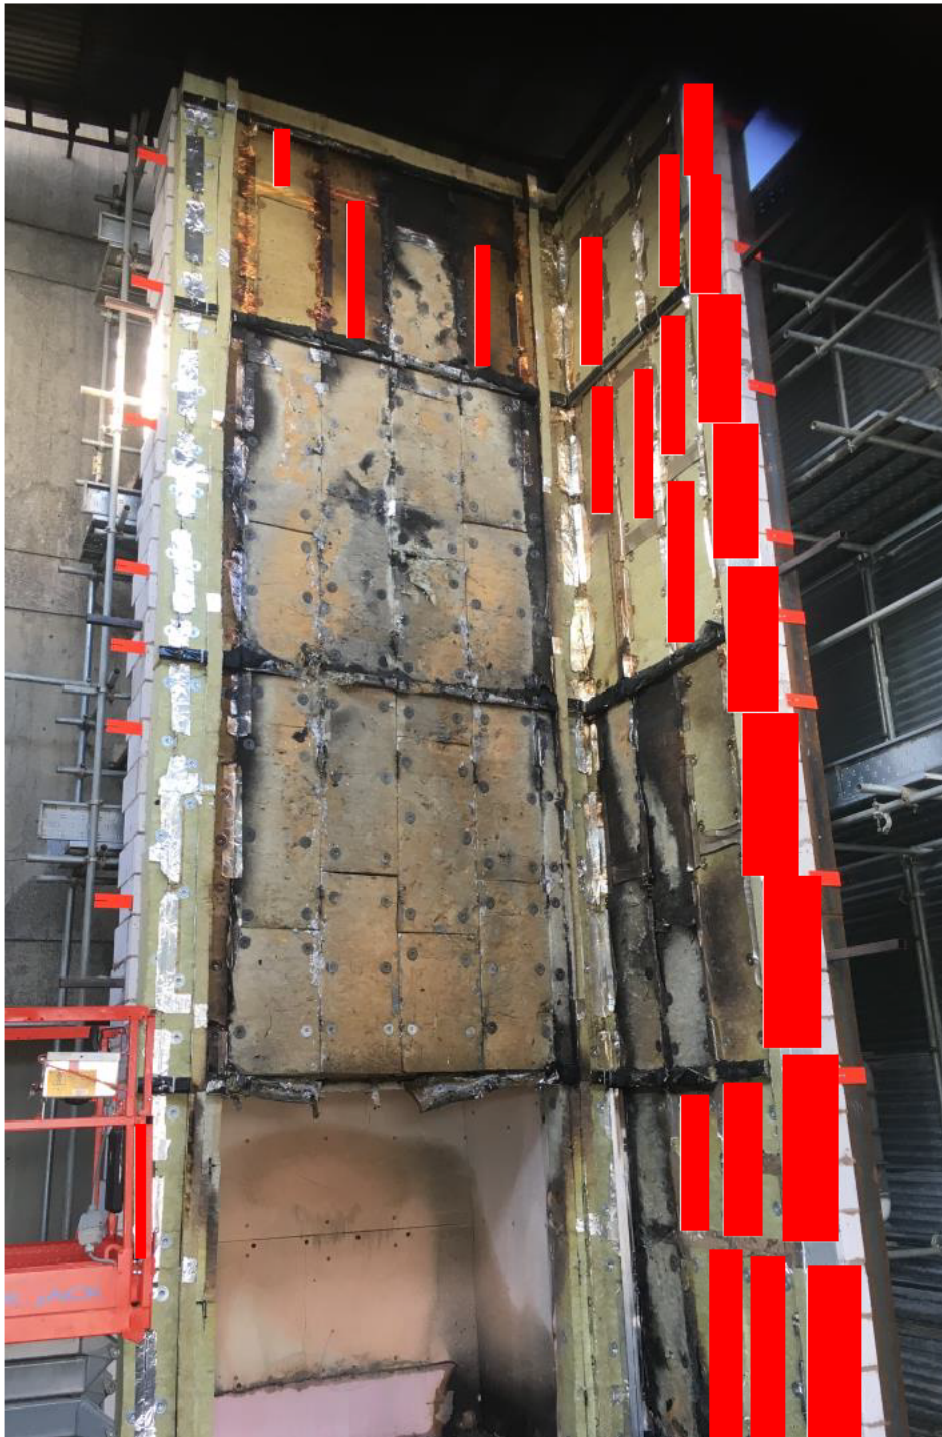
Figure 23 – Insulation and cavity barriers following removal of the rainscreen and support rails

- The insulation had smoke deposits on the front surface, but otherwise it was generally in good condition. See Figure 23.

- The 3 vertical barriers appeared to be in good condition. See Figure 23.

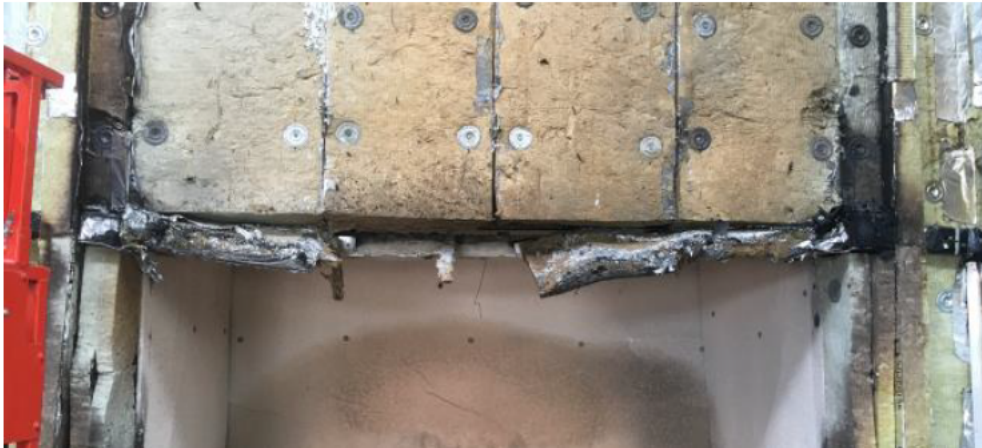
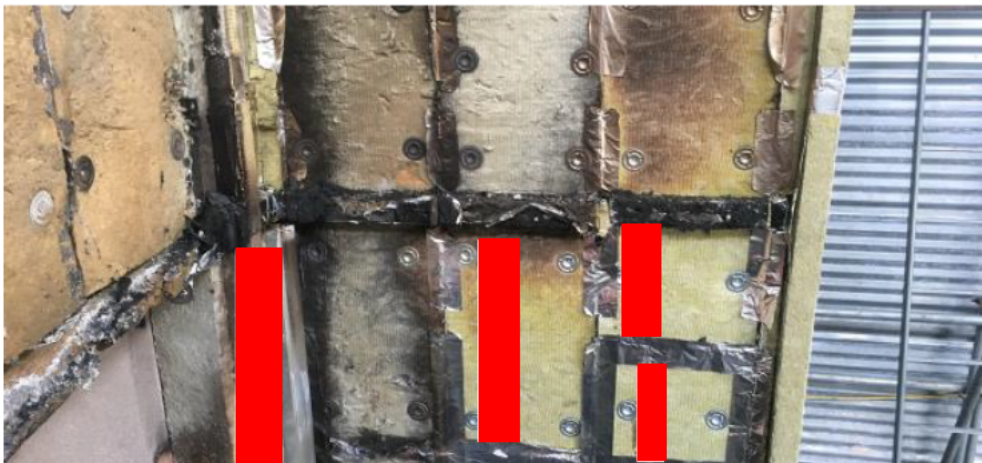
- 1st cavity barrier (directly above combustion chamber). See Figure 24 and Figure 25.
 - Above the combustion chamber, the barrier was partially detached from the wall and the intumescent strip was not present.
 - On the return wall the intumescent strip had fully activated.
- 2nd cavity barrier. See Figure 26 and Figure 27.
 - The barrier was intact.
 - On the section between the vertical cavity barriers, directly above the combustion chamber, the intumescent strip was not present.
 - Outside this area on the main wall and on the return wall the intumescent strips had fully activated.
- 3rd cavity barrier. See Figure 28 and Figure 29.
 - The barrier was intact.
 - On the section between the vertical cavity barriers, directly above the combustion chamber, the intumescent strip had fully activated.

Figure 24 – 1st cavity barrier (directly above combustion chamber) from main wall following removal of the rainscreen

Figure 25 – 1st cavity barrier (directly above combustion chamber) from return wall following removal of the rainscreen

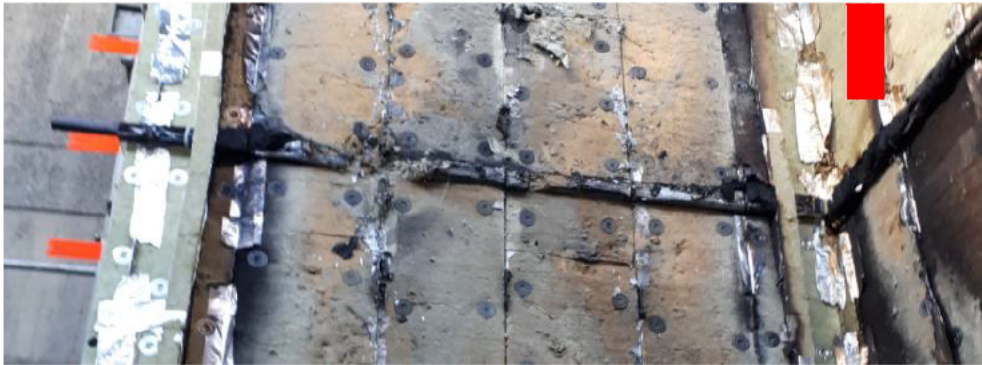
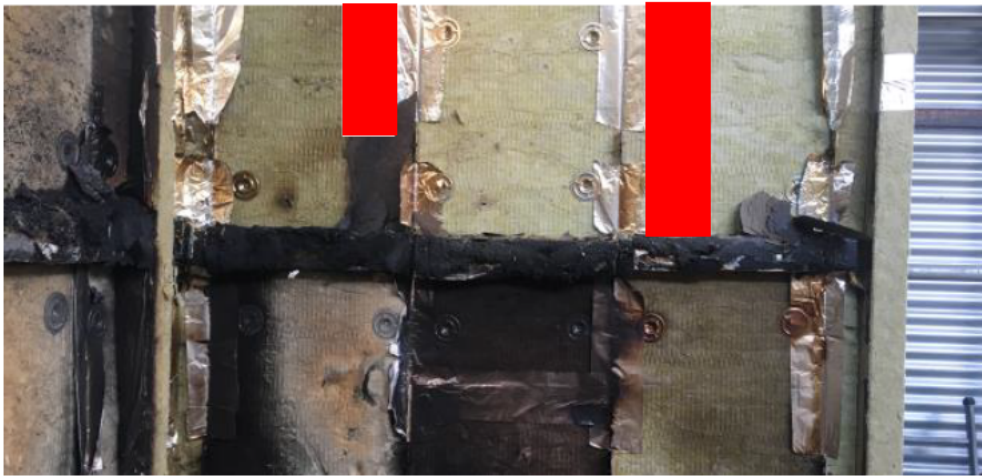
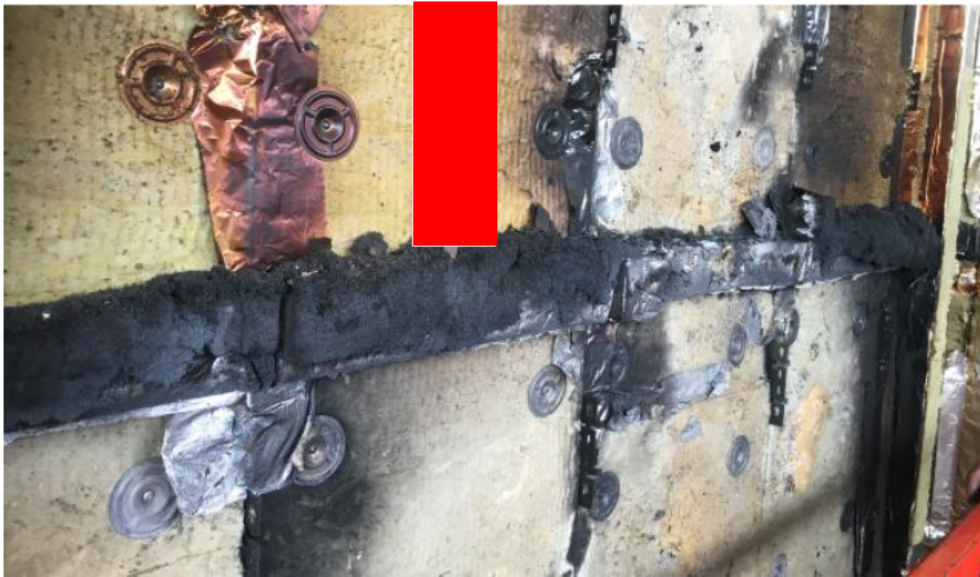
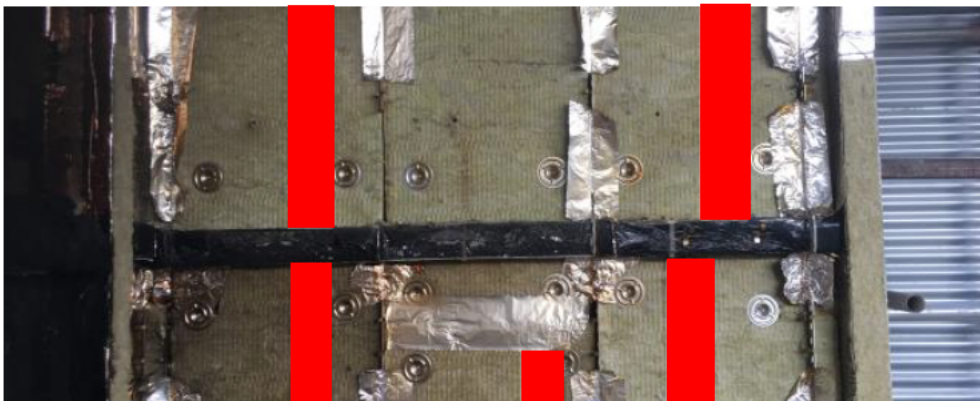
- Outside this area on the main wall and on the return wall the intumescent strips had partially activated.
- 4th barrier (near top of wall). See Figure 30 and Figure 31.
 - The barrier was intact.
 - On the section between the vertical cavity barriers, directly above the combustion chamber, the intumescent strip had partially activated.
 - Outside this area on the main wall and on the return wall the intumescent strips had partially activated.

Figure 26 – 2nd cavity barrier from main wall following removal of the rainscreen

Figure 27 – 2nd cavity barrier from return wall following removal of the rainscreen

Figure 28 – 3rd cavity barrier from main wall following removal of the rainscreen

Figure 29 – 3rd cavity barrier from return wall following removal of the rainscreen

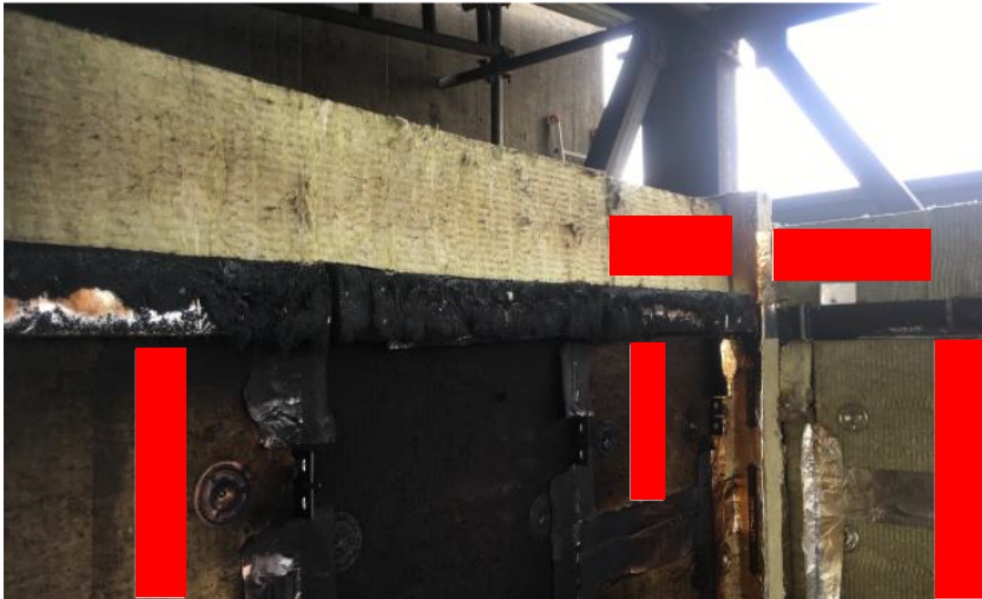
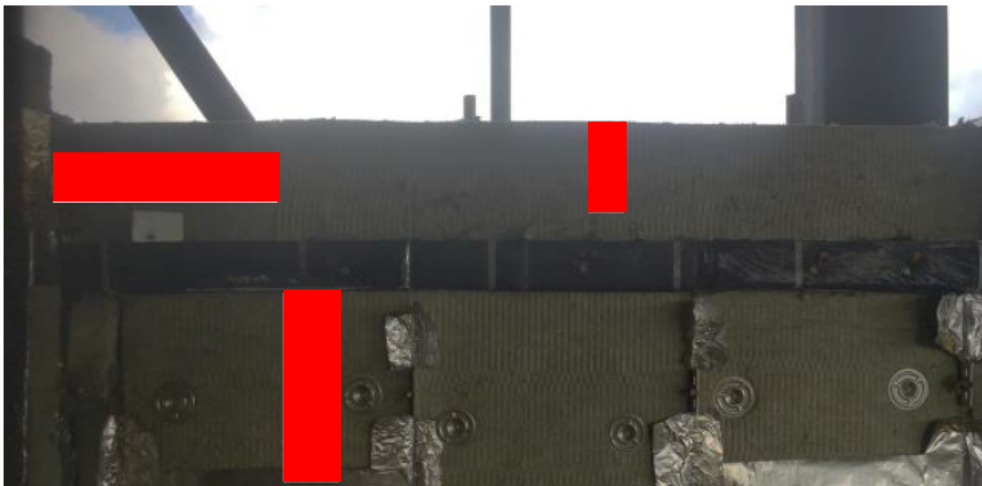
Figure 30 – 4th cavity barrier (top) from main wall following removal of the rainscreen

Figure 31 – 4th cavity barrier (top) from return wall following removal of the rainscreen
