Report detailing the testing  
of an HPL rainscreen  
cladding system tested in  
accordance with the  
requirement as described  
in British Standard 8414-1

# CUSTOMER CLASSIFICATION REPORT

BR 135 (Third Edition) Classification Report

Report Reference: 101856.002

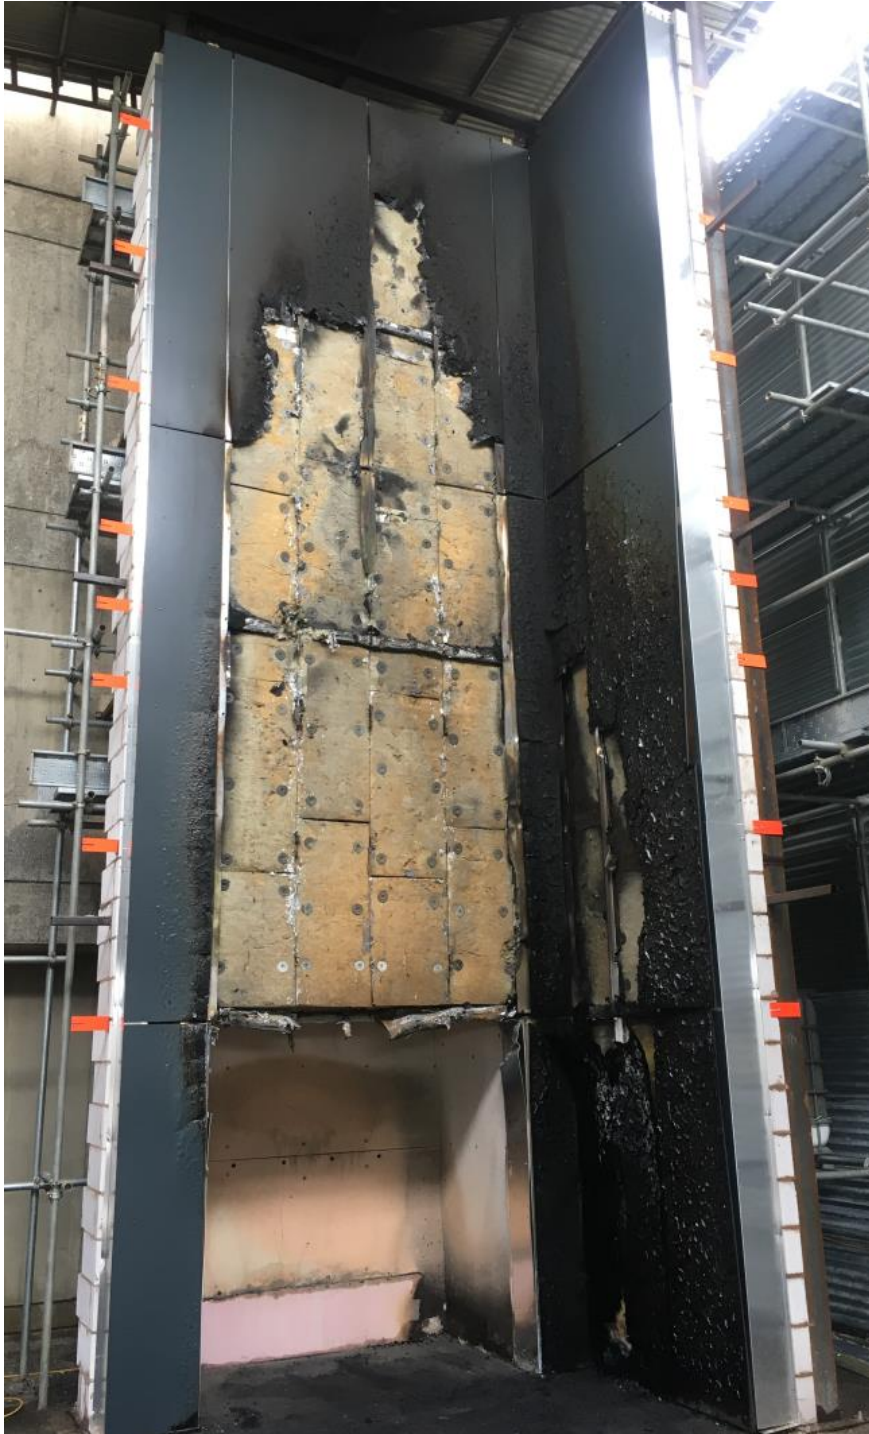
- All panels were damaged or partially damaged. See Figure 3, Figure 4 and Figure 5.
- On the main wall the worst damaged area was directly above the combustion chamber. Approximately 50% (by area) of the panels had been consumed or become detached from the system.
- On the return wall the worst damaged areas were adjacent to and directly above the combustion chamber. Approximately 15% by area of the panels had been consumed or become detached from the system.
- On the return wall near the base, the panels had warped, resulting in the outside edge curling in towards the combustion chamber.

- Where the rainscreen had been consumed/fallen away from the system, the majority of exposed aluminium rails were missing. See Figure 3.
- In areas where the rainscreen was still present, the rails remained intact although slightly warped in places.

Figure 3 – Front face of system post test

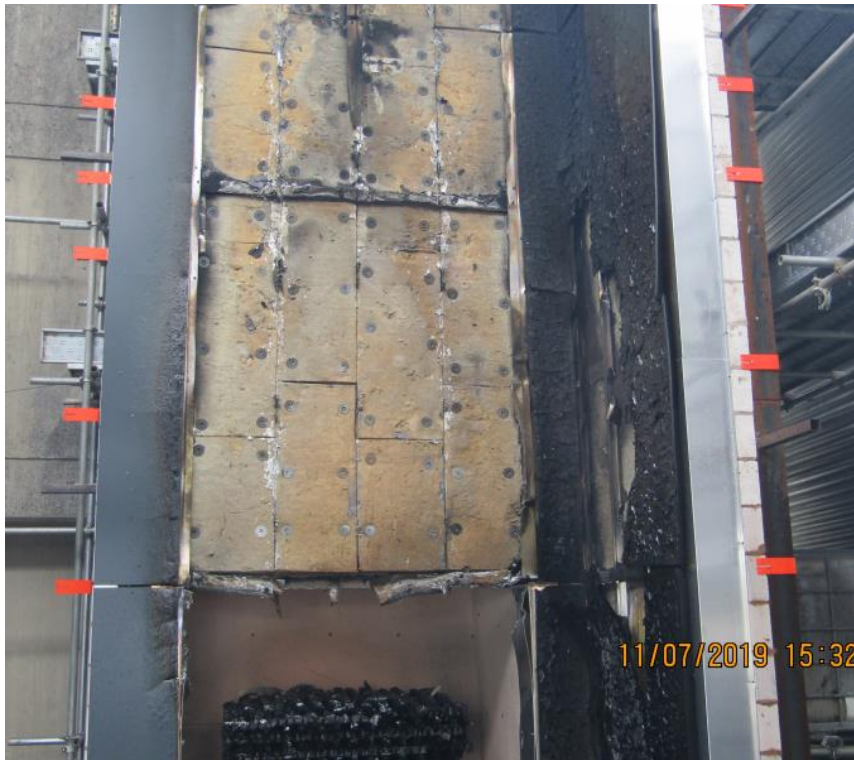
Figure 4 – Area directly above combustion chamber post test

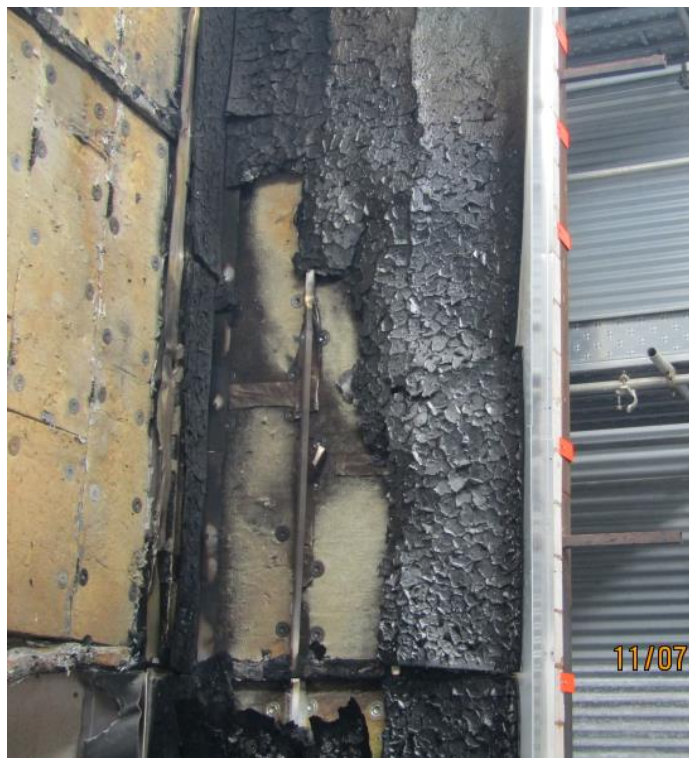
Figure 5 – Return wall above combustion chamber post test

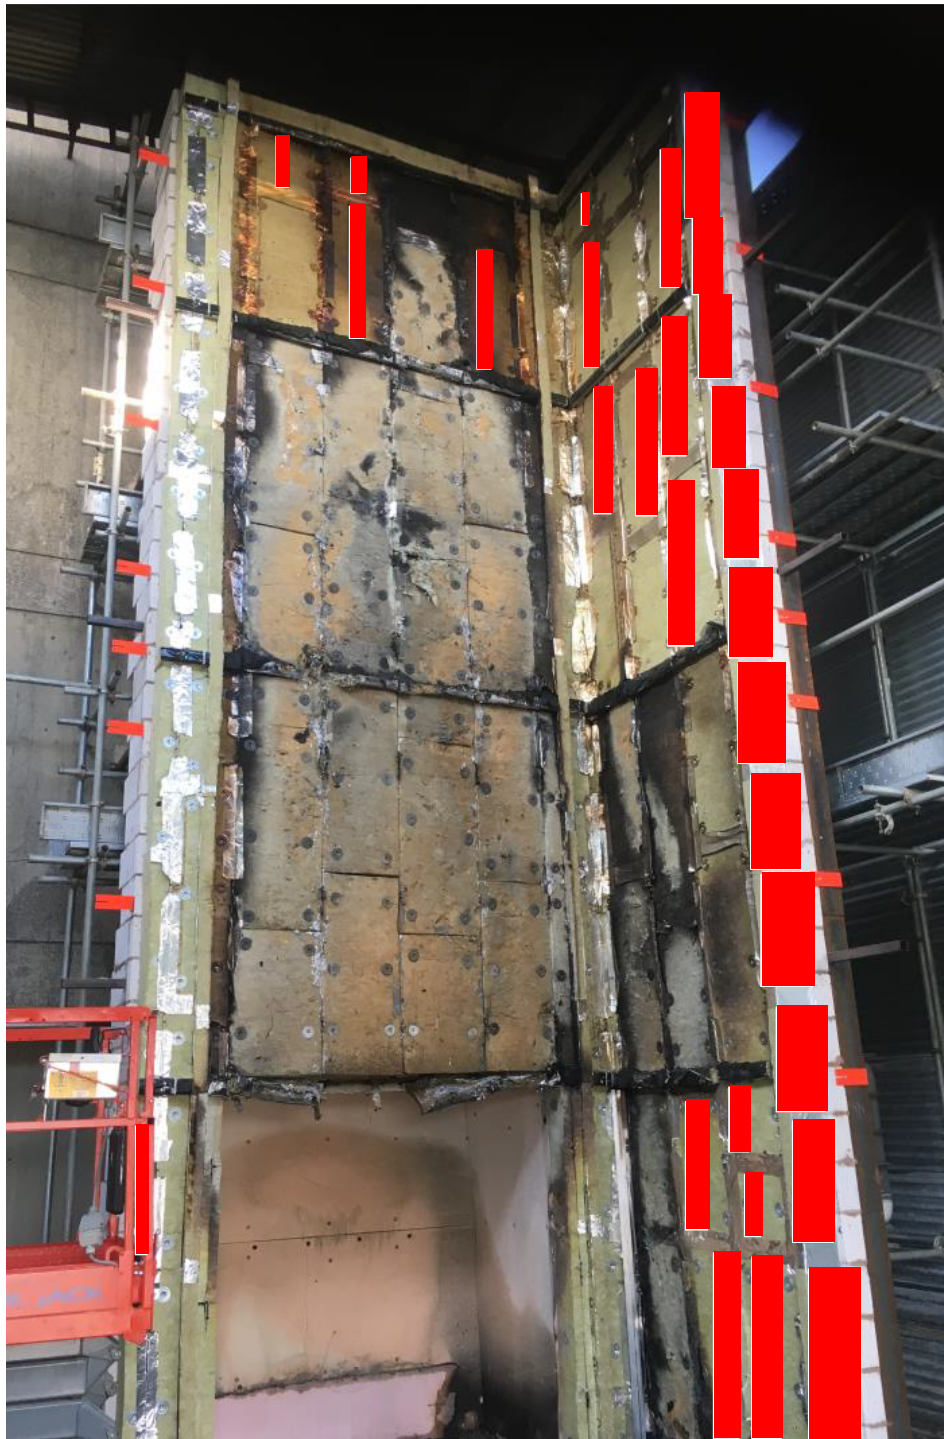
- The insulation had smoke deposits on the front surface, but otherwise it was generally in good condition. See Figure 6.

- The 3 vertical barriers appeared to be in good condition. See Figure 6.

Figure 6 – Insulation board and cavity barriers following removal of the rainscreen and support rails

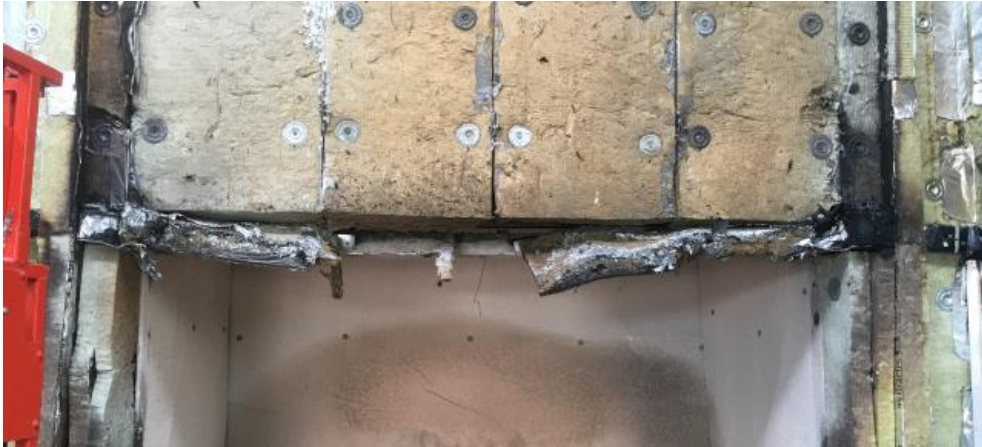
- 1<sup>st</sup> cavity barrier (directly above combustion chamber). See Figure 7 and Figure 8.
  - Above the combustion chamber, the barrier was partially detached from the wall and the intumescent strip was not present.
  - On the return wall the intumescent strip had fully activated.
- 2<sup>nd</sup> cavity barrier. See Figure 9 and Figure 10.
  - The barrier was intact.
  - On the section between the vertical cavity barriers, directly above the combustion chamber, the intumescent strip was not present.
  - Outside this area on the main wall and on the return wall the intumescent strips had fully activated.
- 3<sup>rd</sup> cavity barrier. See Figure 11 and Figure 12.
  - The barrier was intact.
  - On the section between the vertical cavity barriers, directly above the combustion chamber, the intumescent strip had fully activated.

Figure 7 – 1<sup>st</sup> cavity barrier (directly above burn chamber) from main wall following removal of the rainscreen

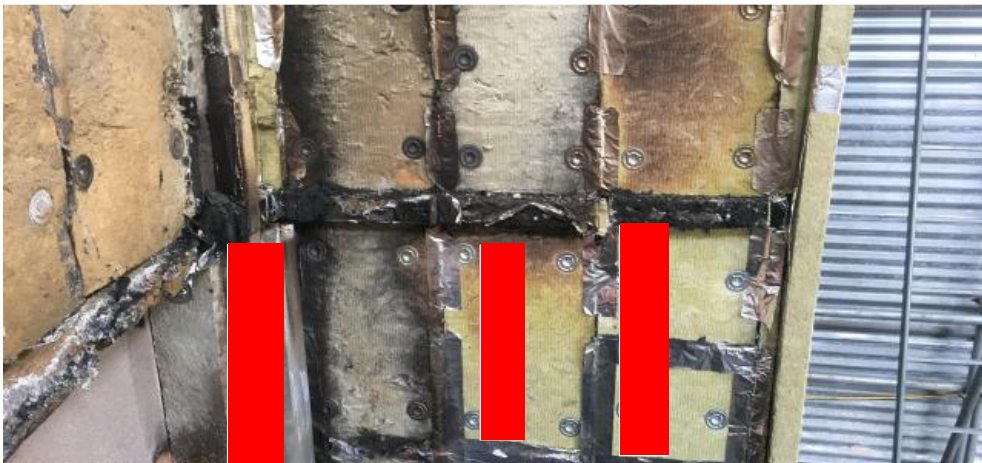
Figure 8 – 1<sup>st</sup> cavity barrier (directly above burn chamber) from return wall following removal of the rainscreen

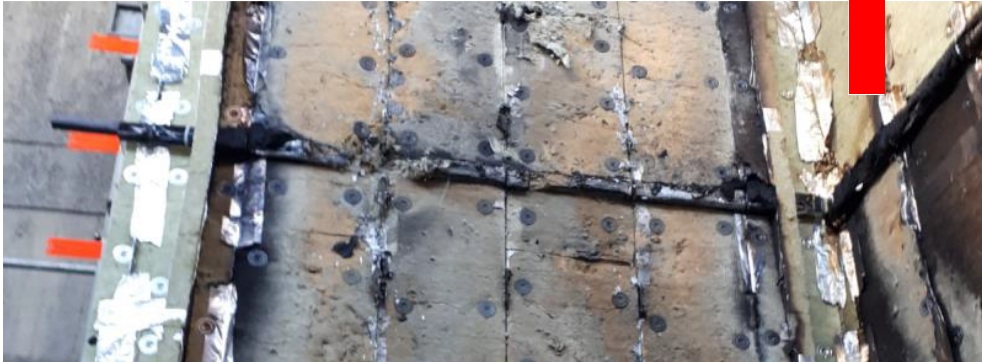
Figure 9 – 2<sup>nd</sup> cavity barrier from main wall following removal of the rainscreen

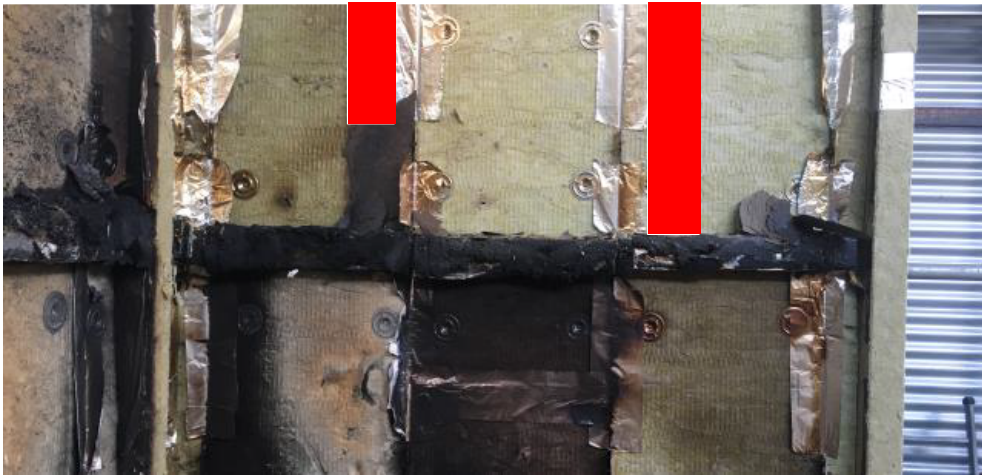
Figure 10 – 2<sup>nd</sup> cavity barrier from return wall following removal of the rainscreen

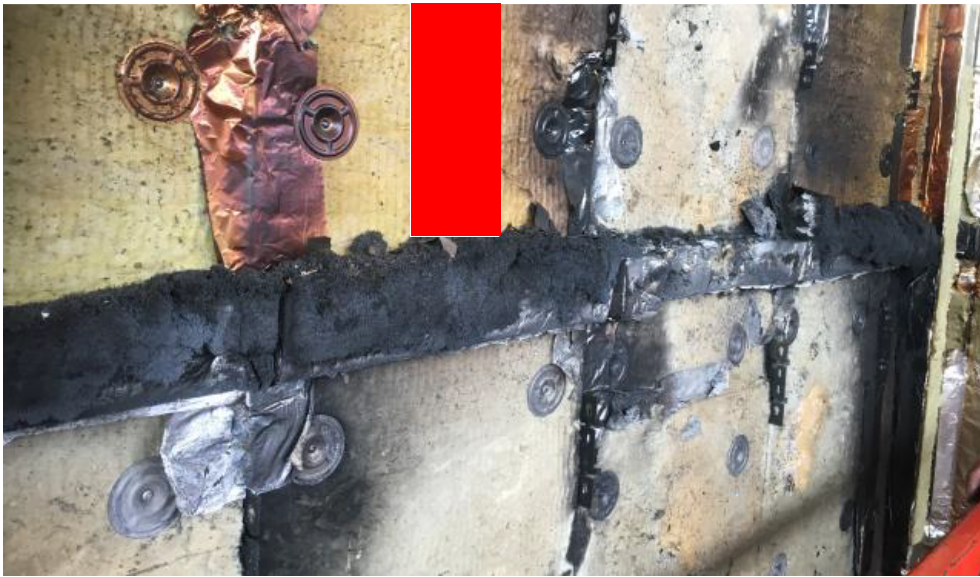
- Outside this area on the main wall and on the return wall the intumescent strips had partially activated.
- 4<sup>th</sup> barrier (near top of wall). See Figure 13 and Figure 14.
  - The barrier was intact.
  - On the section between the vertical cavity barriers, directly above the combustion chamber, the intumescent strip had partially activated.
  - Outside this area on the main wall and on the return wall the intumescent strips had partially activated.

Figure 11 – 3<sup>rd</sup> cavity barrier from main wall following removal of the rainscreen

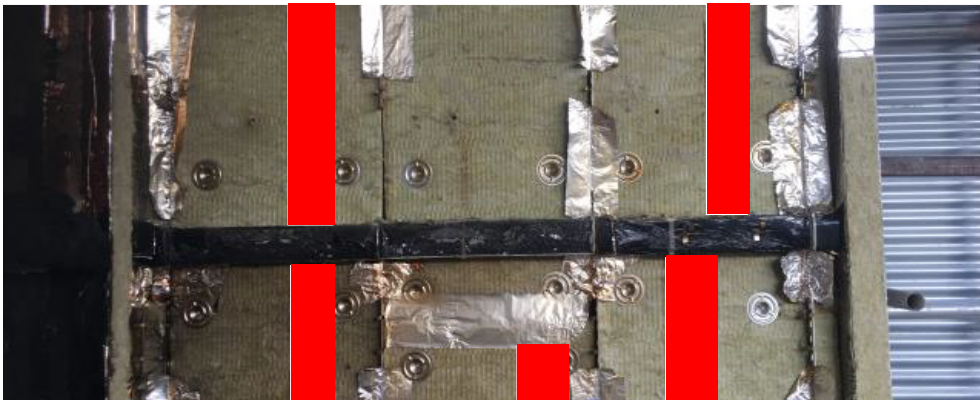
Figure 12 – 3<sup>rd</sup> cavity barrier from return wall following removal of the rainscreen

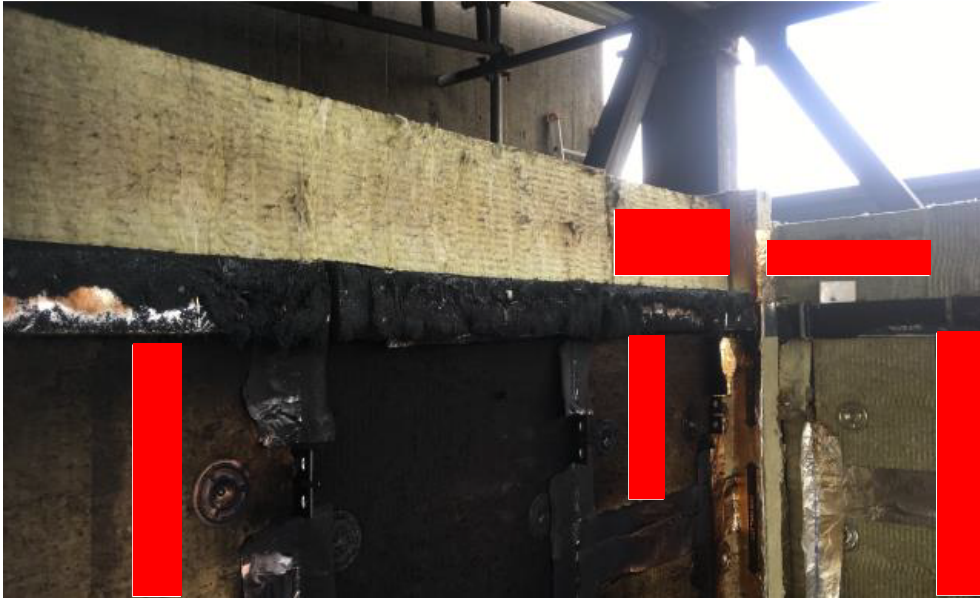
Figure 13 – 4<sup>th</sup> cavity barrier (top) from main wall following removal of the rainscreen

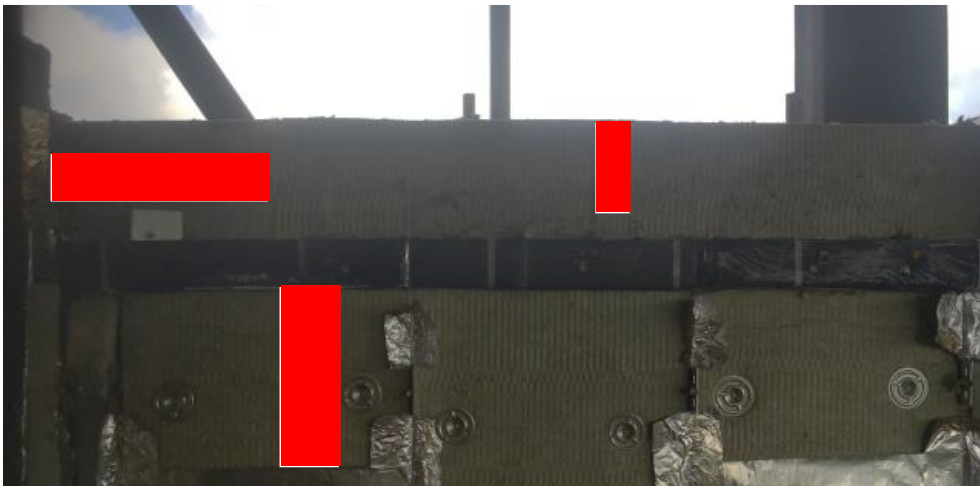
Figure 14 – 4<sup>th</sup> cavity barrier (top) from return wall following removal of the rainscreen
