SERIOUS INCIDENT

Aircraft Type and Registration:	Airbus Helicopters AS 350, VP-CIH
No & Type of Engines:	1 Lycoming LTS101-600A-3A
Year of Manufacture:	1981 (Serial no: 1411)
Date & Time (UTC):	30 August 2018 at 1540 hrs
Location:	Owen Roberts International Airport, Grand Cayman
Type of Flight:	Commercial Air Transport (Passenger)
Persons on Board:	Crew - 1 Passengers - 4
Injuries:	Crew - None Passengers - None
Nature of Damage:	Tail rotor gearbox actuating rod failure
Commander's Licence:	Commercial Pilot's Licence
Commander's Age:	Not known
Commander's Flying Experience:	19,000 hours (of which 10,000 were on type) Last 90 days - 34 hours Last 28 days - 11 hours
Information Source:	Aircraft Accident Report Form submitted by the pilot

Synopsis

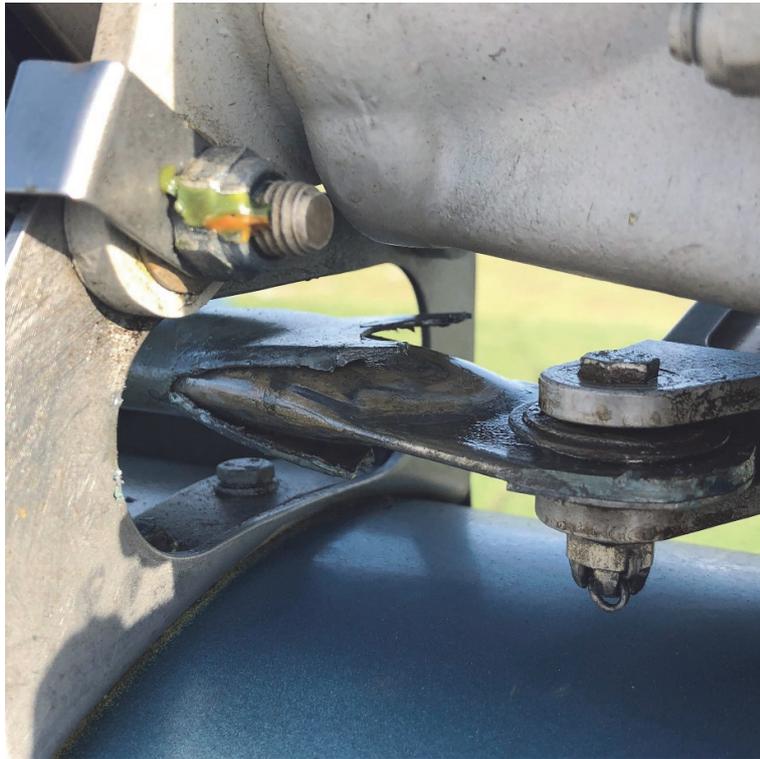
Figure 1

During examination of the helicopter it was found that the TGB actuating rod (part number 350A27191003) had ruptured at the aft end (Figure 1). No other damage was evident from the in-depth inspections of the airframe and flight controls requested by the helicopter manufacturer. The manufacturer reported that this was the first such event on the AS 350 that they were aware of.

Photo showing rupture at aft end of TGB actuating rod

It was established that the rupture of the TGB actuating rod was associated with the uncoupling of the steel sleeve inside the external aluminium alloy tube. An anomaly in the internal structure of the material of the rod was identified, along with the presence of cracks in a cold worked area. The same TGB actuating rod is used on AS 355 helicopters.

As a result of these findings, on 20 March 2019 the EASA issued Airworthiness Directive 2019-0060, mandating dye penetrant crack checks of TGB actuating rods on affected AS 350 and AS 355 helicopters.
