**Grounding of the bulk carrier *Kuzma Minin*
Falmouth Bay
England
18 December 2018**

SUMMARY

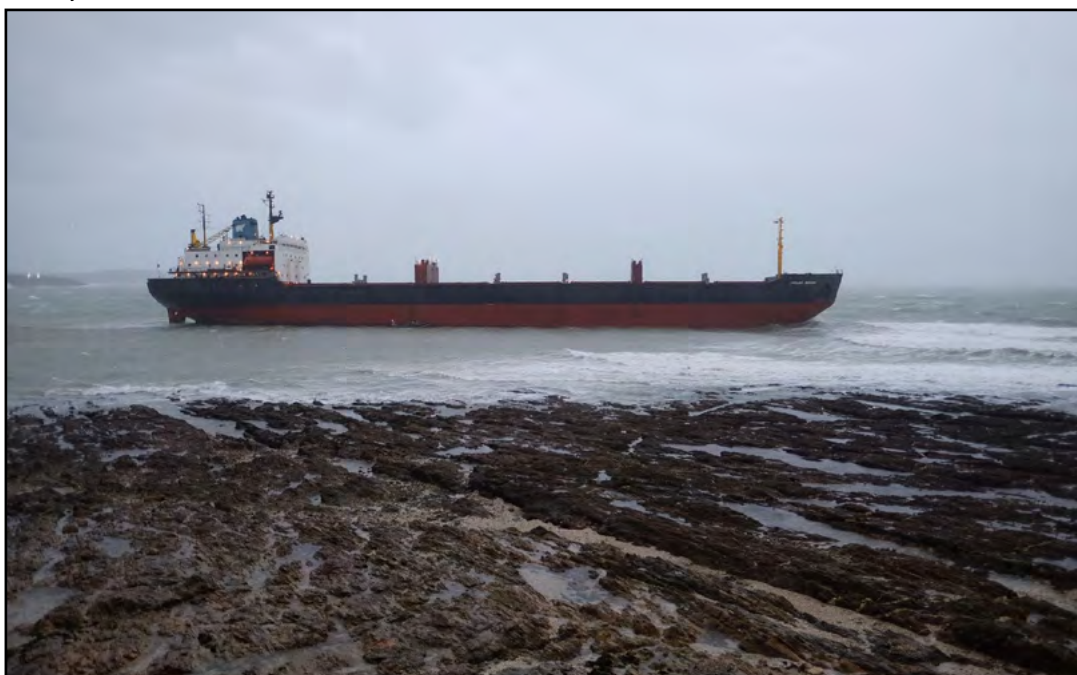
Kuzma Minin

On 18 December 2018, the Russia registered bulk carrier *Kuzma Minin* grounded after dragging its anchor in Falmouth Bay, England. The vessel was in ballast and was successfully refloated on the next high water. Damage below the waterline included shell plate deformation and breached tanks. There were no injuries and no pollution.

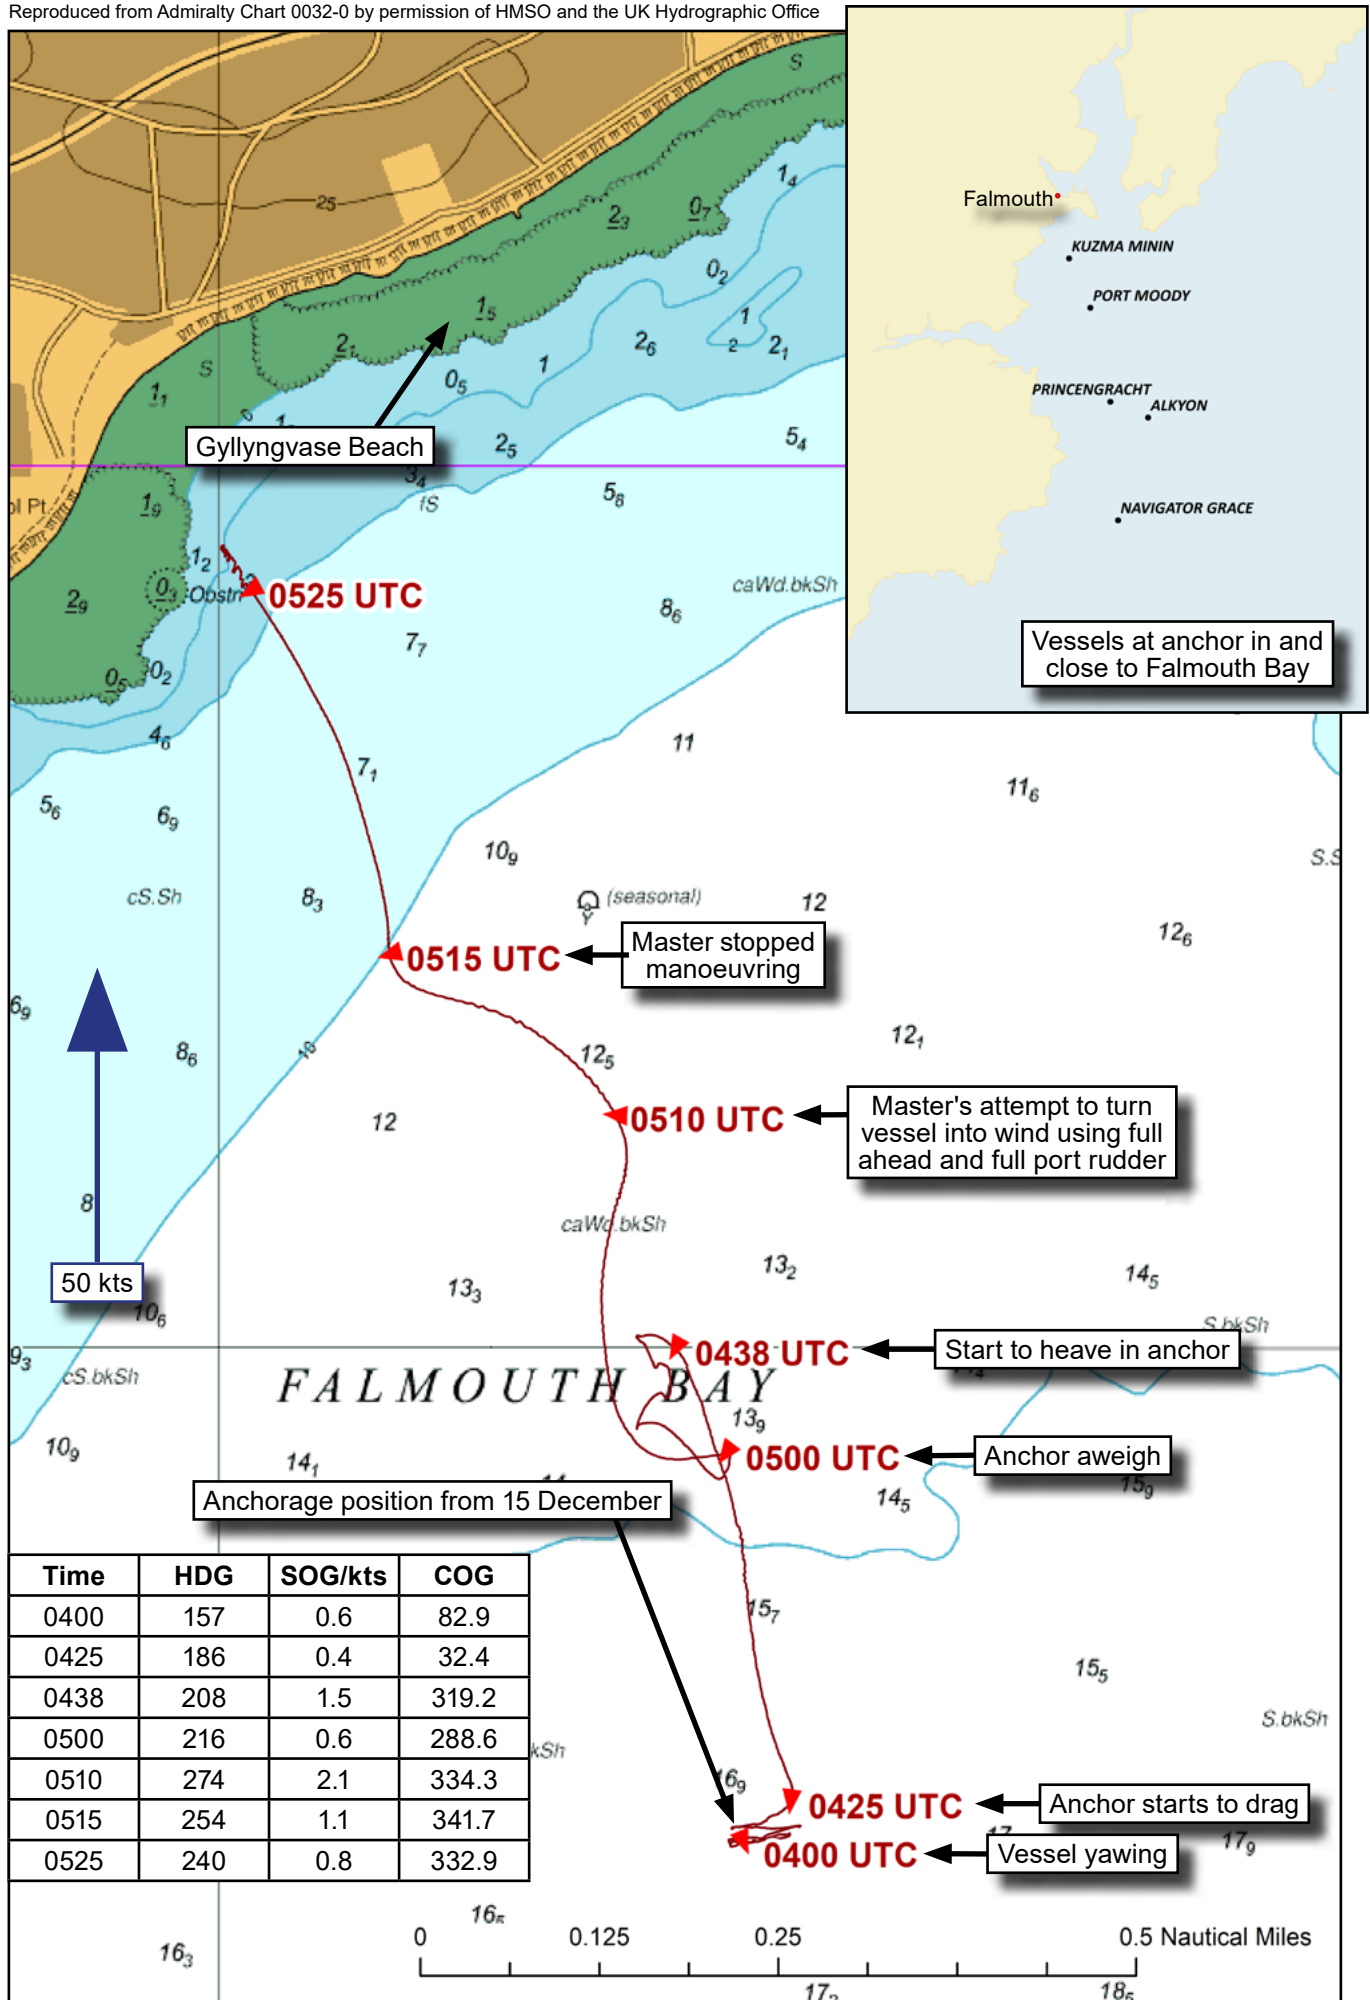
Figure 1: Kuzma Minin's track on 18 December 2018 (0400 - 0525)

On 15 December 2018, *Kuzma Minin* shifted 4.3nm from an anchorage east of the Manacles to an anchorage in Falmouth Bay (**Figure 1**), within Falmouth harbour's limits. A harbour pilot embarked during the move and the vessel anchored at 1700² in a charted depth of 17m, 1nm off Gyllyngvase beach using the port anchor with 7 shackles of anchor cable. By that time, *Kuzma Minin*'s bunkers comprised 105 tonnes (t) of heavy fuel oil (HFO), and 5t of marine diesel. There was no spare lube oil on board. During the evening, a bunker barge delivered 30t of marine diesel to *Kuzma Minin*, but because of MSCO's unpaid debts from previous ship visits to Falmouth, the supplier had required payment before delivery.

At 0510, *Kuzma Minin* was approximately 6 cables off Gyllyngvase beach (**Figure 1**) on a heading of 274° and making over 2kts leeway to the north. The master was aware that the vessel was running out of sea room so applied full port rudder and put the engine to 'full ahead' to try to turn the vessel to the south and into the wind. Five minutes later, the master assessed that *Kuzma Minin* would not clear Pannance Point, which was only 0.5nm to the west, and stopped the engine.

When the southerly wind started to gust in excess of 50kts, *Kuzma Minin* began to yaw (**Figure 1**), creating increased load on the anchor and its cable. Although the use of 7 shackles of cable in a depth of about 21m at high water provided a scope of about 9:1, this was insufficient to cope with the forces generated by the wind acting on the bulk carrier, which was in ballast and inevitably heaving in the 4m to 5m swell. In such circumstances, and with *Kuzma Minin* only 1nm from the shore, increasing the scope of the cable by utilising more of the 11 shackles available might have provided greater surety of the anchor holding.

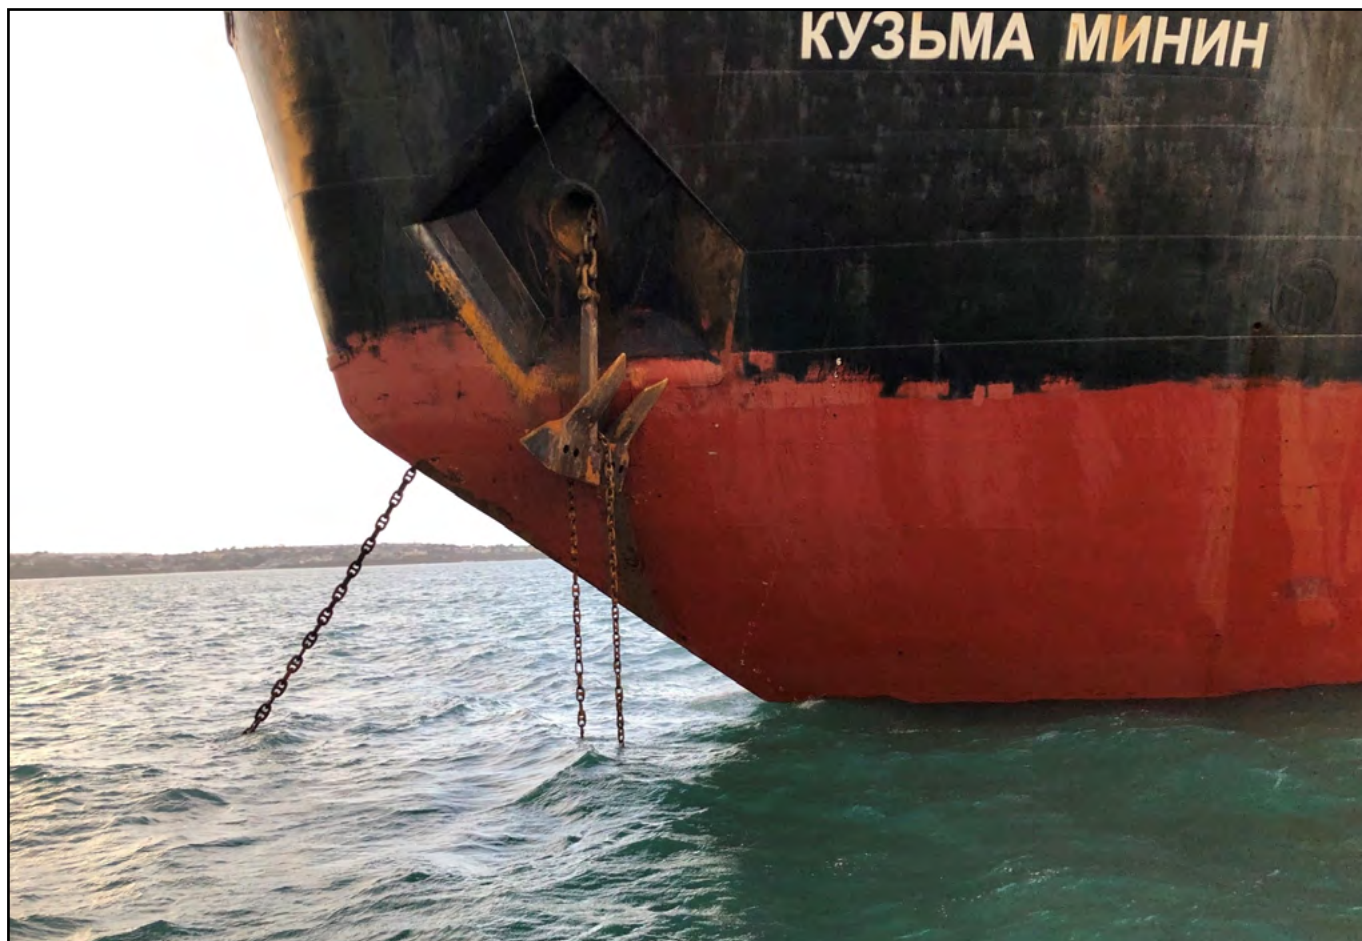
Figure 2: Port anchor fouled by chain

At 0438, the bosun started to heave in the anchor while the master used the rudder and main engines to manoeuvre and take the weight off the anchor cable. Heaving the anchor was difficult, but shortly before 0500 it was aweigh, and *Kuzma Minin* started to fall beam to the wind on a westerly heading (**Figure 1**). The master's attempts to keep the bow into the wind and check the leeway by the intermittent use of the engine were not successful. When the anchor came into view, the bosun saw that a chain cable was snagged across its flukes (**Figure 2**). The bosun advised the master that the anchor was fouled by a substantial length of chain. In response, the master stopped manoeuvring. An attempt to clear the chain by dropping the anchor and heaving it in again was unsuccessful.

On 19 December, the chain fouling *Kuzma Minin*'s port anchor (**Figure 2**) was removed on to *Sarah Grey*. The chain was 28m long with a 3.8cm diameter, was extremely worn, and appeared to have been submerged for a significant period of time. On 22 December, an underwater dive survey on *Kuzma Minin* commissioned by the SOSREP identified that:

chain still attached might result in damage to the anchor, windlass or even the bulk carrier's propeller. Neither the bosun nor the master had any way of knowing that the chain fouling the anchor was only 28m in length and that it was not impeding *Kuzma Minin's* departure.

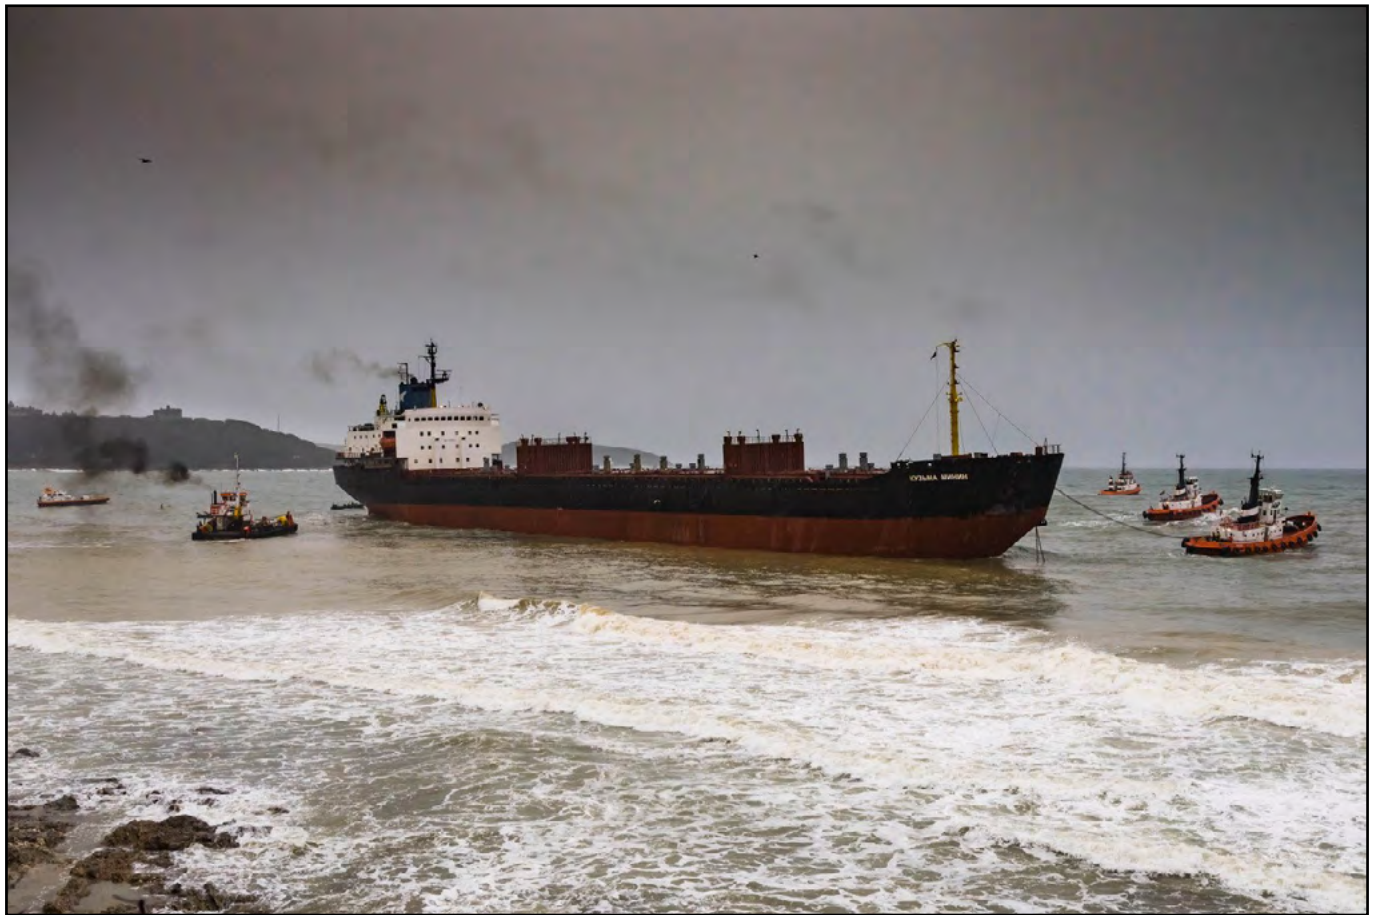
Figure 3: *Kuzma Minin* - refloating

By 1122, lines from the Falmouth harbour tugs had been secured to *Kuzma Minin* and the tugs gradually increased the weight on the lines as the bulk carrier de-ballasted. Several lines parted due to the tugs' movement in the swell, and had to be replaced. By 1345, *Sarah Grey* and *Cannis* had arrived on scene and the sea and swell had moderated. The tugs pulled and the workboat pushed with as much power as the conditions allowed (**Figure 3**) and, assisted by *Kuzma Minin*'s main engine, the bulk carrier refloated at 1415. Thirty minutes later, the vessel was anchored by its starboard anchor 1nm south of Pendennis Point. After the refloating operation, the harbourmaster reiterated to the SOSREP the need for a salvor to be appointed for the damaged vessel.
