# Rail Accident Report

**Overspeed at Sandy South Junction,  
Bedfordshire  
19 October 2018**

Report 10/2019  
August 2019

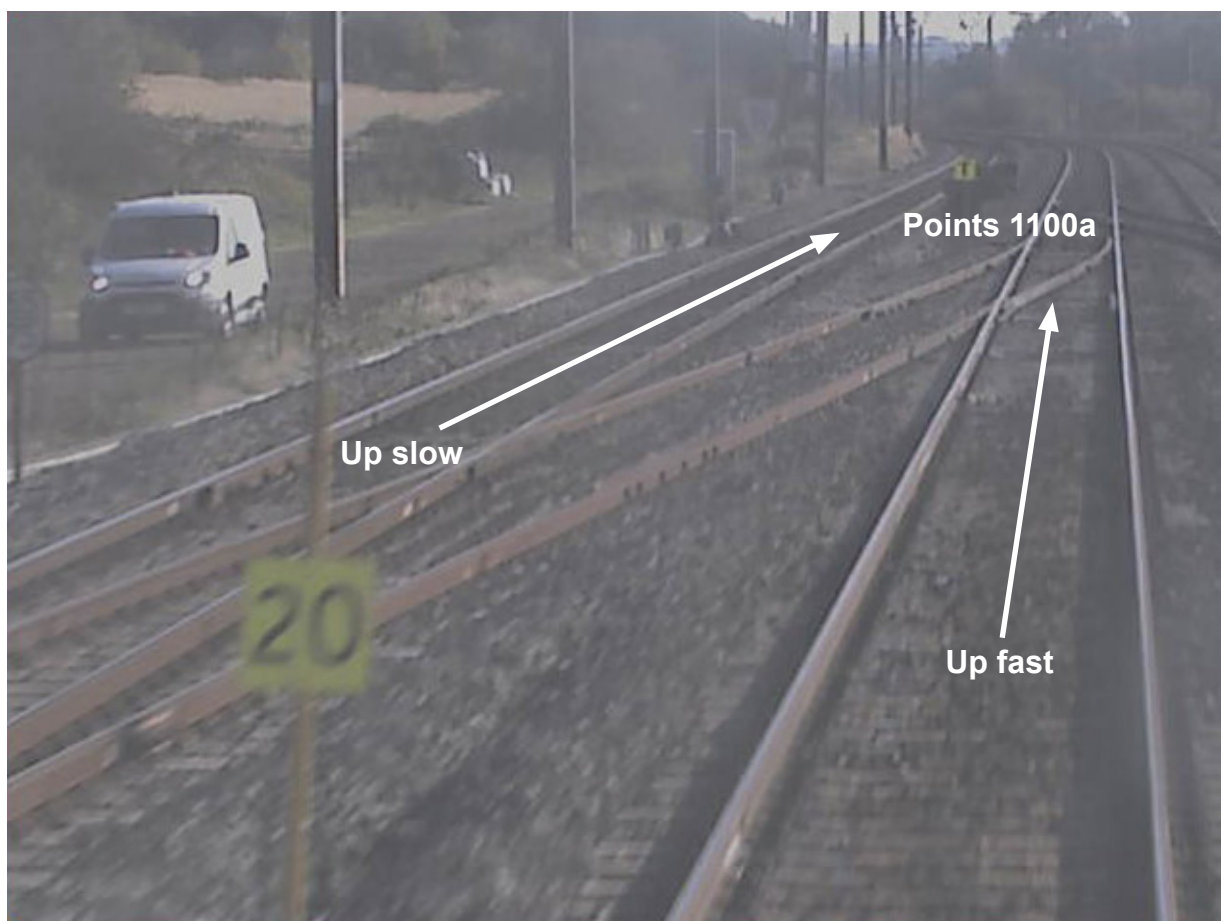
Figure 2: Forward facing closed-circuit television view of points 1100A and its associated crossing on the East Coast Main Line at Sandy South Junction annotated to show key features (image courtesy of LNER)

- 23 On 18 October 2018 at around 10:00 hrs, a Network Rail patroller carrying out a basic visual inspection of the track identified a crack estimated to measure 60 mm long in the crossing of 1100A points at Sandy South Junction.

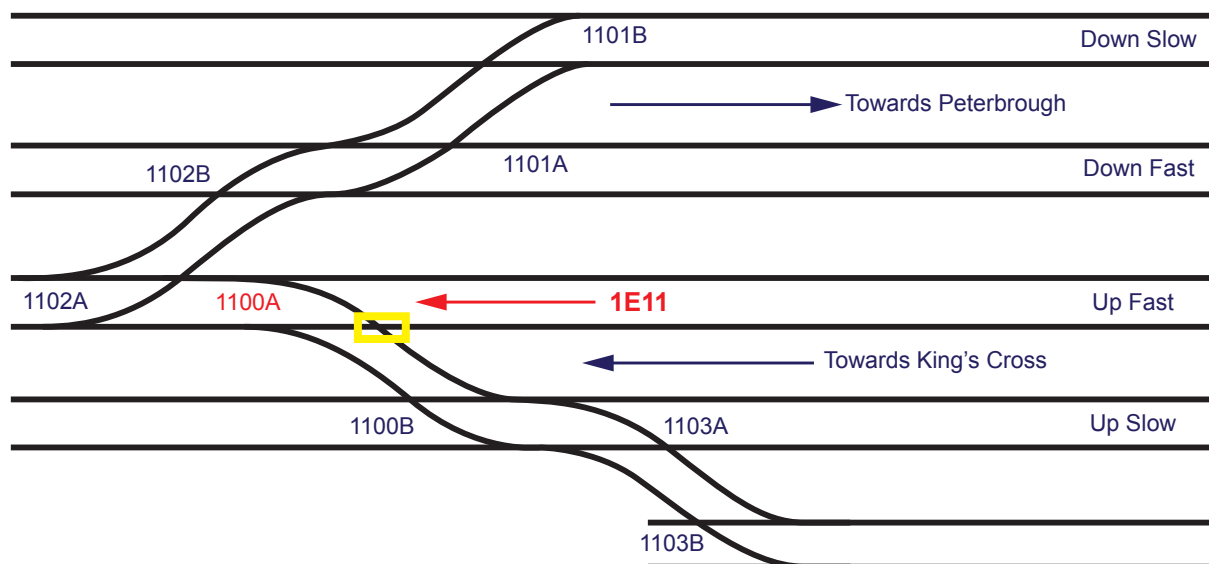
- 6 Sandy South Junction is on the East Coast Main Line to the south of Sandy station, which is about 44 miles (71 km) from London King's Cross (see figure 4).
- 7 Points 1100A, where the crack in the crossing was found, are located in the up fast line, at 43 miles and 61 chains (380 m south of Sandy station), and are part of a crossover which allows trains to pass from the up slow line on to the up fast line.

Figure 4: Sandy South Junction, with yellow box around the relevant crossing

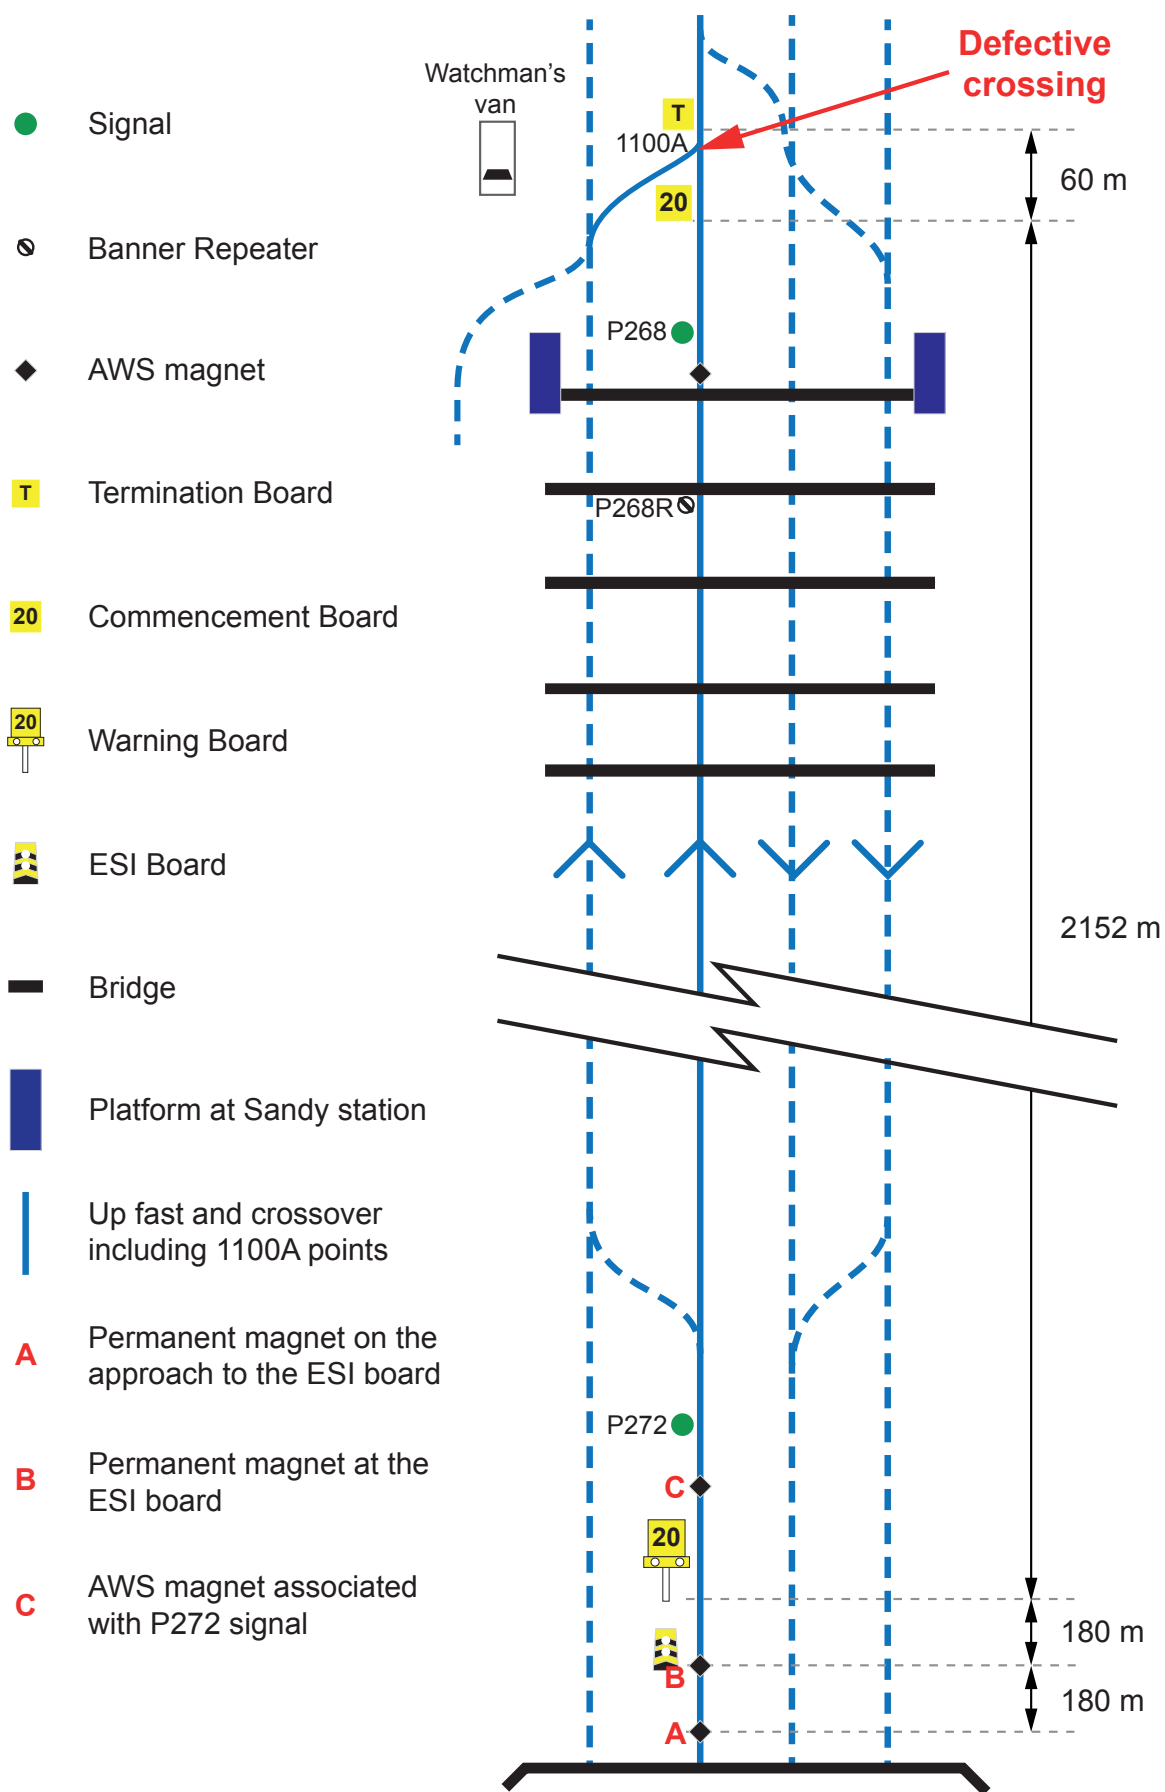
- 15 Emergency speed restriction lineside equipment (figure 5) consists of an AWS permanent magnet, which is intended to alert the train driver to the presence of an emergency speed indicator (ESI) board (figure 6), which is approximately 180 metres further along the track. A second AWS magnet is placed alongside the ESI board, and this is intended to alert the driver to look for the the warning board which describes the speed restriction ahead. The driver must control the speed of the train to the indicated value by the time it reaches the commencement board, which is placed at the point where the restriction begins.

- 16 The speed warning board is placed a prescribed distance from the commencement board; in this case, the distance was 2.17 km. At the end of the restriction there is a termination board, which in this case was 60 metres beyond the commencement board. The train may return to line speed once the rear of the train has passed the termination board. The position of the emergency speed restriction warning equipment at Sandy was in accordance with Railway Group standard GK/RT0075.

Figure 5: Layout of emergency speed restriction equipment at Sandy (not to scale)

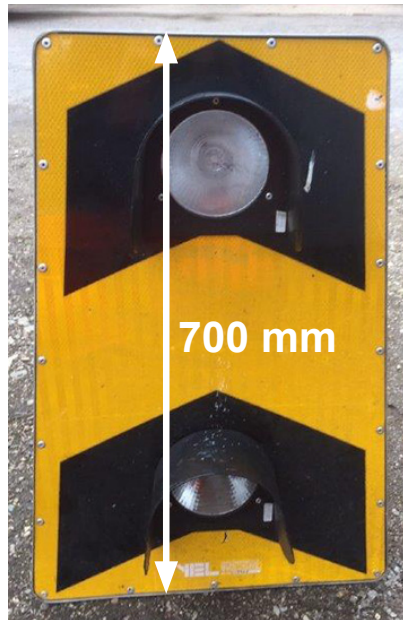
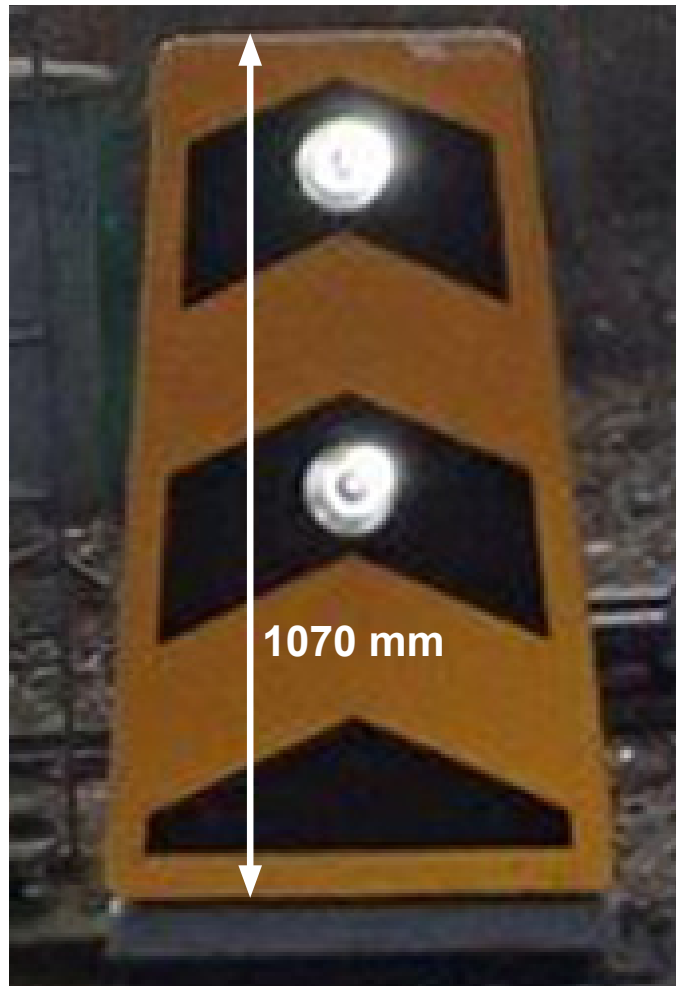
*Figure 6: An example of a miniature ESI board on the left, similar to the type used at Sandy (see paragraph 69), and a full size board on the right, shown at the same scale*

- 22 The position and the brightness of the sun may have contributed to the driver mis-reading the warning board (see paragraph 73), and shadowing may have contributed to the driver not seeing the ESI board (see paragraph 66).

- 3 *The intent of this recommendation is to review the design and use of the emergency speed indicator board in order that the flashing lights are clearly visible for as long as possible even when the board is in shadow or bright sunlight.*

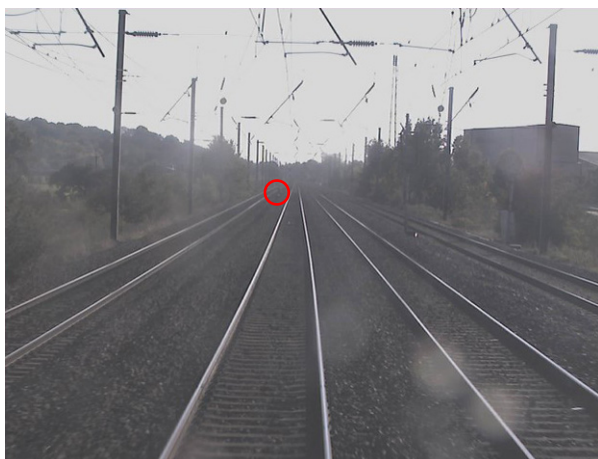
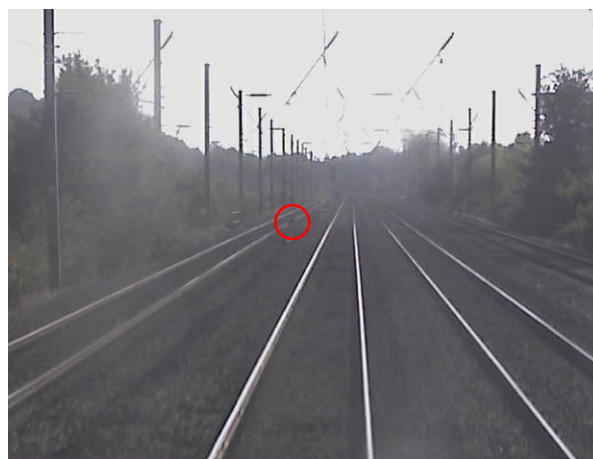
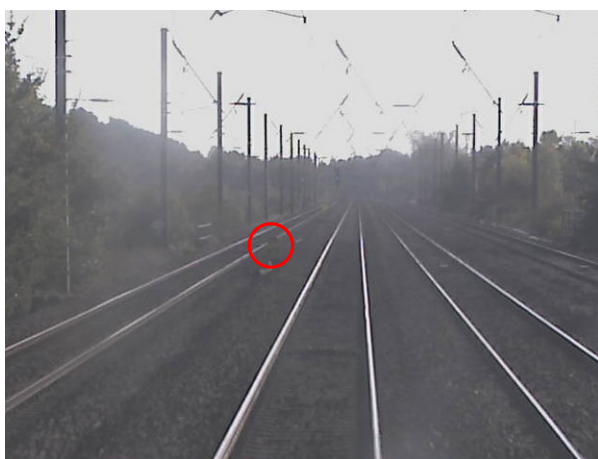
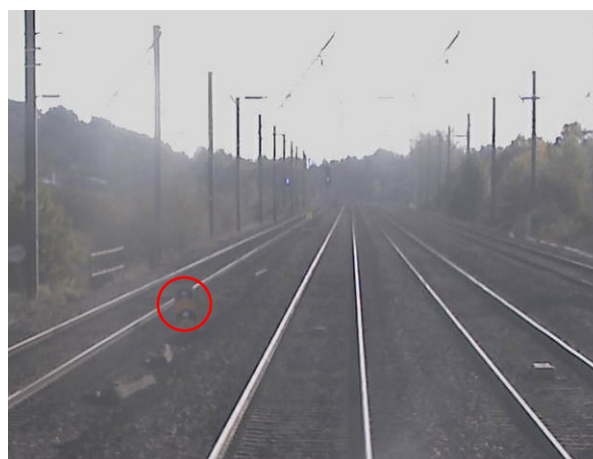
- 66 The driver stated that he did not see the ESI board. The board would have come into view at a range of around 400 metres, 7 seconds before the train passed it. However, the miniature ESI board is not conspicuous in the forward facing closed circuit television (FFCCTV) footage provided to the RAIB (figures 7a-7d) (see paragraph 69). While the quality of the video recording may not reflect the actual conditions, it is apparent that the sun was shining brightly from behind the ESI board and there was significant shadowing cast over the board by structures and vegetation on the right hand-side of the railway line. There are also some reflections from small unidentifiable items in the space between the up slow and up fast running lines a short distance on the approach to the ESI board, which may have diverted attention from the board itself.

- 67 The lights on the board flash with the aim of drawing the driver's attention to the sign. The RAIB conducted some subjective tests with a similar ESI board and found that a slight horizontal rotation of the board made the lights on the board very hard to see, and this could have reduced the conspicuity of the board itself as it made it more difficult to pick the board out from its surroundings.

- 68 Although there is no direct evidence that the board was incorrectly aligned, RAIB found that there is a significant reduction of luminous intensity when the boards are viewed at an angle. This is in line with the requirements of the standard to which the boards are designed (figures 8a and 8b) as it is intended that only the drivers approaching on the line to which the equipment applies should view them as they may cause an unnecessary distraction to drivers on other lines. For free standing units there is no way to accurately align the boards for optimum visibility, and even the type which are held in place using clamps which attach to the rails have no adjustment to take into account any curvature of the line.

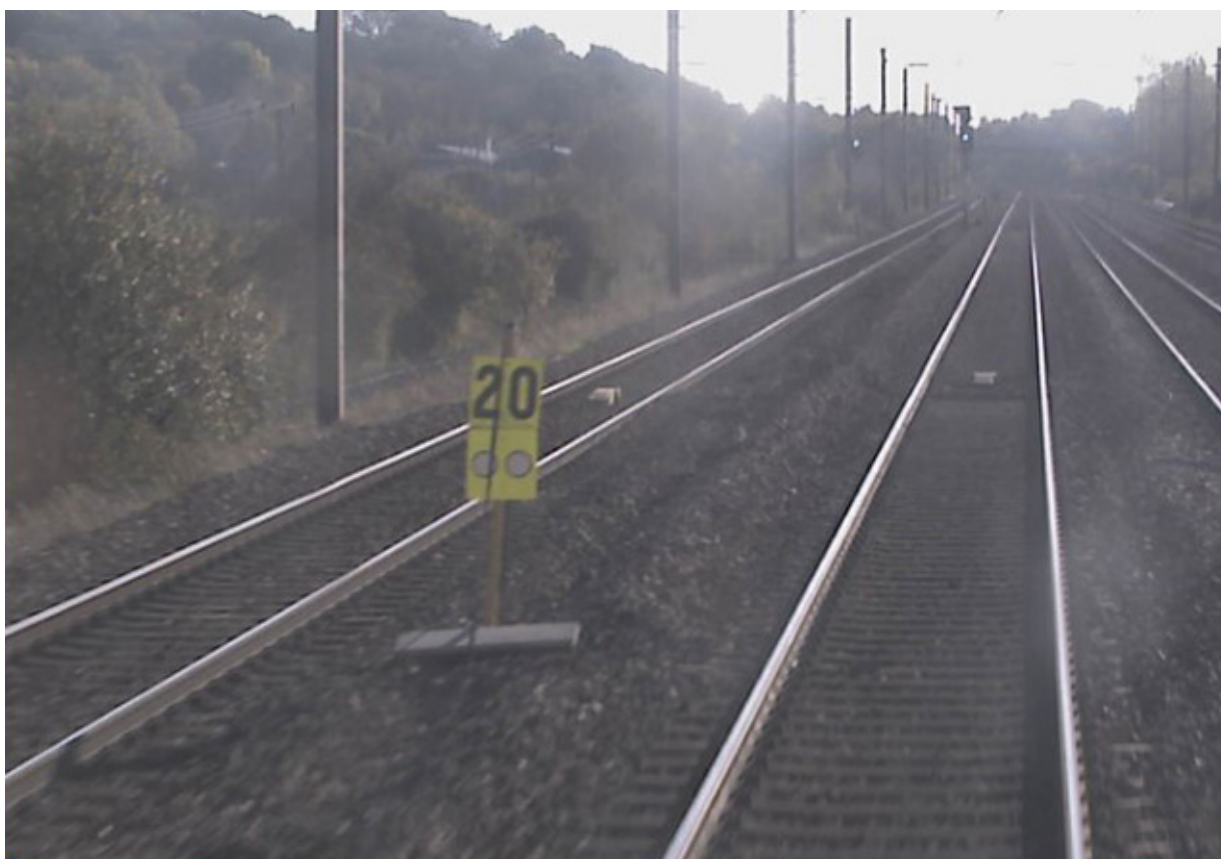
Figure 9: FFCCTV view of the warning board (image courtesy of LNER)

- 73 The driver probably did not see the ESI board and did not recall the first AWS warning. Therefore, he was not expecting to encounter the warning board (paragraph 78). It is likely that he tried to make sense of it in the short time (about one second) that it was visible to him by concluding that it did not apply to him, but to the approaching diverging route, although there was no arrow that would have indicated that it applied to a diverging route (figure 9). Figure 10, shows how the signage would have appeared had the restriction applied in a similar location, but on the up slow line, as the driver believed was the case.

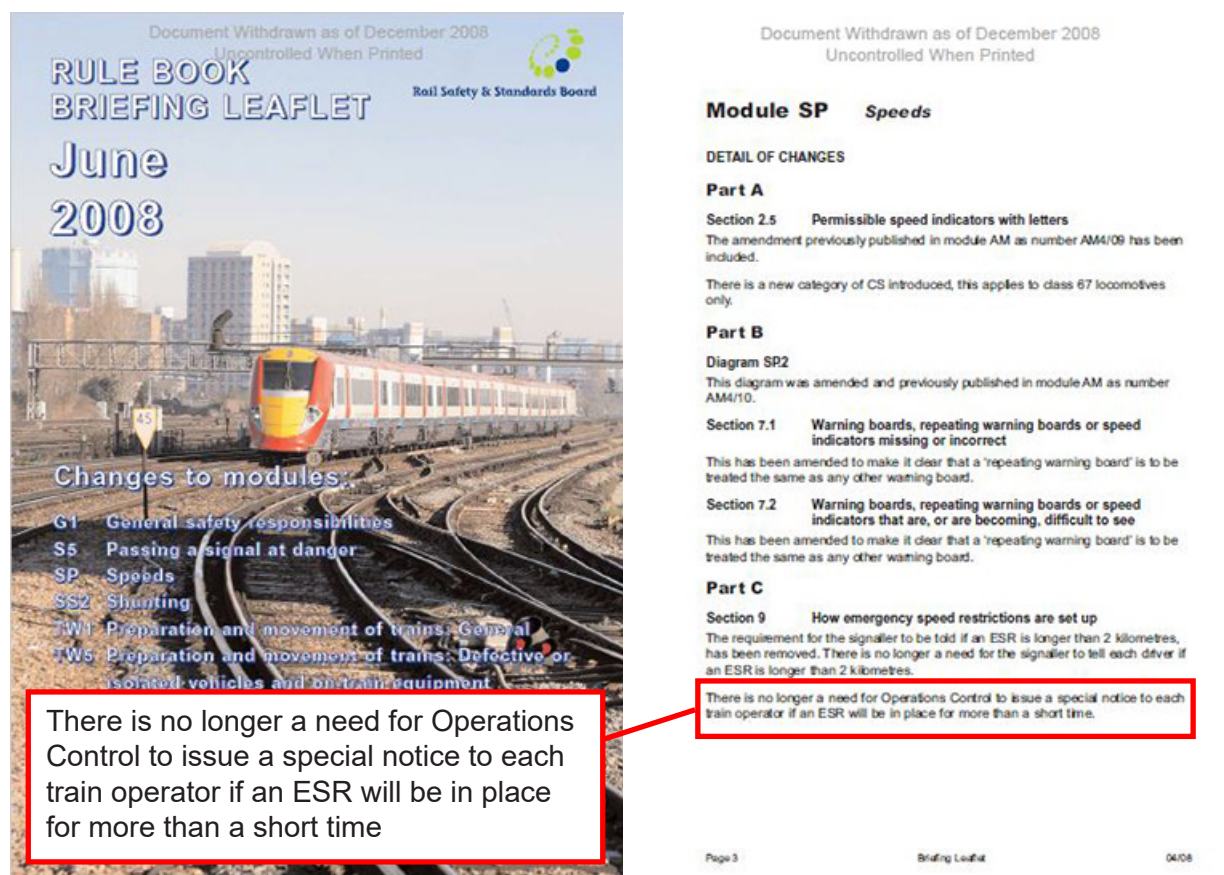
- 90 RSSB produced a leaflet in June 2008 (figure 11) to explain the changes to the rule book for that re-issue.

Figure 11: Extract from the RSSB's Rule book briefing leaflet June 2008

- 5 *The intent of this recommendation is to learn lessons from the 2008 change to the rules relating to emergency speed restrictions and to consider the extent to which these have been addressed by the current processes which are applied by standards committees.*
