Playground Inspection and Maintenance

Site Information

Inspection Ref: 798990

Operational Inspection - 25 March 2019 at 09:35 Inspector:

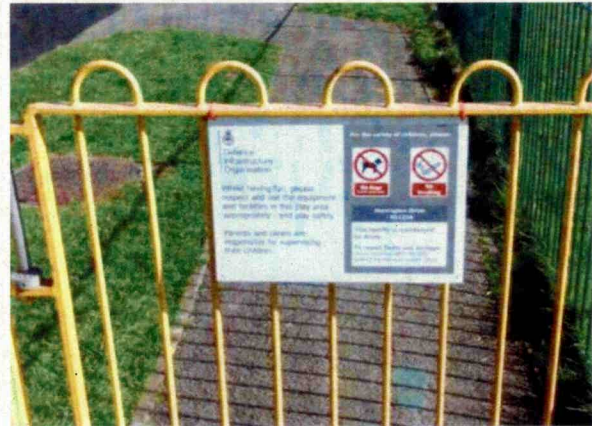
Item: Ancillary Items - Sign
Manufacturer: Not Applicable
Surface Type: N/A
Equipment Compliance: N/A
Surface Area Compliance: N/A
Ref/Part Number:
Total Findings: 1

This item is satisfactory - no work required

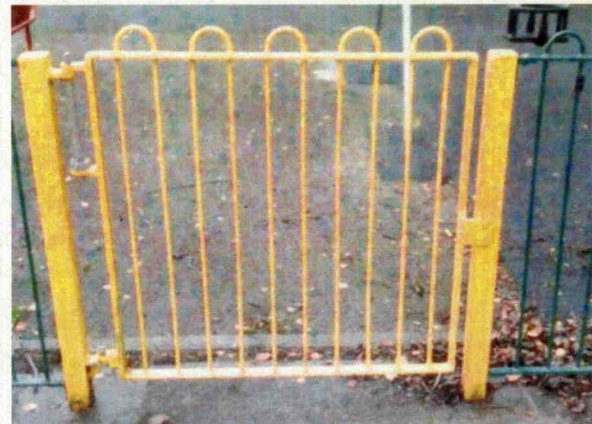
Video taken of gate closing - no issues identified

Item: Ancillary Items - Gate - Self Closing
Manufacturer: Steelway/Fensecure
Surface Type: Tarmac
Equipment Compliance: N/A
Surface Area Compliance: N/A
Ref/Part Number:
Total Findings: 2

The rubber buffer is damaged. - Replace rubber buffer

The gate rebounds when opened quickly and could strike the next user entering the area - Monitor use and adjust/replace as required

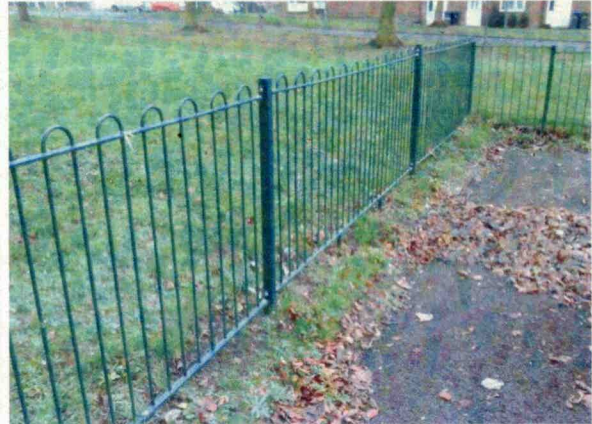
Item: Ancillary Items - Fence - Bow Top
Manufacturer: Steelway/Fensecure
Surface Type: Grass
Equipment Compliance: N/A
Surface Area Compliance: N/A
Ref/Part Number:
Total Findings: 1

There is some damage to the fence sections - Monitor for any further deterioration and repair as required

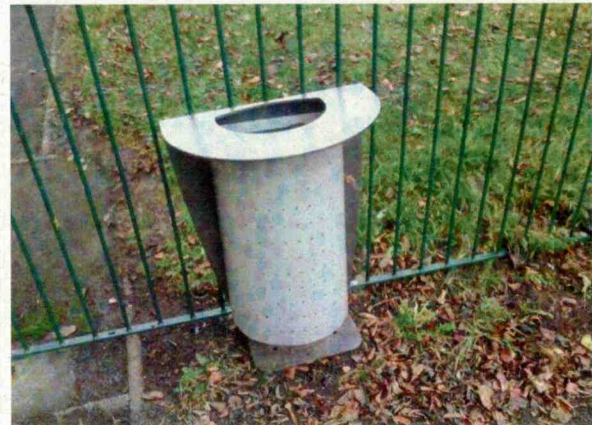
Item: Ancillary Items - Litter Bin
Manufacturer: Proludic
Surface Type: Grass
Equipment Compliance: N/A
Surface Area Compliance: N/A
Ref/Part Number:
Total Findings: 1

This item is satisfactory - no work required

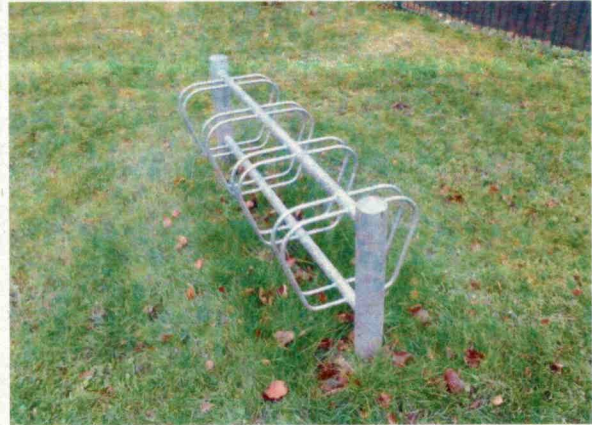
Item: Ancillary Items - Cycle Rack
Manufacturer: Proludic
Surface Type: Grass
Equipment Compliance: N/A
Surface Area Compliance: N/A
Ref/Part Number:
Total Findings: 1

This item is satisfactory - no work required

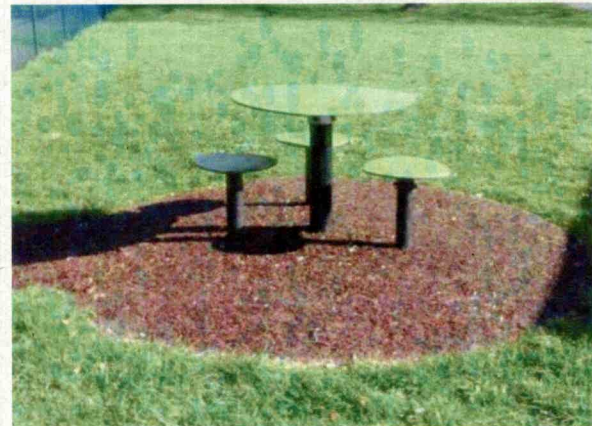
Item: Ancillary Items - Picnic Table
Manufacturer: Proludic
Surface Type: Bonded Rubber Mulch
Equipment Compliance: N/A
Surface Area Compliance: N/A
Ref/Part Number:
Total Findings: 1

There is algae or moss on the surface of the equipment - Clean and treat appropriately

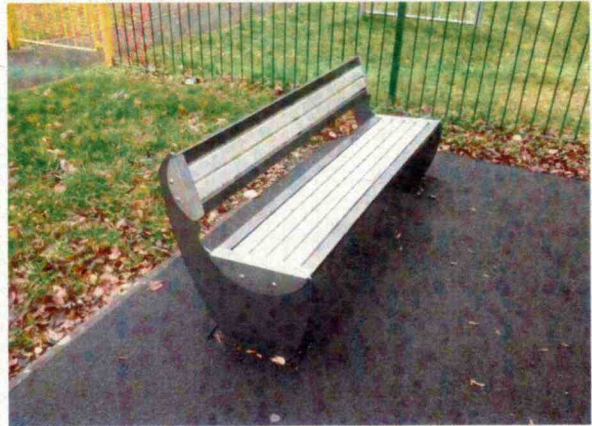
Item: Ancillary Items - Bench
Manufacturer: Proludic
Surface Type: Wet Pour
Equipment Compliance: N/A
Surface Area Compliance: N/A
Ref/Part Number:
Total Findings: 1

The item is loose in its foundations - Reinstall item to secure

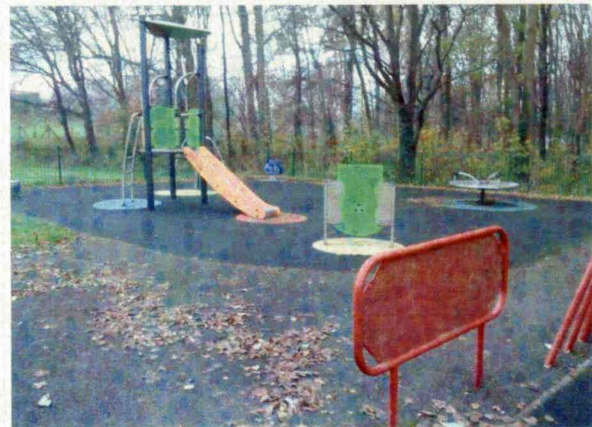
Item: Ancillary Items - Site General
Manufacturer: Owner/Operator
Surface Type: N/A
Equipment Compliance: N/A
Surface Area Compliance: N/A
Ref/Part Number:
Total Findings: 1

This item is satisfactory - no work required

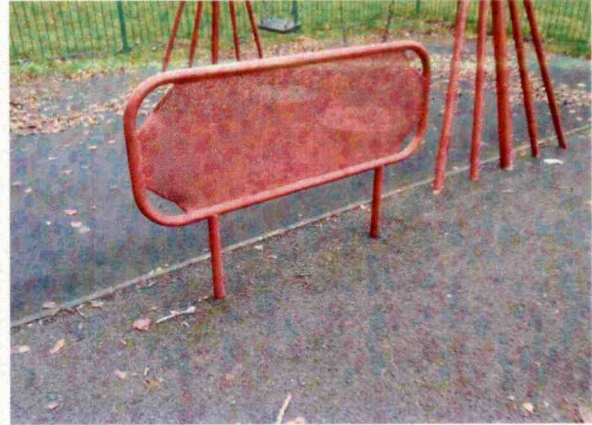
Item: Swings - Swing Barrier
Manufacturer: Wicksteed Playgrounds
Surface Type: Tarmac
Equipment Compliance: N/A
Surface Area Compliance: N/A
Ref/Part Number:
Total Findings: 1

Finding 1
The item has been damaged - Monitor for any further deterioration and replace as required

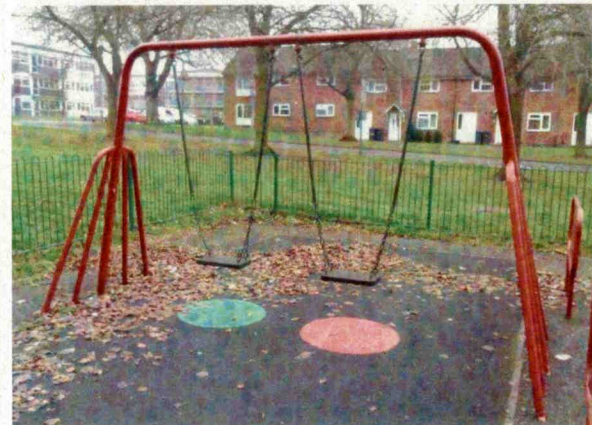
Item: Swings - 1 Bay 2 Seat (Flat)
Manufacturer: Wicksteed Playgrounds
Surface Type: Wet Pour
Equipment Compliance: Yes
Surface Area Compliance: Yes
Ref/Part Number:
Total Findings: 2
Life Expectancy: 5 -10 Years

Finding 1
The bushes are showing signs of wear - Monitor for any further deterioration and replace as required

Finding 2
There is some chain wear - Monitor for any further deterioration and replace when 40% worn

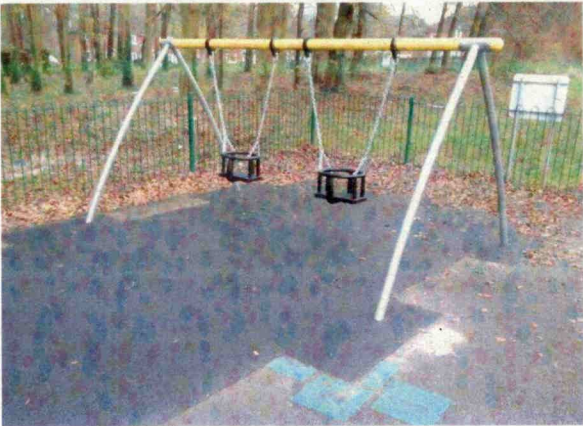
Item:	Swings - 1 Bay 2 Seat (Cradle)
Manufacturer:	Hags
Surface Type:	Wet Pour
Equipment Compliance:	Yes
Surface Area Compliance:	Yes
Ref/Part Number:	
Total Findings:	1
Life Expectancy:	>10 Years

This item is satisfactory - no work required

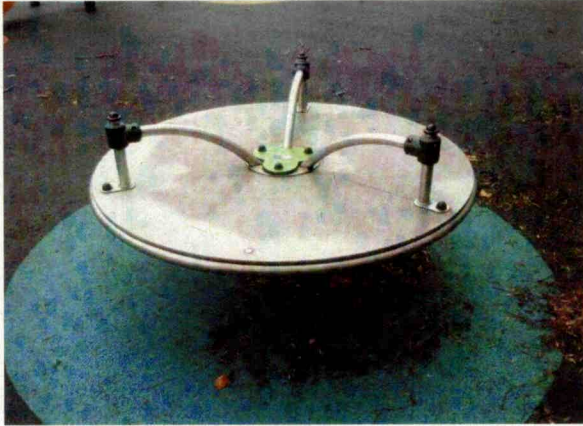
Item:	Rotor Play - Roundabout
Manufacturer:	Proludic
Surface Type:	Wet Pour
Equipment Compliance:	Yes
Surface Area Compliance:	Yes
Ref/Part Number:	
Total Findings:	1
Life Expectancy:	5 -10 Years

This item is satisfactory - no work required

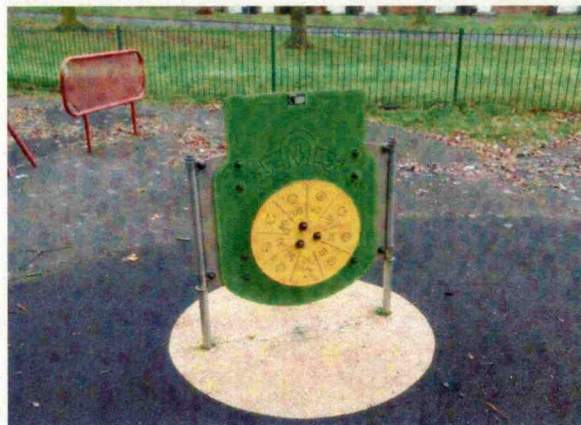
Item: Activity Equipment - Play Panel
Manufacturer: Proludic
Surface Type: Wet Pour
Equipment Compliance: Yes
Surface Area Compliance: N/A
Ref/Part Number:
Total Findings: 1
Life Expectancy: 5 -10 Years

This item is satisfactory - no work required

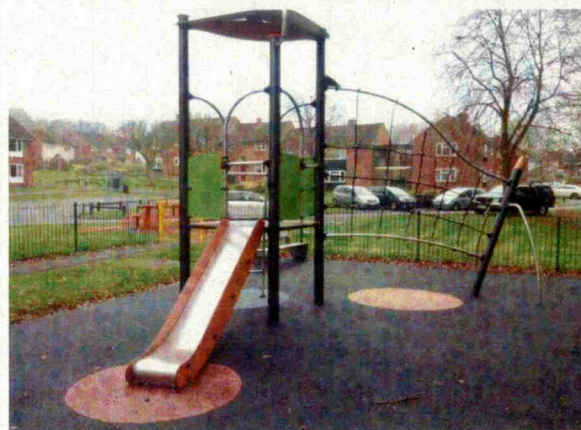
Item: Activity Equipment - Multi Play (Junior)
Manufacturer: Proludic
Surface Type: Wet Pour
Equipment Compliance: Yes
Surface Area Compliance: Yes
Ref/Part Number:
Total Findings: 1
Life Expectancy: >10 Years

There is/are bolt cap covers missing or damaged on the item - Replace missing or damaged bolt cap covers X 8

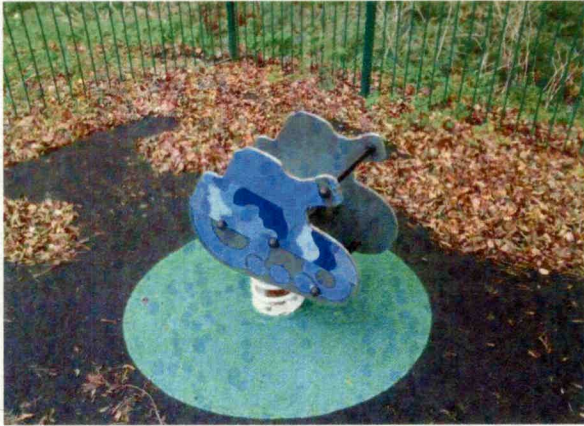
Item:	Rocking Equipment - Misc Springer
Manufacturer:	Proludic
Surface Type:	Wet Pour
Equipment Compliance:	Yes
Surface Area Compliance:	Yes
Ref/Part Number:	
Total Findings:	1
Life Expectancy:	3 - 5 Years

This item is satisfactory - no work required

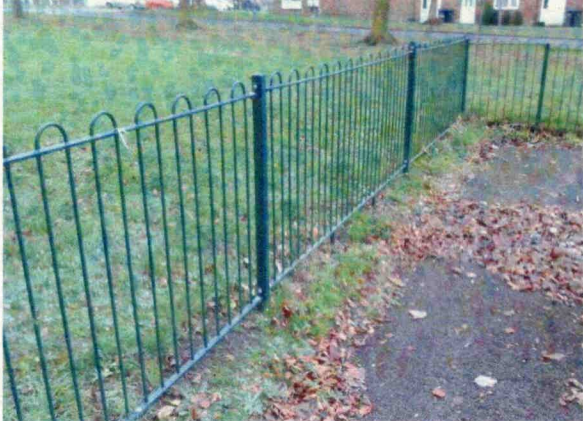
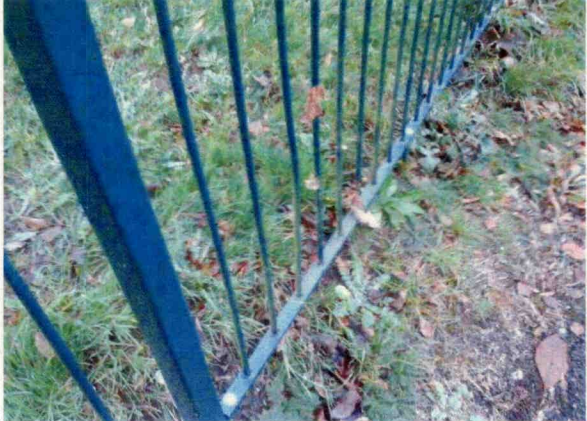
6 - Low Risk (Finding 1)			
Item:	Ancillary Items - Fence - Bow Top	Risk Level:	L - Low Risk
Manufacturer:	Steelway/Fensecure	Surface:	Grass

Finding:	There is some damage to the fence sections		Action: Monitor for any further deterioration and repair as required

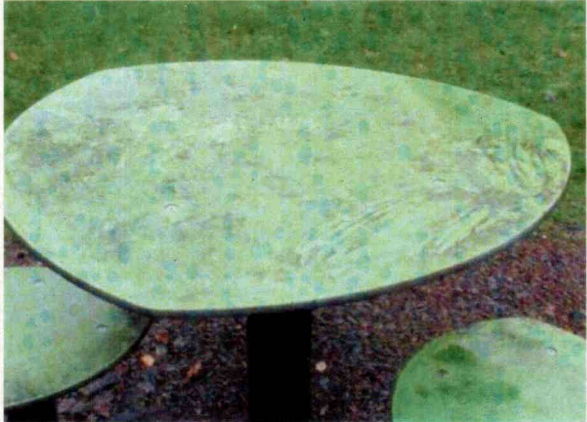
8 - Low Risk (Finding 1)			
Item:	Ancillary Items - Picnic Table	Risk Level:	L - Low Risk
Manufacturer:	Proludic	Surface:	Bonded Rubber Mulch

Finding:	There is algae or moss on the surface of the equipment		Action: Clean and treat appropriately

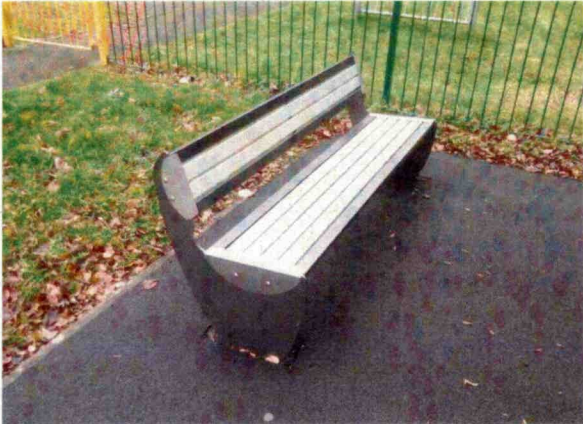
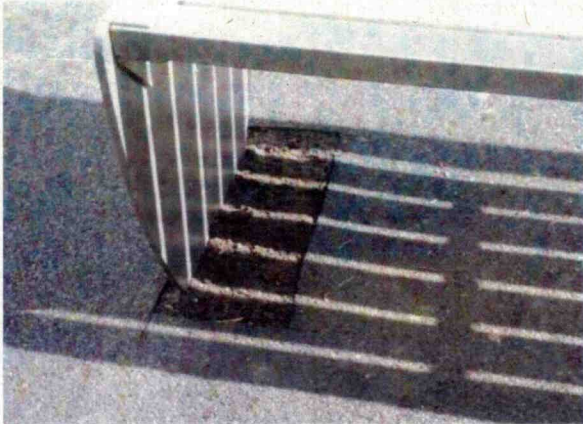
12 - Moderate Risk (Finding 1)

Item:	Ancillary Items - Bench	Risk Level:	M - Moderate Risk
Manufacturer:	Proludic	Surface:	Wet Pour

Finding:	The item is loose in its foundations	Action:	Reinstall item to secure
-----------------	--------------------------------------	----------------	--------------------------

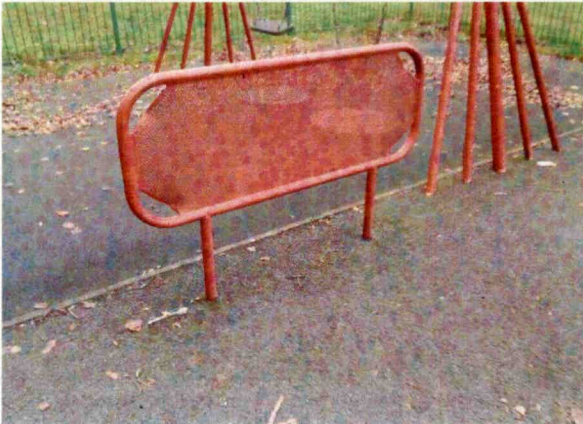
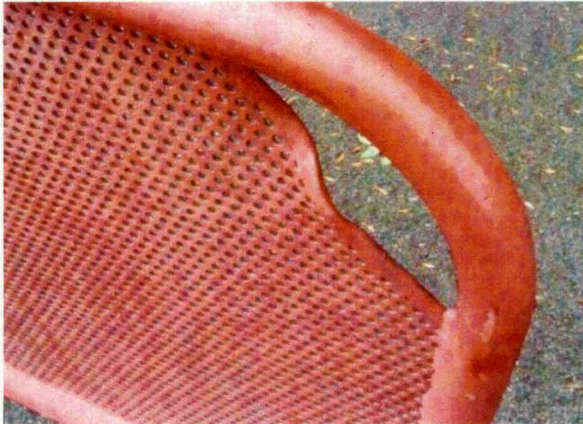
6 - Low Risk (Finding 1)

Item:	Swings - Swing Barrier	Risk Level:	L - Low Risk
Manufacturer:	Wicksteed Playgrounds	Surface:	Tarmac

Finding:	The item has been damaged	Action:	Monitor for any further deterioration and replace as required
-----------------	---------------------------	----------------	---

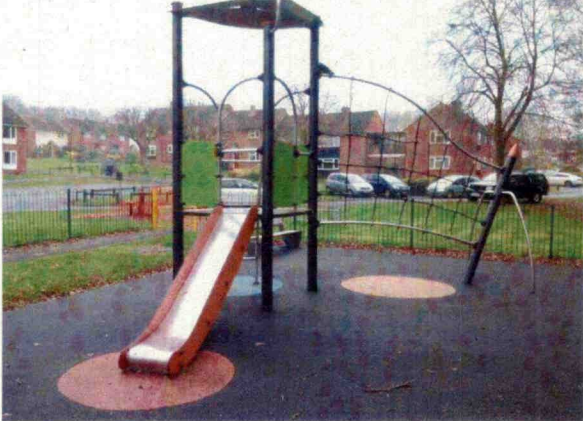
6 - Low Risk (Finding 1)			
Item:	Activity Equipment - Multi Play (Junior)	Risk Level:	L - Low Risk
Manufacturer:	Proludic	Surface:	Wet Pour

Finding:	There is/are bolt cap covers missing or damaged on the item		Action: Replace missing or damaged bolt cap covers X 8

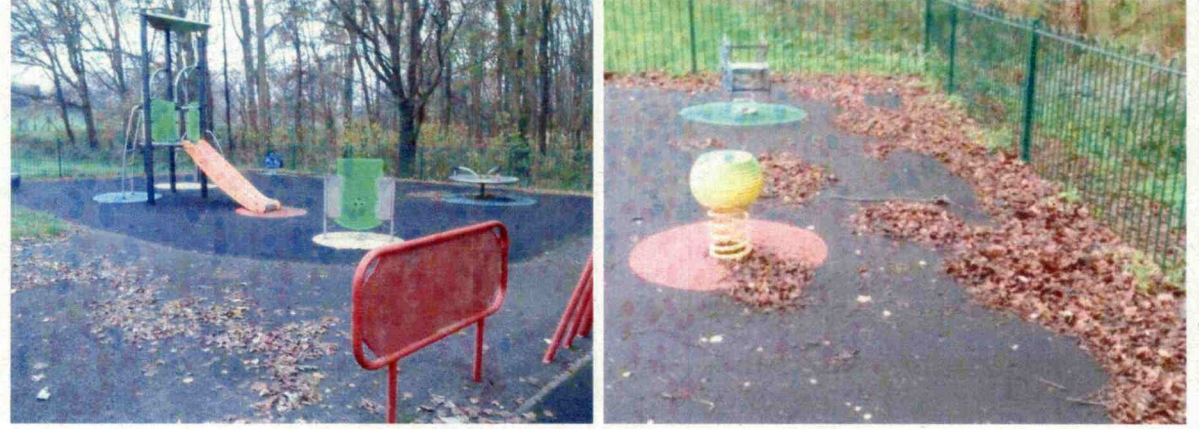
6 - Low Risk (Finding 1) - Marked as complete on 28/03/2019

Item:	Ancillary Items - Site General	Risk Level:	L - Low Risk
Manufacturer:	Owner/Operator	Surface:	N/A

Finding:	There is some tree debris on the surfacing	Action:	Remove and maintain
-----------------	--	----------------	---------------------
