## Safety Investigation Report

Watchkeeper WK050 ACCIDENT - NSI

13 June 2018

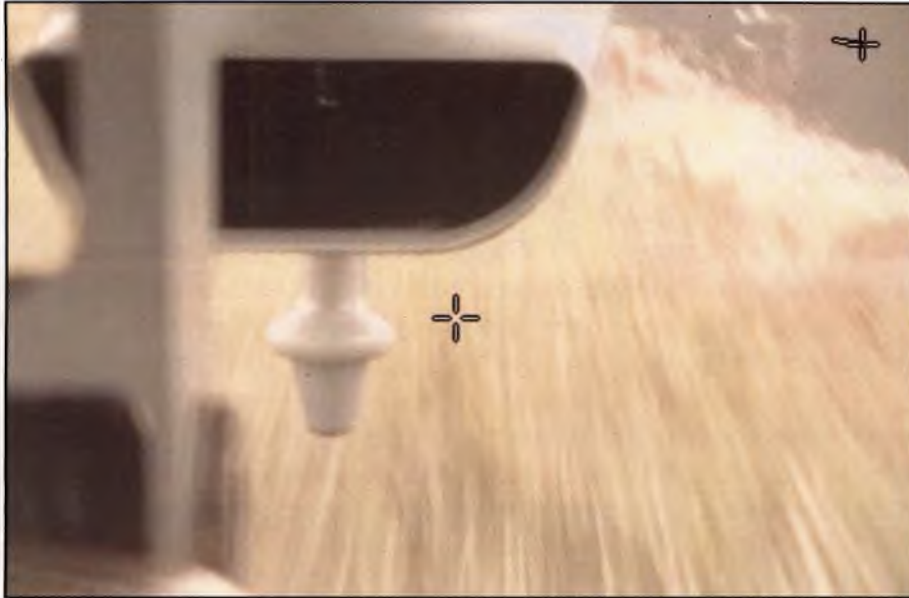
**Figure 2: Image from rear-facing EOP as AV departed the RW (seen top right).**

Everything was normal with the AV during the final approach to RW25. The AV was visibly crabbing to the left, due to the crosswind component but was tracking the RW centreline. P2 stowed the EOP in preparation for TD<sup>10</sup>. P1 verbalised semi-flare<sup>11</sup> and de-crab<sup>12</sup>. After de-crab the AV started drifting right, verbalised by P2. Air Traffic Control (ATC) reported touchdown. The AV landed long of the TD point, just to the right of the centreline; it immediately deviated to the right during the landing roll, reported by ATC. The AV failed to register ground contact and auto-aborted for LSTO as it approached the edge of the RW. The AV continued to deviate as its engine powered up, rotating when both MLG wheels were on the grass (figure 2). P2 reported the AV was on the grass and said the emergency code words to abort the landing. Expletives from the AI and P1 followed. P1 verbalised abort and engine cut immediately followed by the spare pilot saying cut engine. P1 manually aborted the landing 4 seconds after the AV had auto-aborted, 2 seconds later he pressed engine cut twice in quick succession. The AV was climbing away to the righthand side of RW25 over the grass and at approximately 40ft AGL with a WOT and a positive rate of climb when the engine was cut. The AV attempted to gain its LLR, in doing so it glided over the road (B4333) before impacting a tree at approximately 1652.

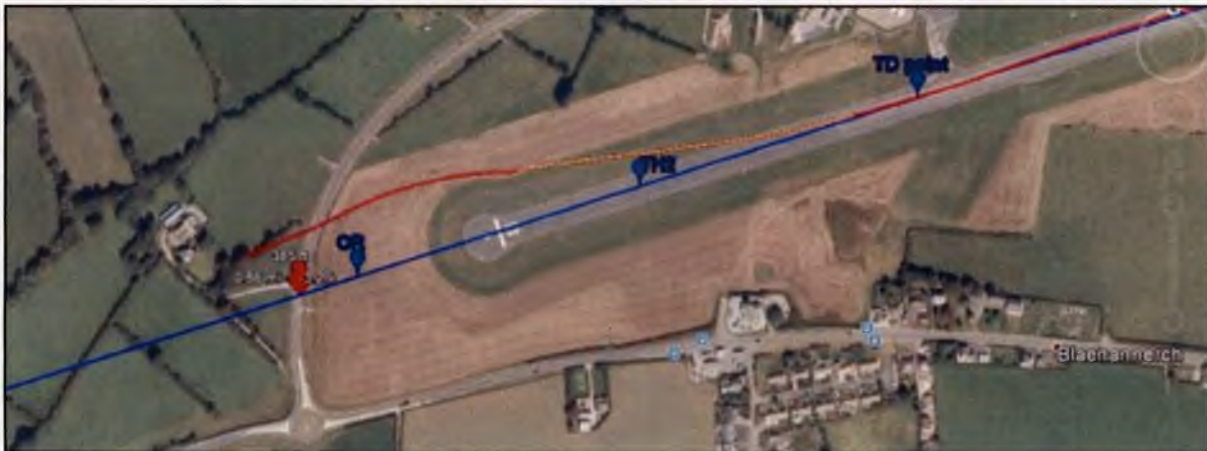
**Figure 3: The AV deviation track (red & yellow) and accident location.**

The AV crashed just outside the airfield boundary past the threshold of RW07 (Figure 3). Due to its proximity to the airfield the PCMIO and a WK Eng deployed to the site. The AV had glided over the B4333 and impacted a large tree just the other side of the road from the airfield. There were no injuries or fatalities and the AV was categorised as CAT 5. The PCMIO arrived at the crash site shortly after 1655 and met an eyewitness who had called the emergency services. An initial cordon of 40m radius around the crash site was setup but subsequently reduced to 15m radius once an initial debris assessment had been carried out.

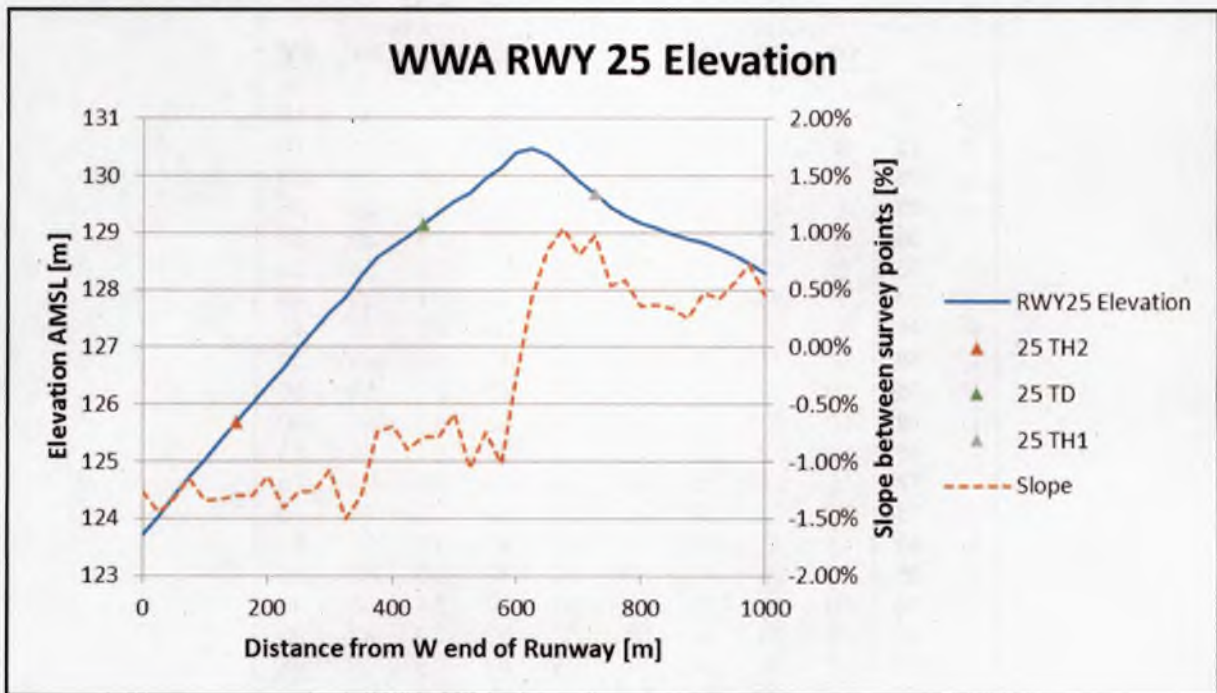
Figure 5: WWA RW25 elevation and slope.

Figure 5 depicts the survey of WWA RW25 showing elevation, slope, and the locations of Threshold 1 and 2 and the TD point. The RW was surveyed at 25m intervals along its length.

**Safety Recommendation – The Head of the Unmanned Air System Team should review the current Air Vehicle runway slope limitations to determine whether they are fit for purpose.**

**Safety Recommendation – The Accountable Manger (Military Flying) should consider relocating the Automatic Take-off & Landing System on runway 25 West Wales Airport to an area that has less slope.**

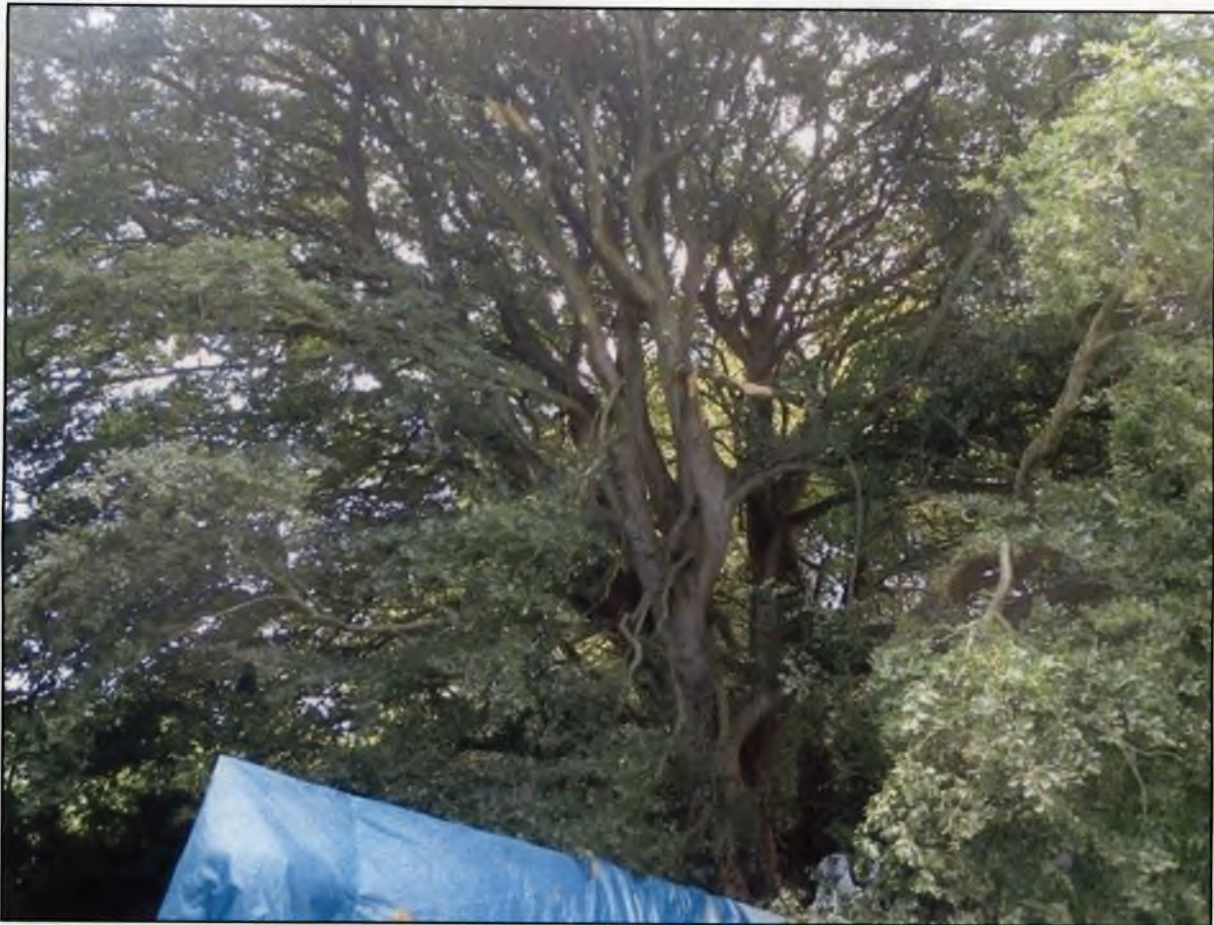
**Figure 10: Impact damage to large tree.**

The AV directly impacted a large tree before coming to rest with its propeller on the ground at the base of the tree (Figure 10). The tree had sustained impact damage and several branches had become detached or broken as the AV fell to the ground.

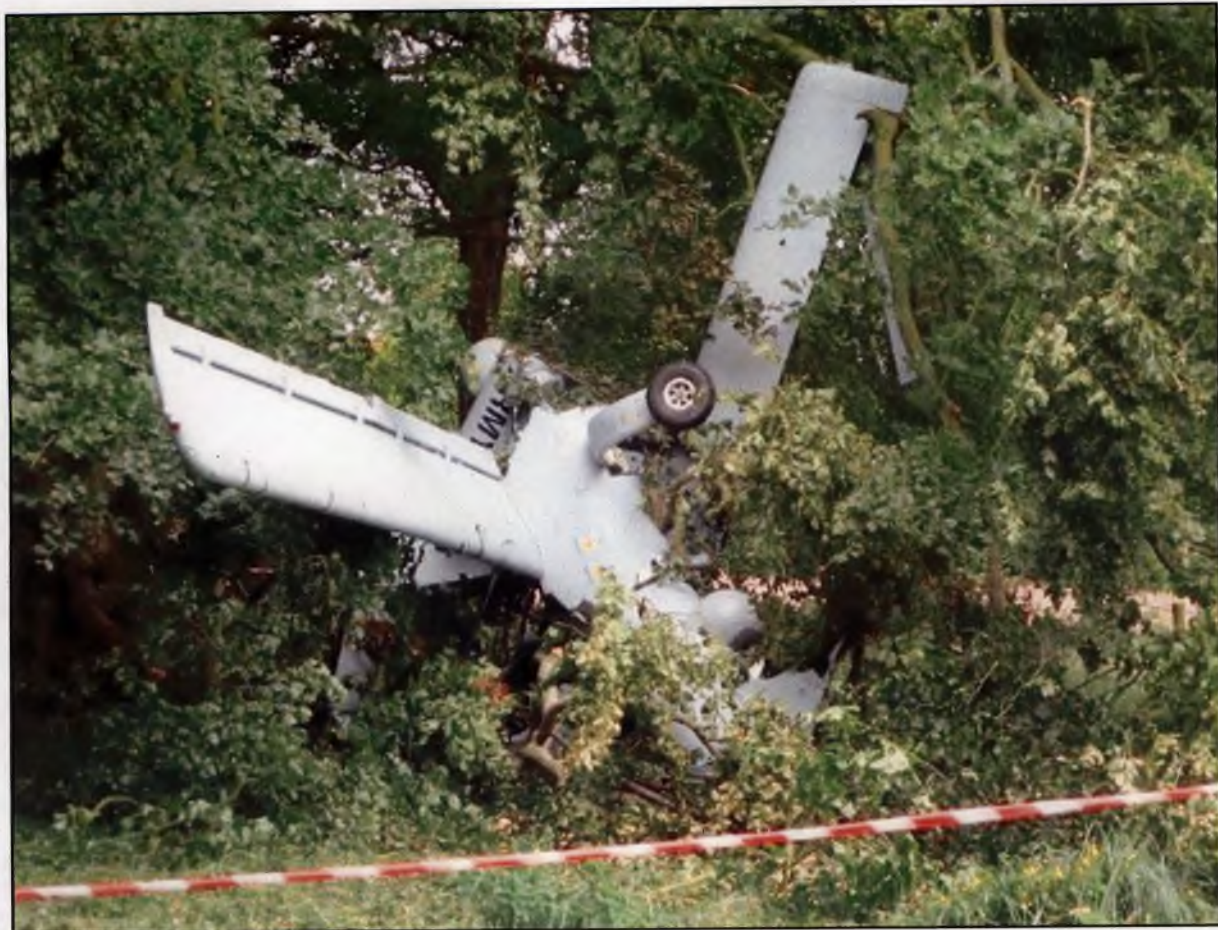
Figure 11: WK050 wreckage at base of large tree.

The fuselage structure was broken in 2 aft of the wing section and the forward section was lying upside down on the ground (Figure 11). The right-hand wing had become detached from the main fuselage and was resting vertically to the ground. The aileron and flap control surfaces were detached from the right wing and were resting in branches next to the wing. Much of the wreckage had been contained by the branches with the remainder lying at the base of the tree resting on the ground. Several small fuselage and nose cone fragments had shattered due to impact damage and were scattered around the base of the tree within a 5m radius.

Despite extensive damage to the main fuselage assembly, the LRUs contained within the AV were secure in situ and appeared to be in a good physical condition, however their serviceability status was unknown. The EOP and radar were secured within the main fuselage and appeared to be in a good state of repair. The AV's fuel tank was ruptured and completely empty of fuel. The oil tank was damaged and did not contain any oil.

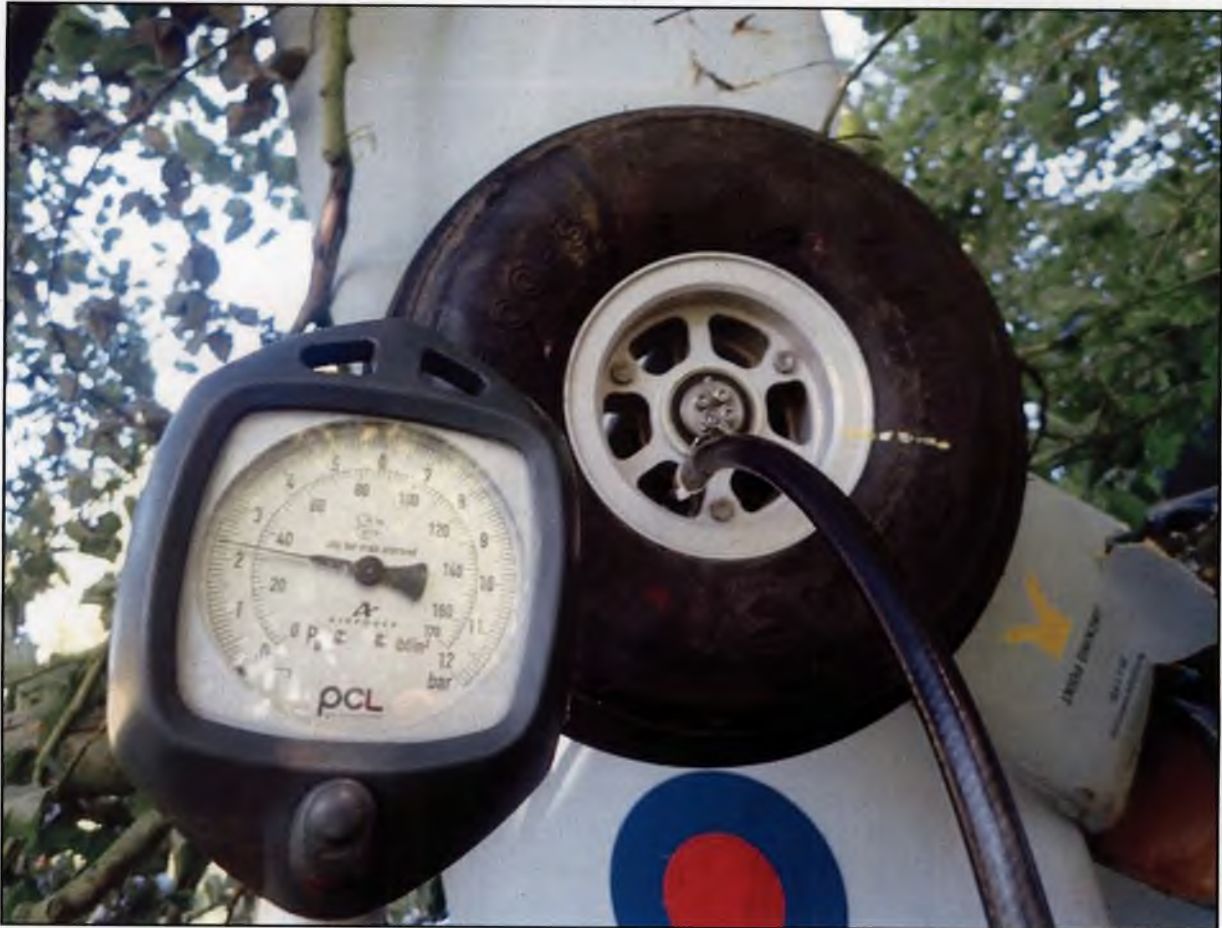
Figure 12: Main wheel tyre pressure check.

All tyre pressures were checked in accordance with the IETP<sup>37</sup> during the triage investigation. The NSI team were able to confirm that the all tyre pressures were correct and therefore would not have affected the landing (Figure 12). The NLG was in the locked position and slightly misaligned. The misalignment was consistent with impact damage with the tree and there was no evidence to suspect the serviceability of the AV's undercarriage during the attempted landing. The NSI team concluded that the AV's undercarriage was **not a factor** in this accident.

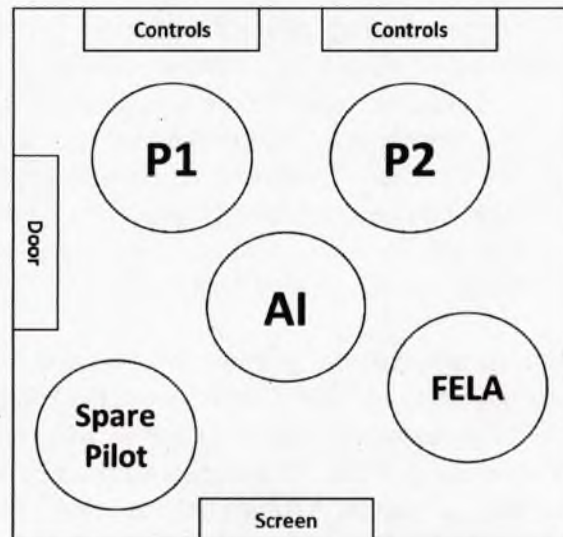
**Figure 13: The crew layout within the GCS.**

The GCS is a small working environment and interview evidence indicated that there were more people in the GCS than was typical. RA pilots are accustomed to training with up to 3 people in the GCS: P1, P2 and AI. The larger crew made the GCS feel cramped and increased the amount of chatter<sup>52</sup>. This fact may have impeded the ability of the FELA to obtain the information, from the pilots' screens, that his role required. On several occasions this information was verbally requested, increasing the amount of talking on the intercom. Both pilots commented that the amount of talking added to their workload<sup>53</sup>. They said it was difficult, at times, due to the quality of the audio in the headsets and the numbers of crew to distinguish voices and to know whether they were giving instructions or information.

The spare pilot was only qualified as P2 and had not been current P1 since Jul 16. The NSI team considered this to detract from the role set out within the TRHA as he was only qualified to monitor P2. The benefit of his presence was likely outweighed by the negative factors of an extra person and possible confusion caused by his role in the GCS. The team also noted that the role of the spare pilot was not laid down in the Thales UK Ltd Flight Operations Organisation Terms of Reference (People) unlike all the other crew roles. The team recognised it could have been difficult for the pilots to differentiate who said a command during a high-pressure situation as 3 of the crew were sat behind them and only one of them was the aircraft commander. This is likely to have had a detrimental impact on the command and control within the GCS.

**Safety Recommendation – The Accountable Manger (Military Flying) should conduct a review of the current manning and command arrangements within the Ground Control Station to determine if they are fit for purpose.**

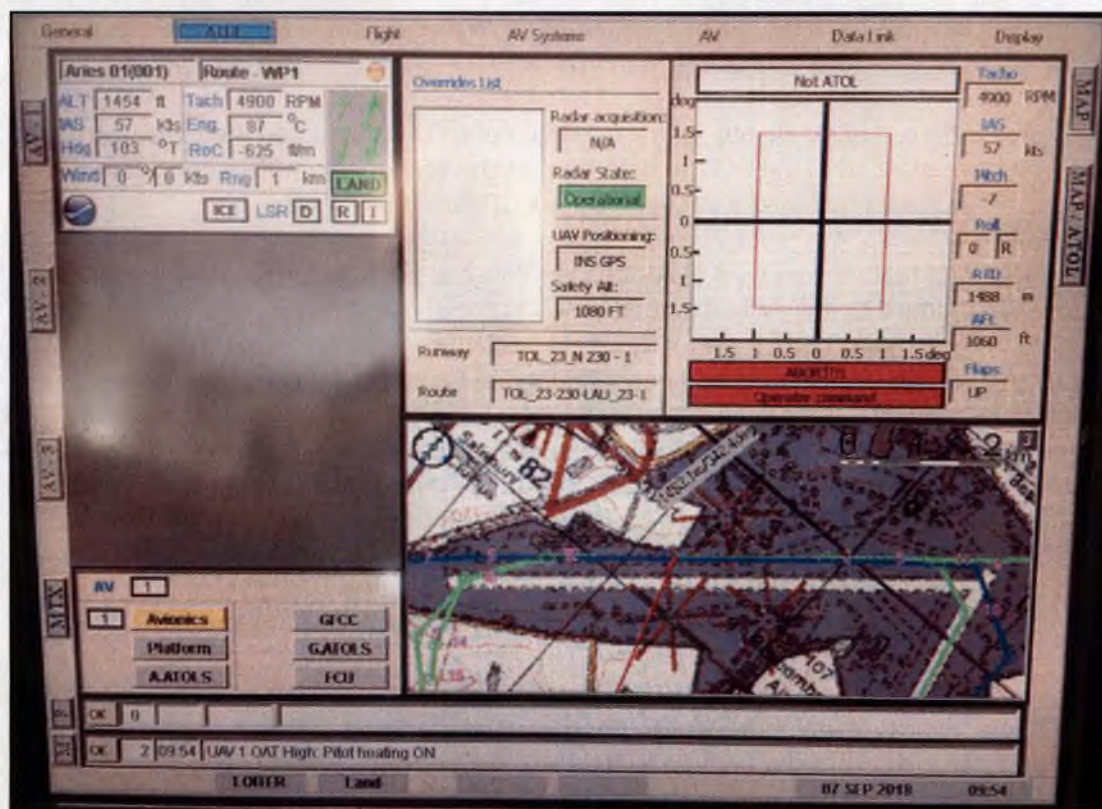
**Figure 14: The red ATOLS abort caption on the AVDC.**

The AV landed long of the TD point just to the right of the centreline; it immediately deviated to the right during the landing roll. It failed to register ground contact during the ground touch window and auto-aborted for LSTO as it approached the edge of the RW. The AV continued to deviate as it powered up, rotating when both MLG wheels were on the grass. The AV climbed away to the righthand side of RW25 over the grass. These circumstances had not been encountered in the previous 749 WK ES2 flights. P1 manually aborted the landing 4 seconds after the AV had auto-aborted, 2 seconds later he pressed engine cut twice in quick succession. The AV was at approximately 40ft AGL with a WOT and a positive rate of climb at the time engine cut was pressed, an irreversible event. The NSI team sort to understand why P1 pressed the engine cut.

Had no action been taken, the AV would have completed its automatic go-around from which it could have been commanded to conduct a further approach. At 30ft AGL on the approach the EOP had been stowed, rotating through approximately 180 degrees to protect the lenses; however, the FMV remained on and displayed in the GCS. The AV flight modes had been
