**DIRECTION TO CONVENE A SERVICE INQUIRY (SI) INTO 105MM HE ARTILLERY ROUND FIRED OUTSIDE OF THE RANGE AREA ON SALISBURY PLAIN TRAINING AREA (SPTA) ON 5 MAR 14.**

**CONVENING ORDER FOR A SERVICE INQUIRY**

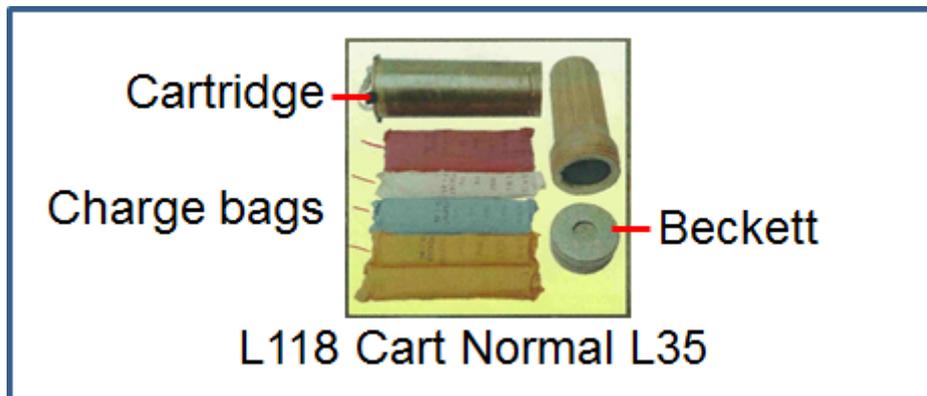
d. **105MM Ammunition.** The HE ammunition used by the 105mm Light Gun (L118) in this case was the 105mm HE L31 projectile, paired with the “L118 Cart Normal L35”. The cartridge is issued with the ability to be used at six different charges based on the five component charge bags provided. The photo below shows the cartridge, charges and the “beckett”, a threaded bung which retains the charge bags inside the cartridge once loaded.

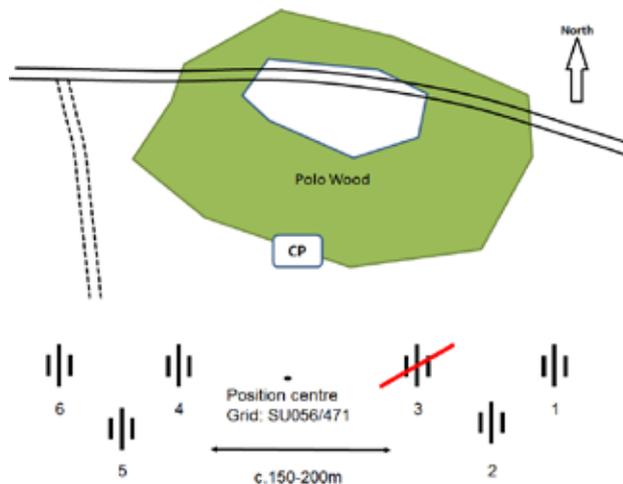
Fig 1. (Not to scale).

13. In total the Service Inquiry interviewed 14 individuals which were on the gun position during the morning of 5 Mar 14. Each were asked to draw a plan of the gun position and confirm who was the GPSO that morning alongside other basic facts about the day. The resulting plans can be found in the evidence folder but which demonstrate a very mixed picture. The prevailing picture was of a split gun position with guns 1 and 2 to the East and guns 4, 5 and 6 about 200m to the West (gun 3 was not firing). The Control Post (CP) was to the front of the guns meaning the rounds were fired over the heads of anyone at the CP. The diagram below offers the Panel's understanding of what the position layout was on the morning of the 5 Mar 14. There appears to have been two CPs operating, one managing guns 1-2 and one managing guns 4-6.

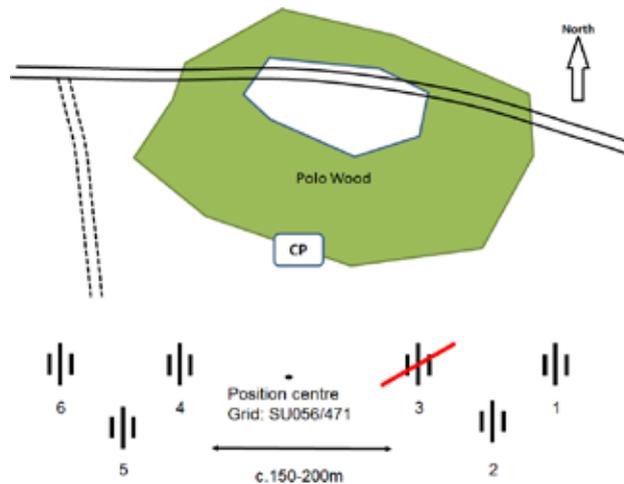
Fig 1. (Not to scale).

6. On 5 Mar 14 F Bty deployed the guns in a split gun position with guns 1 and 2 to the East and guns 4, 5 and 6 about 200m to the West (gun 3 was not firing). The Control Post (CP) was to the front of the guns meaning the rounds were fired

over the heads of anyone at the CP. The diagram below offers the Panel's understanding of what the position layout was on the morning of the 5 Mar 14.
