Rail Accident Investigation Branch

# Rail Accident Report

**Fatal accident at Tibberton No. 8 footpath  
crossing  
6 February 2019**

Report 13/2019  
October 2019

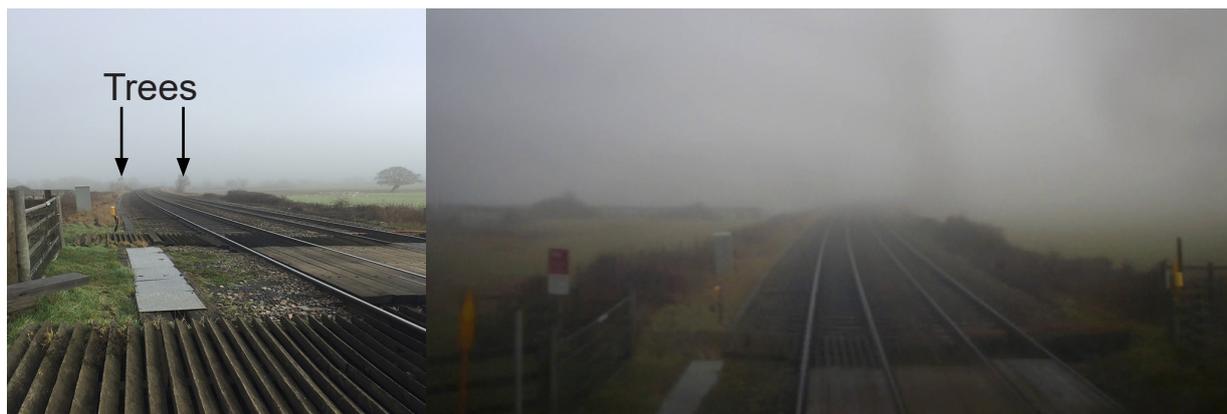
Figure 9: (left) Site conditions at 10:45 hrs and (right) FFCCTV from train 1M29 showing site conditions at 09:58 hrs (left image courtesy of Network Rail, right image courtesy of CrossCountry Trains)

- 62 **Because of the fog, the approaching train was not visible until it was three to four seconds away from the crossing.**
- 63 When train 1V05 left Birmingham New Street station at 09:30 hrs the weather was overcast but clear. It was only when the train passed Barnt Green on the outskirts of Birmingham that fog began to appear. Visibility got progressively worse and witness evidence indicates that by the time the train reached Bromsgrove, visibility was limited to a '*couple of hundred metres*'. The weather at this location on the day of the accident was described as '*very foggy*'.

- 64 The CCTV footage from train 1V05 shows how the fog progressively thickened as the train approached Tibberton No. 8 footpath crossing. Based on the footage, the RAIB calculated that the sighting time four kilometres north of Tibberton No. 8 crossing was approximately eight seconds. As the train approached the crossing, the visibility and hence the sighting time reduced to between three and four seconds.
- 65 Railway staff who attended the site took a photograph (figure 9) approximately 45 minutes after the accident (at around 10:45 hrs), at a time when the fog had started to lift. They indicated that at the time of their arrival on site (at around 10:20 hrs), the trees shown on the photograph were not visible.

- 66 A still image in the FFCCTV footage from train 1M29 which passed over the crossing approximately 20 seconds before the accident is shown in figure 9. The same trees cannot be seen on this footage. The trees are about 225 metres away from the crossing which, at a travelling speed of 100 mph (161 km/h), represents 5 seconds of warning time. A second later, the tree on the left-hand side starts to become visible.
- 67 At the time of the accident, the sighting time of a class 170 train<sup>21</sup> from the crossing was therefore between three and four seconds<sup>22</sup>. This is significantly less than the minimum required warning time of 7.6 seconds calculated in the narrative risk assessment.

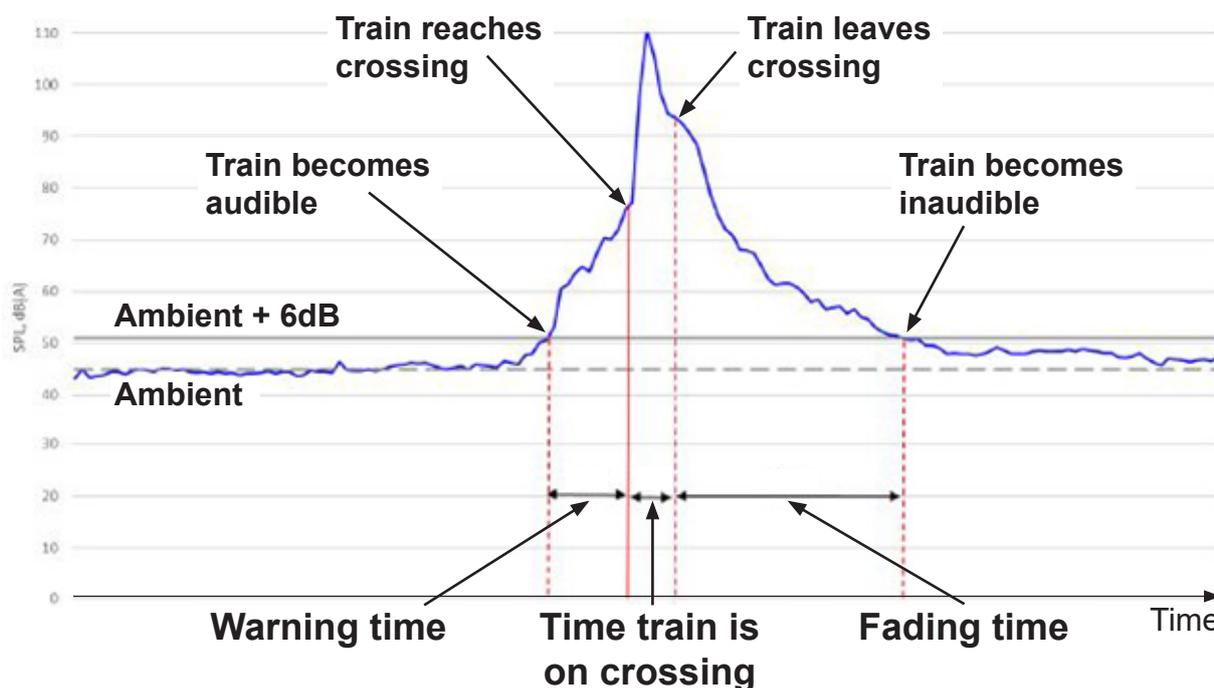
Figure 10: Typical sound trace recorded at Tibberton No. 8 footpath crossing

- 70 Measurements of background sound pressure levels (SPL) were carried out and found to be between 34 and 46 dB, depending on the time of day. The acoustic specialist advised the RAIB that there was no existing standard or research which defined the required difference in sound pressure level to make the general noise caused by an approaching train audible above the ambient noise<sup>23</sup>. Based on his experience, he suggested that a 6 dB difference represented a 'just audible' condition<sup>24</sup> (this being double the sound pressure). A typical sound trace of a train passing the crossing is shown in figure 10.

- 73 Table 1 shows that, depending on the background sound level, the time from a train becoming 'just audible' to the front of it arriving at the crossing varied between three and eight seconds. The time for it to become 'just inaudible' was longer, between eight and seventeen seconds.
- 74 The time from the train becoming 'just audible' to the front of the train reaching the crossing is the audible warning time. Therefore a user standing at the crossing is provided with three to eight seconds of audible warning time for the types of train considered (class 170 and class 220/221), from either direction. For a class 170 train approaching on the down line, as was the case during the accident, the audible warning time was between three and four seconds.
- 75 This is significantly less than the minimum required warning time of 7.6 seconds calculated in the narrative risk assessment.

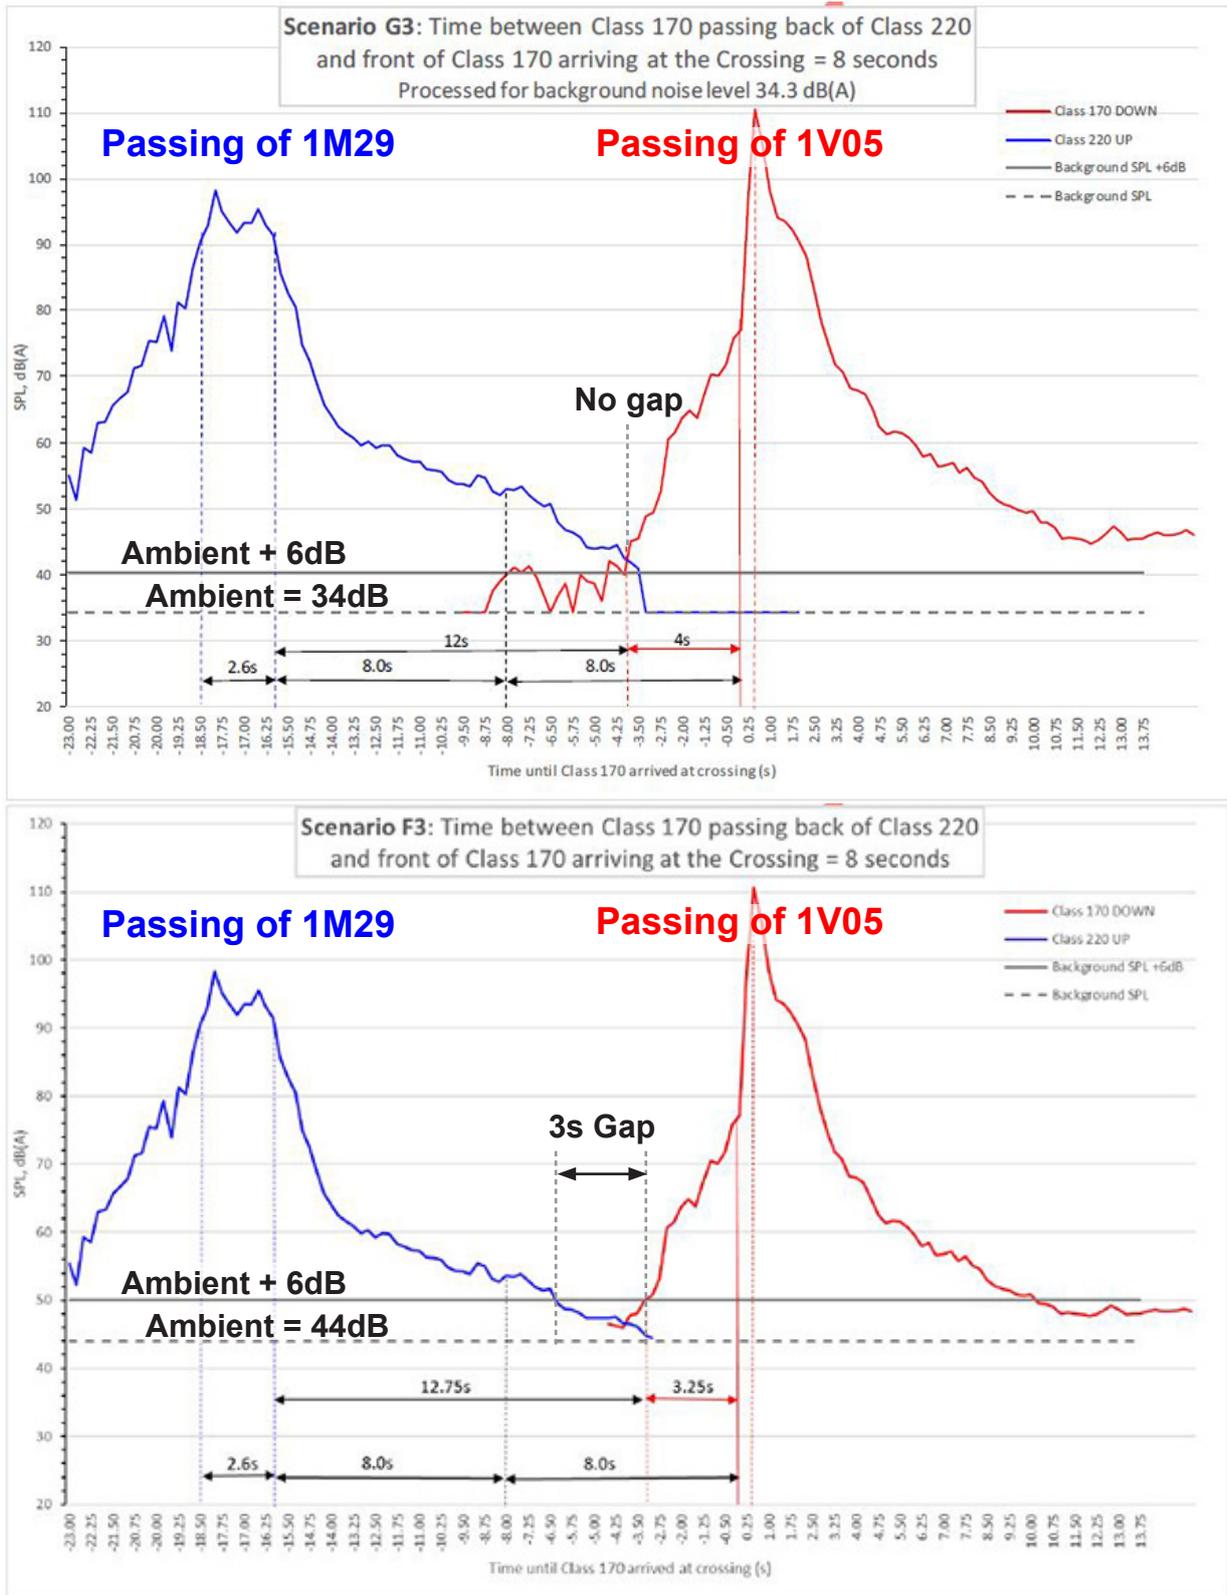
Figure 11: Passing of the two trains (low/high ambient)

- 76 The acoustic study also considered whether the passing of the first train (1M29) audibly masked the approach of train 1V05. The precise sequence of events on the day could not be replicated during the tests. However, using the sound measurement results for a class 170 train travelling on the down line and a class 220/221 train travelling on the up line, the accident scenario was recreated. The sound measurement results were aligned as if the front end of the class 170 train passed the back end of the class 221 train eight seconds before the class 170 train reached the crossing (paragraph 23).
- 77 Figure 11 shows the effect of the ambient sound level on the audibility of the trains for a user standing at the crossing in the scenario on the day of the accident.

- 78 Figure 11 shows that, for a low ambient sound level at 34 dB, the sound of the passing train (1M29) reached the inaudible level just as the sound of the approaching train (1V05) became audible. Figure 11 also shows that, for a higher ambient sound level at 44 dB<sup>26</sup>, the sound from the passing train (1M29) had been inaudible for approximately three seconds before the sound of the approaching train (1V05) became audible.

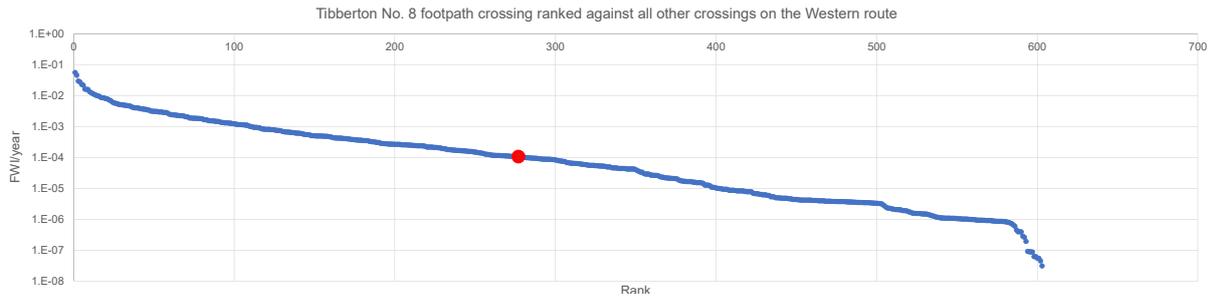
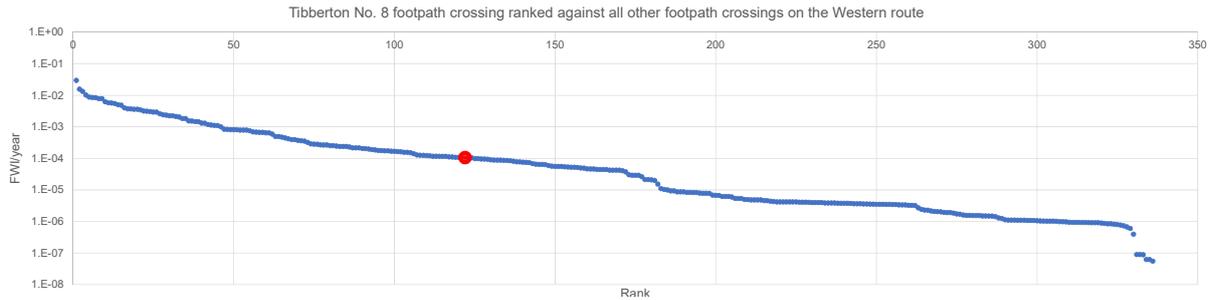
Figure 12a: Tibberton No. 8 footpath crossing ranked against all other crossings on the Western route

Figure 12b: Tibberton No. 8 footpath crossing ranked against all other footpath crossings on the Western route

- 93 Data provided by the Western Route indicates that fog was mentioned in the ALCRM input script for 48 of the 340 footpath crossings, that is one in seven crossings. Tibberton No. 8 footpath crossing was ranked 16 out of 48 footpath crossings for which fog had been identified as a potential risk factor in ALCRM.
- 94 Had fog been coded in the algorithms underpinning ALCRM, those crossings at which it had been identified would have sat higher in the risk ranking. This may have made crossings like Tibberton No. 8 footpath crossing more likely to be considered for investment opportunities.

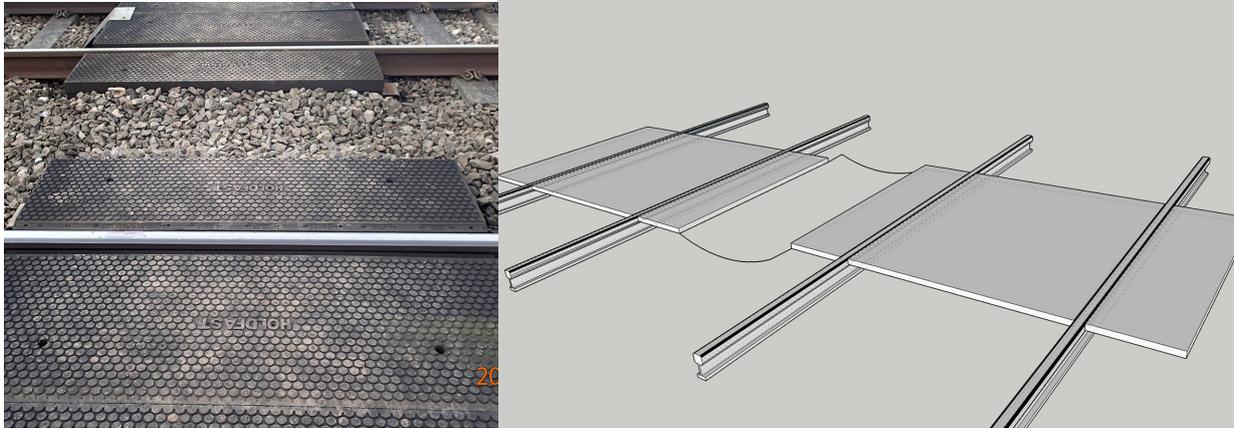
Figure 13: Crossing surface

103 The crossing surface at Tibberton No. 8 footpath crossing was made of two rubberised crossing decks with a gap in the six-foot (figure 13). The gap was approximately 840 mm wide and the ballast at this location was up to 100 mm lower than the crossing surface itself. As such, the crossing surface did not comply with the requirements of NR/L2/SIG/30015.

104 Although the gap and drop in ballast height may have slightly increased the pedestrian's traverse time and directed his attention to the ground, there is no evidence to suggest that this was a factor in this accident.

- 1 Level crossing designers and level crossing managers are reminded that, in accordance with Network Rail's standard NR/L2/SIG/30015, crossing surfaces should be level with the head of the rail, without tripping hazards and gaps greater than 10 mm and constructed from a single type (where track layout permits) (paragraph 116a).
