Rail Accident Investigation Branch

# Rail Accident Report

**Fatal accident involving a train passenger at  
Twerton  
1 December 2018**

Report 14/2019  
October 2019

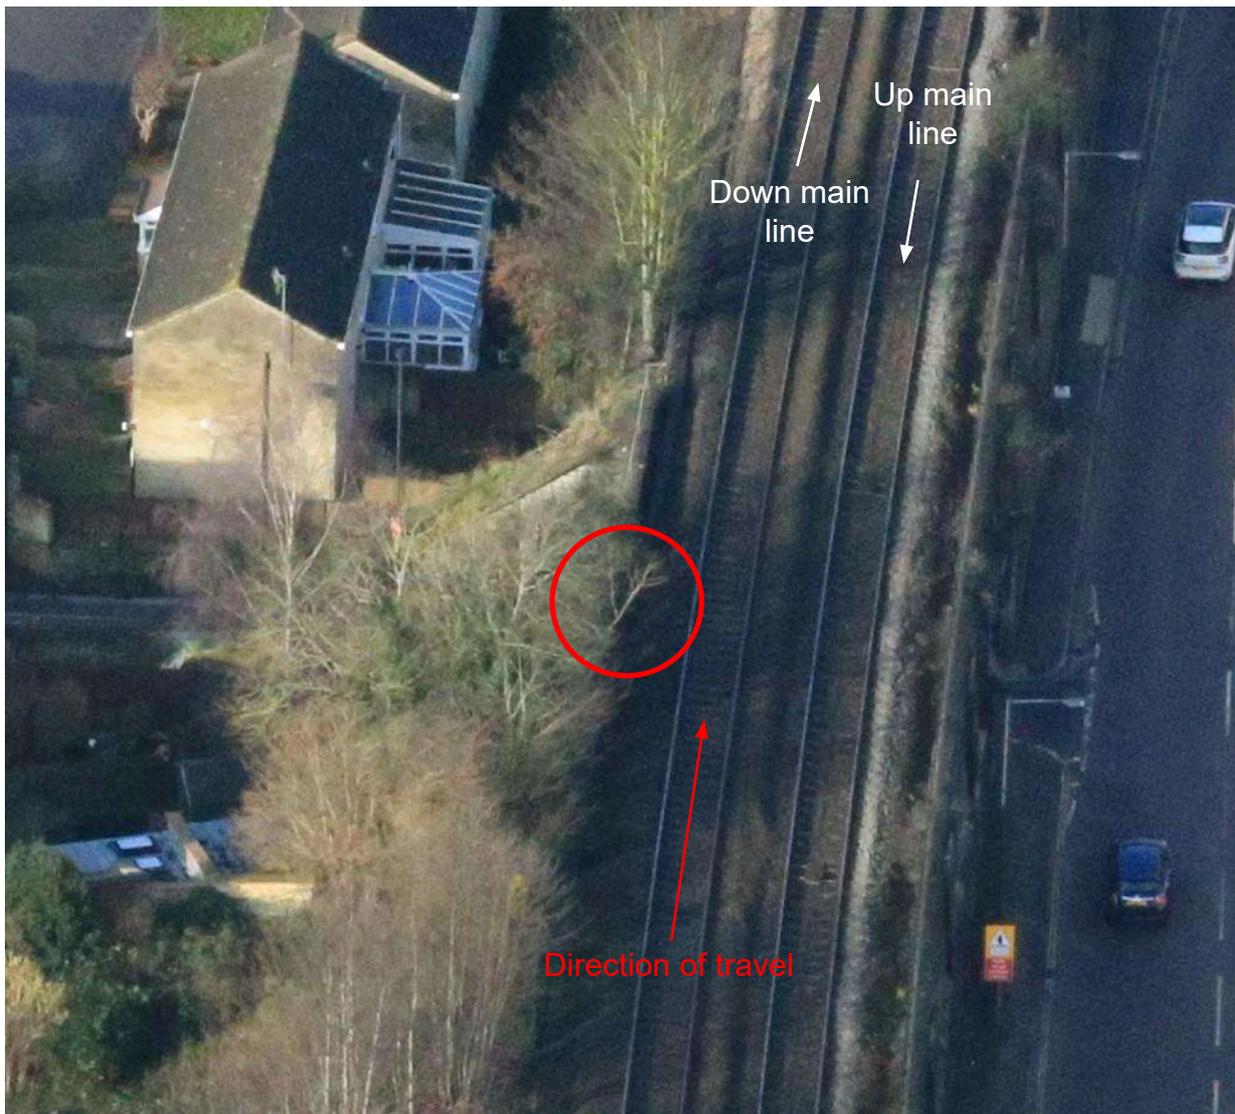
Figure 2: General photograph of the scene before the accident showing the tree branch involved (circled) (courtesy of Network Rail)

- 15 The branch which the passenger came into contact with was attached to a stem that was growing from the stump of an ash tree.

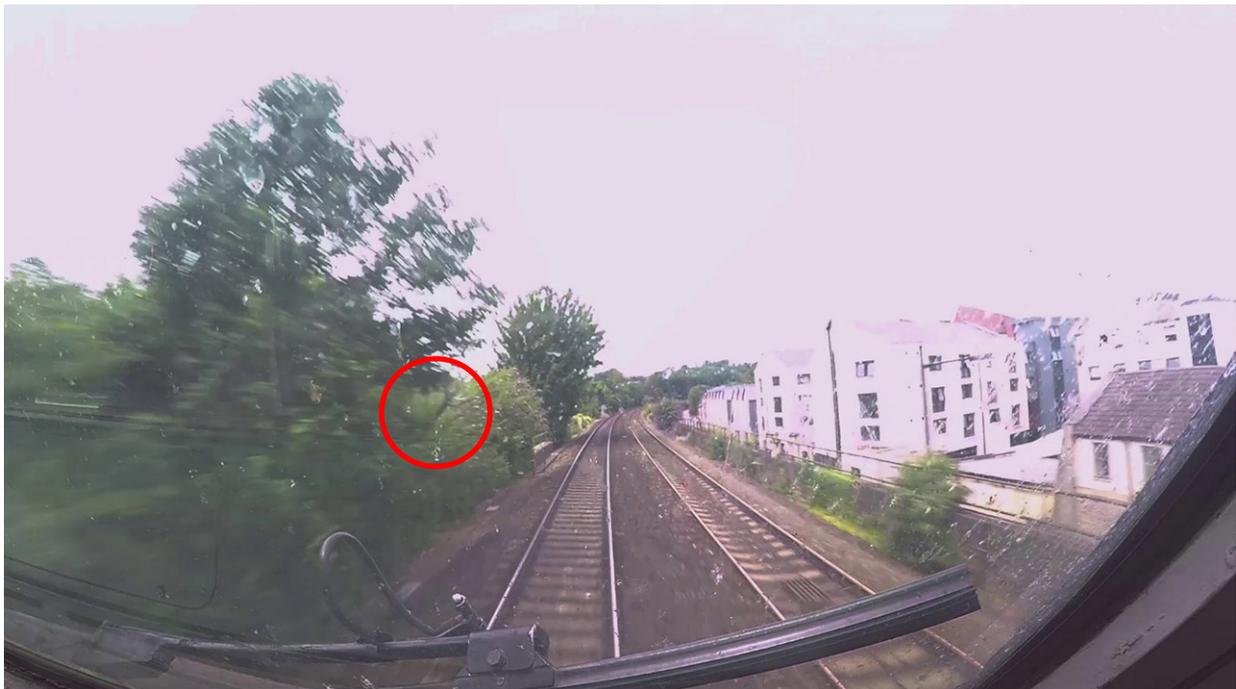
Figure 4: Forward Facing CCTV from July 2018, showing tree amongst growing vegetation (courtesy of Network Rail)

- 68 'Cab ride' inspections should be done at intervals of between 12 and 16 months. No issues were identified near Twerton from the last cab ride, undertaken on 22 July 2018. This inspection was video recorded. A post-accident review of the footage, paying particular attention to the accident location, revealed a dead tree branch amongst the green leaves of other trees. However, since this inspection was focussed on sighting and obstruction issues it would have been unusual if it identified the dead tree as a hazard.

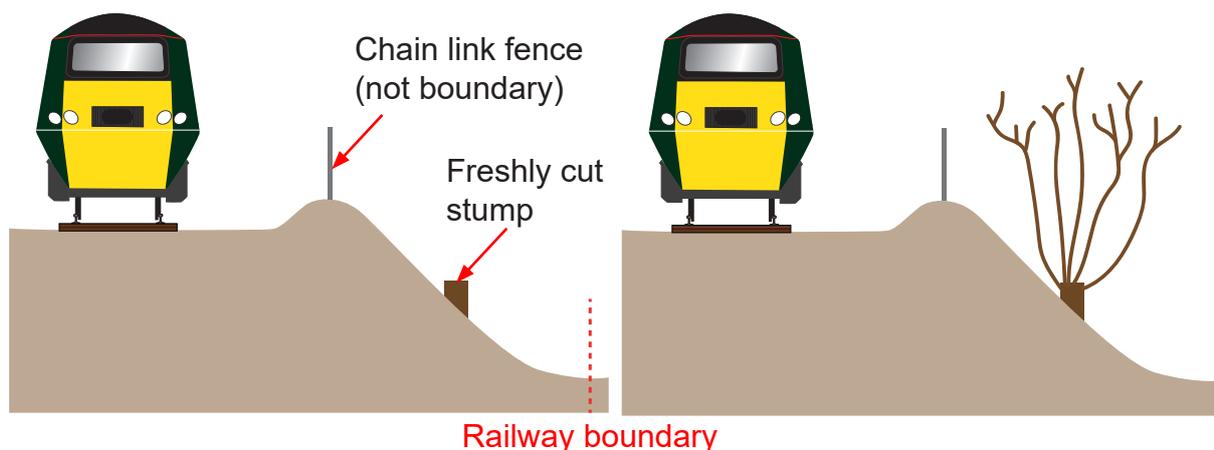
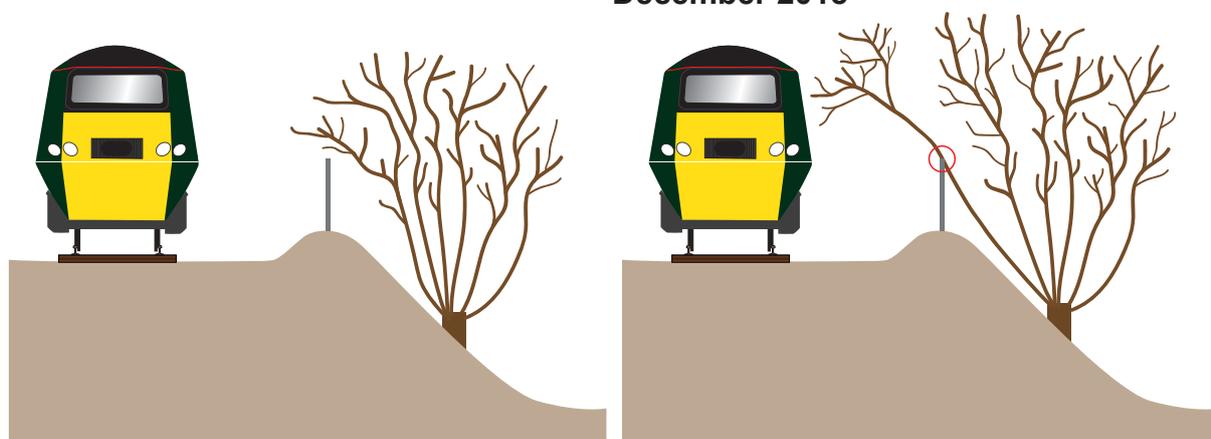
Figure 5: Tree history

- 17 The report describes how the tree was either felled or coppiced<sup>2</sup> around 1998 and after that seven stems grew out from the stump. Eventually the stump became colonised by two or three types of wood decay fungi which ultimately led to the failure of the stems. The stem involved then fell towards the railway, coming to rest on a chain link fence at the top of the embankment.

- 18 From a review of historical aerial photographs and video footage, the RAIB has concluded that the stem involved did not fail before 18 April 2015. However, by 4 February 2017, it had fallen and was resting on the fence with some branches extending out towards the railway line. The photographs and video footage also show that the tree remained largely unmoved in this position until at least late on the afternoon of the day of the accident. Given that the tree had been in this position for at least 22 months without moving significantly, it was not a particularly windy day and the RAIB is not aware of any other events that could have affected its position, the RAIB believes it is likely that it was still in that position at the time of the accident.

- 72 The arboricultural report commissioned by Network Rail after the accident reported that the stem involved was in poor health, growing from a severely decayed stump which had been colonized by readily visible fungal fruit bodies. The report states '*A competent inspection of the tree undertaken at any time since at least 2014 would have identified the decay and, from this time onwards, the fungal fruit bodies. The decay alone, confirms the tree to have been in hazardous condition for several years, and prior to January 2018 at least three stems would have been clear threats to the railway.*'

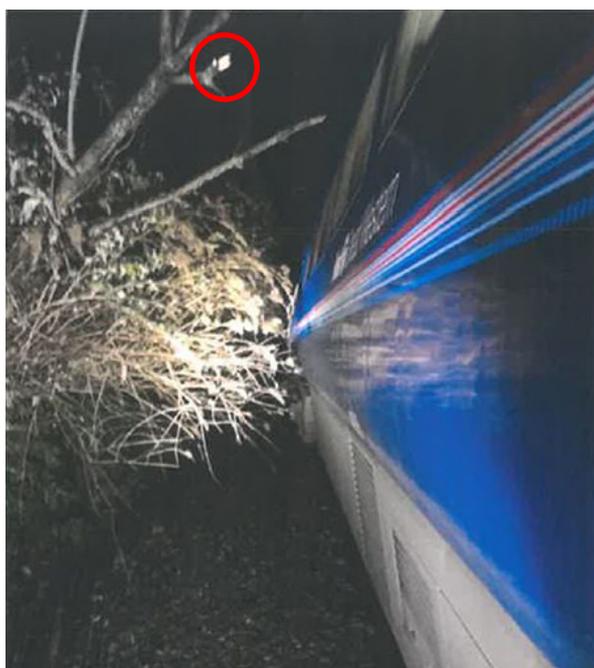
- 33 While at the scene, the MOM took photographs and recovered the branch. It is approximately 55 cm long and 4 cm in diameter. It was handed to the BTP which was subsequently able to confirm, by way of a forensic examination, that it was the branch that the passenger had come into contact with.

Figure 6: The train's proximity to the tree (courtesy of Network Rail)

- 34 The end of the branch that had been nearest the railway had marks consistent with having being sawn through. The cut was not recent and the RAIB was not able to determine when the branch had been cut. It is possible that it was done on 2 January 2018 when a tree in the vicinity was cut back after a train crew reported that their train had struck a branch in that area; no damage was reported to that train. The sawn branch end did not show any signs of having been in contact with trains.

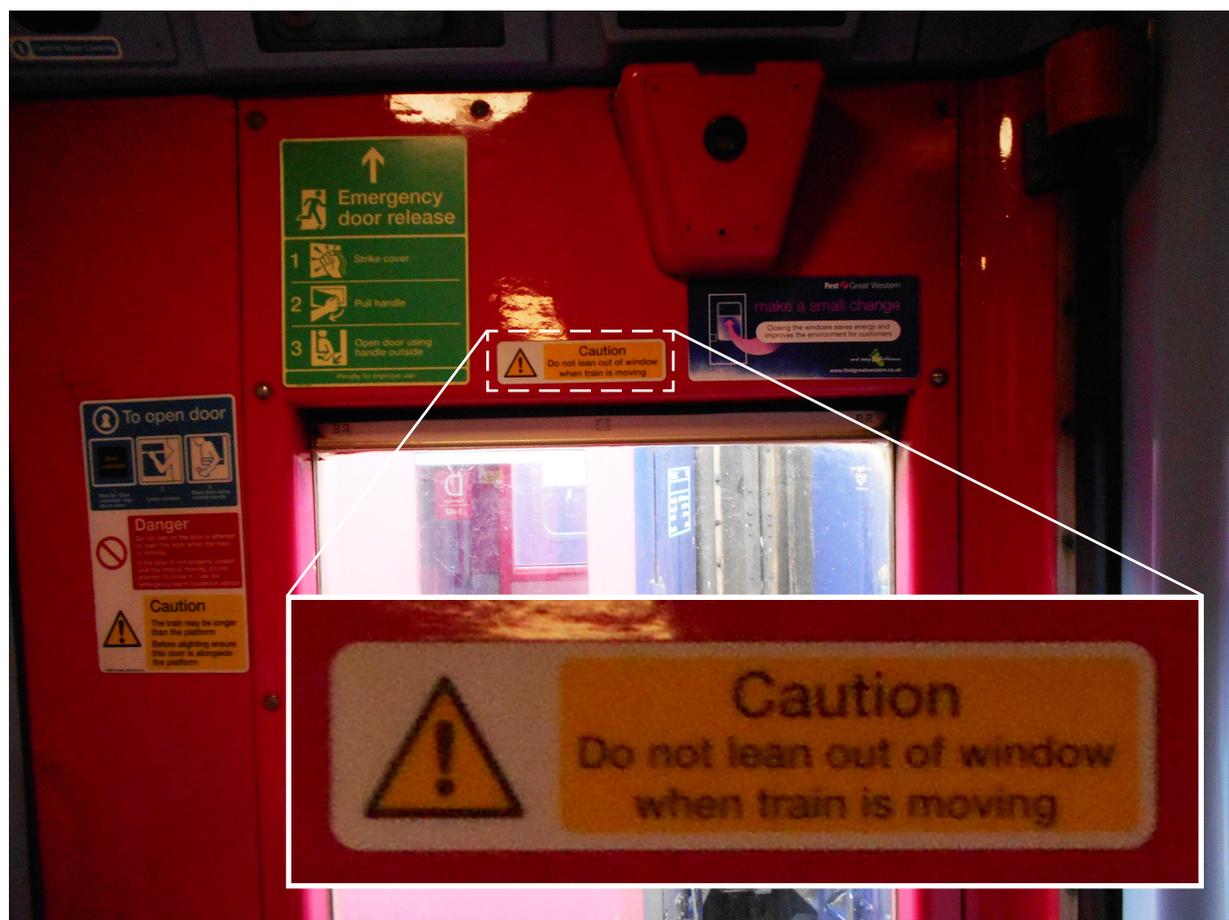
#### **42 The warning signs provided and their arrangement did not deter the passenger from leaning out of the window while the train was moving. Their design and content, although in accordance with industry guidance, did not maximise the chances of passengers being fully informed about the risk.**

43 The warning signs on display (figure 7) were fitted in 2007 following a refurbishment of the coaches. The signs relating to not leaning out of the window was the smallest of four signs on or around the door. One of the other related to the risks associated with trains stopping at short platforms and the dangers of leaning against or trying to operate doors while the train is moving. The other two related to emergency door operation and ventilation.

Figure 7: Warning signs (courtesy of the Office of Rail and Road)

- 44 The RAIB considers that the sign relating to the risk from leaning out of the window did not adequately convey the level of risk for the following reasons:
- the wording used, in particular the word ‘caution’<sup>6</sup>, suggests that leaning out of the train window is something that may be done safely if a degree of care or precautions are taken<sup>7</sup>;
  - the use of a yellow background to the sign is a recognised characteristic of a warning sign as opposed to the more appropriate use of a red background to convey danger or a prohibited activity<sup>8</sup>; and
  - the sign is much smaller than the other signs around it, one of which is not safety related.
- 45 It is not possible to say with any certainty whether the content, colour and size of the signs was a factor in this accident. Even prominent, clear warning signs are not guaranteed to be effective.

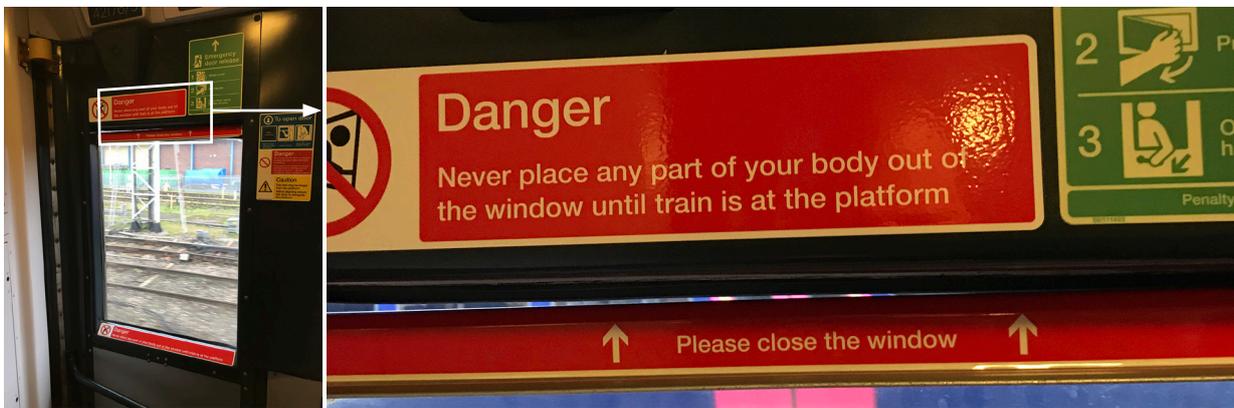
Figure 8: Photograph showing revised signage as fitted by GWR

- 103 As a direct result of this accident, GWR undertook a review of its risk assessment of the operation of Mk3 coaches with droplight windows. As a result, it implemented a series of measures intended to mitigate the associated risks in the interim period before they are eliminated. This included enhanced signage on doors (figure 8), train managers making announcements about the dangers of leaning out of open windows and briefing staff about challenging unsafe passenger behaviour and closing windows.
