Title: GUN 105MM FIELD, L118 TOWED.

AIR RESERVOIR CATASTROPHIC EXPLOSION

Report Reference No: SI/07/0232/SEFIT (A)

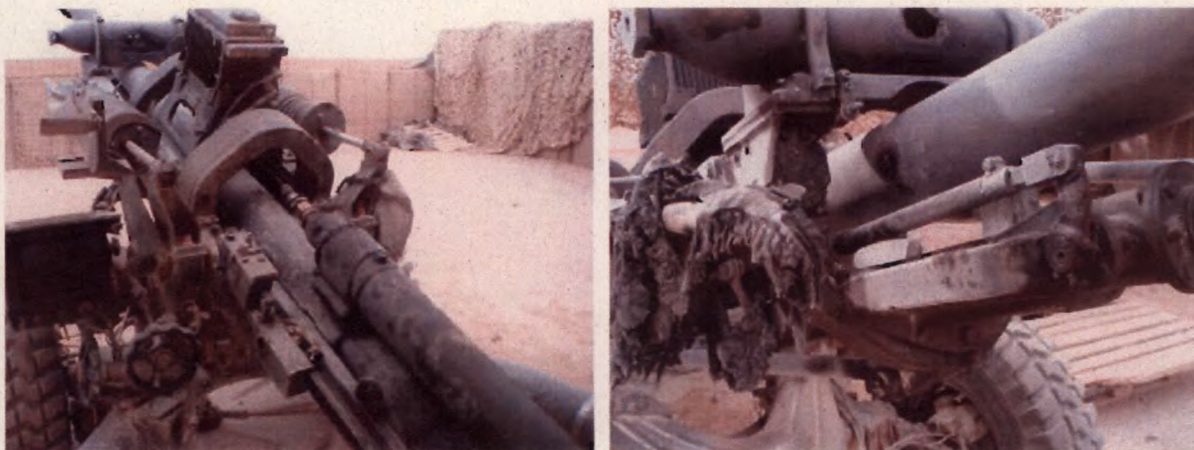
**Figure 2 – Fire and smoke damage**

8. **General.** There was significant cosmetic fire and smoke damage on most components (Figure 2) which were also subject to melted camouflage net droplets. The trailer assembly escaped any significant visible damage.

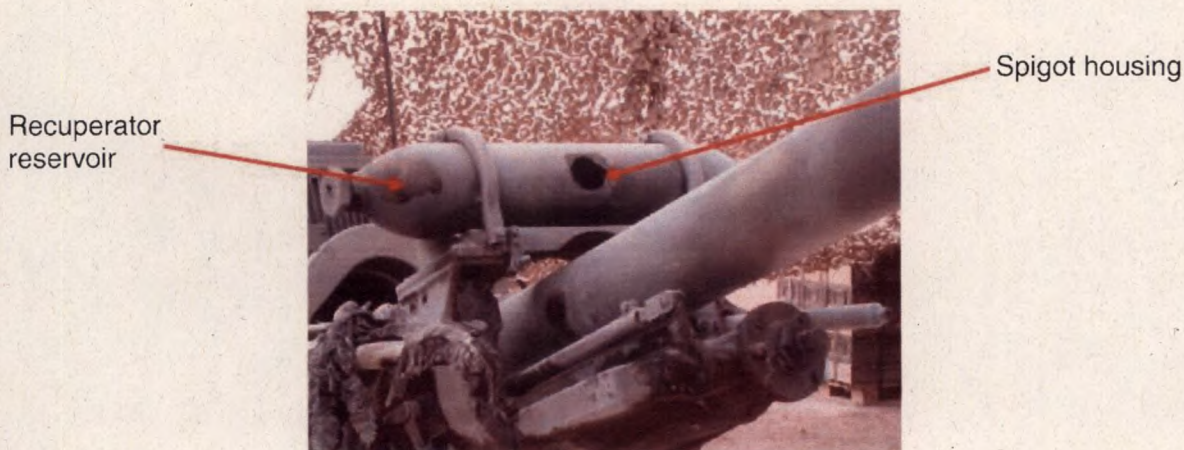
**Figure 3 – Recuperator reservoir front view**

9. **Recuperator reservoir.** The recuperator reservoir (Figures 3 – 6a) had suffered catastrophic damage. The forward end of the spigot had fractured and been forcefully ejected from the reservoir and was not recovered. Both left and right end screwed plugs were punctured on the end faces (Figs 5 and 5a) and in the areas of the screw threads and sealing washers (Figs 6 and 6a).

19. It is concluded that the catastrophic failure of the recuperator and reservoir system was due to the introduction of oxygen into the system thus providing the correct environment for combustion to take place.

- a. Issue an immediate priority signal to remind all users of the dangers of incorrect filling of high pressure systems.
- b. Produce an amendment to the AESP warnings and cautions to include the dangers of incorrect filling of high pressure systems.
- c. Record this incident with a view to monitoring future trends.

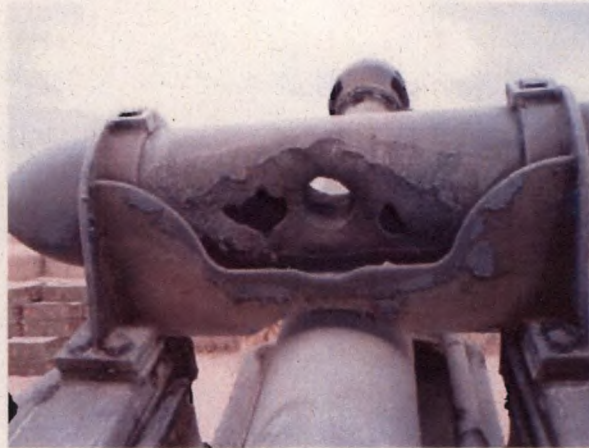
Figure 4 – Recuperator reservoir rear view

10. **Recuperator.** The recuperator piston rod (Figure 7) had been subjected to considerable forward force fracturing the spigot, compressing/disfiguring the brass jacking nut, and damaging the rear face of the reservoir (Figure 4). The piston rod anti-rotation washer was not recovered. There was impact damage at the rear of the recuperator where it had struck the breech ring assembly (Figure 8).

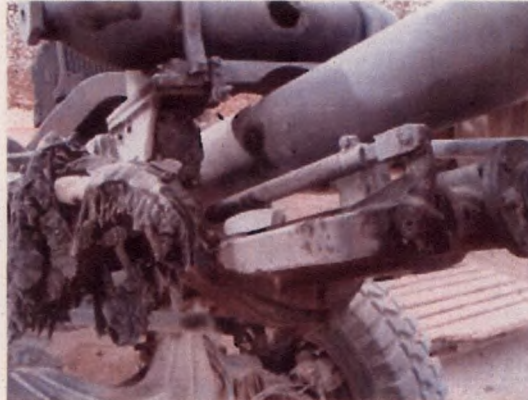
Figure 9 – Cut-off gear front rod assembly

11. **Cut-off gear assembly.** There was fire damage to the clamping rod, end cap and clamping screw (front rod). There was minor cosmetic damage to the bevel gearshaft lever, scale rod and fork ends (Figure 9). There was no significant visible damage to the rear connecting rod assembly.

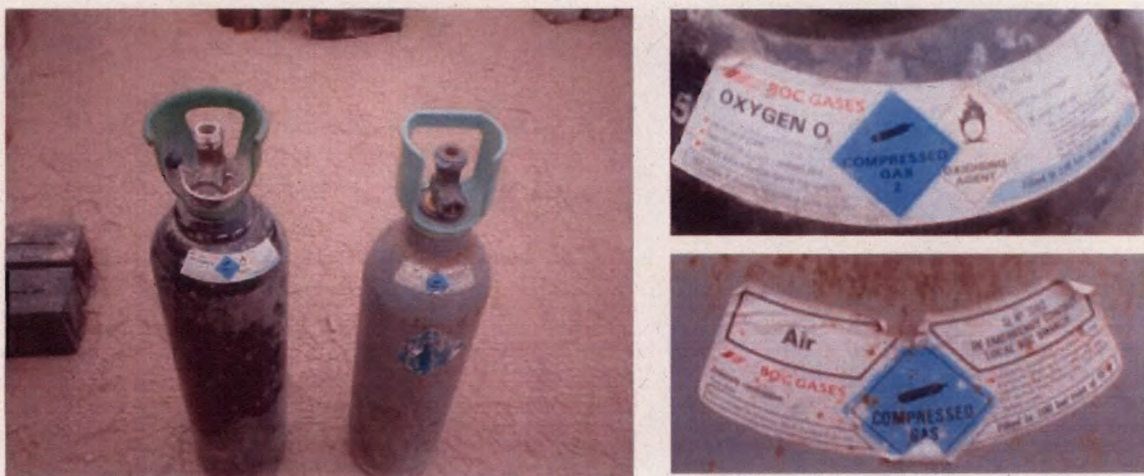
Figure 10 – Compressed air and oxygen bottles at location

14. Both oxygen and compressed air bottles (Figure 10) within the FOB were similar in size, colour and fittings (both accommodated the same pressure regulator). There was also excessive dust in the area. They were stored in the same location when not in use.

17. On inspection of the two types of bottle on site it is understandable how easy it would be to mistake them, particularly if it was assumed that all bottles were compressed air and considering the conditions at the time of use.

24. It is recommended that HQ NSC(A) SO3 Fuels (in conjunction with BFI):
- a. Review its procedures in the identification, marking and confirmation with recipient of all gas cylinders prior to issue.

- b. Complete the attached report response form and return it to SEFIT(UK) technical officer within 30 days.
25. It is recommended that 4 Regt RA:
- a. Review its processes regarding both the identification of all gas cylinders and confirmation of type and use with any recipient prior to issue.
