Wolfson Report No 2702 - Assessment of keel and associated structure of the sailing vessel
Tyger of London

Report No. 2702

Date : 4th June 2018
Compiled By : [REDACTED]
Verified By : [REDACTED]

Assessment of Keel and associated structure of Sailing Vessel ‘Tyger of London’

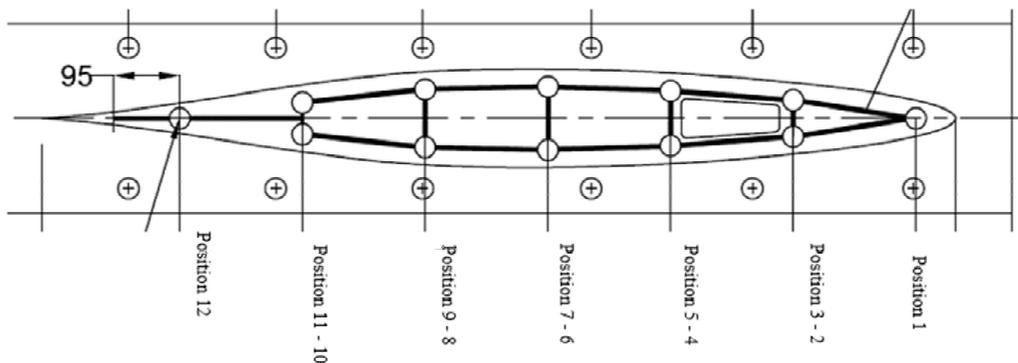
Figure 1 Keel rod locations

An assessment was also conducted with rods 6 and 7 removed this showed the ratio of compliance reduced below 1.0, indicating non-compliance with the standard. This does not mean that there would be a failure but indicates that the factors of safety are insufficient.

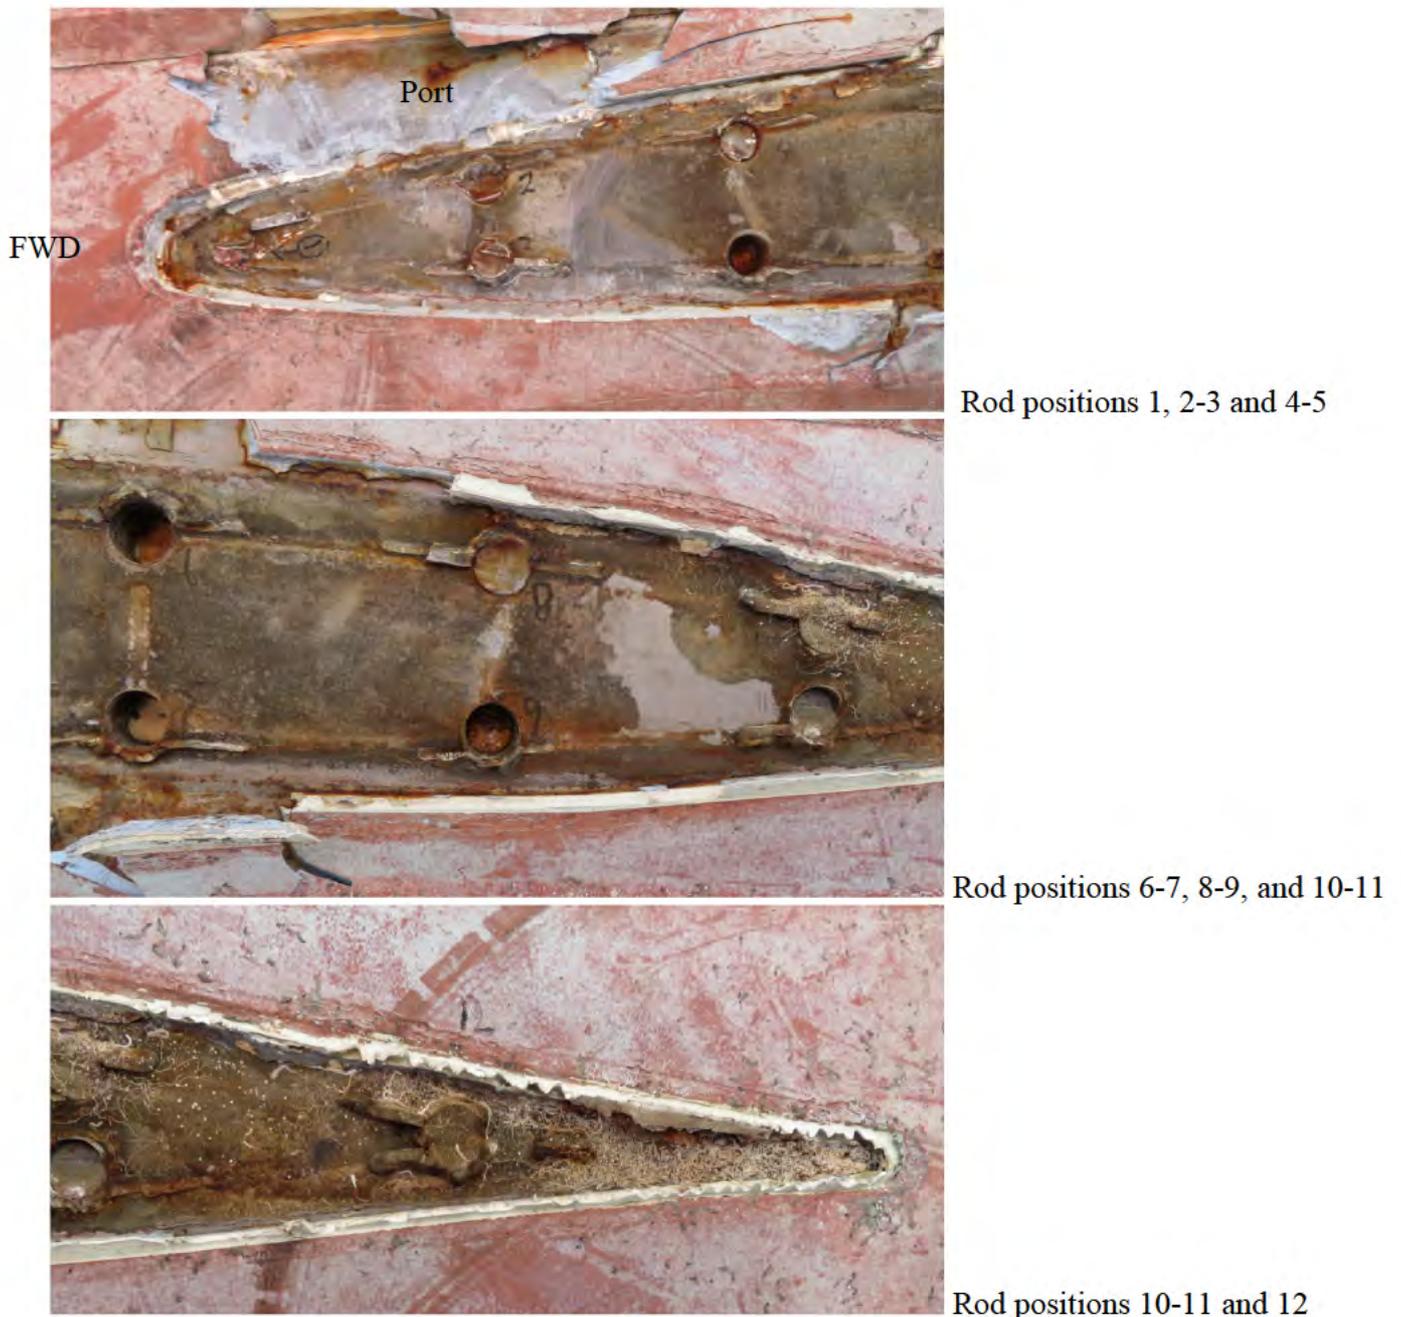
The as-received examination of the plate (shown in Figure 2) confirmed what had been previously reported by MAIB: all twelve fixing points had failed. Eight remnants of rod were present at positions 1, 2, 3, 4, 8, 10, 11 and 12. Within the center of the plate four positions were empty of any large rod remnants (5, 6, 7 and 9). Note 1 was at the FWD end and even numbered positions along the port side.

Figure 3: Overview images taken by MAIB.

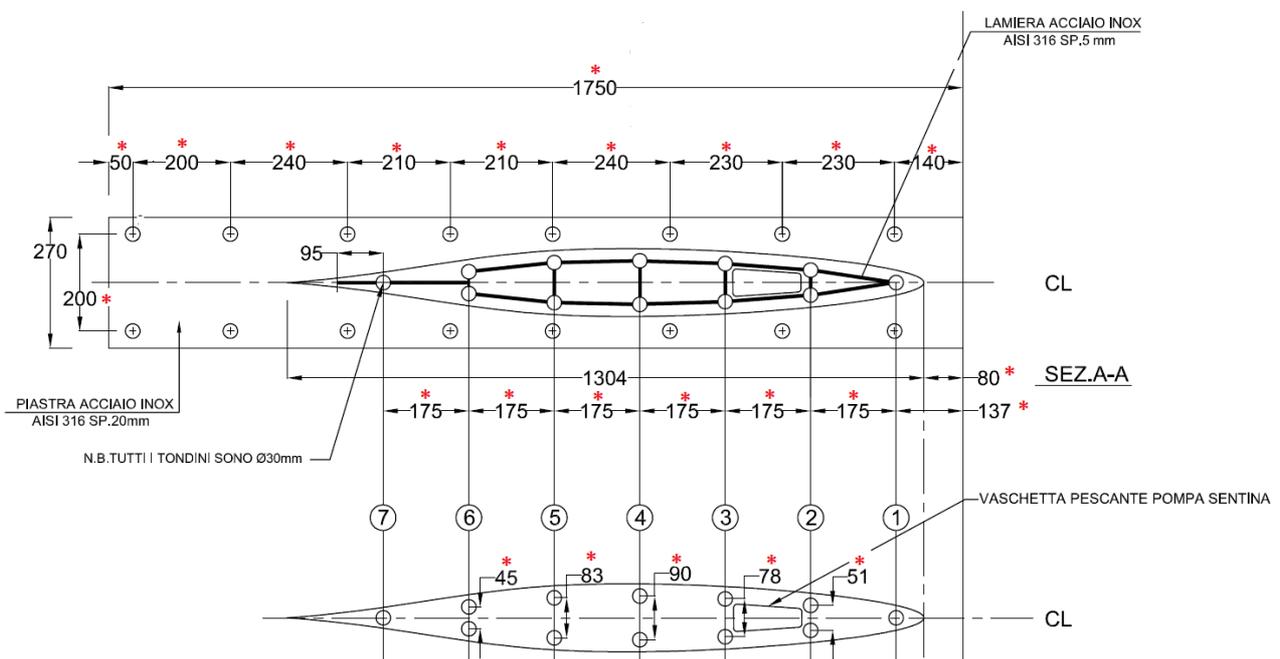
Key dimensions were measured and checked against the supplied drawings. It was noted that all the dimensions relevant to the construction of the keel were correct – see Figure 4. The expected arrangement of the stiffener plates (shown as thick black lines in Figure 4) was not as shown in the drawing, see Figure 7. Specifically it was noted that position 12 was welded to three stiffener plates not two.

Figure 4: Extract from supplied drawings. The sample has been measured. All the dimensions with a red * are ok. The thickness was measured at 21.22 mm instead of 20 mm. The width of the plate was measured as 257-260 mm instead of 270 mm as in the drawing.

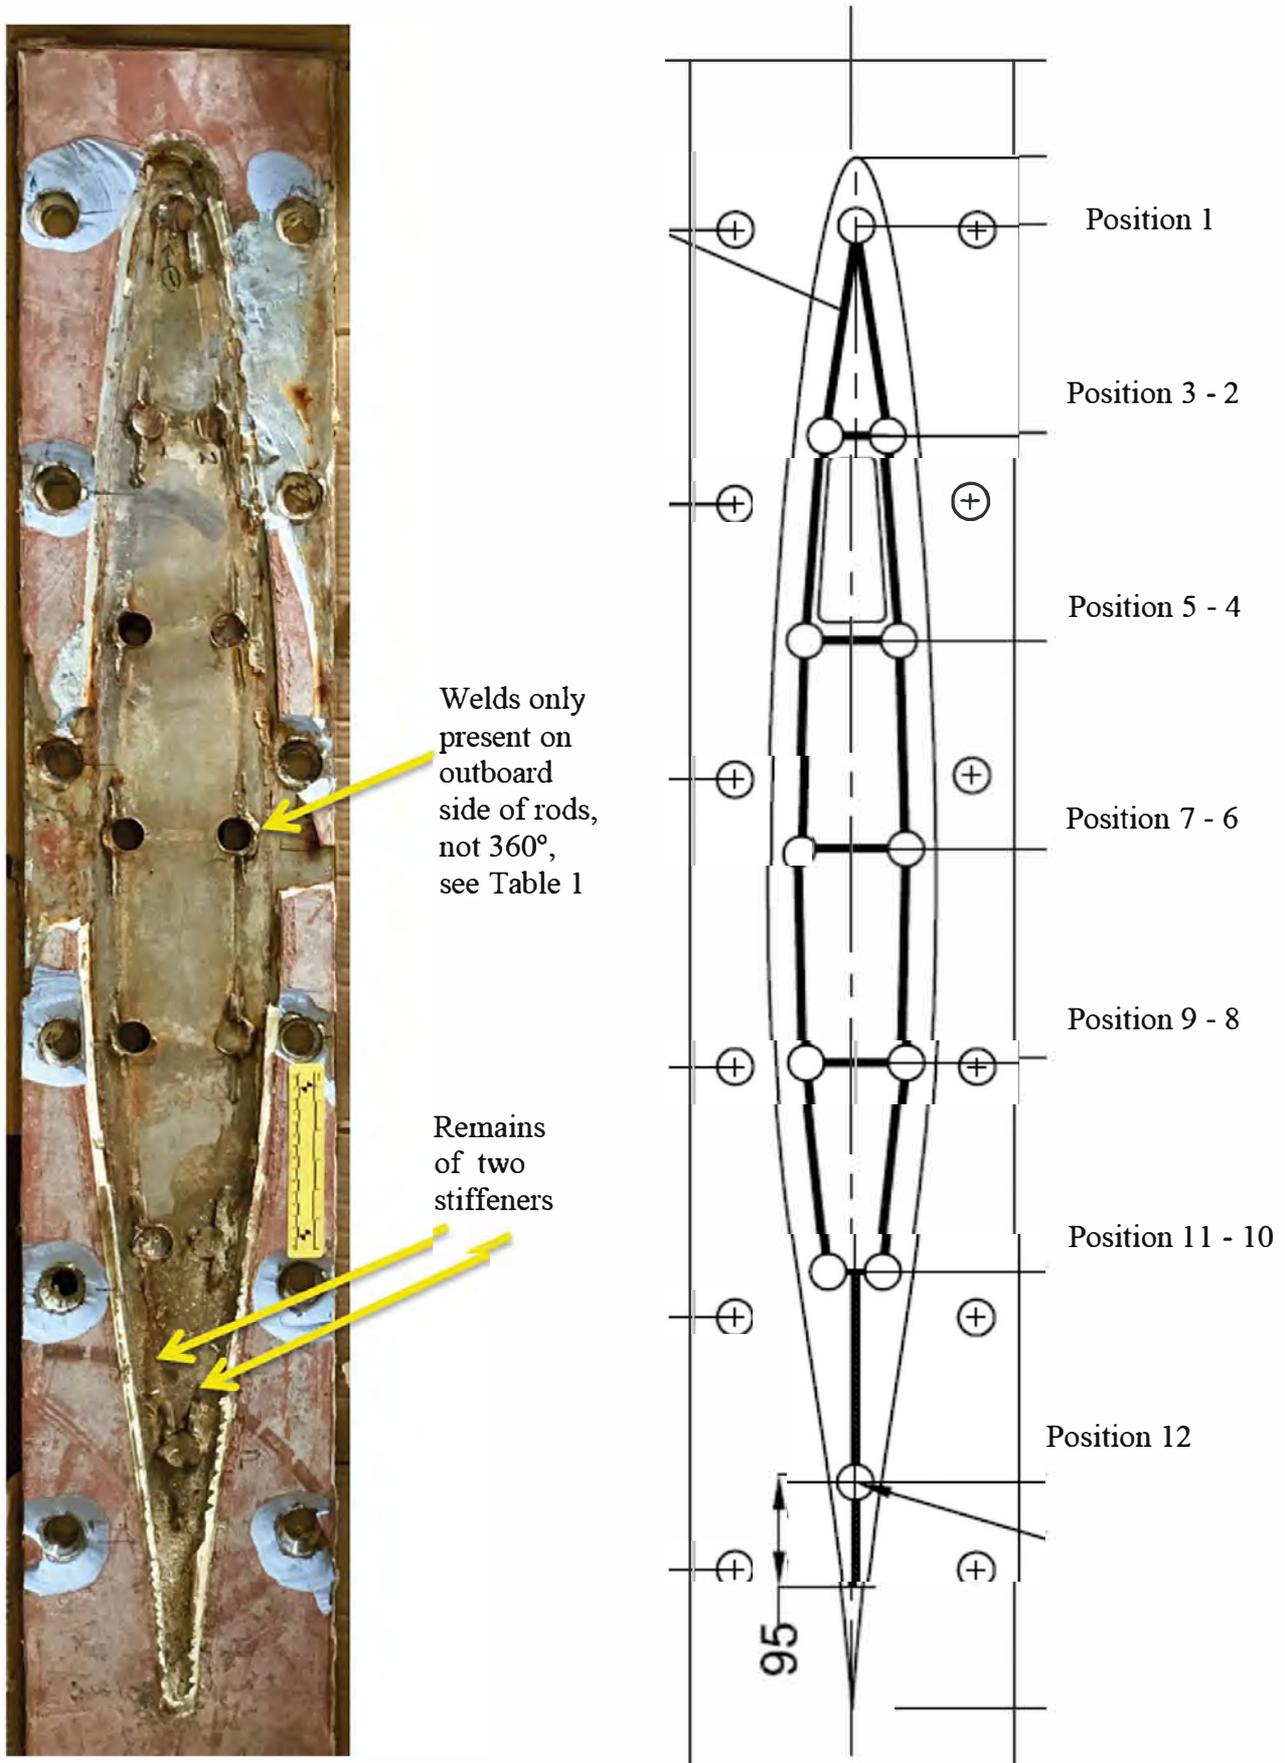
Figure 5: Image and drawing of plate. Note the different stiffener arrangement.

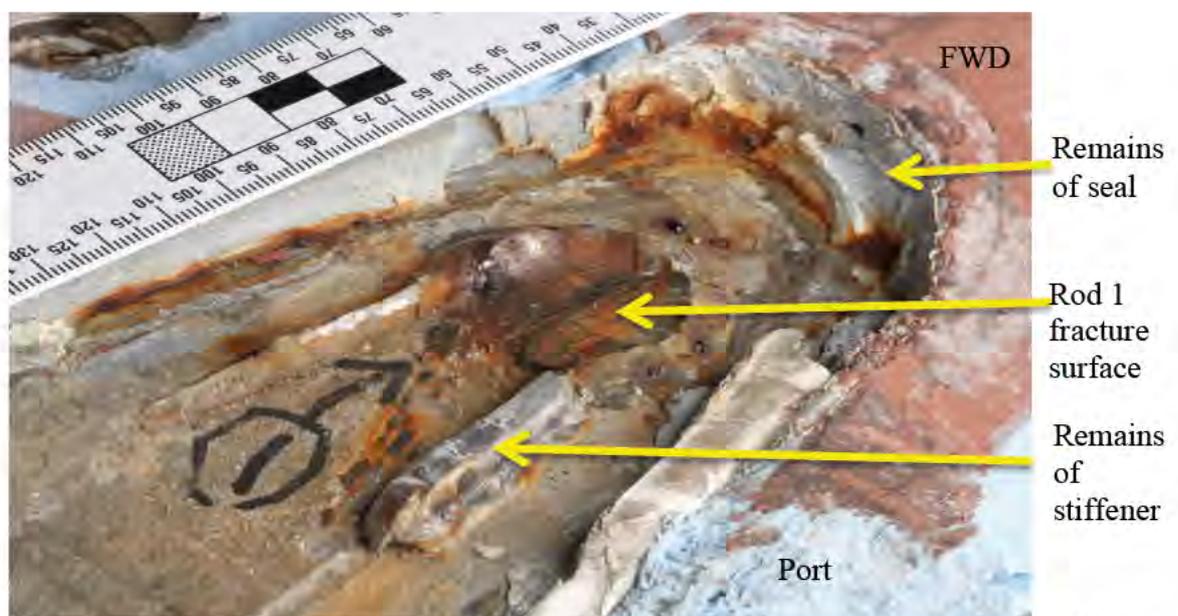
Examination of position 1 revealed that Rod 1 had failed by fatigue driven by a reverse bending cyclic load. In addition to the rod fracture, there was remains of a stiffener which had also failed in fatigue, the remains were 38.4 mm long and 5.6 mm above the plate face, see Figure 6.

Figure 6: Oblique view of the remnants of Rod 1, the forward most keel fixing point.

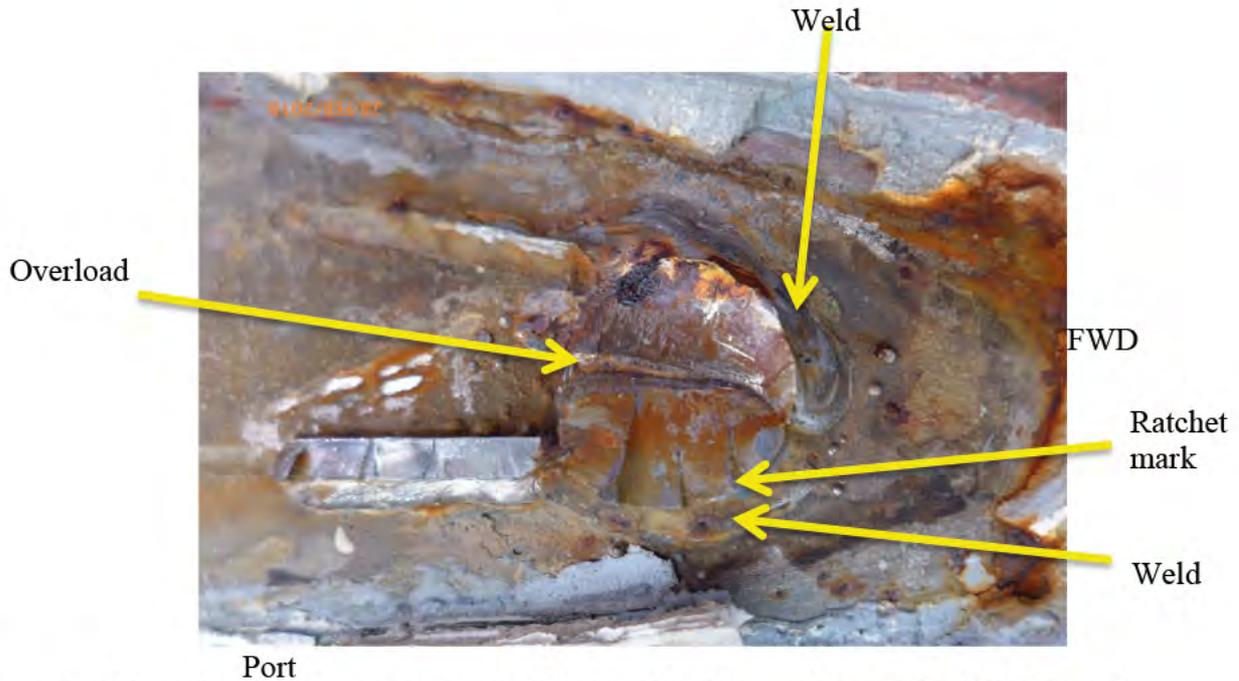
Rod 1 fracture surface had symmetry about the longitudinal axis, (Figure 7) with raised edges on the port and stbd welded sides (4.4 mm above the plate face). The center of the fracture surface displayed a line feature and was approximately level with the plate face. The shape, profile, roughness and features of the fracture surface indicate that fatigue initiated on the port and stbd sides of the rod at a location coincident to the edge of the weld. The number of ratchet marks indicates that there were multiple crack initiation points and therefore a large stress concentration was present around the circumference. The crack fronts propagated towards the centre of the rod until the loads present were great enough to overload the remaining cross-section of material. This area accounted for less than ten percent of the fracture surface indicating that the overall load at failure was low, suggesting a constant cyclic deflection (not contact stress).

Figure 7: Plan view of the remnants of Rod 1, the forward most keel fixing point.

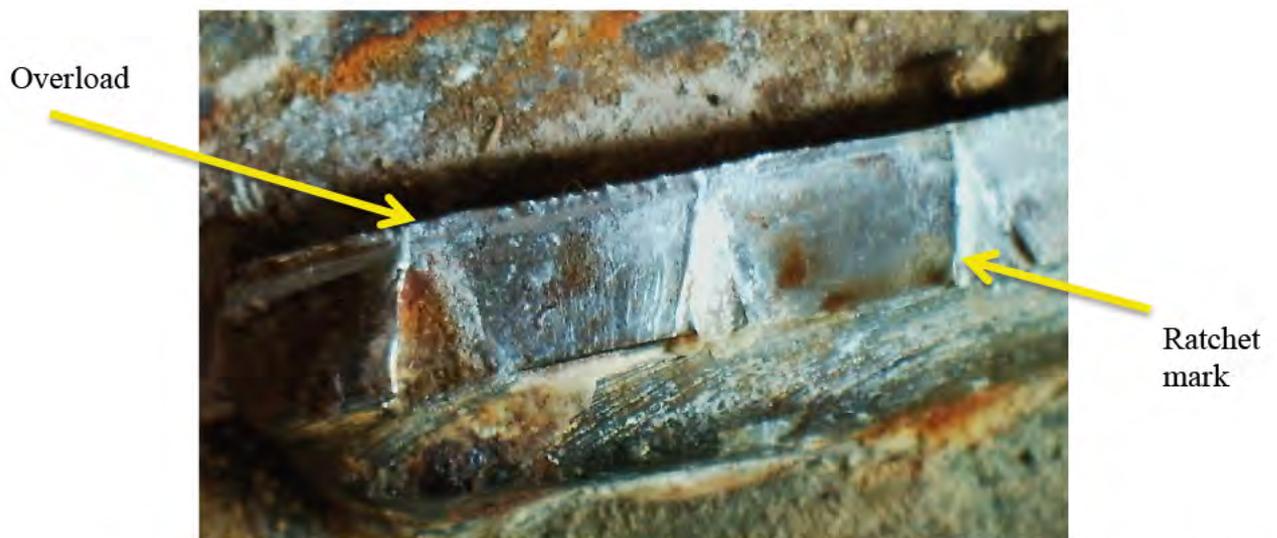
Higher magnification examination of the stiffener fracture surface (Figure 8) revealed evidence of a small overload region on the stbd side and several ratchet marks, confirming that it was subjected to the same loads as the rod and likely occurred at the same time. The lower level of corrosion on the stiffener is expected to be the result of material composition not exposure time.

Figure 8: Macroscopic image of the port-side stiffener fracture surface adjacent to Rod 1.

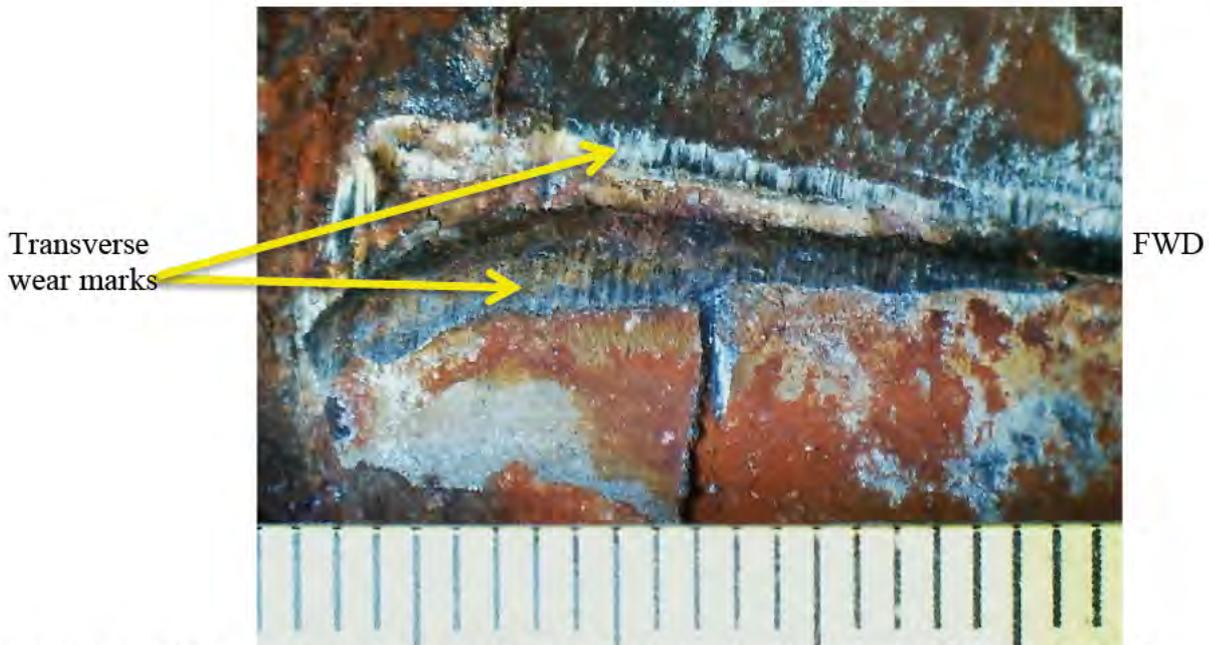
Higher magnification examination of the overload region of Rod 1 revealed that the surface had been worn back and forth in a transverse direction post fracture (Figure 9). Therefore the cyclic movement was still present after fracture. Therefore Rod 1 was not the last rod position to fail.

Figure 9: Macroscopic image of the central overload region of Rod 1. Note the material has been worn with transverse witness marks present.

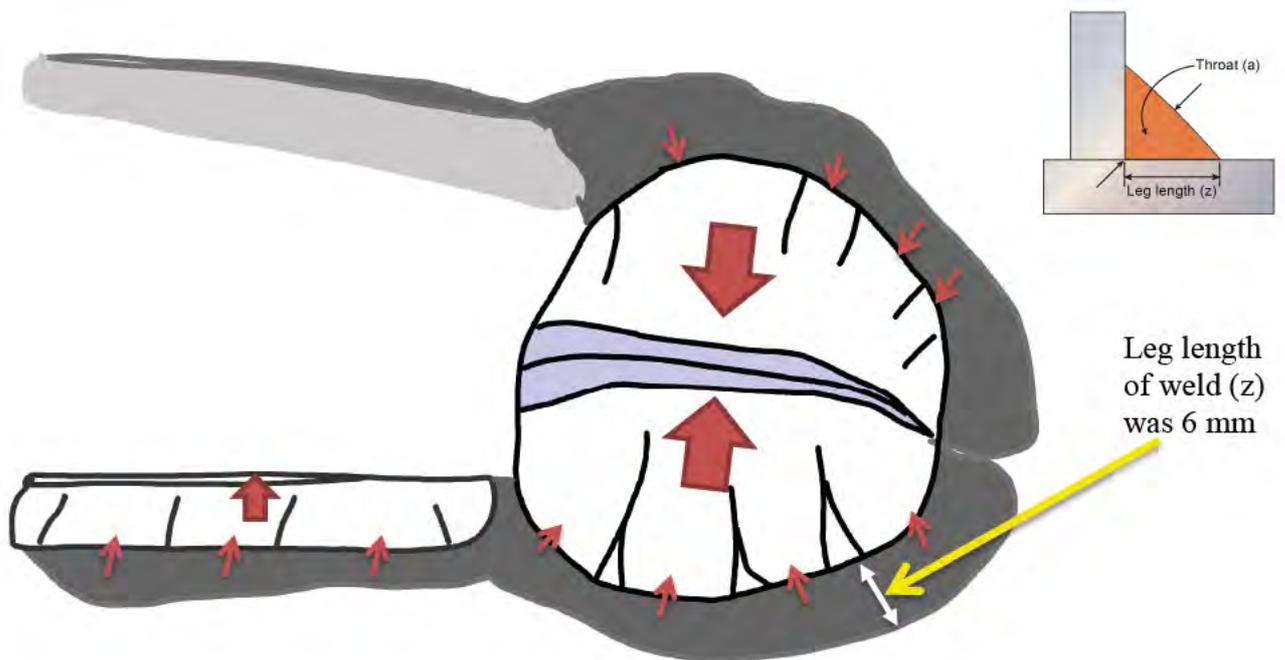
A schematic of the fracture of Rod 1 and the adjacent stiffener is shown in Figure 10. The figure highlights the key features of the fracture and also explains the weld leg length measurement.

Figure 10: Schematic of Rod 1 fracture. Small red arrows highlight the multiple initiation points at the weld/rod interface. The large red arrow identify the general direction of fatigue crack growth. Note the loading was reverse bending as two fatigue fractures grew towards the centre of the rod. Overload area is shown in blue. The leg length of the weld (insert provides mitre fillet weld schematic) was measured to be 6mm.

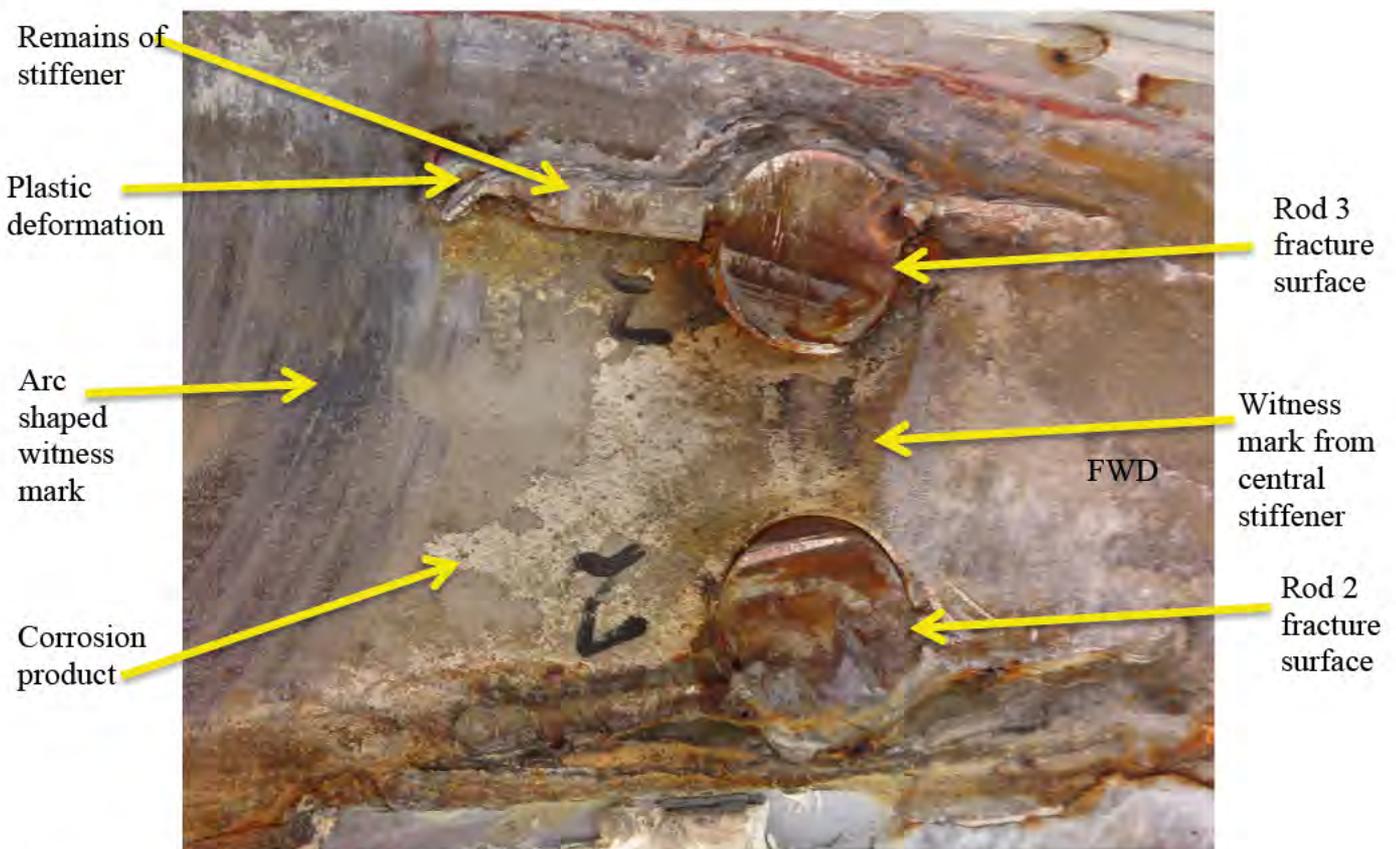
Examination of positions 2 and 3 revealed that both rods failed by fatigue: Rod 3 driven by unidirectional bending; Rod 2 by reverse bending. Co-located with the fracture of Rod 3, there were the remains of a stiffener which had also failed in fatigue; the remains were 37.4 mm long and 6 mm above the plate face, see Figure 11.

Figure 11: Showing remains of two rods at positions 2 and 3.

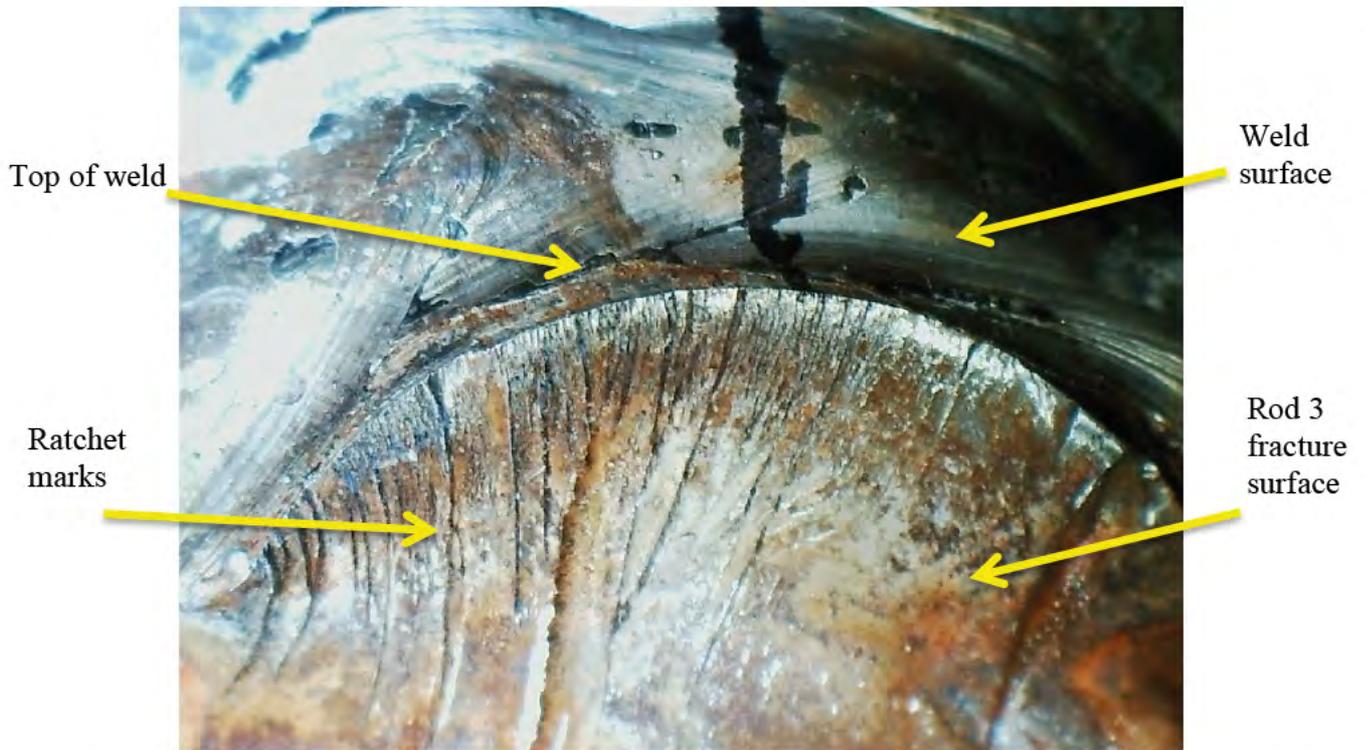
Rod 3 fracture surface initiated on the outboard (stbd) side of rod 4.9 mm above the plate face. The shape, profile, roughness and features of the fracture surface indicate that fatigue initiated at a location coincident to the edge of the weld (note the weld leg length was measured to be 6mm). The number of ratchet marks (shown in Figure 12) indicates that there were multiple crack initiation points and therefore a large stress concentration was present around the circumference. The crack propagated through the rod, beach marks (shown in Figure 13) recording the position of the crack front. There was no clear evidence of any overload region, indicating that the overall load at failure was low. The inboard side of the fracture was level with the plate face, the expected position of maximum stress with no weld present.

Figure 12: Macroscopic image showing multiple fatigue initiation sites (indicated by the ratchet marks) along edge of fracture at the weld/rod interface on the stbd (outboard) side of position 3.

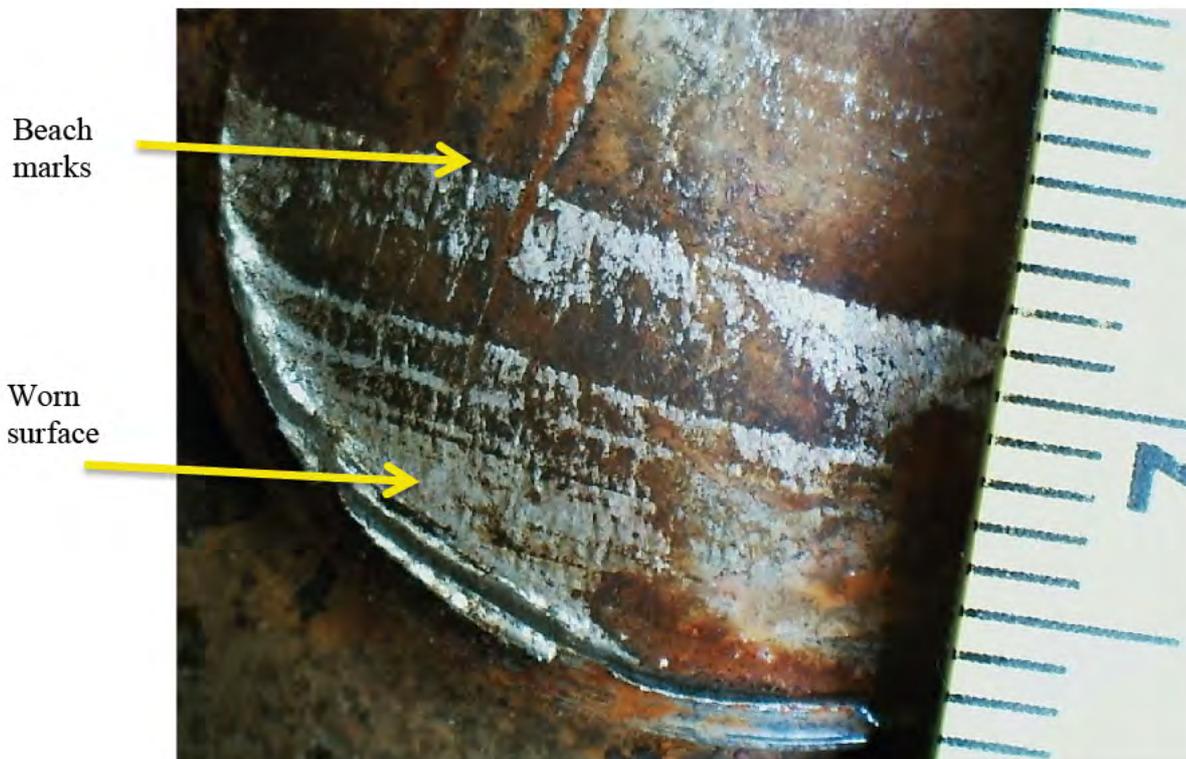
Figure 13: Macroscopic image showing beach marks (confirming fatigue) and a worn surface indicating sustained contact after fracture at position 3.

The inboard side of the Rod 3 fracture surface displayed evidence of wear, see Figure 13, suggesting that this was not the last rod to fracture, as the fracture surfaces remained in contact long enough to rub.

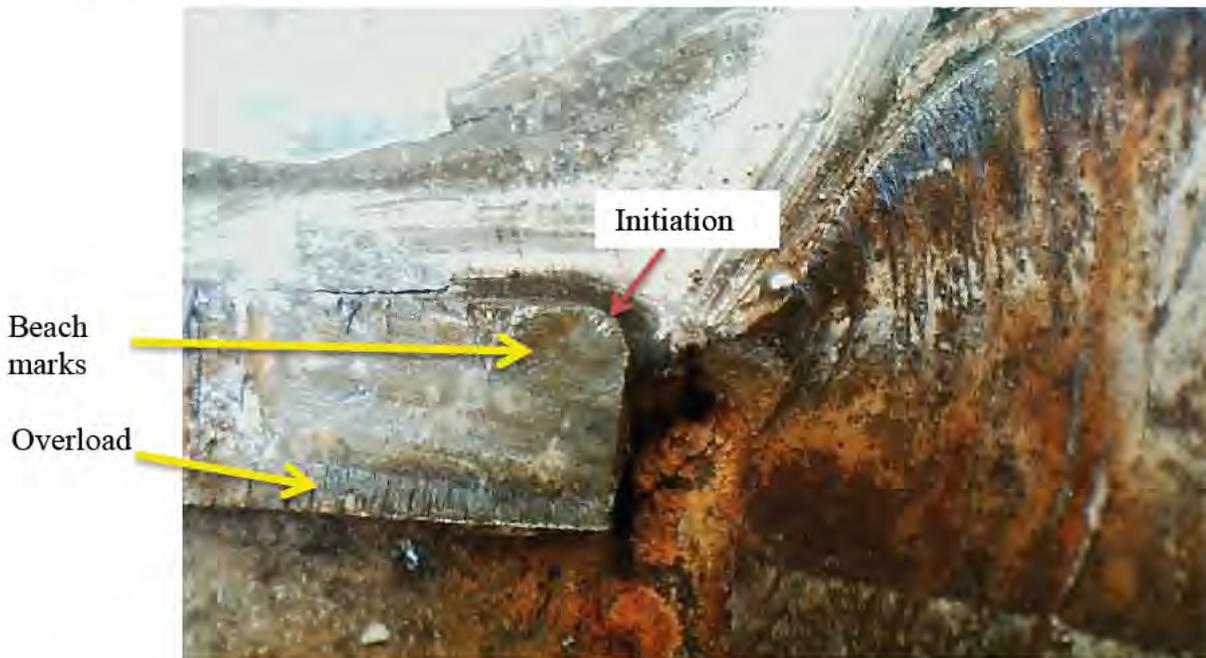
Examination of the failed stiffener at position 3, (shown in Figure 14) confirmed the local loading direction of unidirectional bending, forcing the crack to propagate in an inboard direction initiated at multiple points at the weld interface. An arc shaped witness mark and plastic deformation of the stiffener remains (both highlighted in Figure 11) likely occurred as the keel detached.

Figure 14: Macroscopic image showing beach marks and overload confirming fatigue initiation and direction within the fractured stiffener associated with position 3.

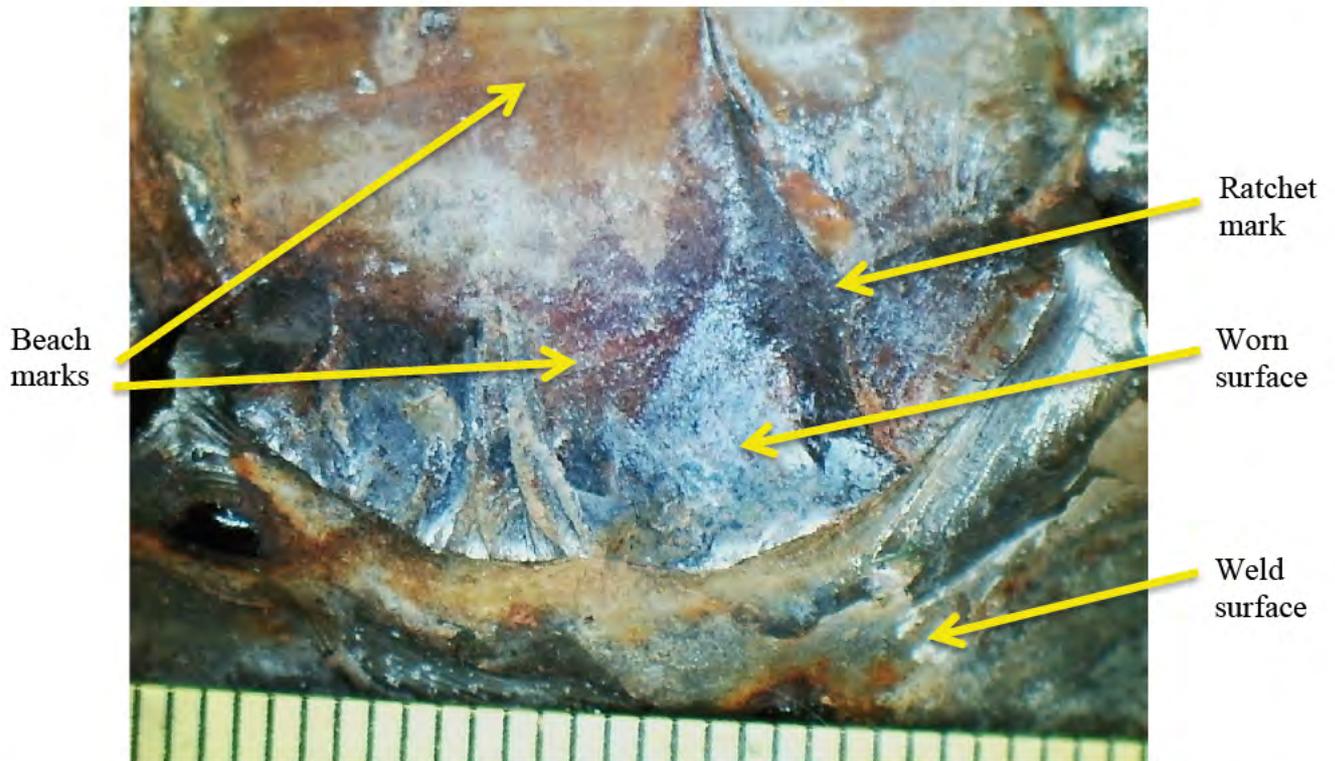
Rod 2 fracture surface had two opposing crack fatigue crack fronts, indicating reverse bending loads. The largest crack initiated at multiple points along the weld line (5.8 mm above the plate face) on the outboard side of the rod, as shown by the presence of the ratchet marks (see Figure 15). The weld leg length was measured to be 6mm. Beach marks confirmed the direction of crack propagation, which ended at the overload zone as shown in Figure 16. A second smaller fatigue crack was also present, on the inboard side of Rod 2 in the plane of the plate face. The presence of the small fracture suggests that this crack was only initiated after complete fracture of Rod 3. Wear of the outboard side of the Rod 2 fracture surface (Figure 15) and the wear of the overload region (Figure 16) confirmed that Rod 2 was not the last rod to fail. A schematic of the Rod 2 and 3 fractures are shown in Figure 17.

Figure 15: Macroscopic image highlighting the presence of beach marks tracking back to multiple origins along the outboard side of Rod 2 at the rod weld interface.

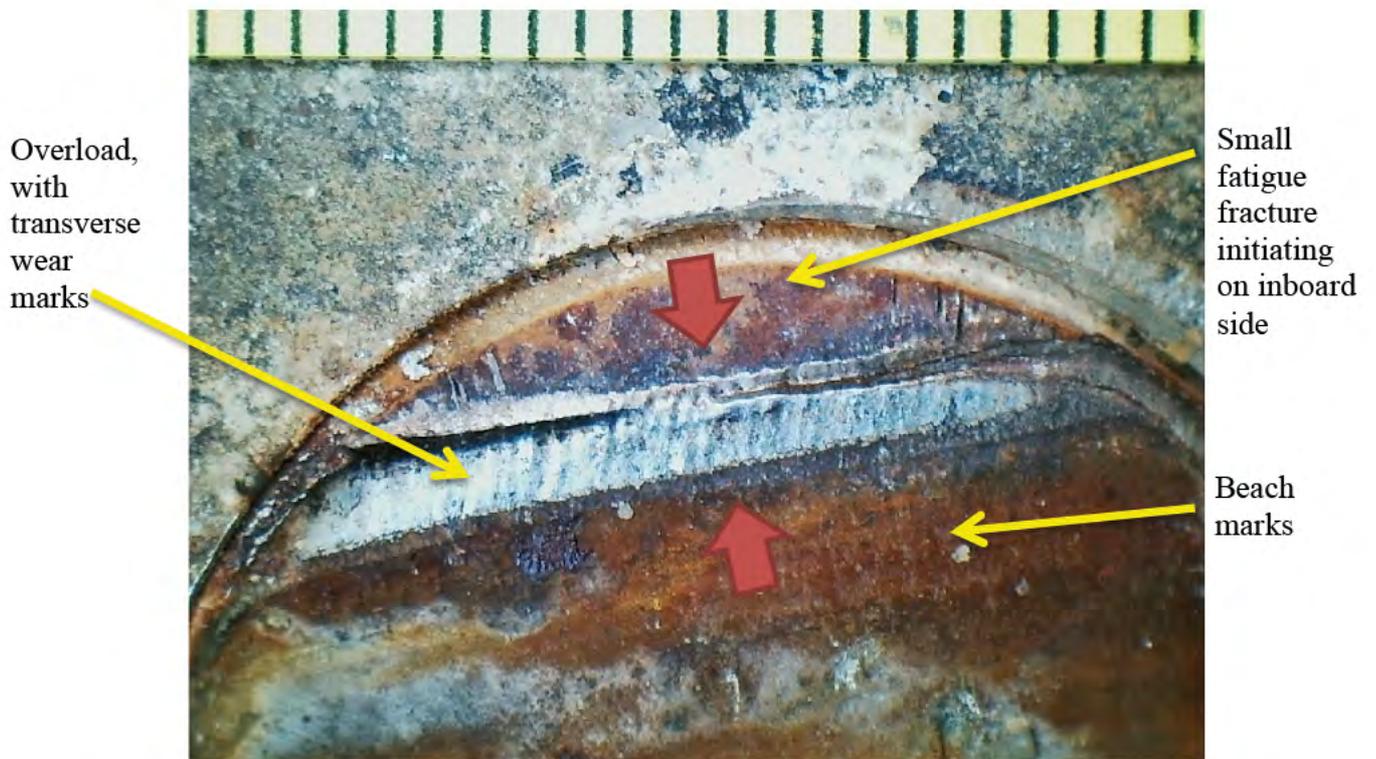
Figure 16: Macroscopic image showing the two fatigue fronts meeting in a band of overload . Note the overload area is heavily worn. Rod 2.

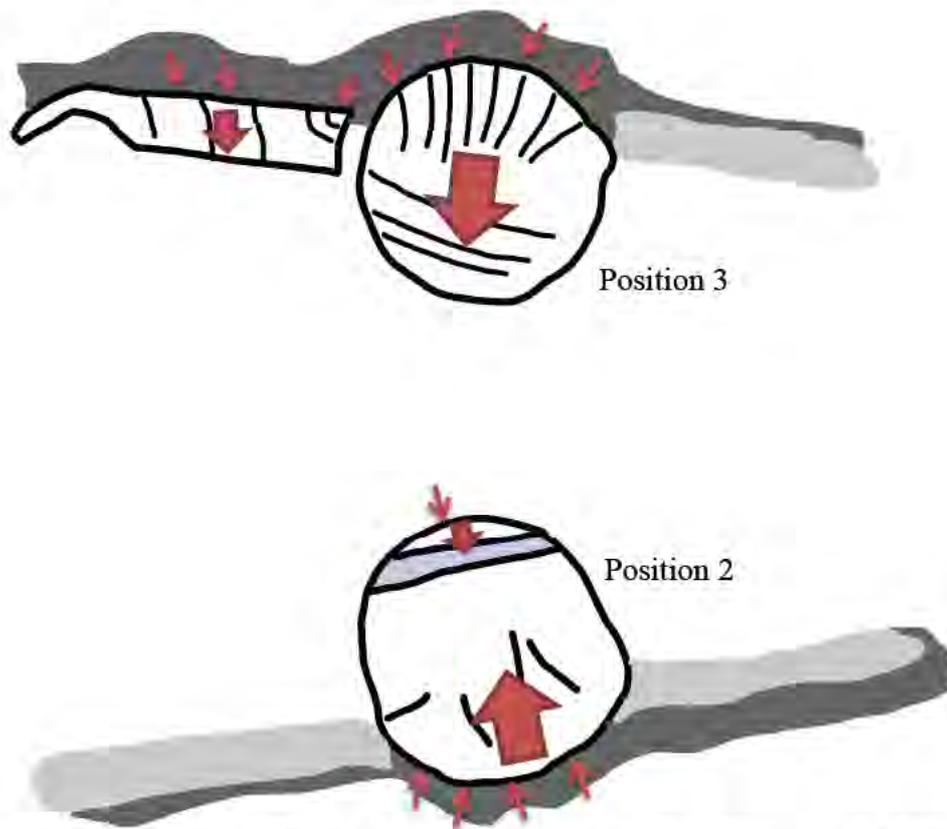
Figure 17: Schematic of Rod 2 & 3 fractures. Small red arrows highlight the multiple initiation points at the weld/rod interface. The large red arrow identify the general direction of fatigue crack growth. Overload area is shown in blue.

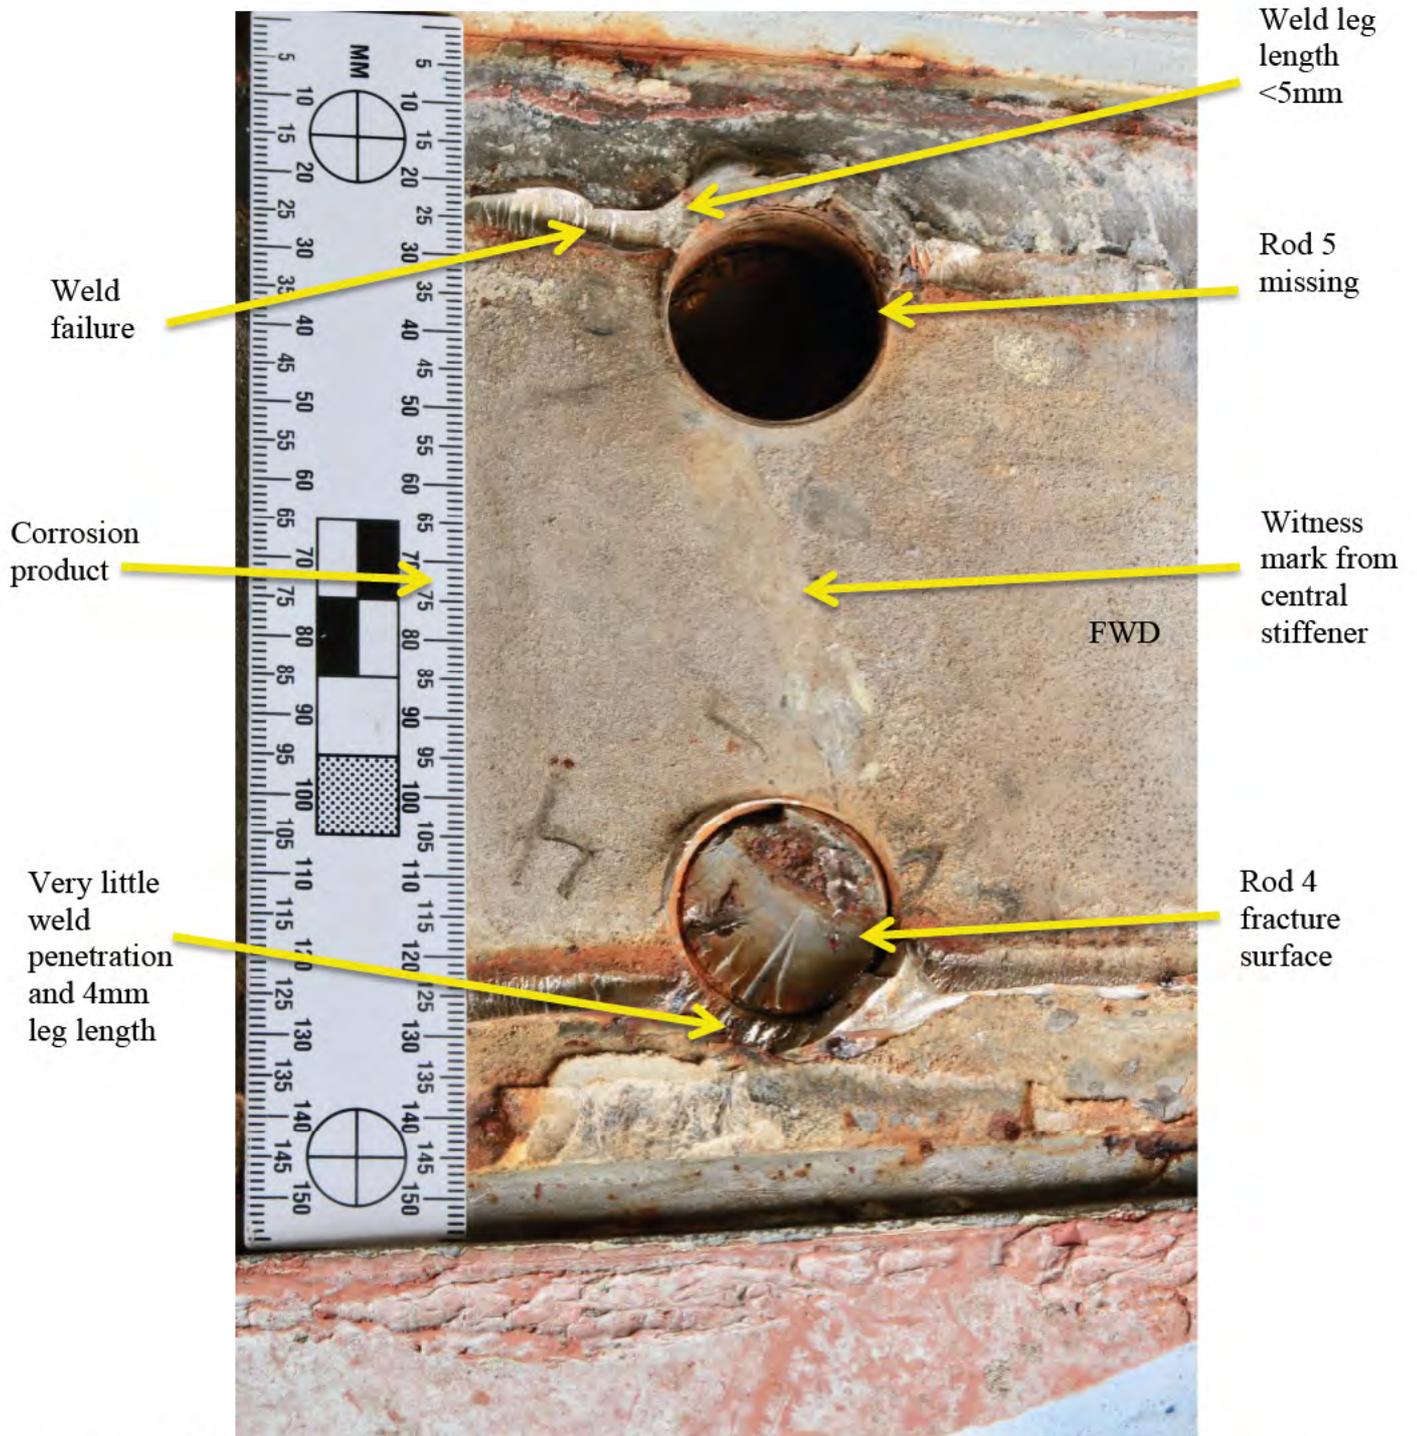
Examination of position 4 and 5 revealed that Rod 5 was missing and Rod 4 failed by fatigue (Figure 18) driven by off-axis (not aligned with the side keel loads) unidirectional bending or tension-tension loading. The weld leg lengths were found to be < 5mm.

Figure 18: Showing remains of rod at positions 4 and the vacant hole at position 5.

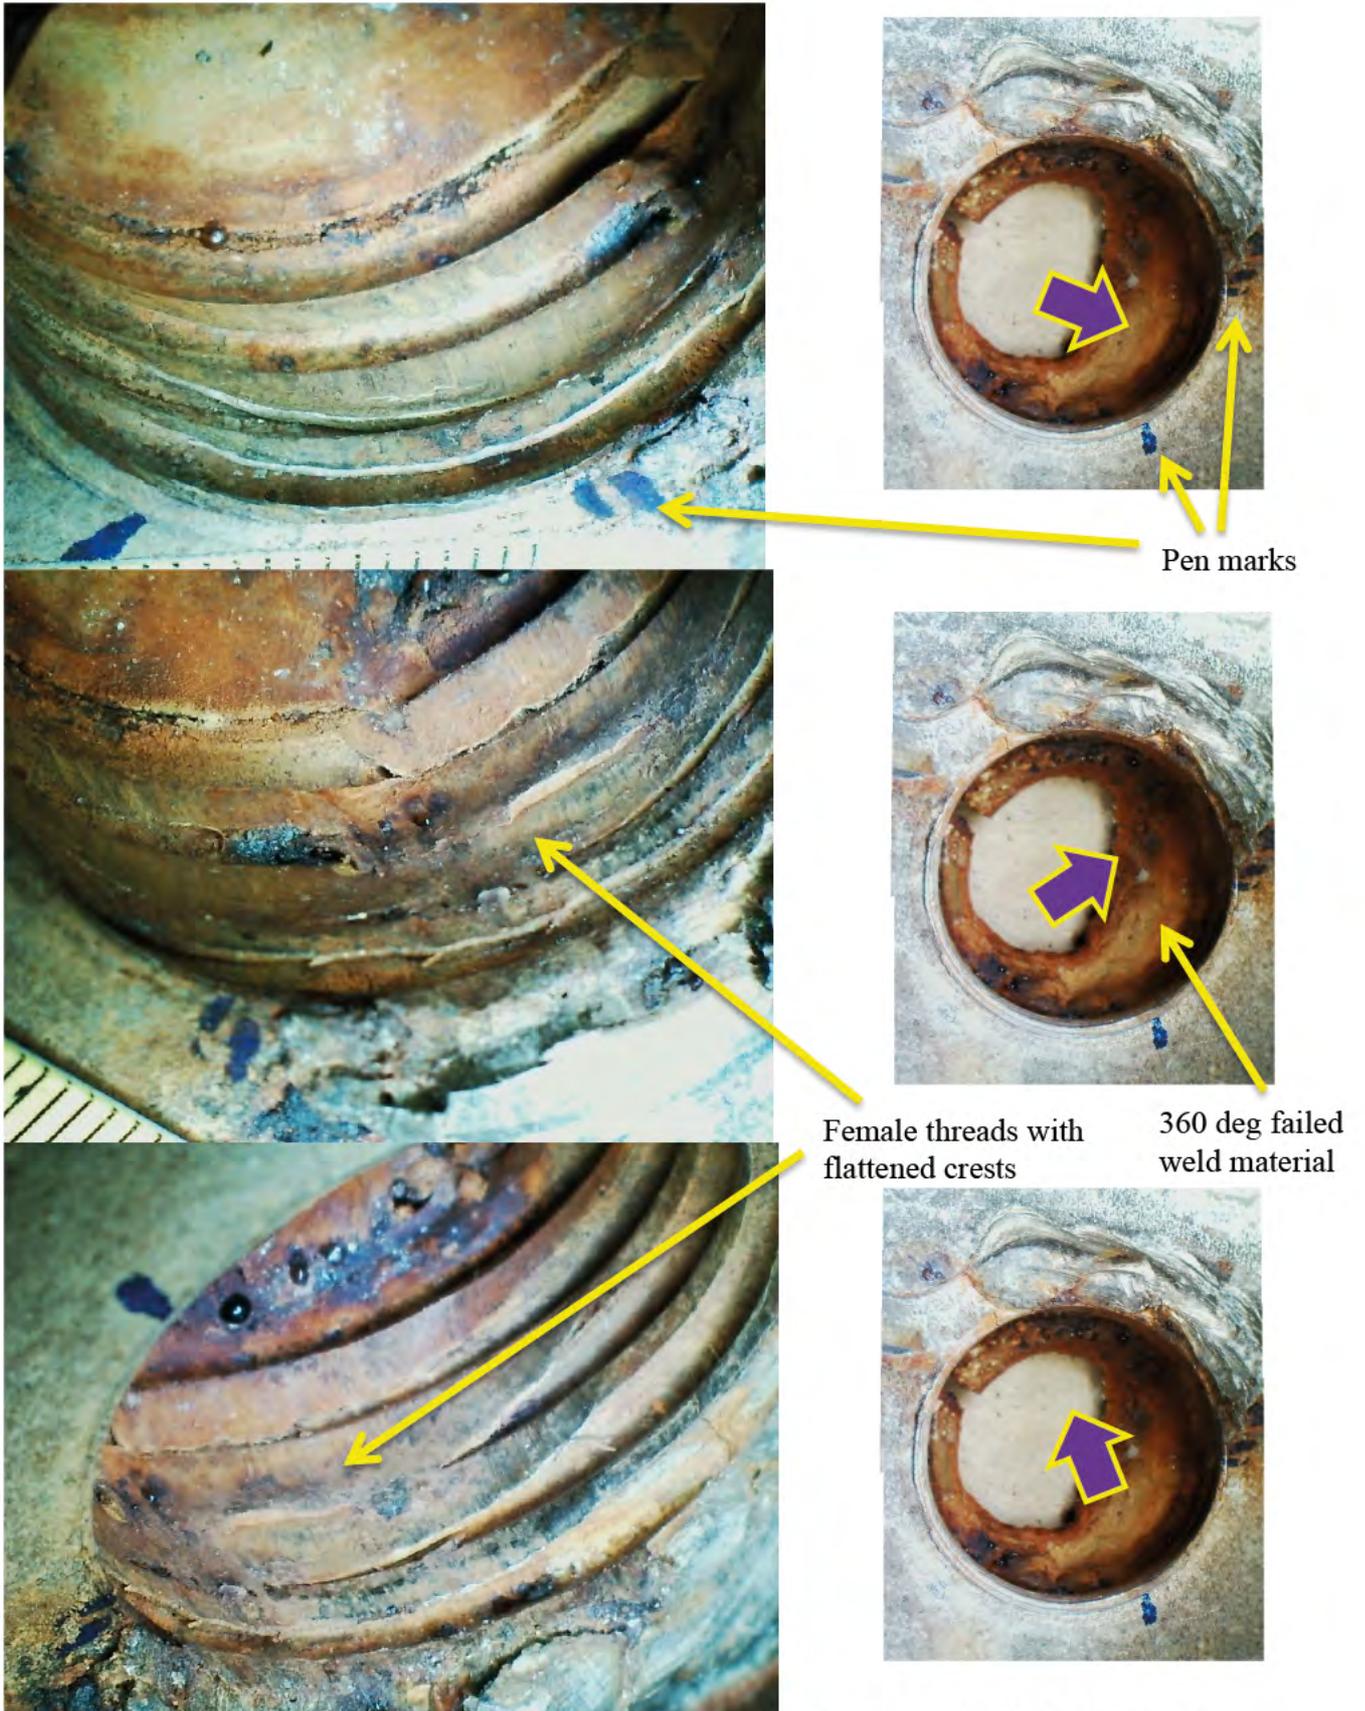
The threaded hole at position 5 was examined from the side shown in Figure 18 (upwards relative to its original position on the yacht). Figure 19 shows three views of the FWD side of hole, where it was noted the crests of the threads had been plastically deformed and ‘smeared’ in a direction consistent with loaded removal of the rod, see Figure 20. No evidence of the rod threads was observed. The remaining circumference of the threaded hole was in serviceable condition, i.e. the threads were still present.

Figure 19: Showing three views within the vacant female threaded hole in the plate at location position 5. Note the forward side of the hole was heavily worn. Evidence of 360 degree weld on 'top' face of plate.
