Wolfson Report No 2702 - Assessment of keel and associated structure of the sailing vessel
Tyger of London

Report No. 2702

Date : 4th June 2018
Compiled By : [REDACTED]
Verified By : [REDACTED]

Assessment of Keel and associated structure of Sailing Vessel ‘Tyger of London’

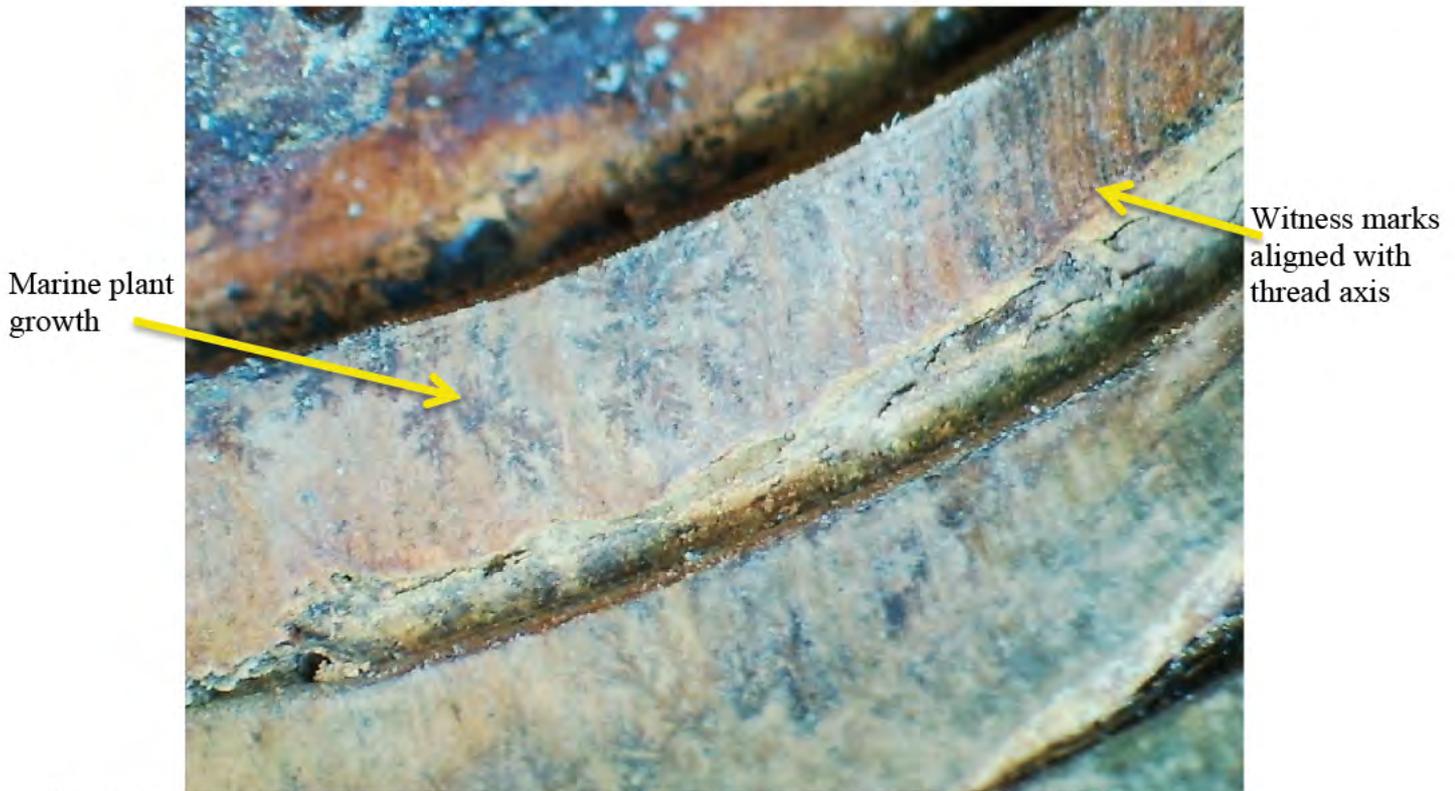
Figure 20: Higher magnification view of the lower image shown in Figure 19.

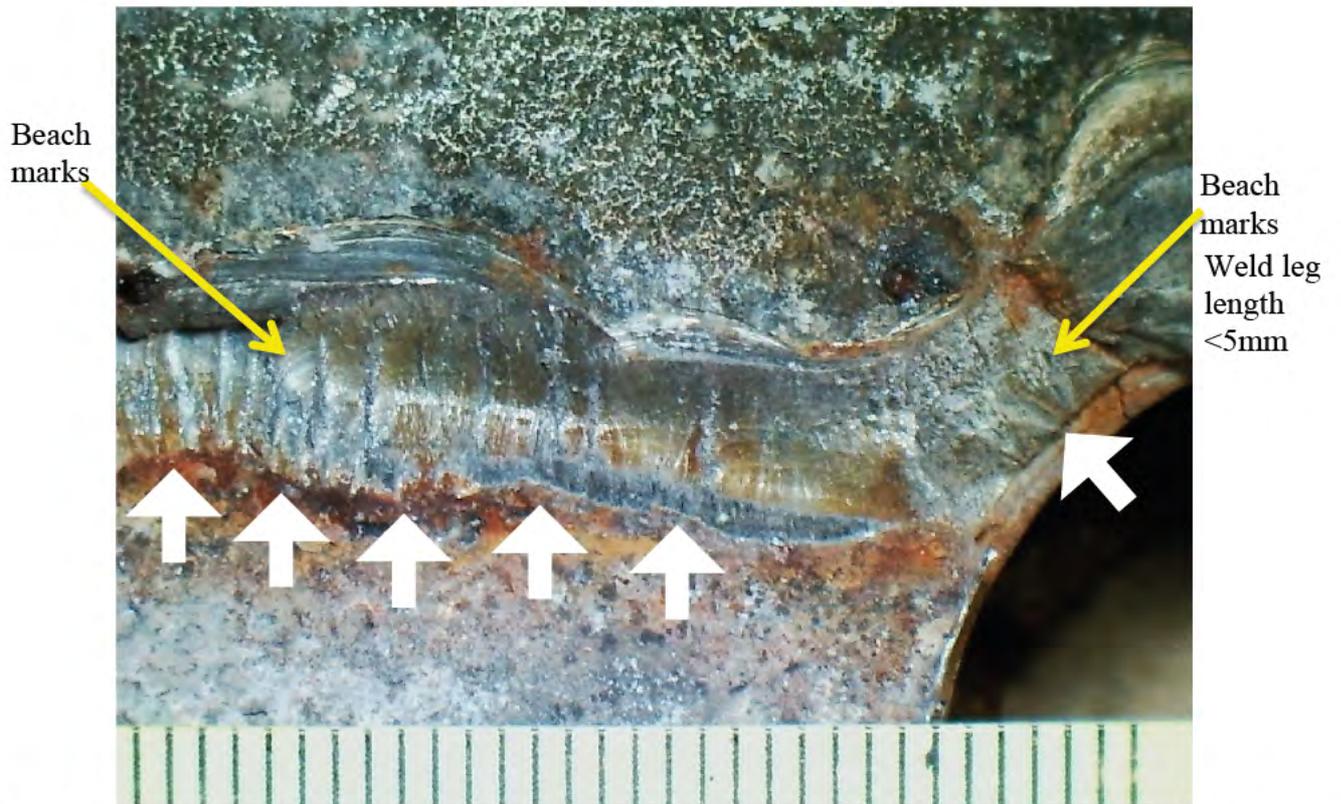
Examination of the weld fracture adjacent to position 5 (highlighted in Figure 18) revealed that the stiffener had not fractured within its bulk but in the weld. It also revealed that the weld had

failed in fatigue (beach marks highlighted in Figure 21) which originated on the inboard (port) side of the stiffener (see Figure 21).

Figure 21: Macroscopic image of weld failure adjacent to position 5. Note the fatigue cracks propagated in an outboard (stbd) direction). Origins marked with an arrow.

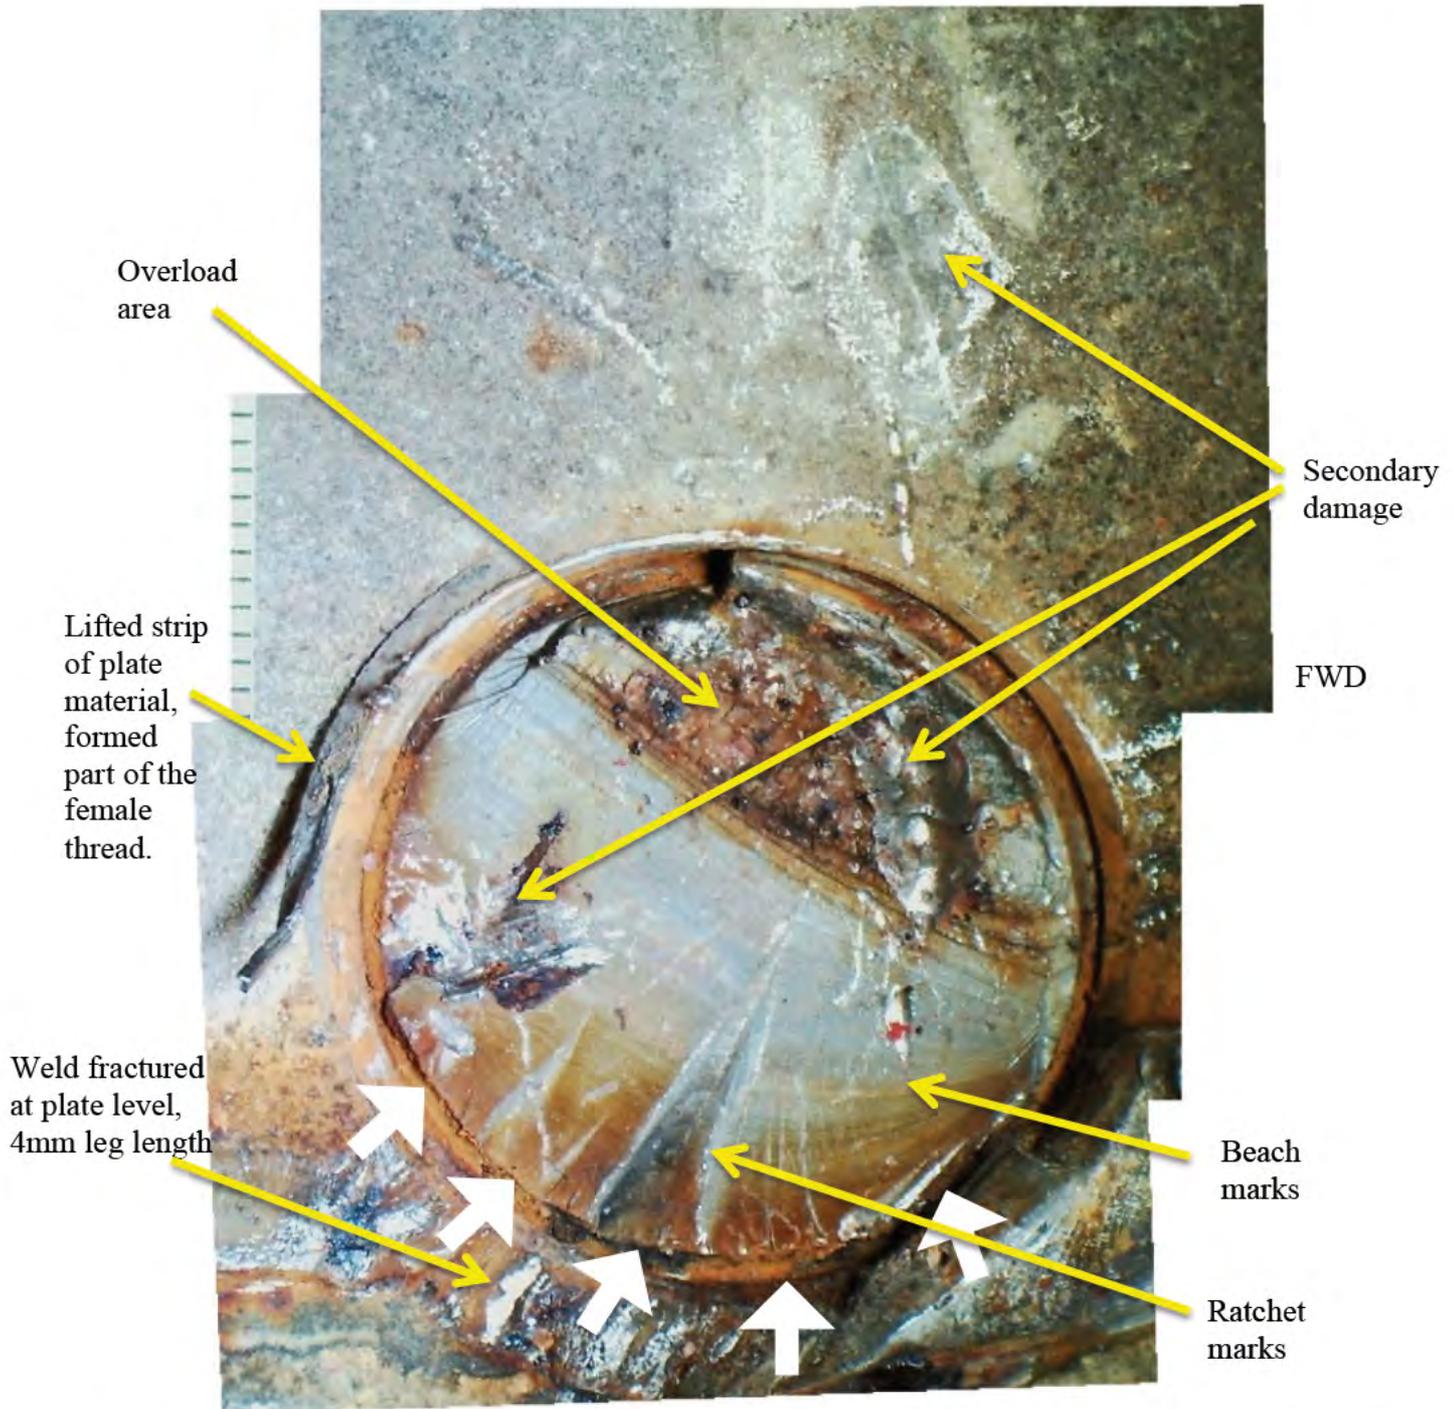
Figure 22: Montage of macroscopic images recorded of Rod 4 fracture. Origins marked with an arrow.

Examination of the fracture surface of Rod 4 revealed features not previously witnessed on the previous (Rod 2 & 3), specifically:

- The overload region was approximately 30% of the cross sectional area.
- There was no evidence of rubbing or local reciprocating wear (previously observed).
- The initiation took place level with the plate height (and not 5mm above in the weld join)

- Weld leg lengths (when present) were < 5mm.
- The beach marks 'turned' as the fracture progressed.
- The final beach mark was not aligned with a dominant keel bending load direction.
- There was significant presence of secondary damage witness marks

The above points all suggest that this rod underwent a form of tension-tension cyclic fatigue which was at a high stress. It also suggests that this rod was the last rod to fail.

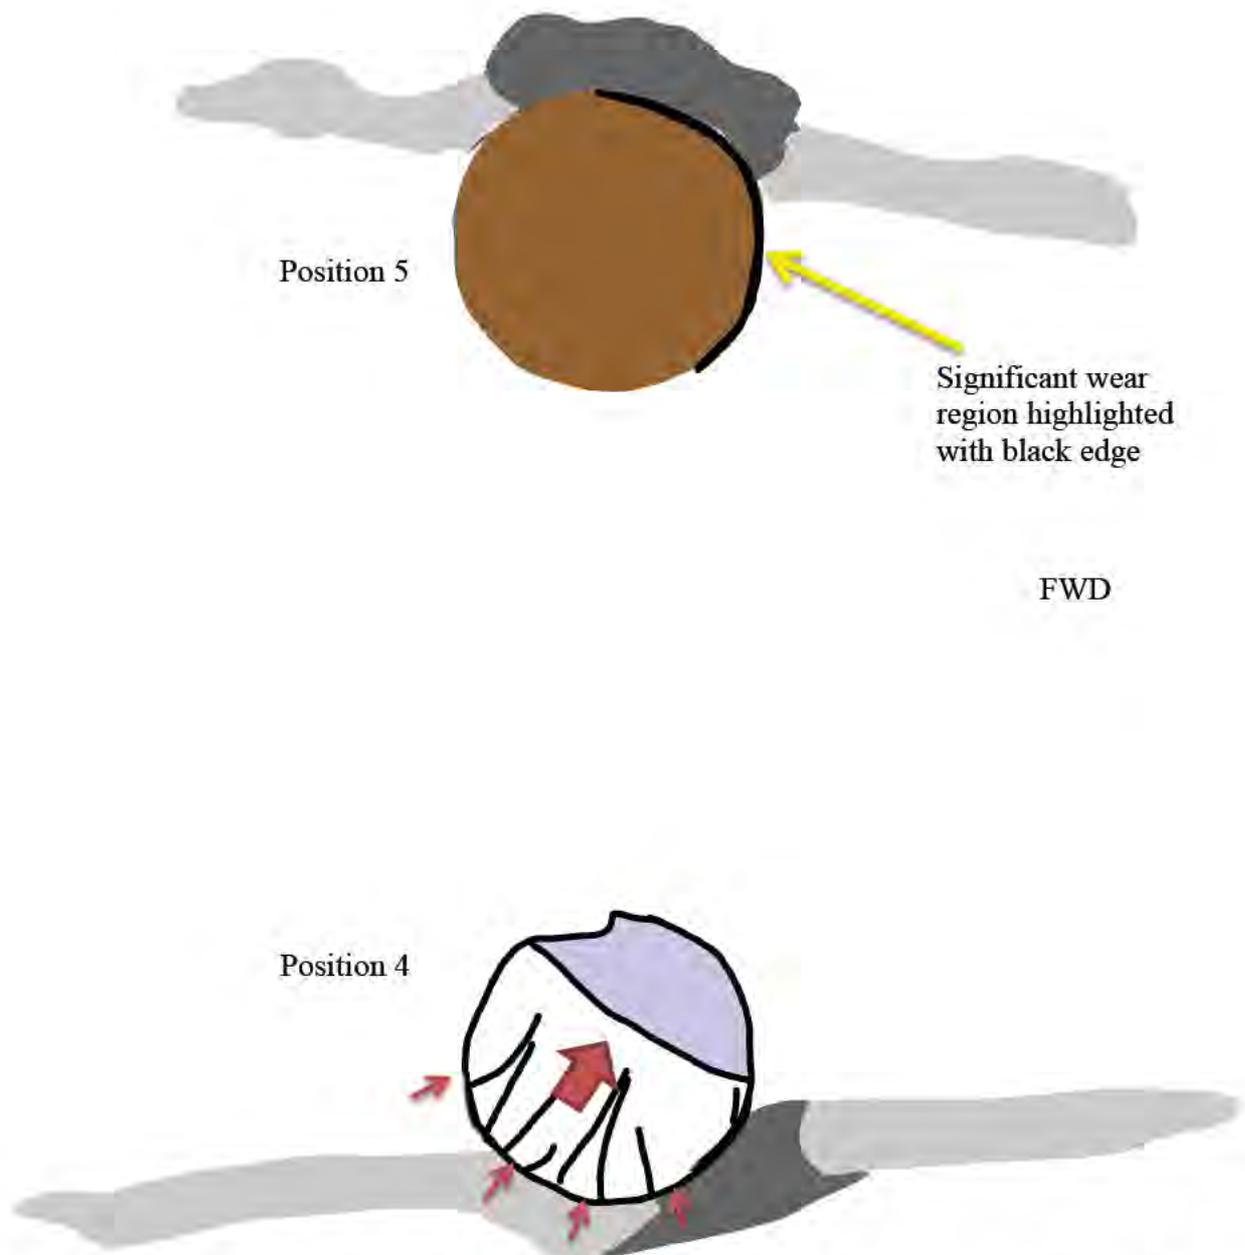
Figure 23: Schematic of Rod 4 & 5 fractures. Small red arrows highlight the multiple initiation points around Rod 4. The large red arrow identifies the general direction of fatigue crack growth. Overload area is shown in blue, the hole left by Rod 5 in brown.

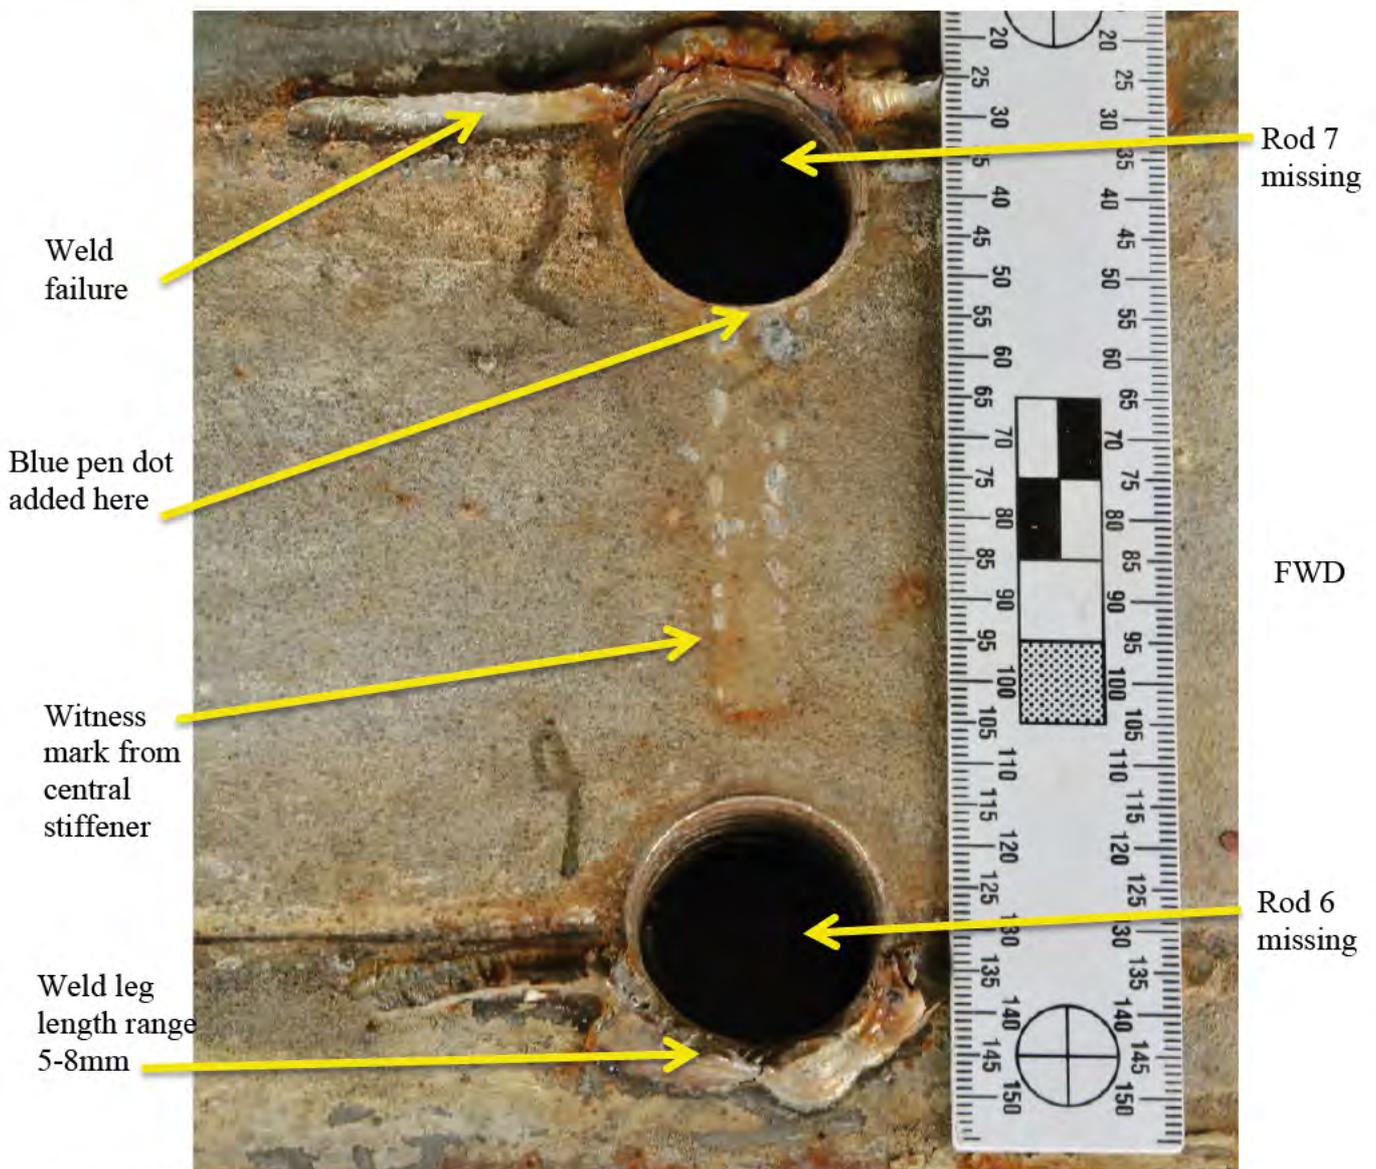
The rods at positions 6 and 7 had been pulled free of the threaded holes within the plate, see Figure 24. Observations within the hole at position 7 revealed that the threads on the inboard side had been severely damaged, see Figure 25, when compared to the rest of the circumference, see Figure 26. The damage was consistent with a large single direction (out of hole) loaded movement of the rod, however the diameter of the hole left indicated that the rod could not have exited the hole with its threads intact. Examination of the hole at position 6 revealed that the female threads appeared to be in similar condition to Figure 26 with no obvious large scale wear like that seen in Figure 25. There was evidence of a shear loading event which had left a male thread crest from Rod 6 within the hole, see Figure 27. The thread length (1.25 turns long) was removed with pliers and examined, revealing wear damage on the loaded flank in some locations, see Figure 28.

Figure 24: Showing vacant holes at position 6 and 7.

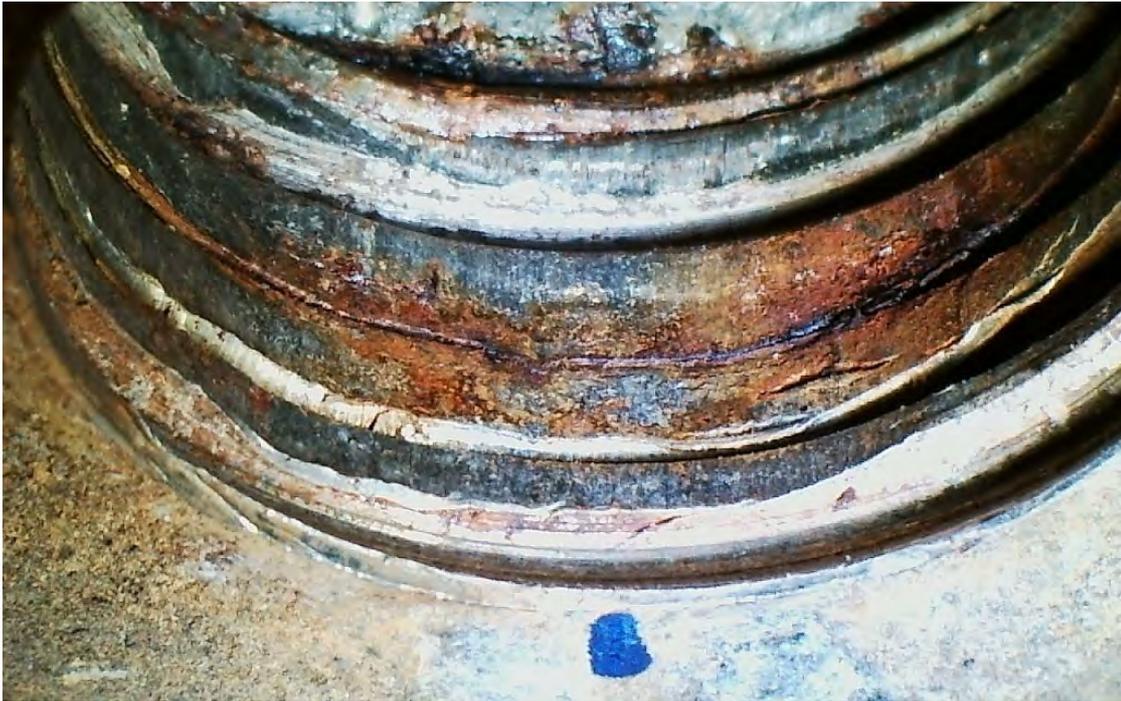
Figure 25: Macroscopic image of view looking inboard at damaged threads of position 7. Blue pen dot at base of image provides orientation reference point.

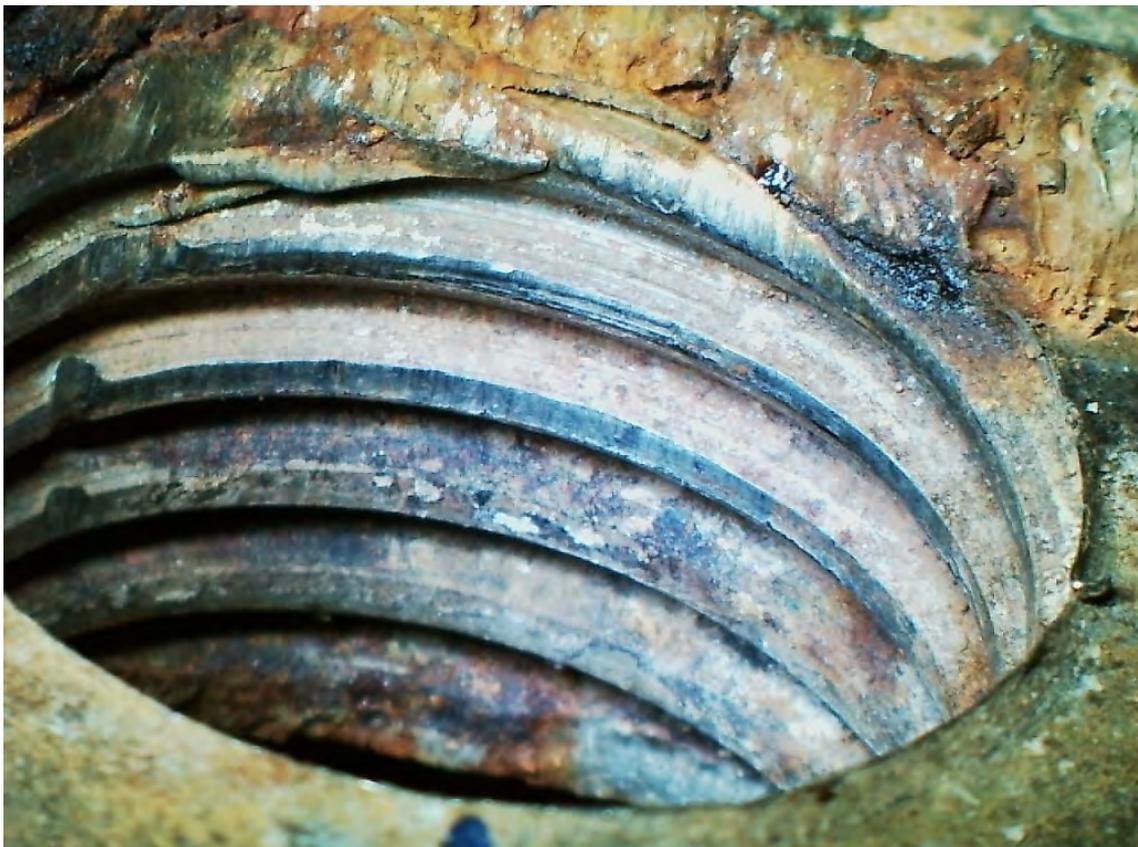
Figure 26: Macroscopic image of view looking outboard at less damaged threads of position 7. Blue pen dot at base of image provides orientation reference point.

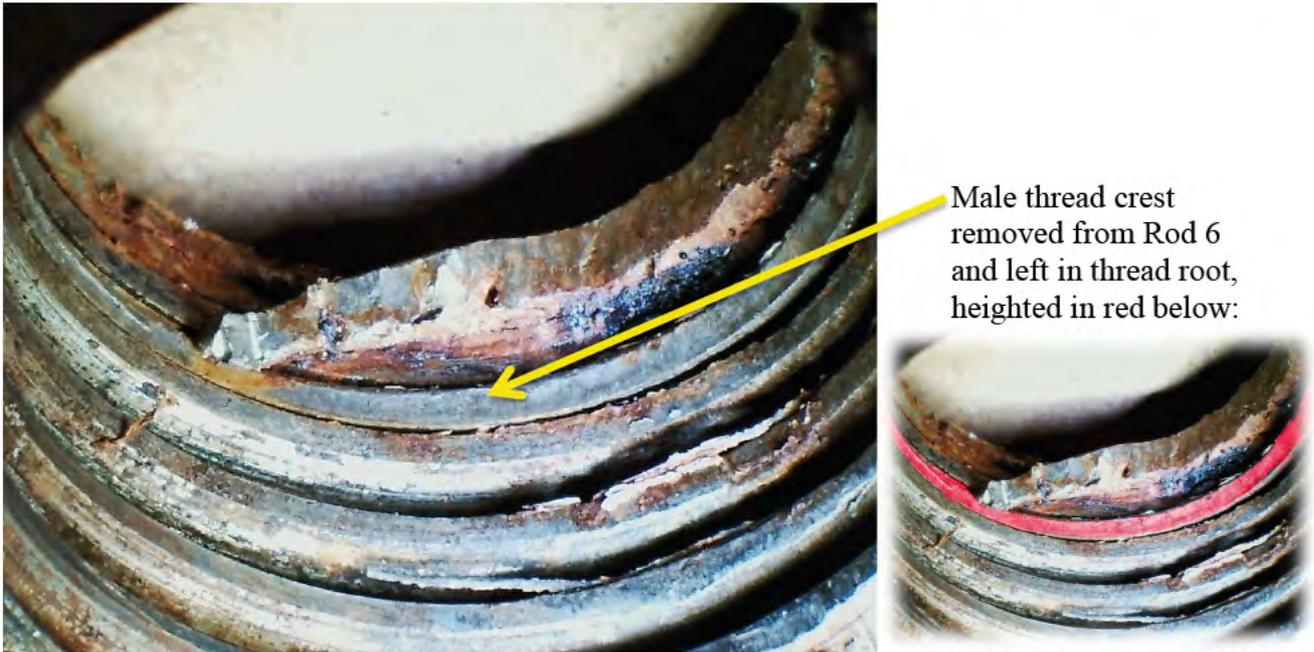
Figure 27: Macroscopic image of view looking aftward at internal threads of position 6. Note a thread crest from Rod 6 has remained within the hole.

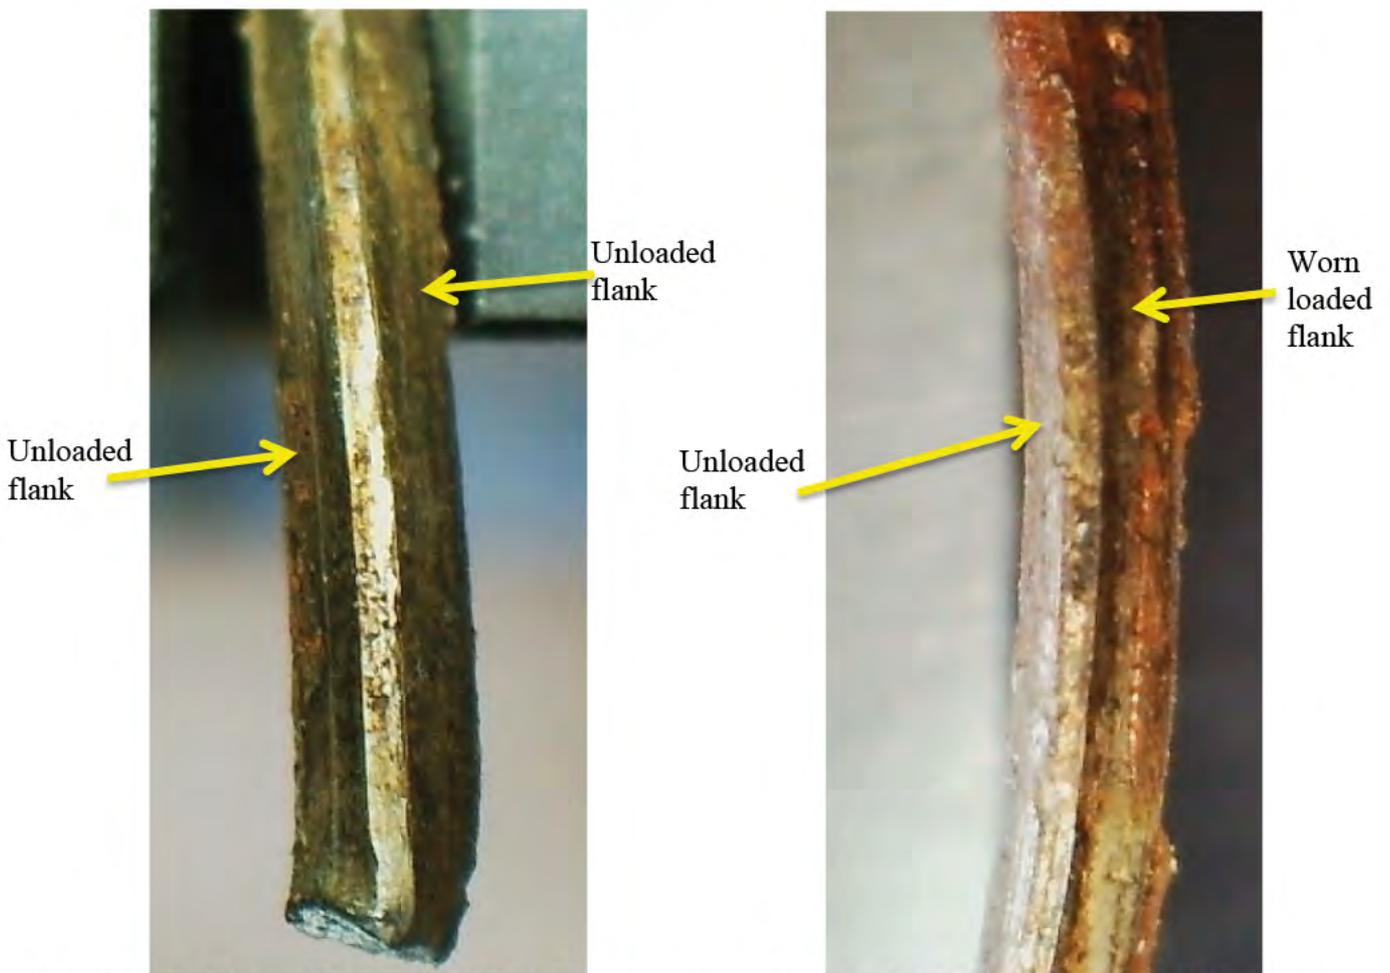
Figure 28: Views of the male thread crest removed from Position 6. Note in some locations the loaded flank has been heavily worn and 'grooved'.

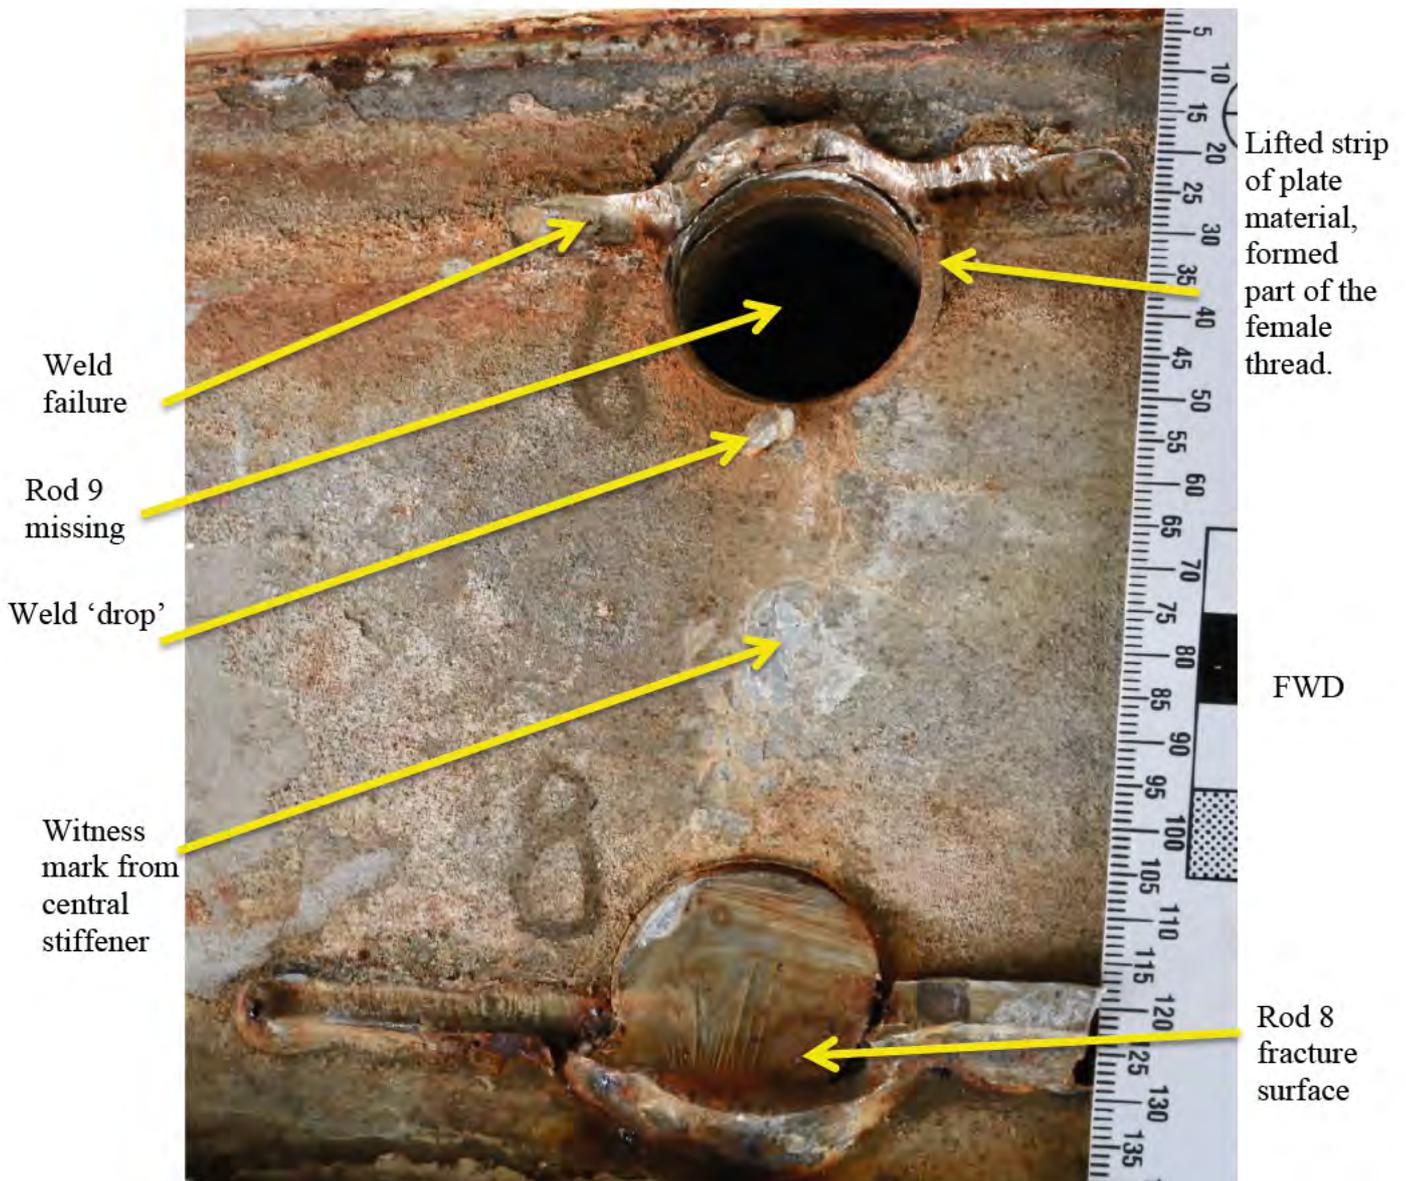
Examination of positions 8 and 9 revealed that Rod 9 was missing and Rod 8 failed by fatigue (Figure 29) driven by unidirectional bending.

Figure 29: Showing vacant holes at position 8 and 9.

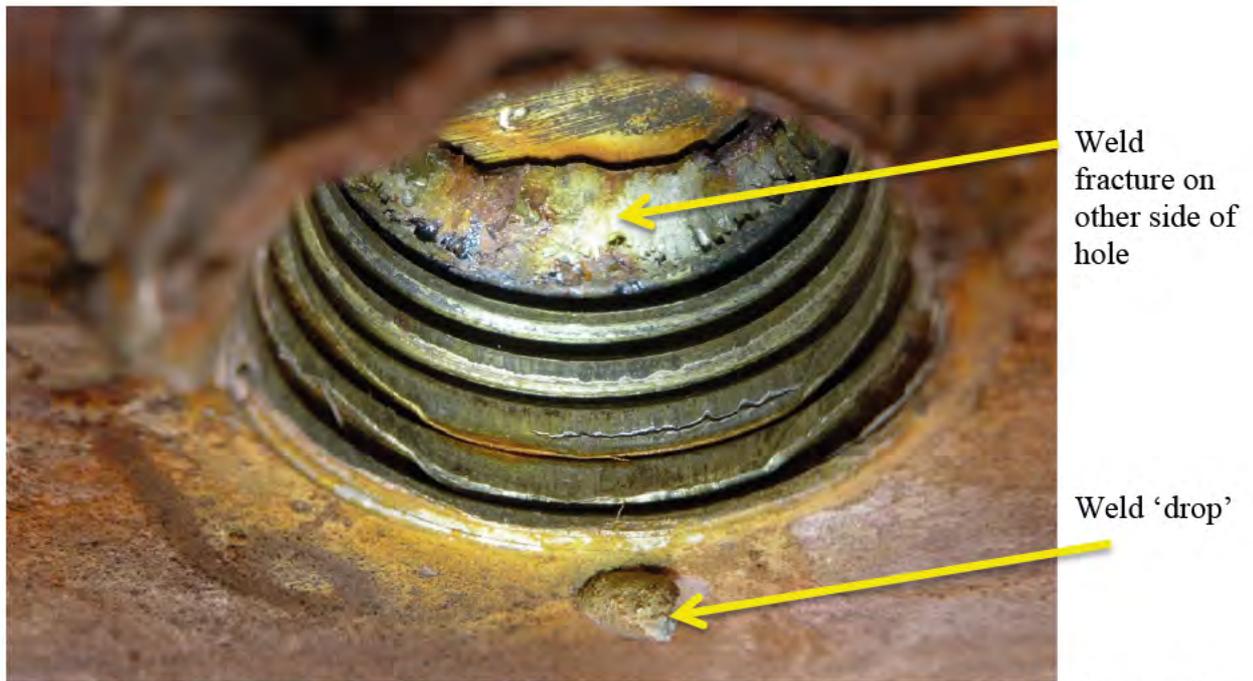
The threaded hole at position 9 was examined. It was noted that the inboard side of the crests of the threads had been plastically deformed and ‘smeared’ in a direction consistent with loaded removal of the rod, see Figure 30. No evidence of the rod threads were observed. The remaining circumference of the threaded hole was in serviceable condition, i.e. the threads were still present.

Figure 30: View looking inboard at damaged threads of position 9. Weld 'drop' at base of image provides orientation reference point. Image provided by MAIB.

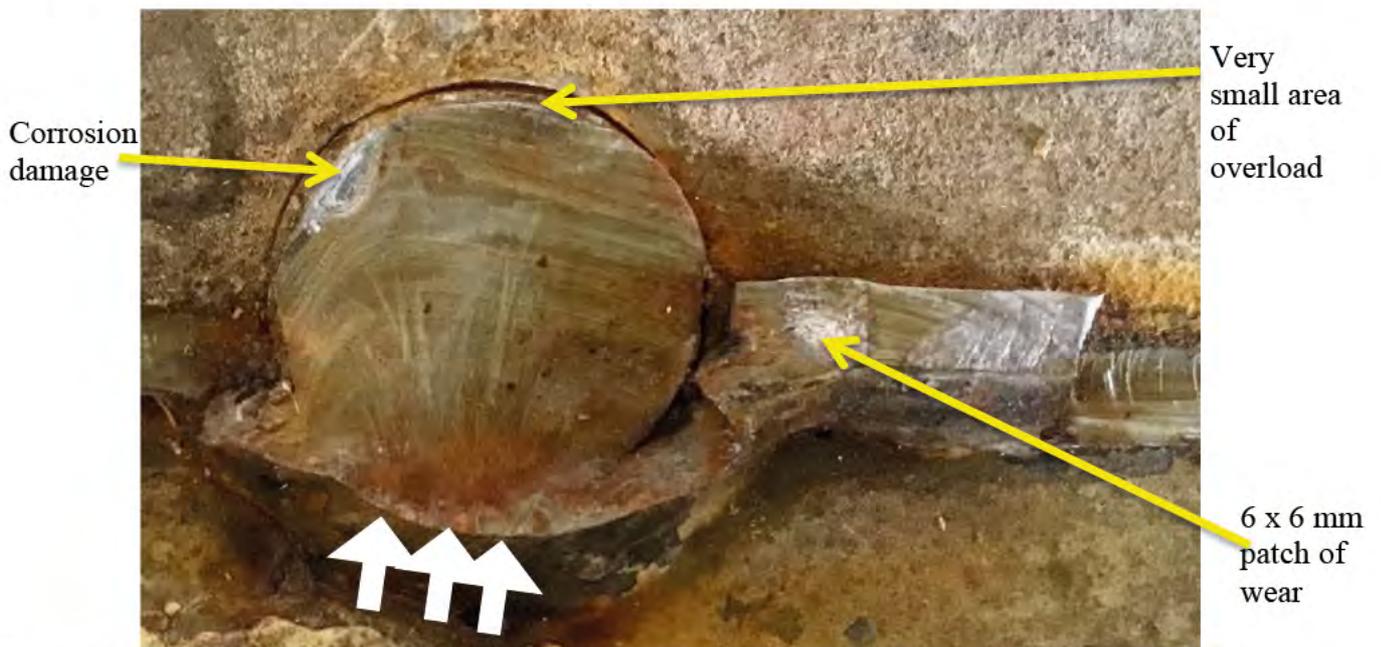
Rod 8 fracture surface initiated on the outboard (stbd) side of rod 5 mm above the plate face. The shape, profile, roughness and features of the fracture surface indicate that fatigue initiated at a location coincident to the edge of the weld (Figure 31).

Figure 31: Showing fatigue fracture surface of Rod 8. Initiation at weld rod interface highlighted with white arrows.

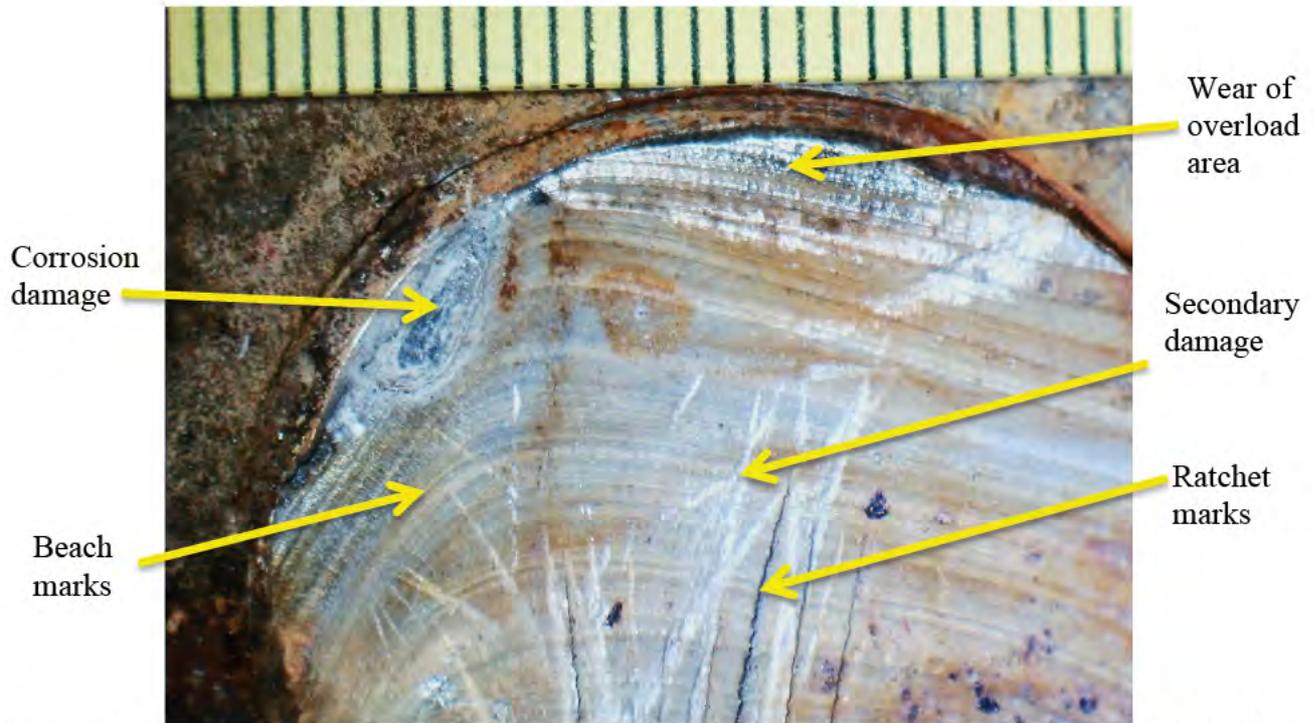
The number of ratchet marks (shown in Figure 32) indicates that there was multiple crack initiation points and therefore a large stress concentration was present around the circumference. The crack propagated through the rod, beach marks (shown in Figure 32) recording the position of the crack front, which appeared to change direction with time, as shown by the bend in the beach marks. There were indications of a small worn overload region. The inboard side of the fracture was level with the plate face, the expected position of maximum stress with no weld present.

Figure 32: Higher magnification view of the fracture surface of Rod 8. Note the beach marks are 'bending' and also the overload area is very small and worn.

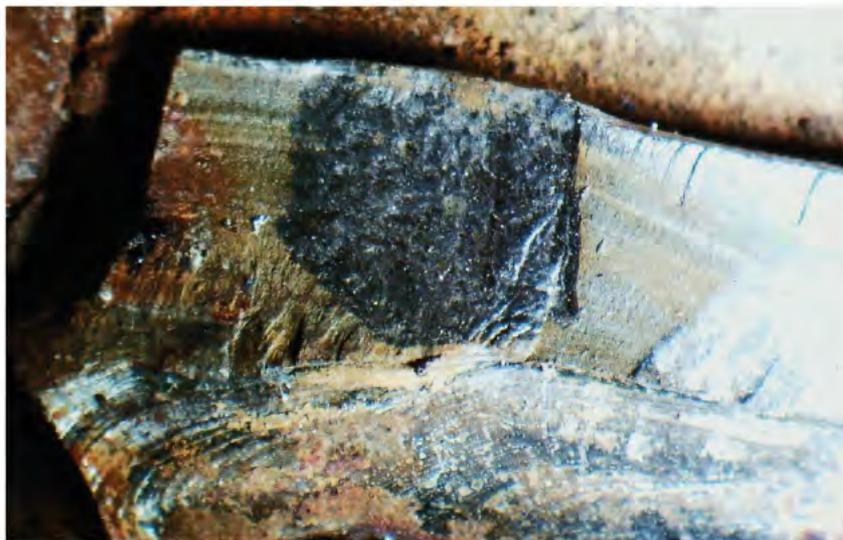
Figure 33: Higher magnification view of the worn patch of stiffener fracture surface at position 8.

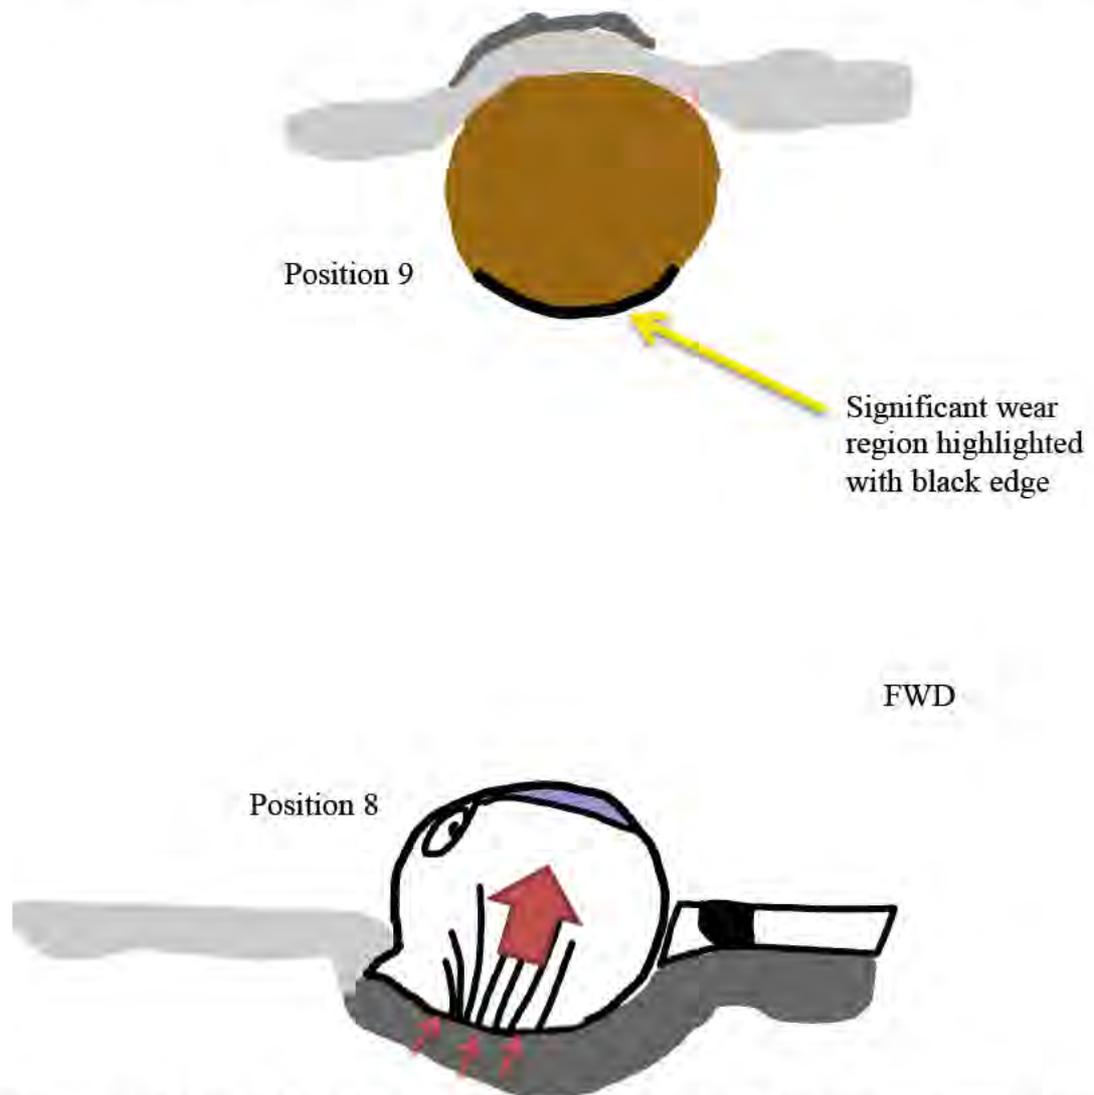
Figure 34: Schematic of Rod 8 & 9 fractures. Small red arrows highlight the multiple initiation points around Rod 8. The large red arrow identifies the general direction of fatigue crack growth. Overload area is shown in blue, the hole left by Rod 9 in brown.

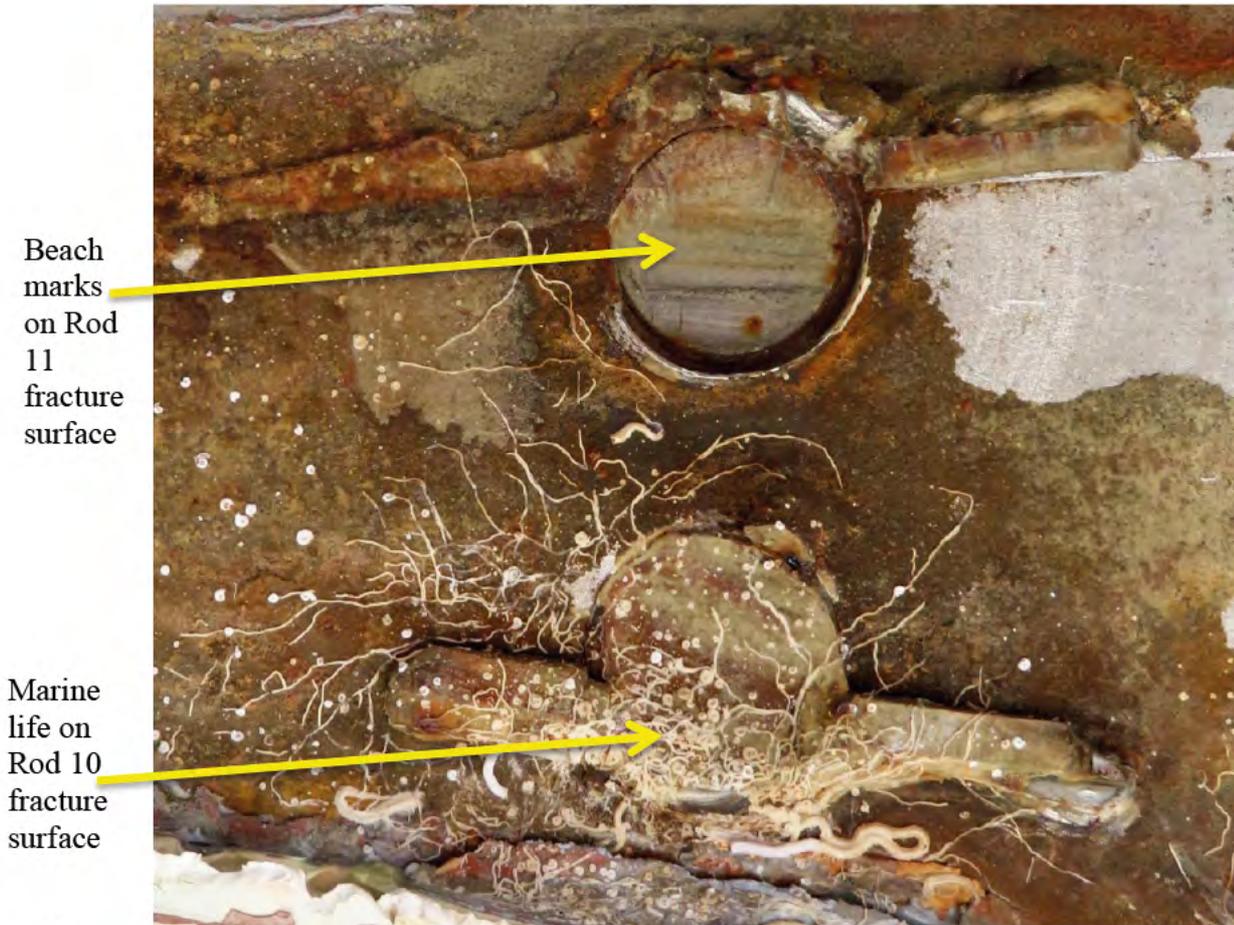
Figure 35: Showing fracture surfaces at positions 10 and 11.

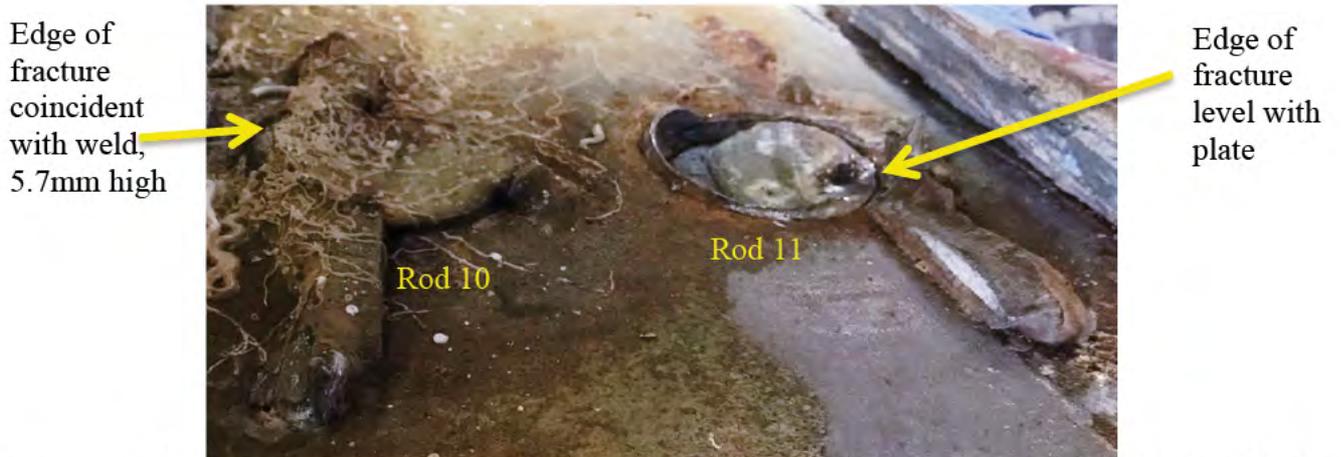
Figure 36: Montage of macroscopic images recorded of Rod 11 fracture. Origins marked with an arrow.

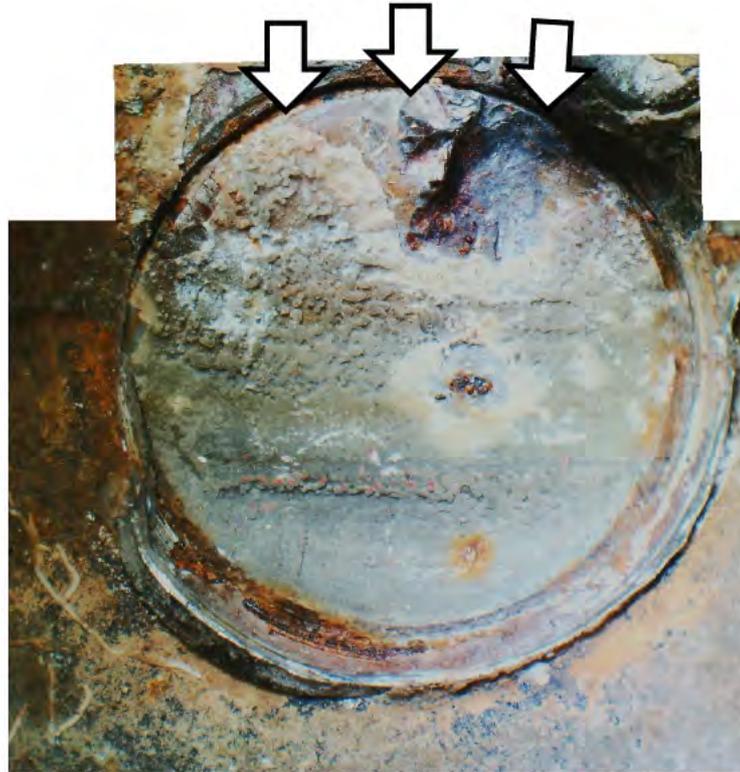
Figure 37: Montage of macroscopic images recorded of Rod 11 fracture. Origins marked with an arrow. Surface very corroded.

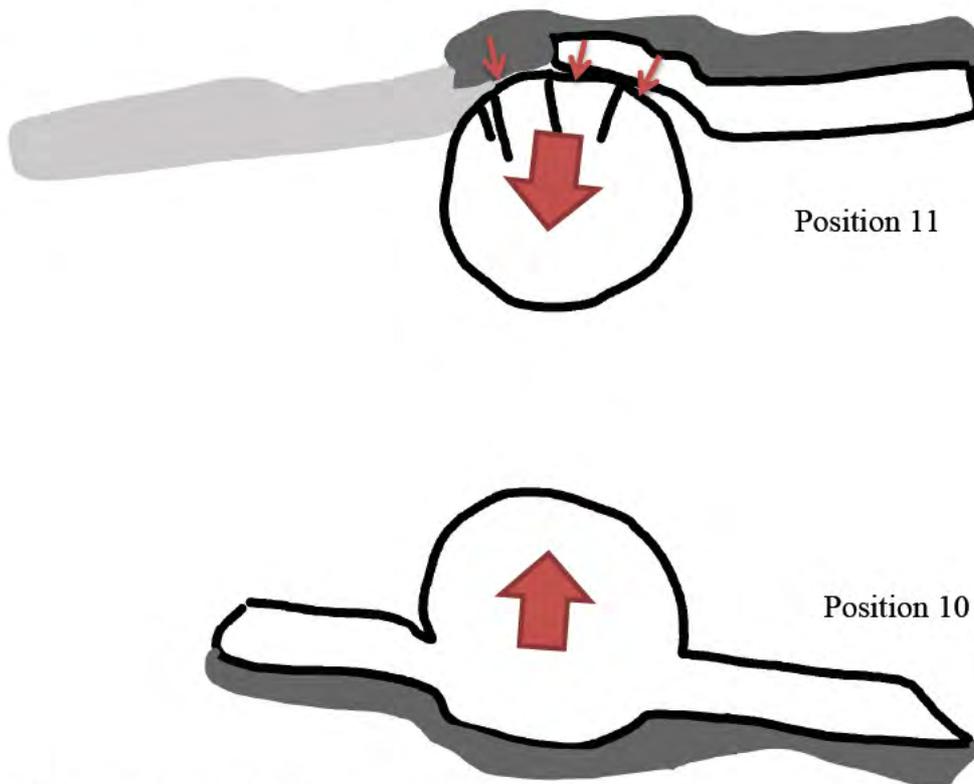
Figure 38: Schematic of Rod 10 & 11 fractures. Small red arrows highlight the multiple initiation points. The large red arrows identify the general direction of fatigue crack growth.

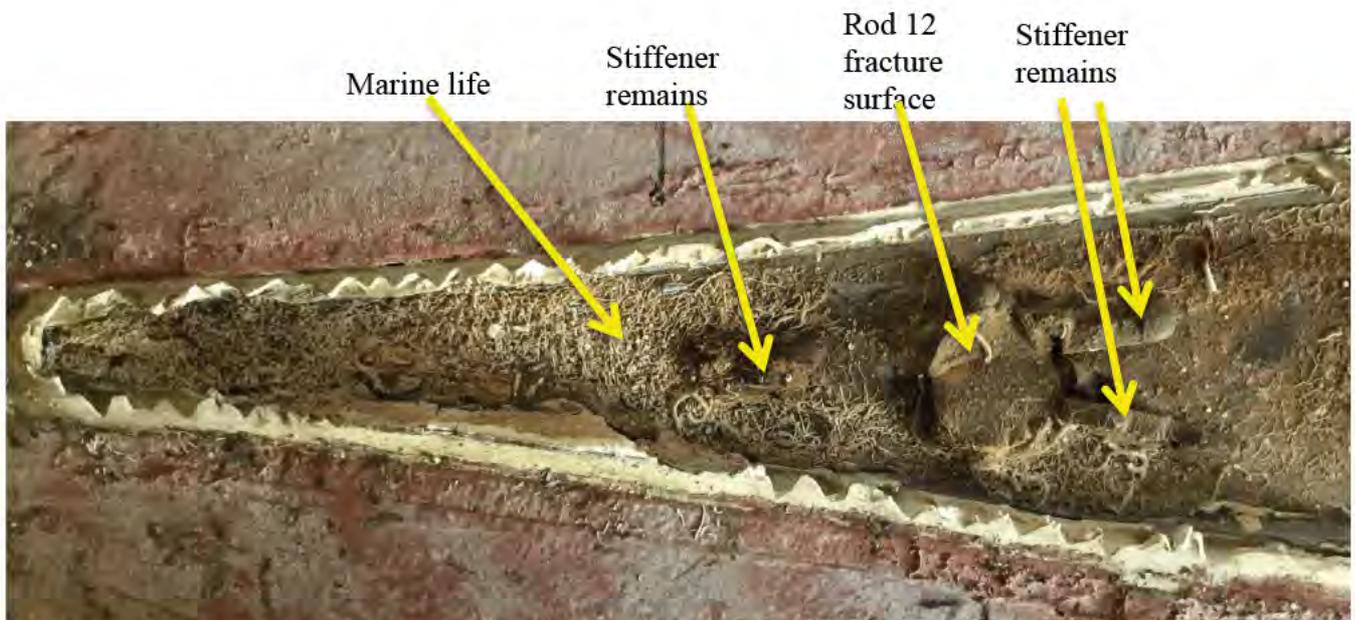
Figure 39: Showing fracture surfaces at position 12 of both Rod 12 and the surrounding three stiffeners.
