Wolfson Report No 2702 - Assessment of keel and associated structure of the sailing vessel
Tyger of London

Report No. 2702

Date : 4th June 2018
Compiled By : [REDACTED]
Verified By : [REDACTED]

Assessment of Keel and associated structure of Sailing Vessel ‘Tyger of London’

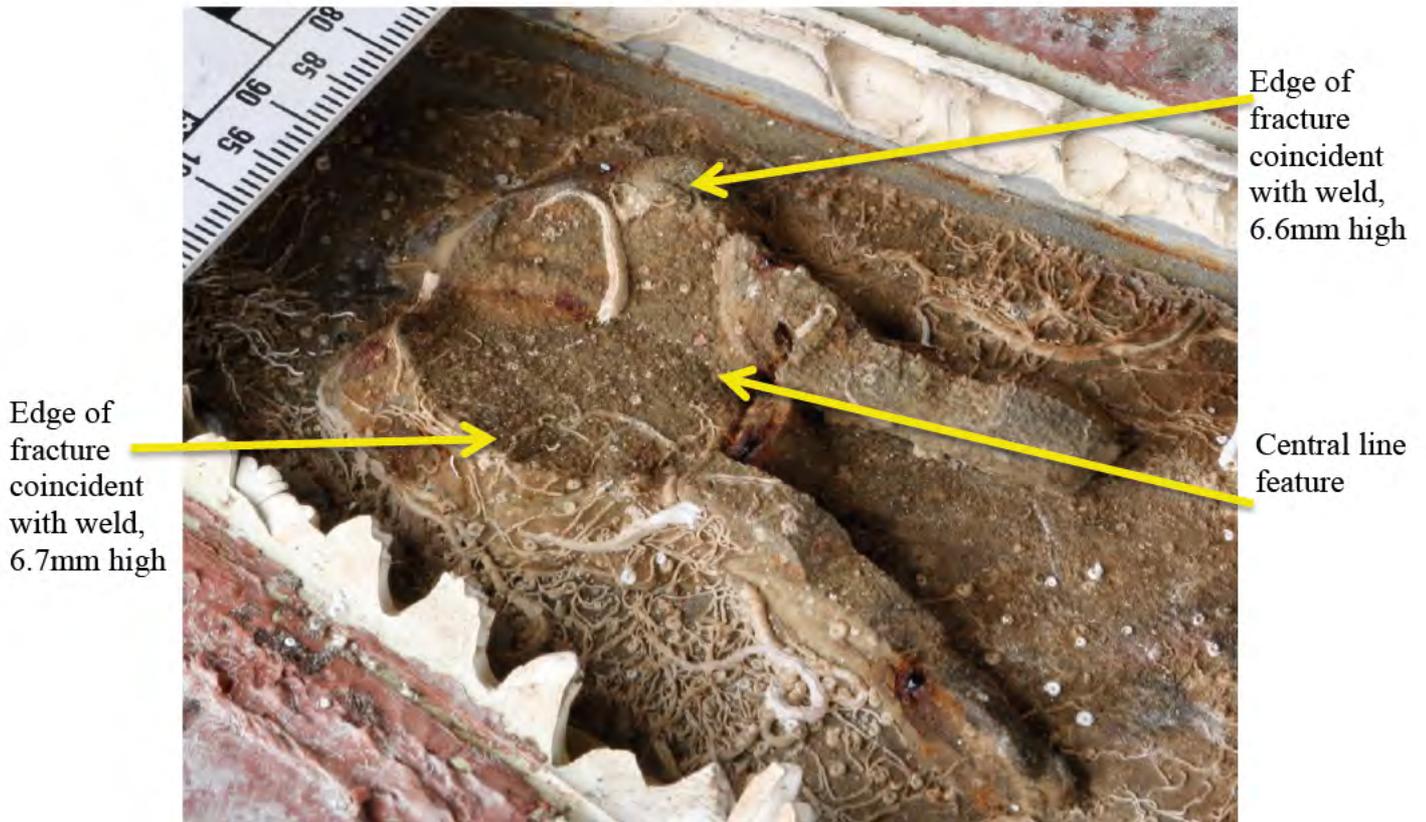
Figure 40: Showing an oblique view of the fracture surface of Rod 12, note the symmetrical features, similar to those of Rod 1.

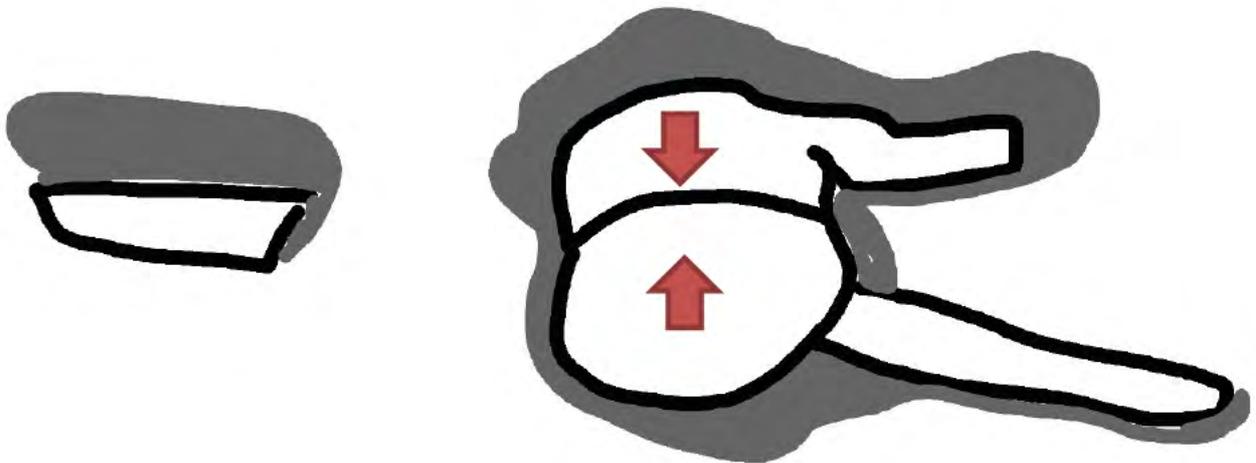
Figure 41: Schematic of Rod 12 fracture. The large red arrows identify the general direction of fatigue crack growth.

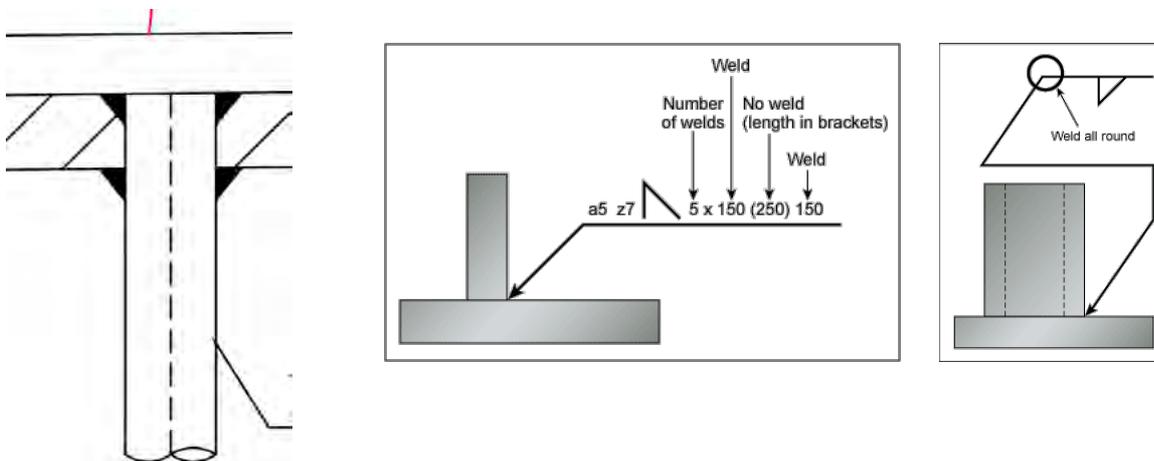
The drawings (Appendix 1) state "TONDINI ACCIAIO INOX AISI 316, Ø30mm FILETTATE NELLA PIASTRA 20mm" which translates to "Rods steel stainless AISI 316, Ø30mm threaded in plate 20mm [thick]". The drawings also provide fillet weld symbols (black filled triangles shown in Figure 42, indicating the requirement for fillet welds to the plate-rod interface on both the upper and lower sides of the plate. Note current examinations only took place on the lower face of the plate, however indications suggest that welds were present on the top face for 360 deg circumference of the rod (see Figure 19). The drawing does not explicitly state any details of the required welds, typically a designer would provide notation (EN 22553, EN ISO 4063) which includes details such as throat size (a) and leg length (z) as shown in the inserts provided in Figure 42. A circle notation is used to show weld all round, however the black filled triangles shown in the drawings (Appendix 1) are present in both transverse and longitudinal views.

Figure 42: Left: Extract from drawings shown in Appendix 1. Black filled triangles indicate a fillet weld on the upper and lower surface of rod-plate interface. Inserts: show typical expected weld notation.

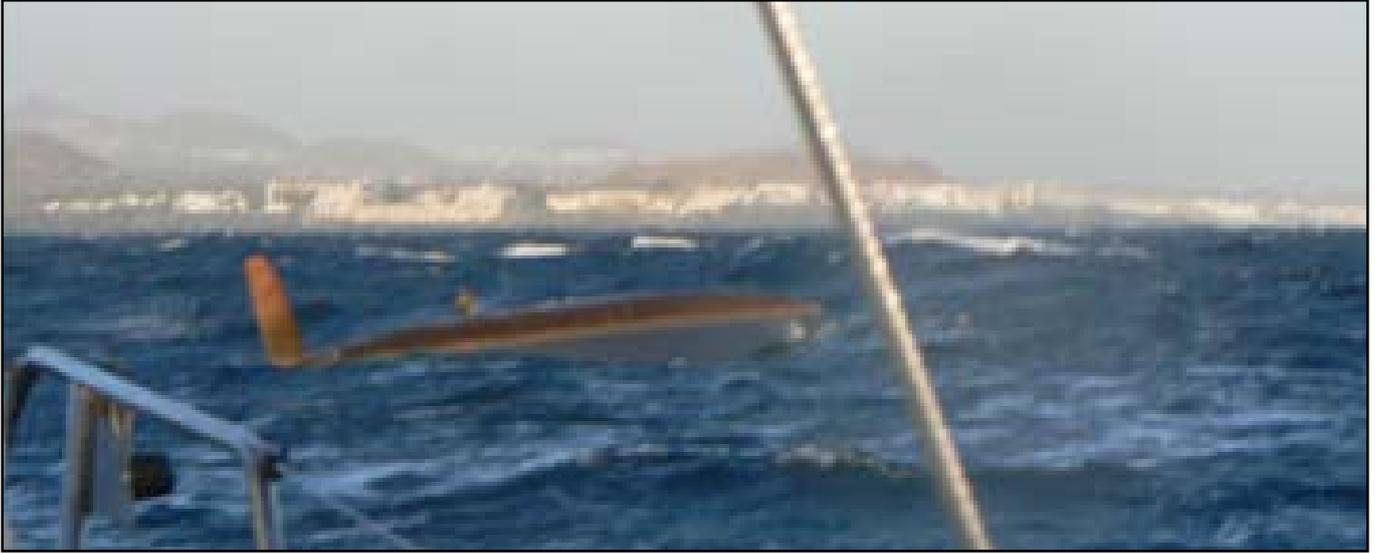
The MAIB is investigating the keel failure and capsizing of the UK registered commercial yacht *Tyger of London* (Figure 1) while on passage from La Gomera to Tenerife, on 7 December 2017. The five persons on board were rescued from the water by the crew of a nearby yacht.

Figure 1: *Tyger of London* post-capsize

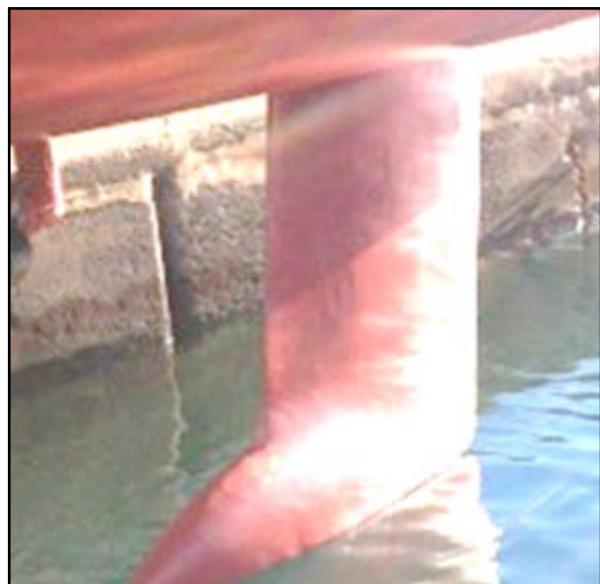
Tyger of London was fitted with the 'shallow draught, lead keel', which is the subject of this safety bulletin.

Figure 2b: Shallow draught, lead keel, fitted to *Tyger of London*, subject of this safety bulletin

- To note that the securing bolts within the bilge of their boats, for this type of shallow draught lead keel, connect the top plate to the hull. The condition and tightness of these keel securing bolts do not indicate the true condition of the keel's internal frame structure.
- To arrange for an out of water inspection of their vessel by a suitably qualified yacht surveyor at the earliest opportunity if the yacht has grounded, been heavily used, or if they have any concern whatsoever as to the condition of the keel, noting the difficulty of inspection of the junction between lead keel and top plate.
