Rail Accident Investigation Branch

Investigating organisational factors in the Bradford Interchange runaway

Runaway at Bradford Interchange

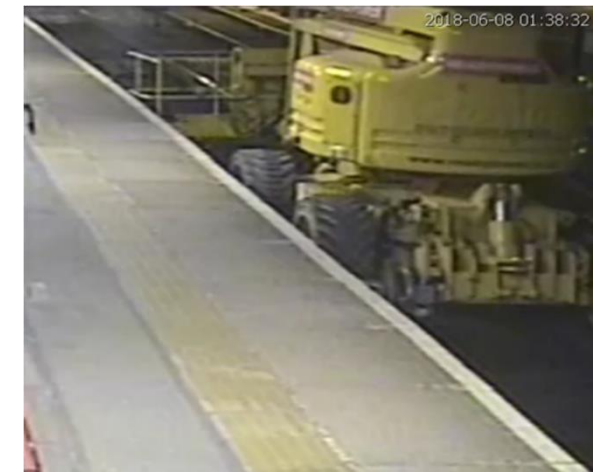
- What happened?
 - At 01:40 hrs on 8 June 2018, a 17.5 tonnes Mobile Elevated Working Platform (MEWP) ran away while being on-tracked at a Road Rail Access Point (RRAP) south of Bradford Interchange station
 - Ran downhill for approximately 340 metres before coming to a stop
 - One track maintenance staff in its path was warned in time (5 to 8 seconds)
- Why did it happen?
 - The machine operator (MO) did not follow the industry-wide on- and off-tracking principle and partially deployed both rail axles
 - The MEWP Direct Rail Wheel Braking (DRWB) system was not effective as it had not been maintained properly

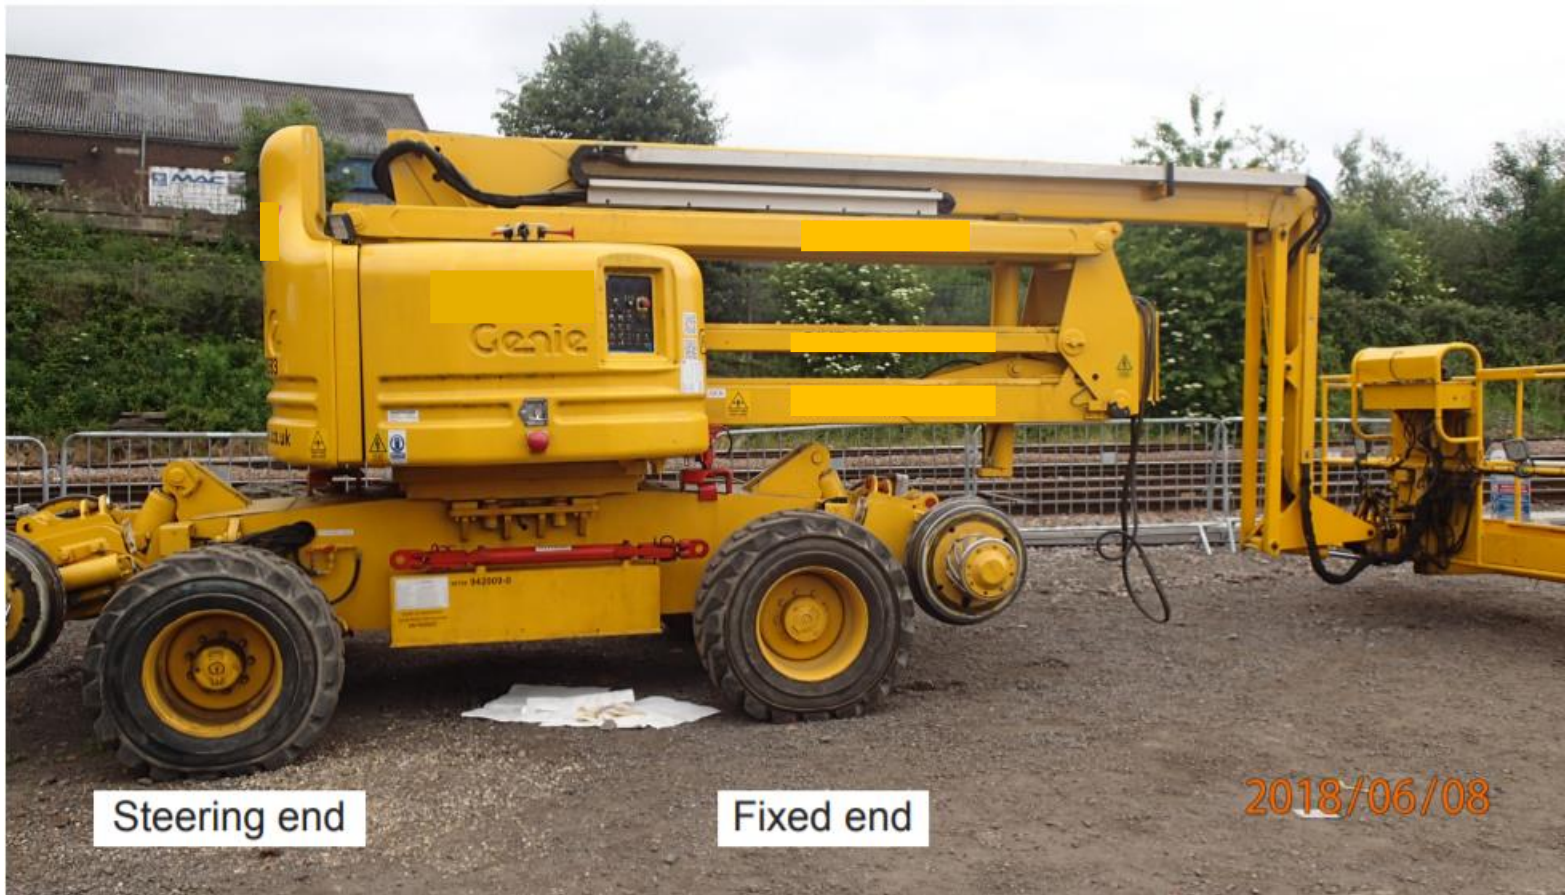
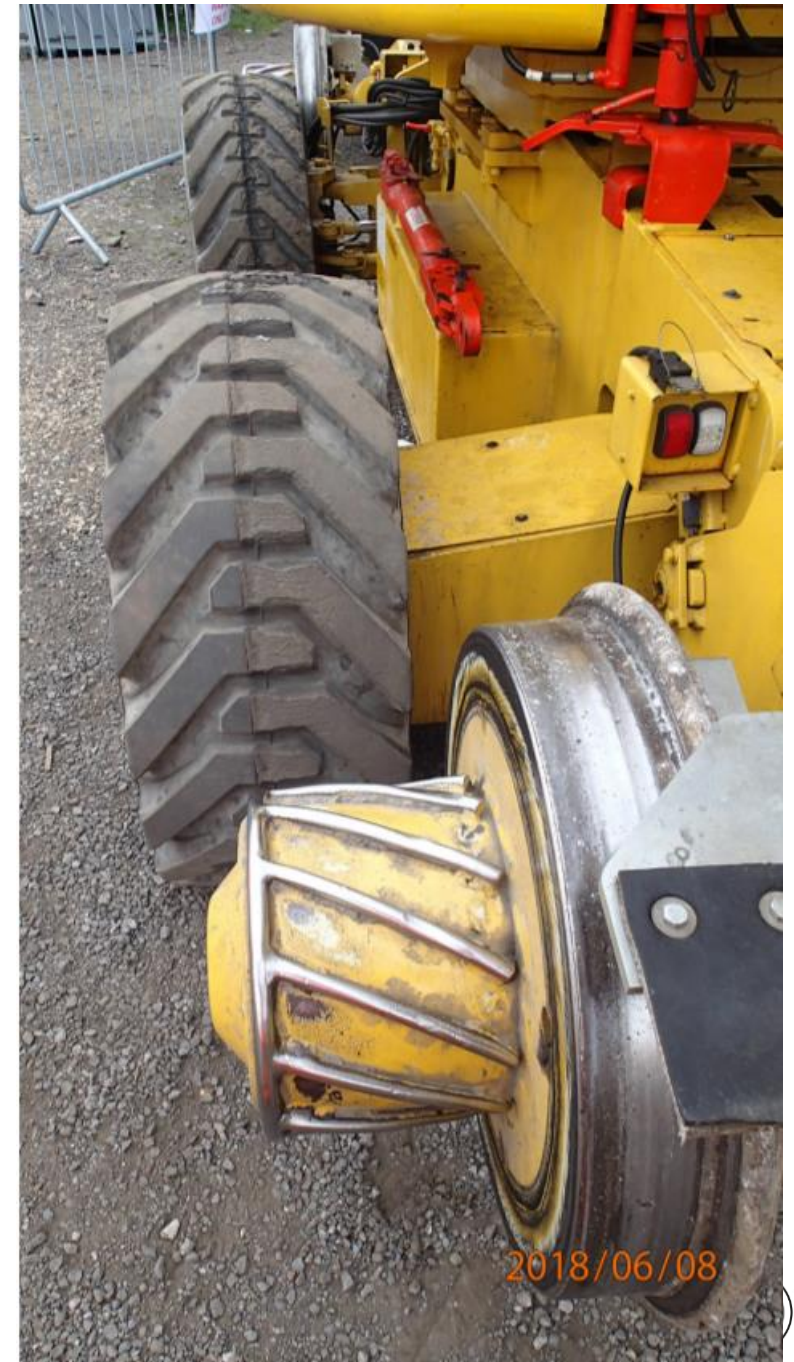
MEWP

- Genie Z60 – Type 9b RRV with DRWB

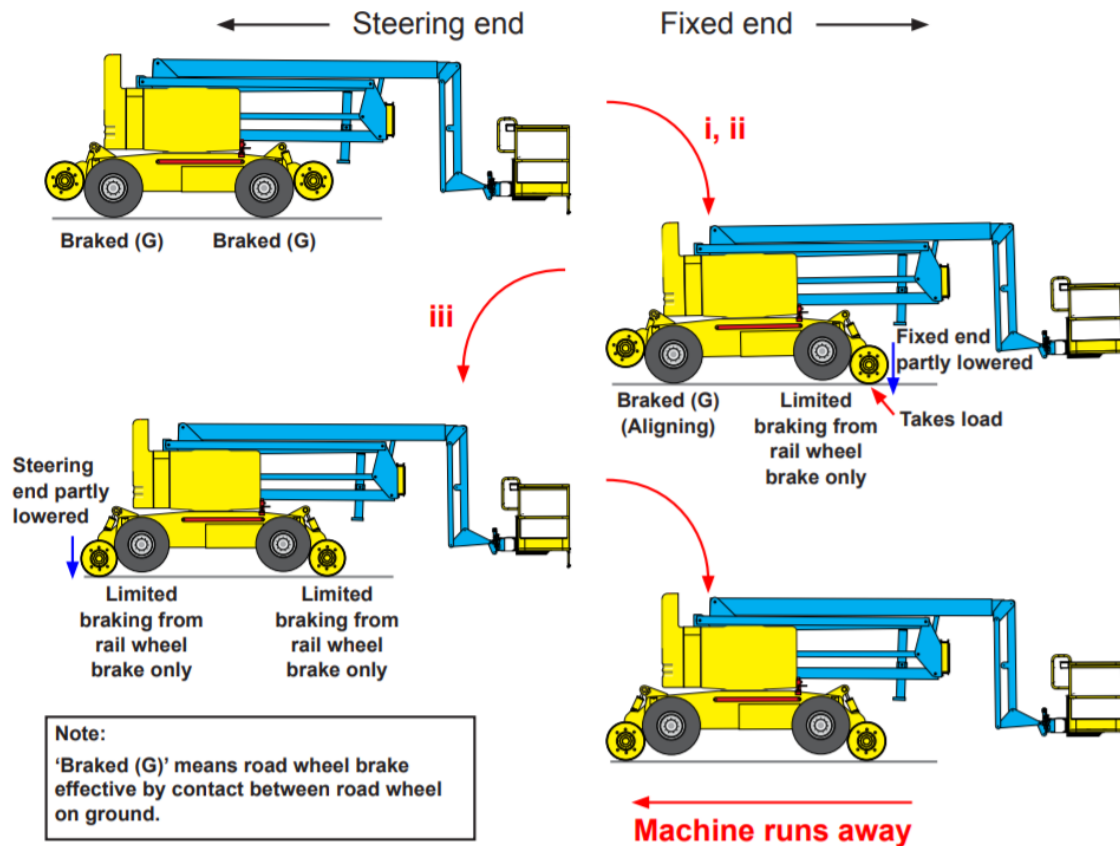
MO incorrectly deploying the MEWP

- Had relevant tickets to demonstrate 'competence' in accordance with NR's processes (since 2016)
- Had been trained on same MEWP type, learning the on- and off-tracking principle
- Had routinely not been following the on- and off- tracking principle

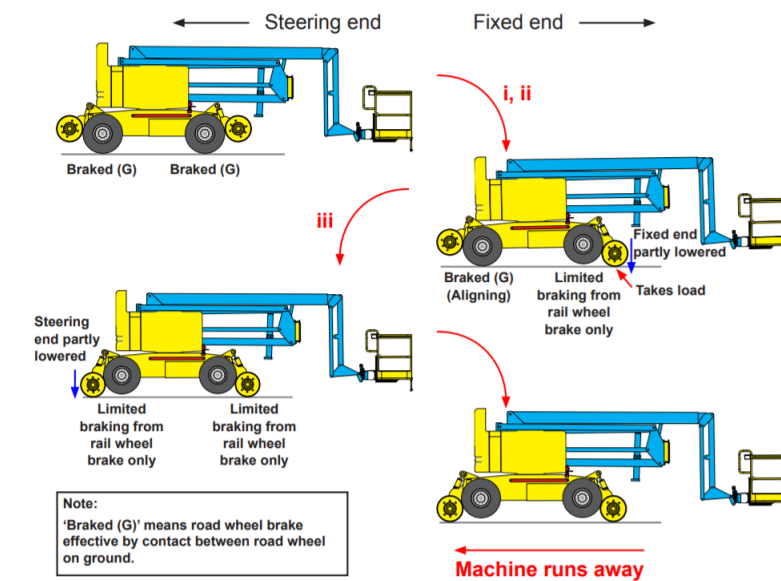
- MO was routinely not following the on-off tracking procedure but his employer had not identified this because:
 - It did not follow its own recruitment process
 - Once in employment, the ongoing competence of the MO had not been checked (no mentoring or monitoring by line manager or POS Rep)
 - Symptomatic of deeper problem with industry's management of MO competence

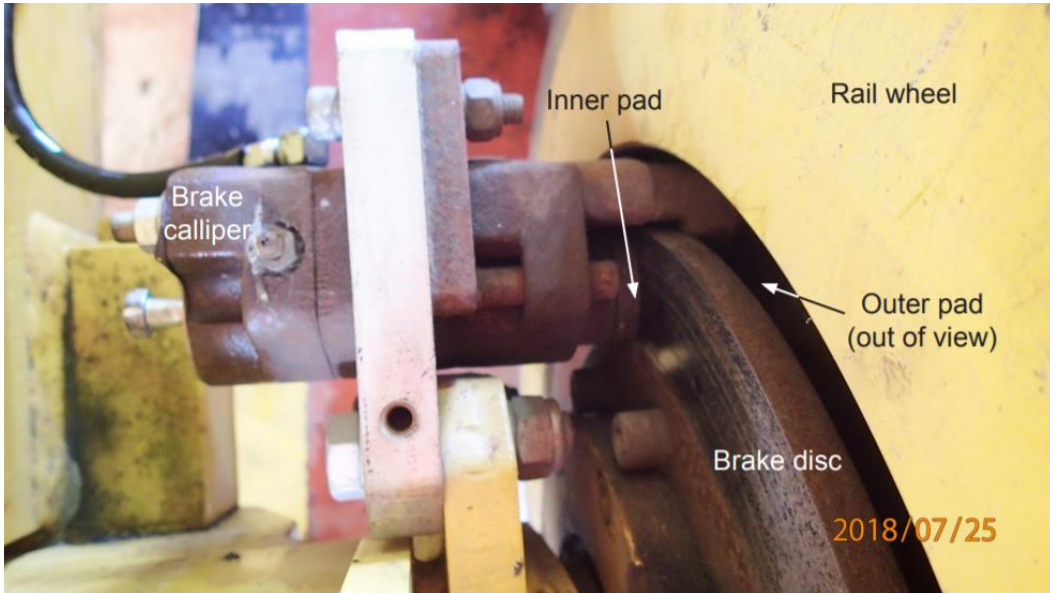
Fitters not maintaining the DRWB in accordance with OEM instructions

- Competent to the relevant Rail Plant Association assessment modules (2-yr cycle)
- Had been provided with relevant OEM instructions and forms created by employers to complete
- Were routinely not following the OEM instructions and just ticking the forms

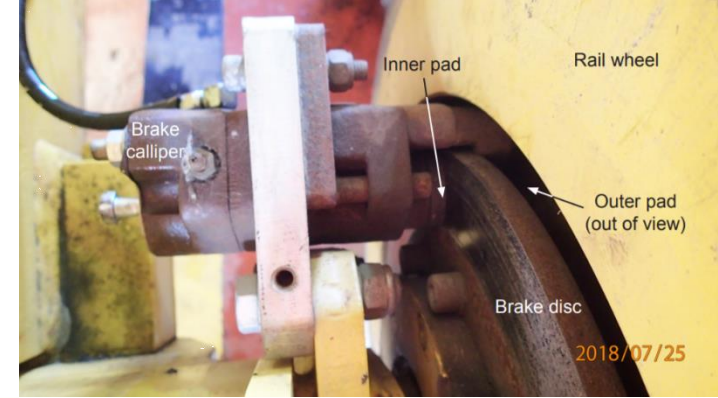
- Fitters were routinely not following the OEM instructions but the employer had not identified this because:
 - Poor design of the employer's inspection form for the DRWB
 - Lack of associated training when DRWB system introduced
 - Lack of supervision and/or audit of fitters
- Inadequate testing regime of MEWP braking systems
- Failure to adopt the latest version of the OEM instruction
