Rail Accident Investigation Branch

# Collision at London Waterloo and loss of corporate memory

Paul Tickner

13 November 2019

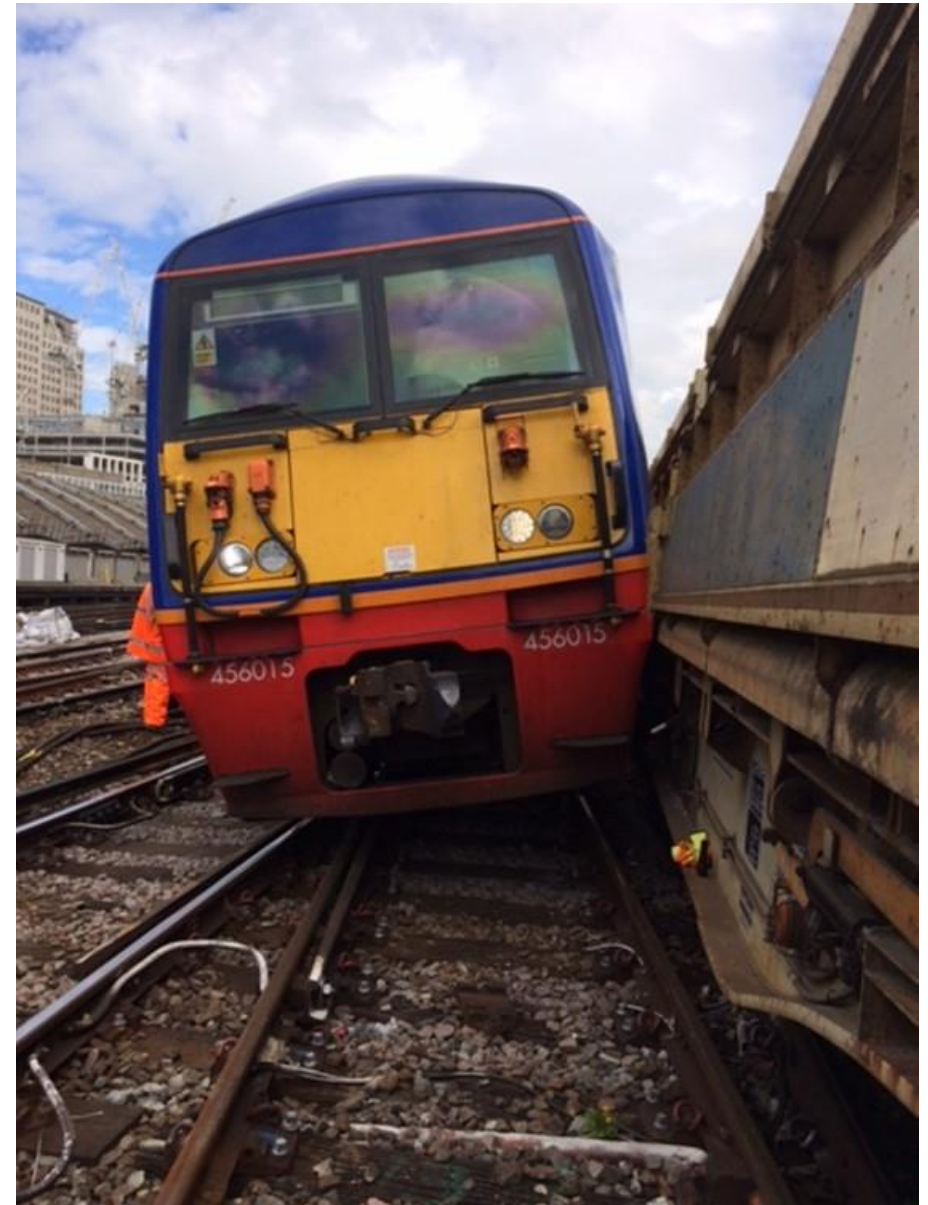
# The accident,

- The accident happened as the 05:40 service from Waterloo to Guildford was departing from platform 11
- Points 1524A were in a mid position and the train took went left rather than following its intended route
- It collided with an engineering barrier train which was in use, primarily for protection purposes by the project
- It was a low speed collision but still caused some damage to the trains
- From an operational point of view, caused the loss of a further 3 platforms, resulting in more disruption

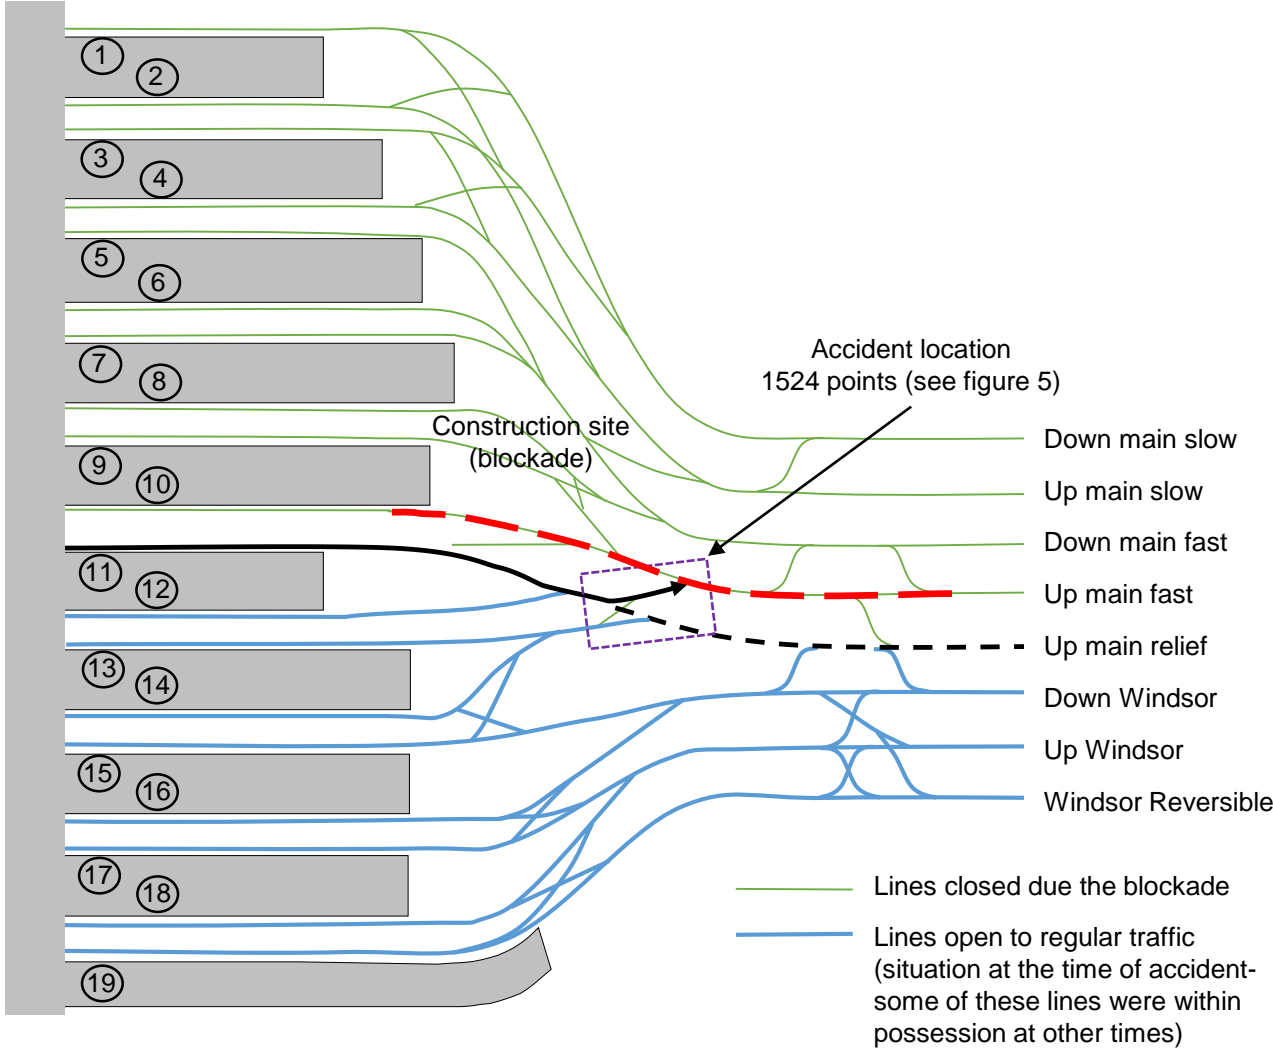
# Waterloo layout

- Lines closed due the blockade
- Lines open to regular traffic (situation at the time of accident—some of these lines were within possession at other times)
- Route of train 2D03
- - - Intended route of train 2D03
- - - Engineering train
- ① Platform number, former international platforms (20 to 24) not shown

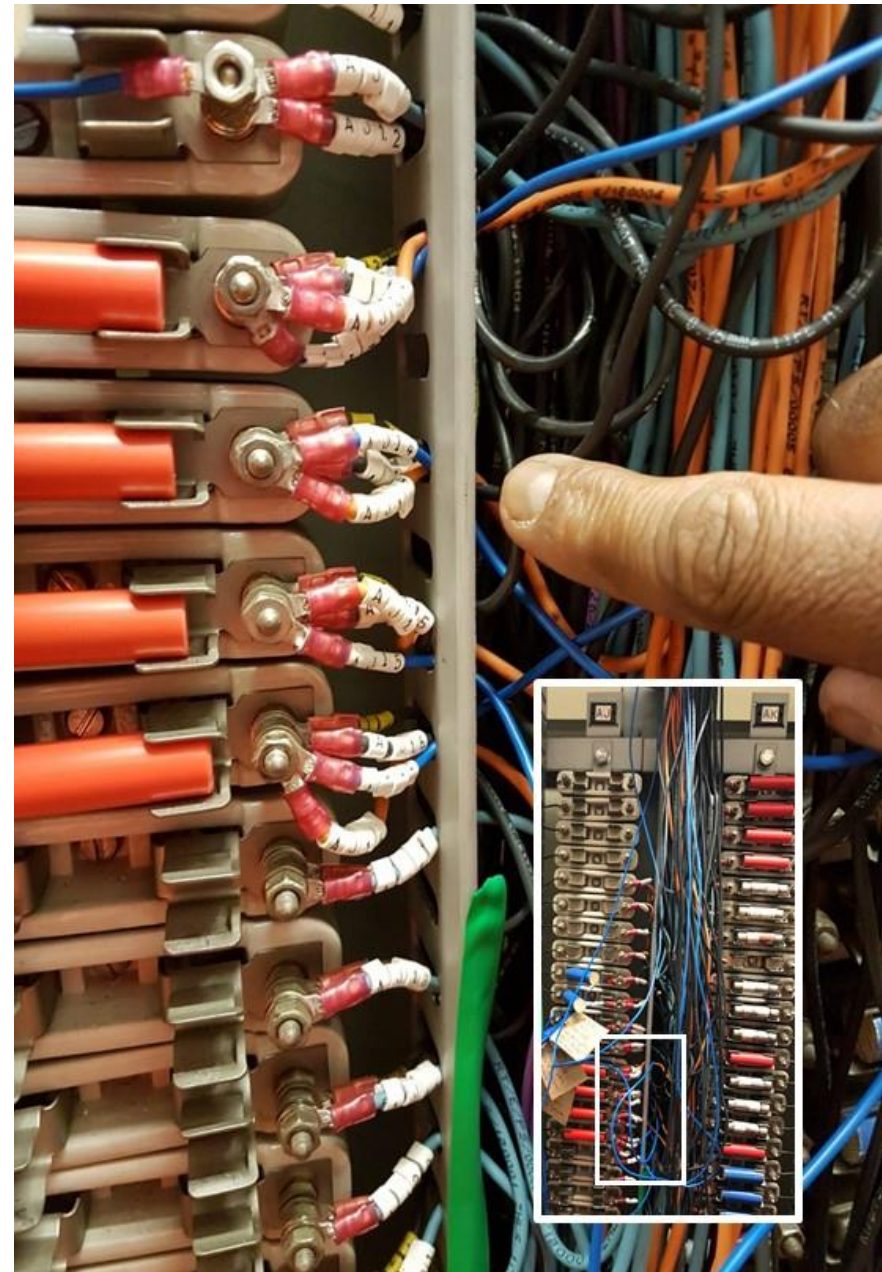
# Initial findings

- Waterloo relay room secured by BTP as sabotage had not been ruled out
- Lots of coloured wiring, not unusual for relay room mid-commissioning
- Most additional wiring related to test desk, but another eight lengths of blue wire were found
- The blue wires did not appear on wiring schedules, all had been made with crimped terminations, collar IDs and were tucked away in wire trays
- Four of the blue wires had cardboard 'baggage' labels which showed their purpose, those attached to 1524 points did not have these.

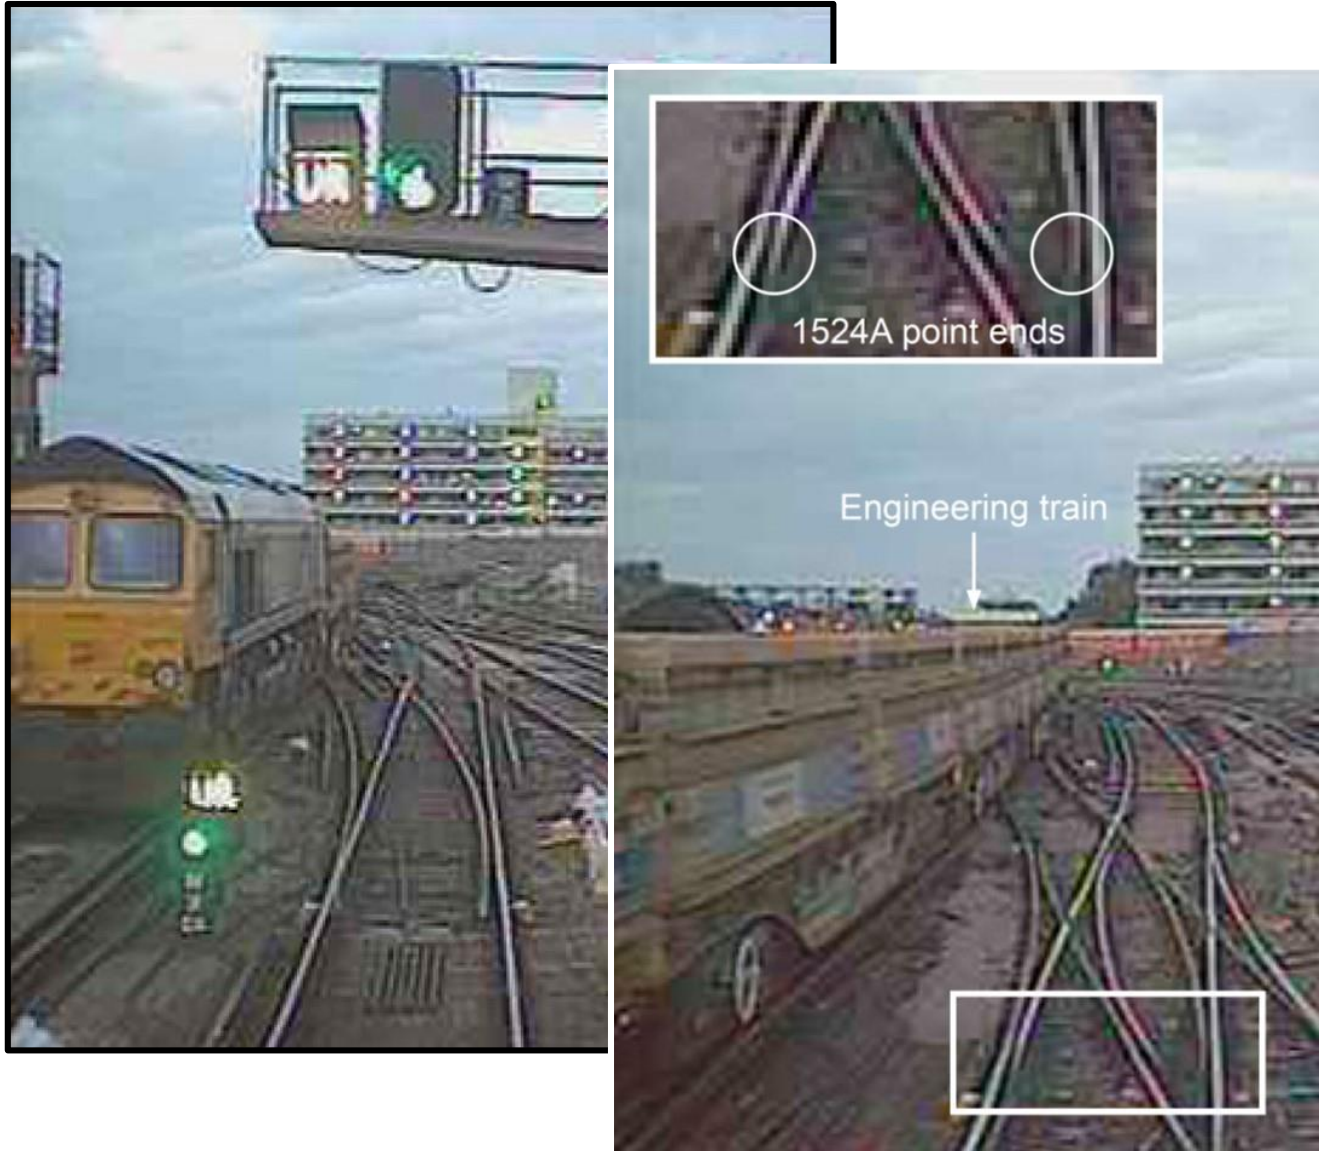
# Immediate cause

- The train was signalled to run over a set of points which were not correctly positioned.
- The driver had authority to proceed out of platform 11 and along the up main relief line, the line running alongside the engineering train.
- Images from the passenger train's forward facing CCTV show a green signal with a 'UR' indication and 1524 points in an intermediate position.

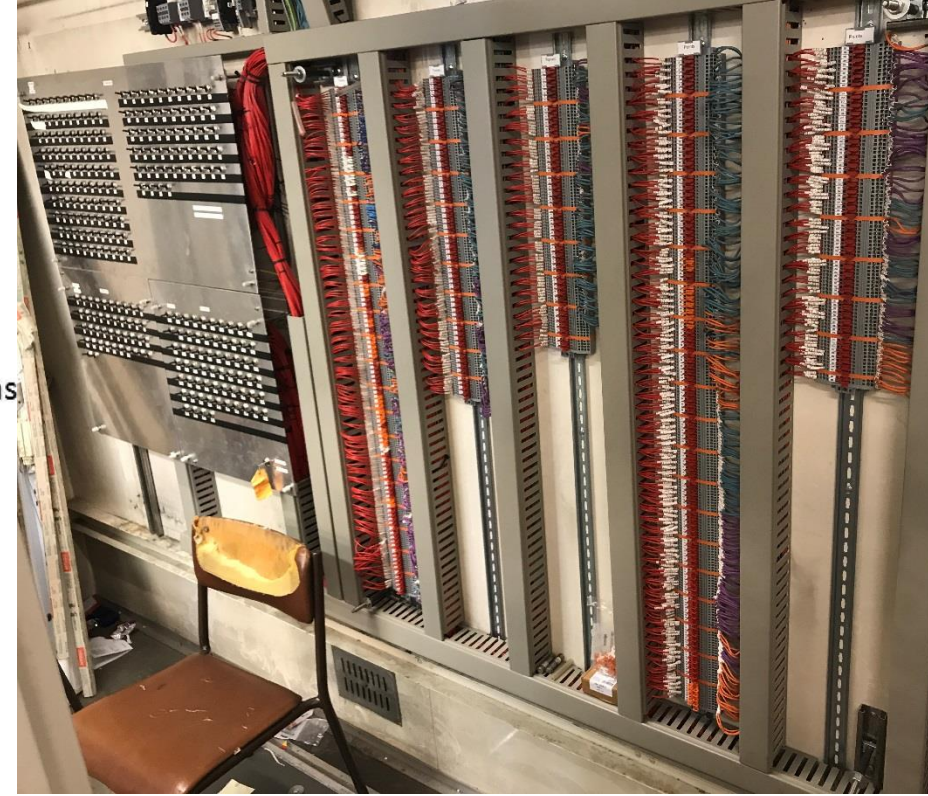
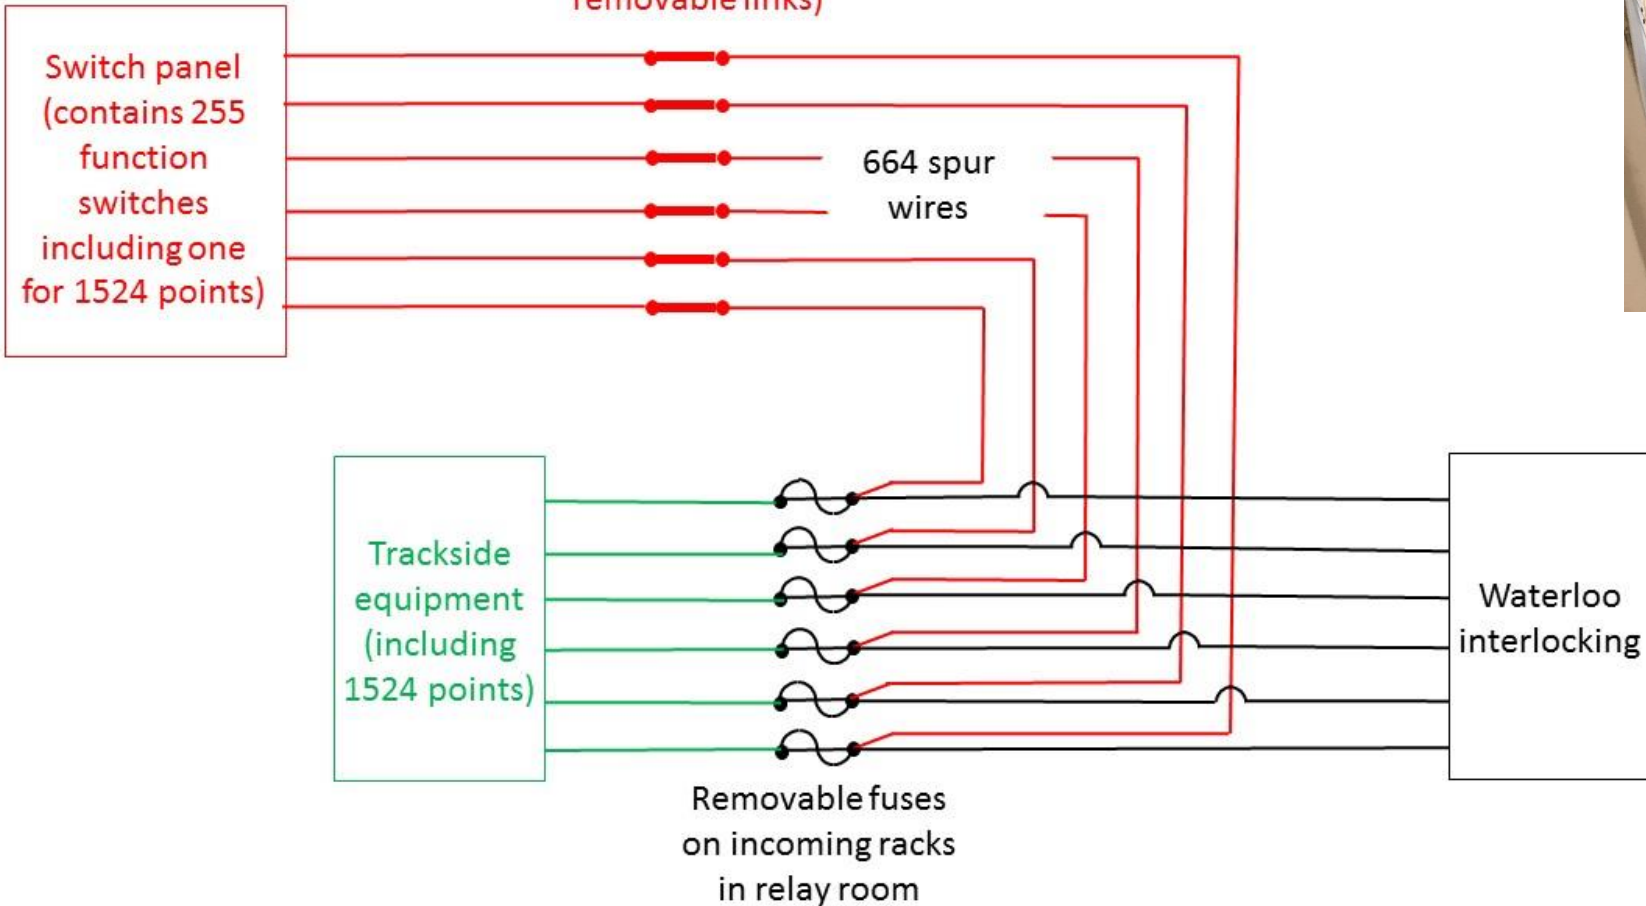
# Test desk concept

The test desk comprised the spur wires, isolation rack, switch panel and connections between the rack and panel.
