Rail Accident Investigation Branch

# Rail Accident Report

## Passenger injury at Ashton-under-Lyne tram stop 12 March 2019

Report 15/2019  
November 2019

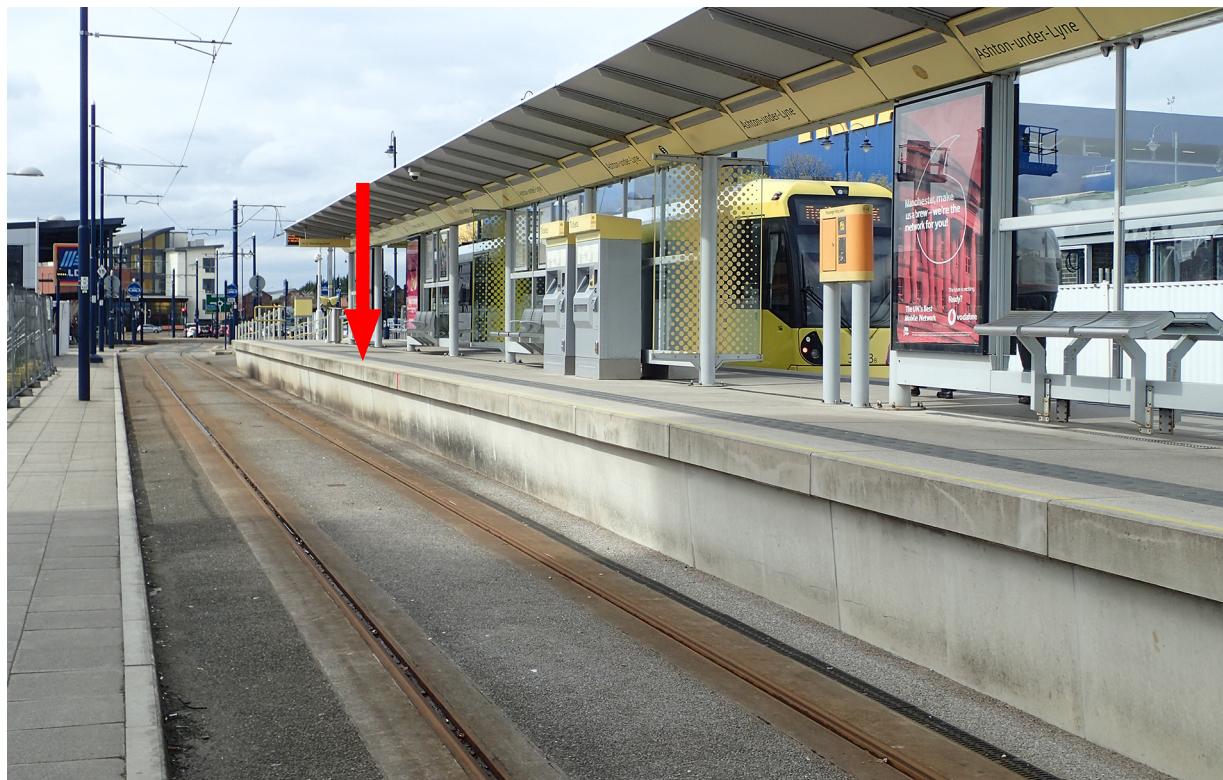
- Ashton-under-Lyne tram stop (figure 2) is situated 10.8 miles (17.4 km) from a datum point located in Manchester city centre. It is the terminus of the East Manchester line. The stop has two platforms, identified as platform 'A' and platform 'B'. Platform 'B' (figure 3), where the accident occurred, is the more southerly of the two platforms.

Figure 3: Platform B at Ashton. The red arrow indicates the point at which the passenger was standing when he fell from the platform.

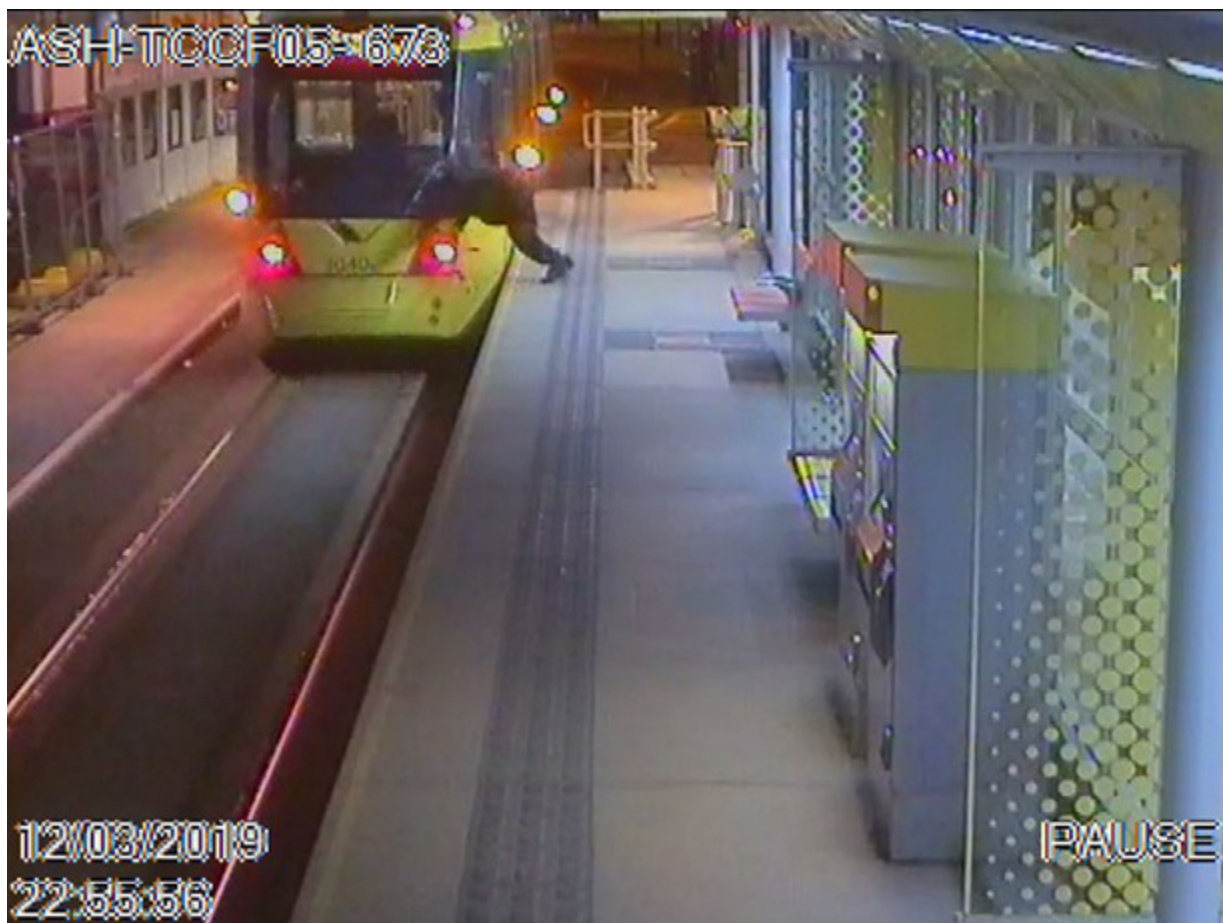
- 27 At 22:55 hrs, the tram started to move. At that moment, the passenger was standing on the platform, leaning on the side of the tram. When the tram initially started to move, the passenger moved slightly away from the tram. However, once the articulation section of the tram (figure 4) had passed him, the passenger moved back towards the tram and once again came into contact with its bodyside.
- 28 Once the tram had passed the passenger, he was no longer supported by the side of the tram and he fell from the platform (a height of 905 mm, paragraph 6) and landed on the track (figure 5). Tram stop CCTV shows the passenger lying motionless thereafter.

Figure 5: The passenger falling from the platform onto the track. Image taken from tram stop CCTV (courtesy Keolis Amey Metrolink)

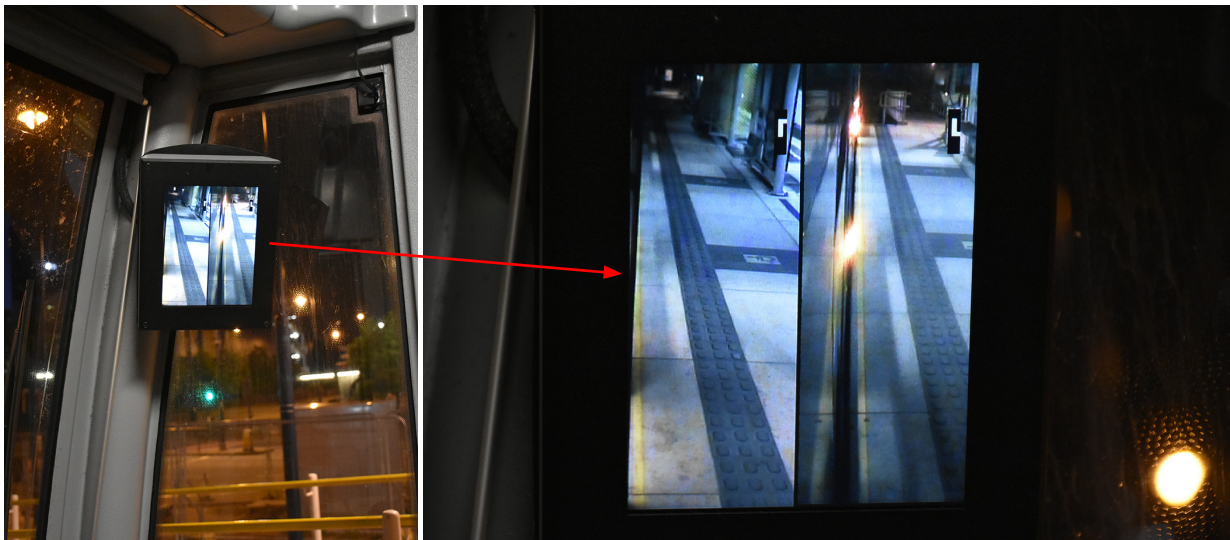
Figure 6: The CCTV screen which provides images to the driver from the side-view cameras. The image shows the screen displaying a 'split' view.

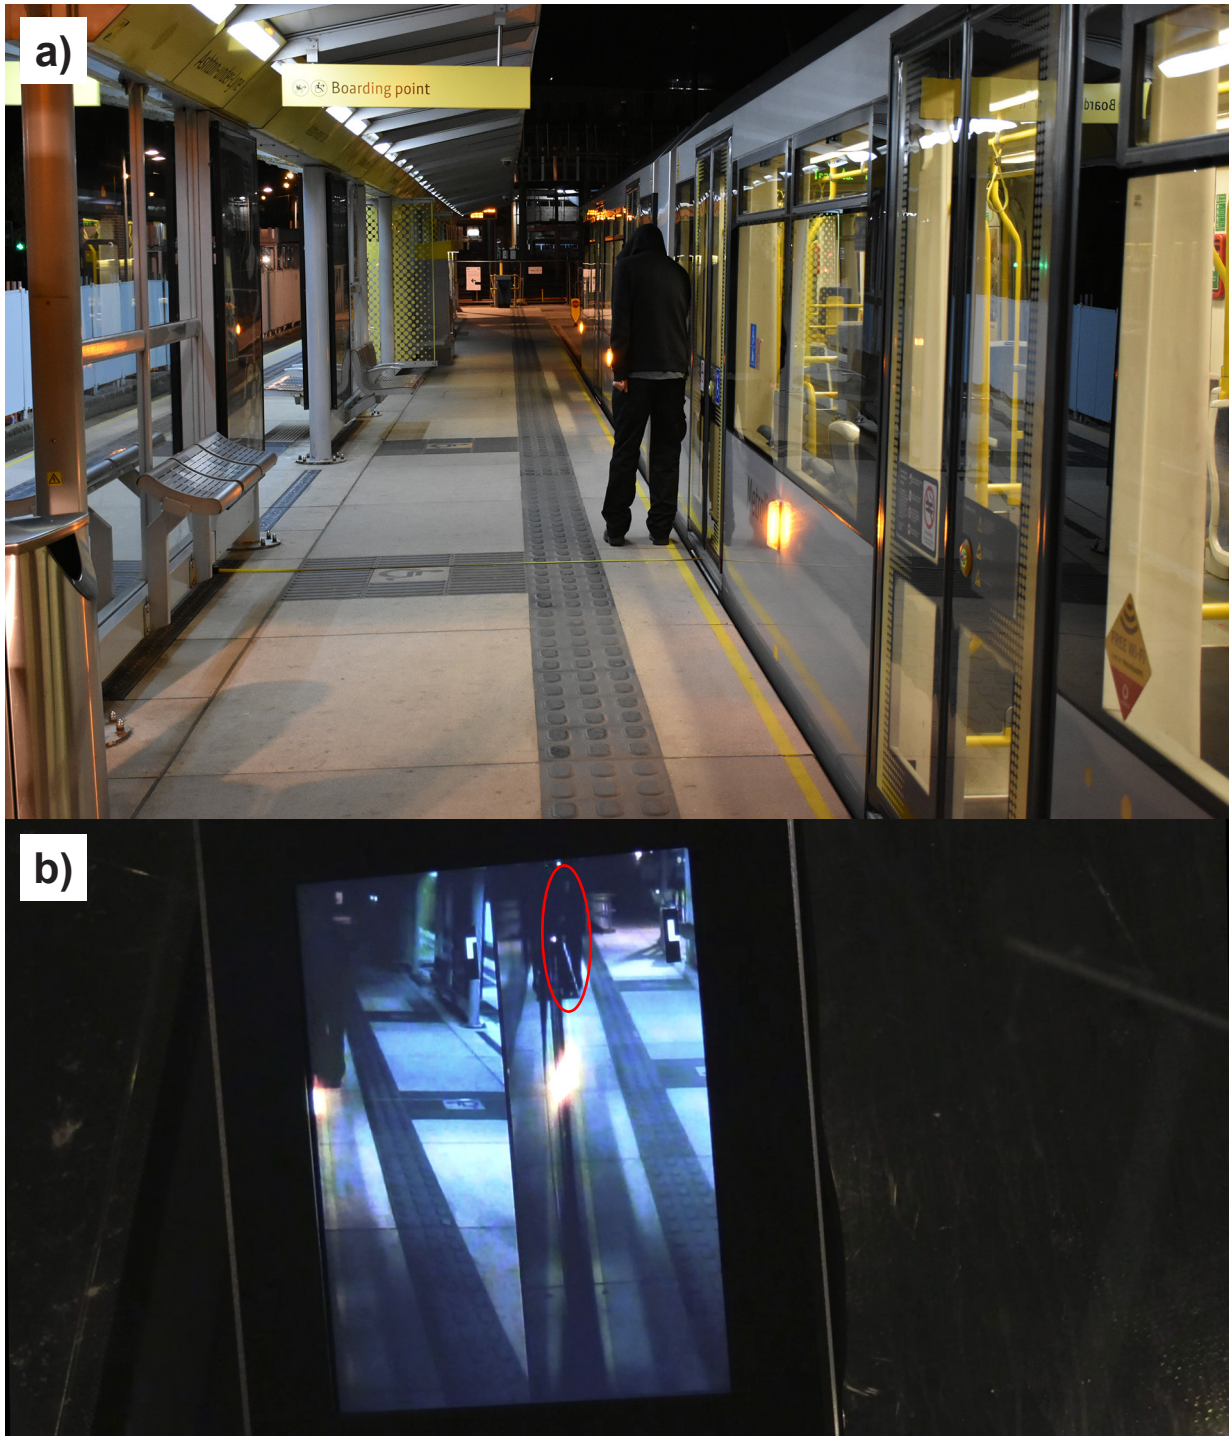
- 55 It was dark at the time of the accident and the passenger was wearing dark clothing. To assess the visibility of the passenger in the side-view CCTV screen, the RAIB carried out a reconstruction at Ashton-under-Lyne tram stop during the hours of darkness.

- 56 The tests were carried out during the night of 31 May into 1 June 2019, using the tram that had been involved in the accident. A member of RAIB staff, of similar build and stature to the passenger, was dressed in dark clothing, provided with a similar walking aid, and acted as the passenger.
- 57 The tram was placed in platform B at Ashton-under-Lyne tram stop, and the actor was then positioned in a similar location to the passenger at the time of the accident (figures 8a and 8b).

Figure 8: a) Photograph taken during the RAIB reconstruction of the accident; and b) CCTV image during the RAIB reconstruction showing the view available to the driver. The individual in the reconstruction is dressed and positioned in a similar location to the passenger at the time of the accident.

- 58 The reconstruction verified that the passenger would have remained within the field of view of the CCTV system regardless of the position of the door side selector switch (paragraph 36) and whether the screen was in 'split' or 'normal' mode.
- 59 However, the reconstruction also showed that a person wearing dark clothing was difficult to see in the CCTV image (figure 8b). Although Ashton-under-Lyne tram stop is well-illuminated, the area to the east of it is dark. Therefore, the CCTV camera looking along the side of the tram would have provided an image of a passenger in dark clothing against a dark background.

- (a) carry out a review of the lighting conditions at tram stops to identify any local lighting conditions, taking into account backgrounds, which may make it difficult for tram drivers to see passengers in close proximity to the tram, particularly during night-time operations.
- (b) implement the findings of the review, in conjunction with TfGM, to improve the visibility of passengers at the platform-tram interface (e.g. by improving platform lighting and/or tram CCTV systems).

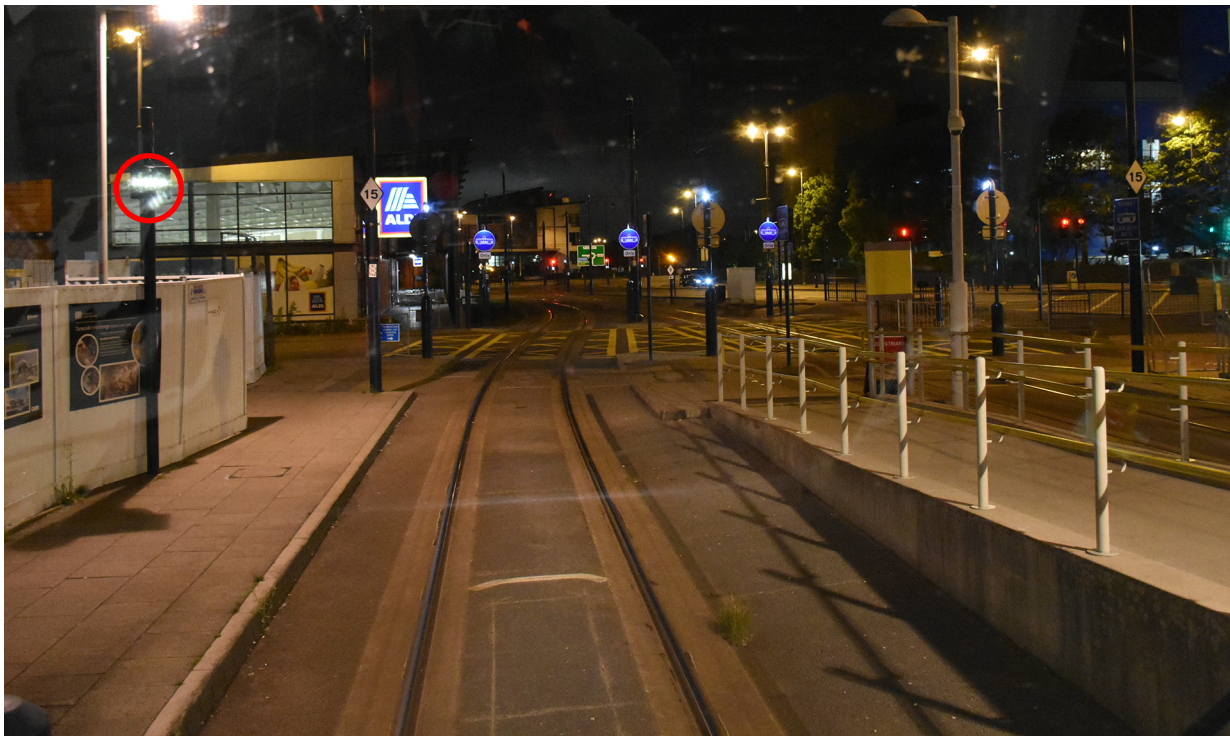
- 64 The tram signal for platform B at Ashton-under-Lyne is placed on the left side of the track (figure 9), whereas the screens providing the side-view CCTV images are on the right side of the cab. Therefore, the driver would have been required to split his attention between the signal and the CCTV screens. It is possible that this may have contributed to the driver not seeing the passenger in close proximity to the tram.

Figure 9: View from the cab at Ashton-under-Lyne platform B, showing the tram signal (circled)
