Report on the investigation of the fatal accident
while boarding the tug

Millgarth

at the north oil stage

on 27 January 2019

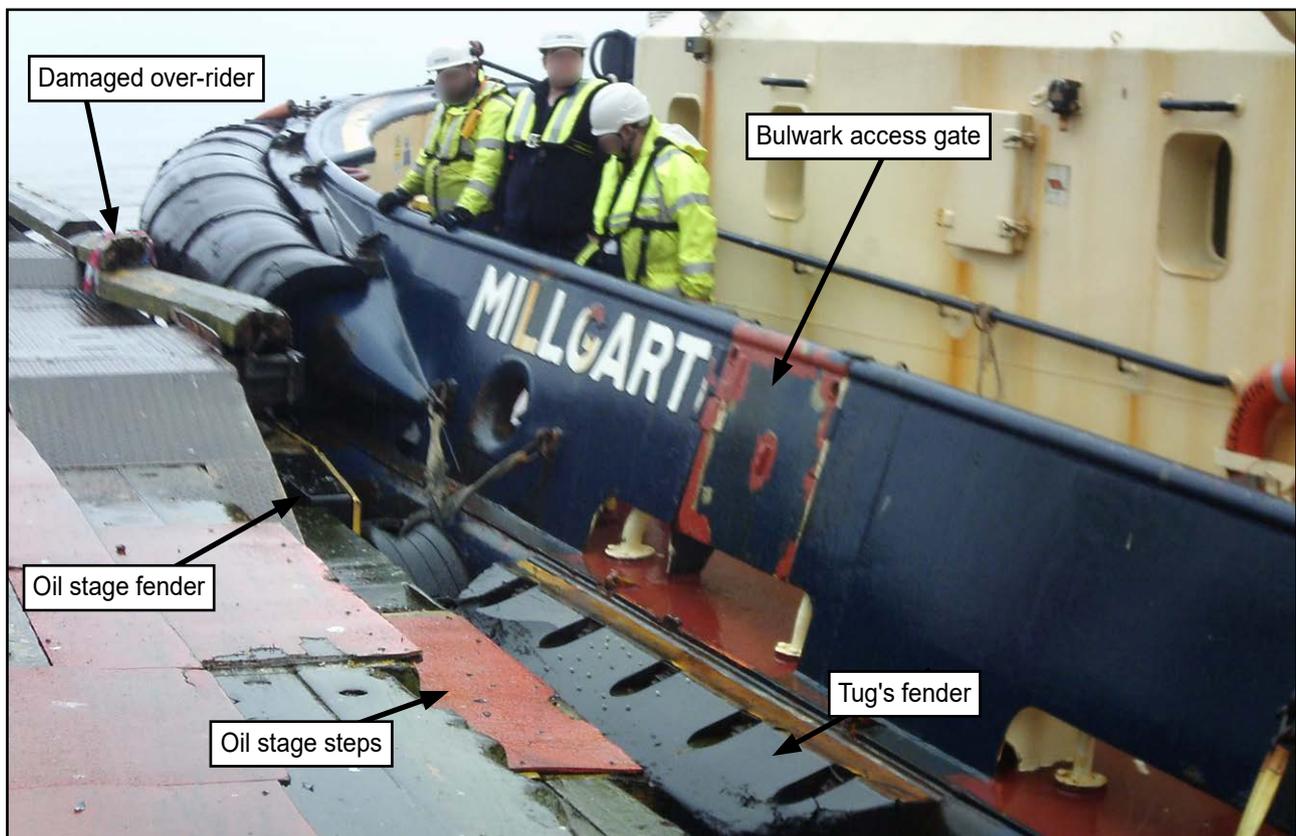
Figure 3: Oil stage steps and *Millgarth's* bulwark access gate (photograph taken during post-accident reconstruction)

It was common practice for the bulwark gates not to be lined up with the oil stage steps during berthing and unberthing operations and when the tugs were made fast alongside. This was due to the risk of the tug's bow fender contacting and causing damage to the over-rider timber. When this was the case, the crew often stepped onto the oil stage fender, which was approximately at *Millgarth's* deck level, and climbed over the timber over-riders, when leaving the tug, and vice versa when boarding.

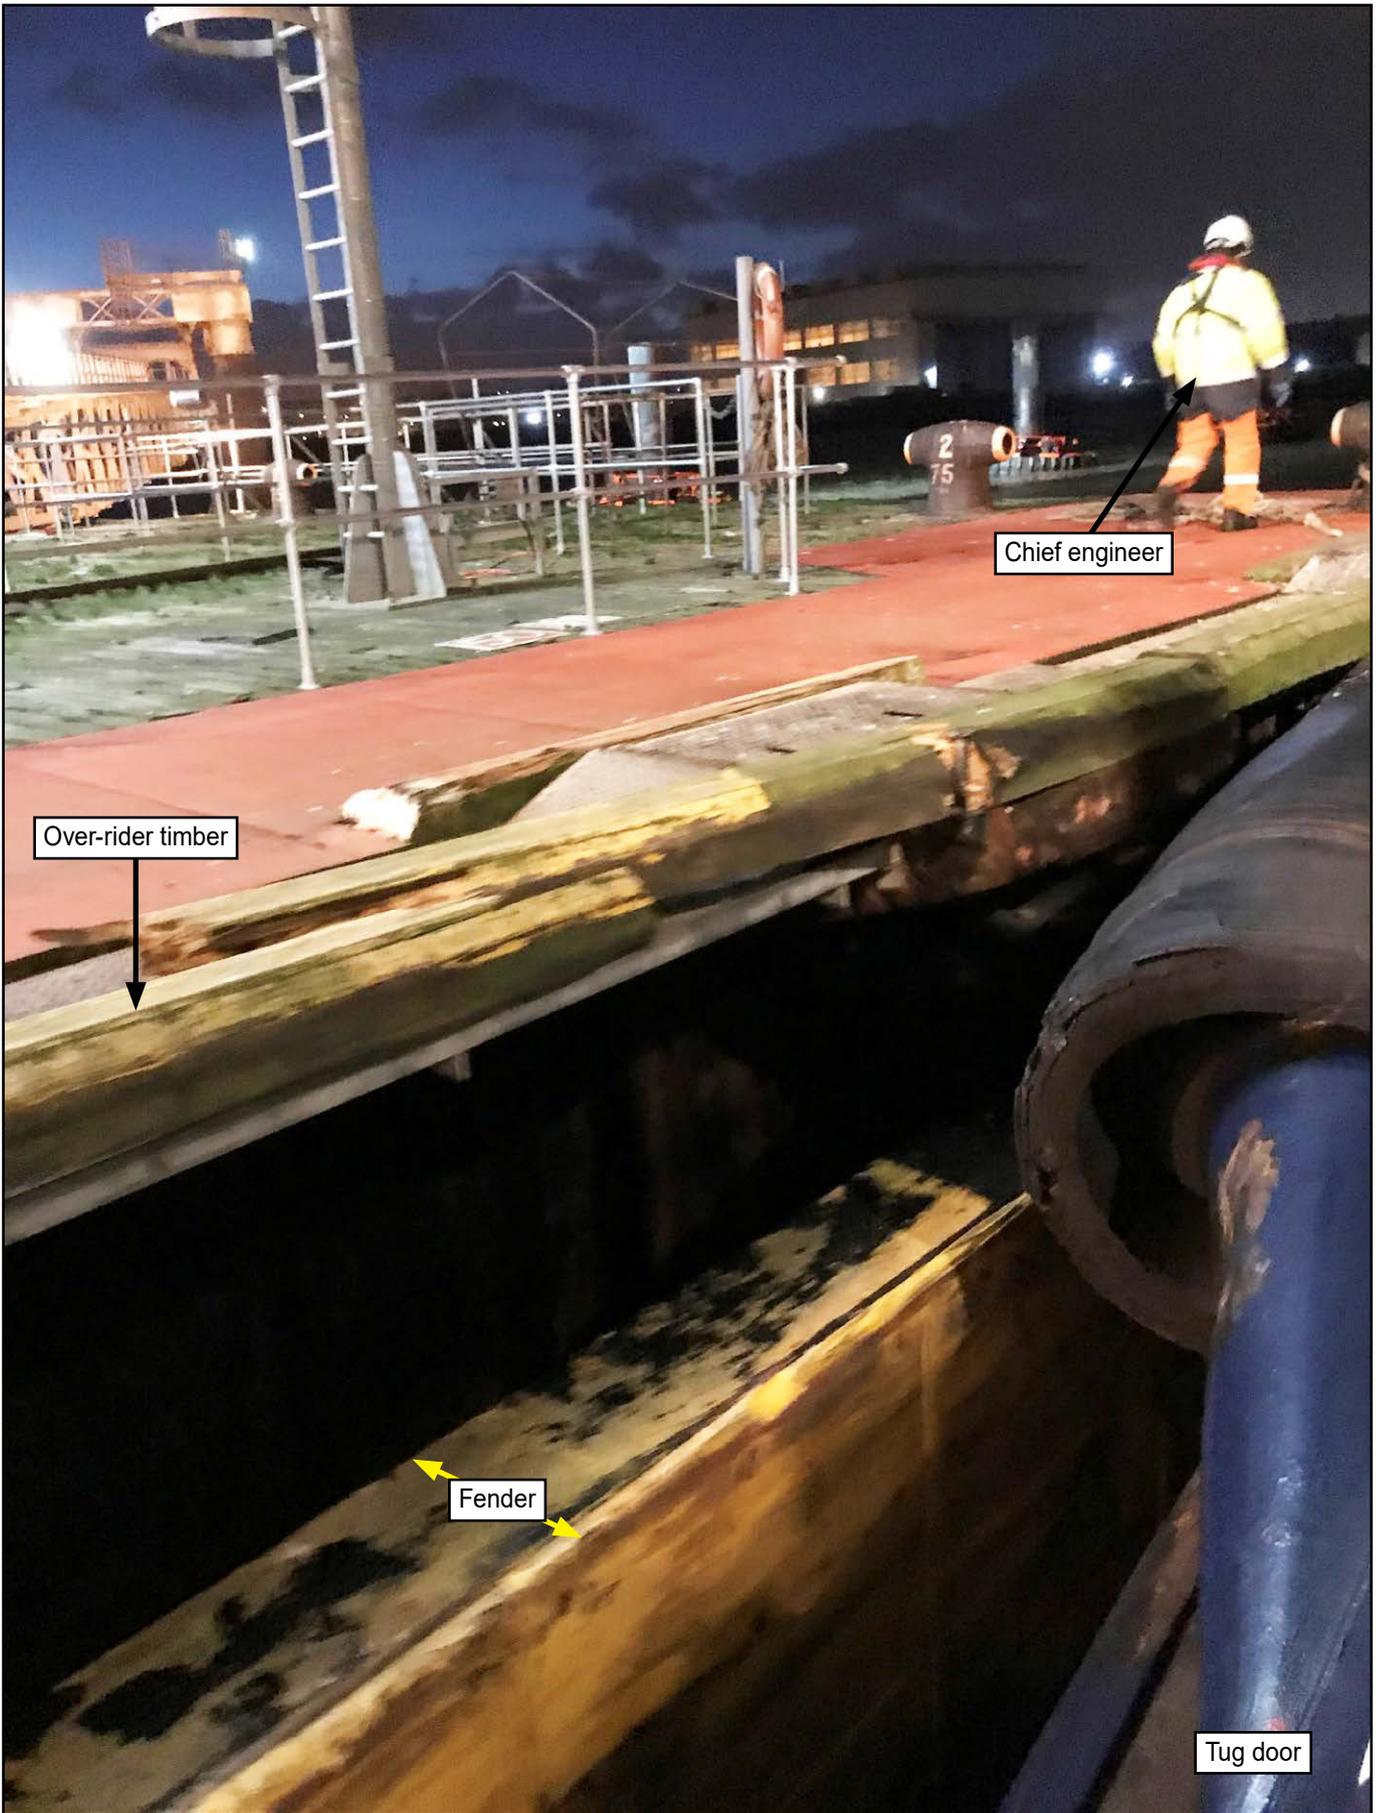
Figure 4: Chief engineer on north oil stage about to release the head line (photograph taken by a crew member to record damage caused to over-rider timber)

At about 1749, the chief engineer stepped over the damaged over-rider and, crouching down, lowered himself onto the top of the fender. As he did so, he fell backwards, through the gap between the oil stage and the fender, into the river. His lifejacket inflated and he started to drift clear of the oil stage and tug with the ebbing tide.

The environmental conditions at the time were severe, and as the chief engineer attempted to board the tug, he would have been buffeted by the strong prevailing wind and *Millgarth* would have been moving on the waves. Although it was not raining at the time, both the fender surface and the oil stage were wet due to spray from the river. It was also apparent, from witness accounts, that the chief engineer had crouched down as he stepped over the timber over-rider. This suggests that he might have been holding on to the broken over-rider, in the absence of any other suitable handhold.

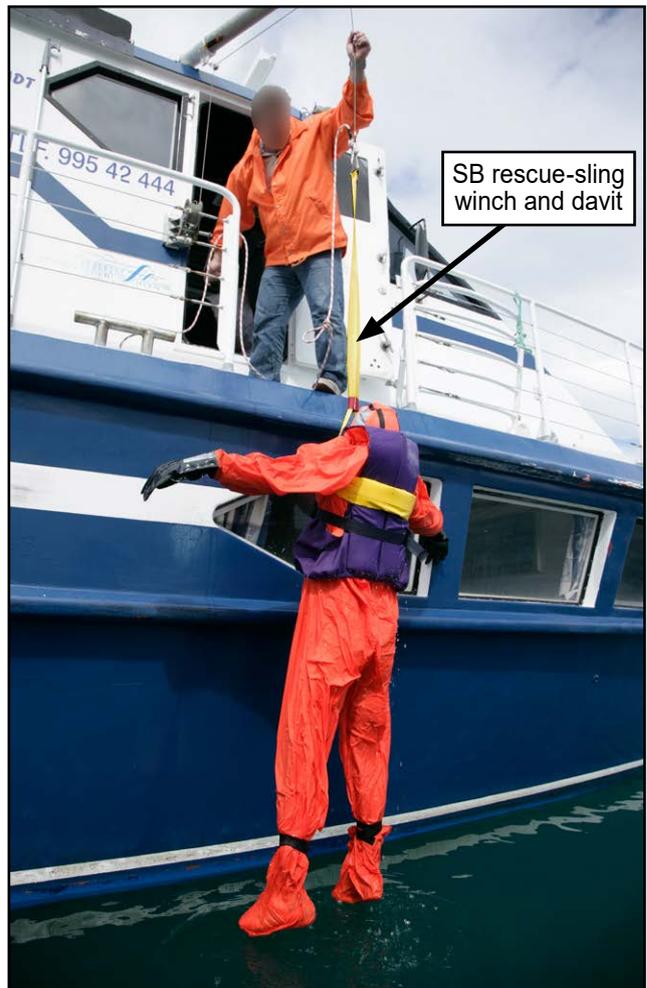
Millgarth did not have dedicated SB davits or winches (**Figure 7c**); the primary purpose of the SB rescue-sling was to help guide the MOB into the Jason's Cradle.

Figure 7c: SB rescue-sling in use

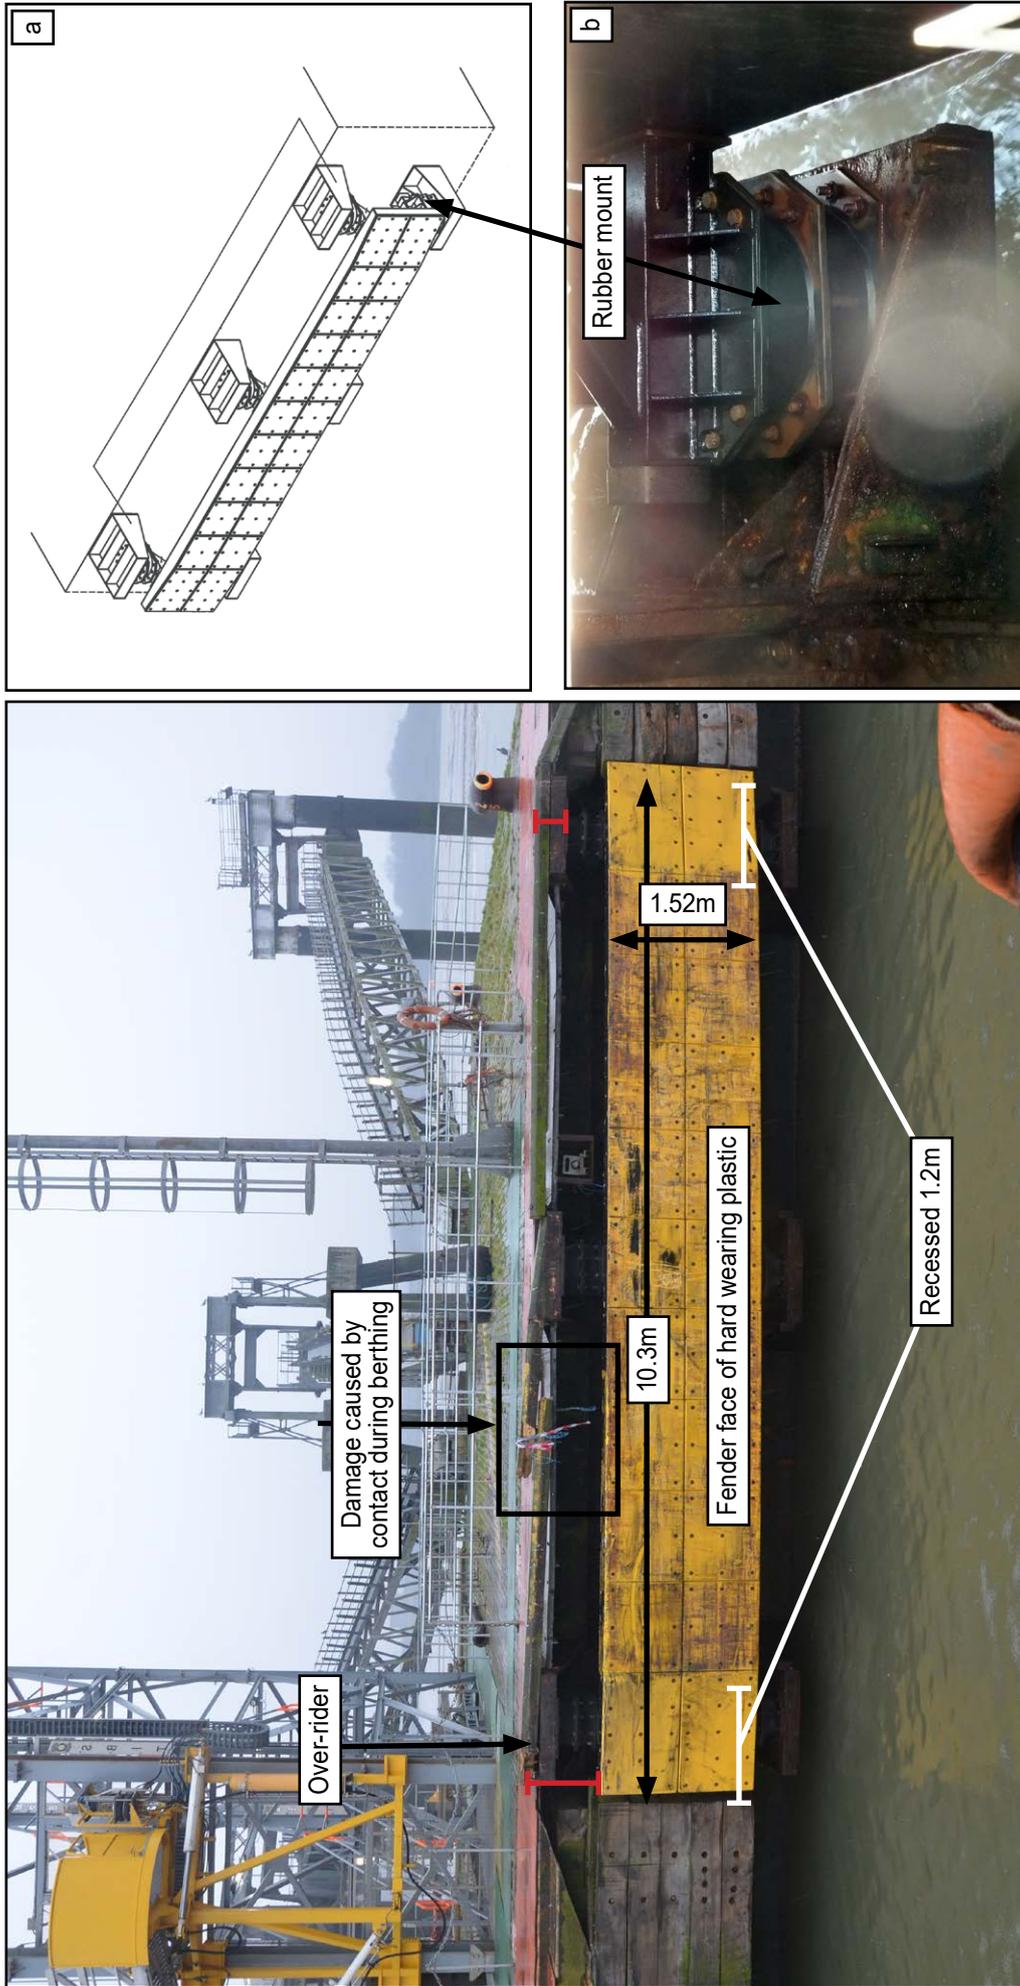
The north and south oil stages were almost identical 110m x 20m buoyant pontoons, connected to shore via articulated arms that moved with the tide, allowing the stages to be unaffected by tidal changes in the river. Each stage was protected by four steel fenders of hollow box construction, each 10.3m long, 1.52m high and 0.34m deep. They were attached to the stage using flexible rubber mounts. The back of each fender stood approximately 0.1m proud of the oil stage, and the drop between the top of the over-rider and the top of the fender was 0.78m (**Figure 9**).

Figure 9: North oil stage fender (inset a: Isometric view and inset b: Rubber mount)

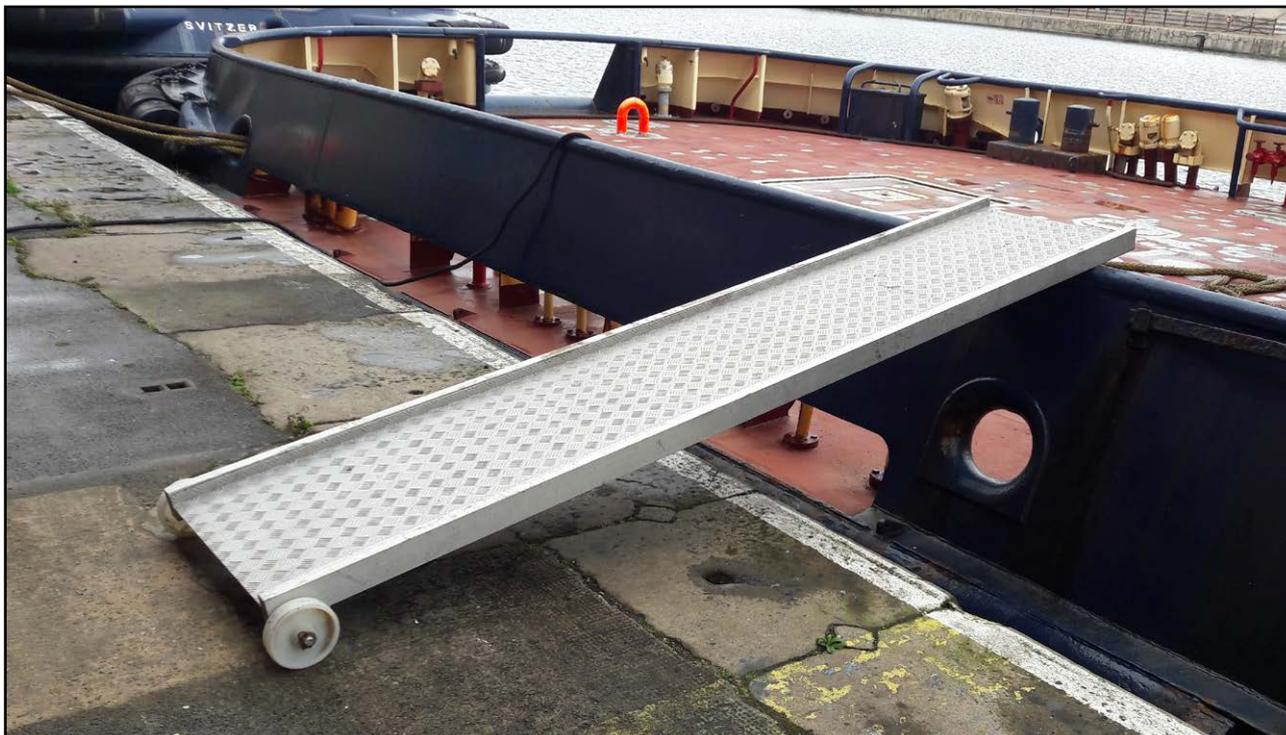
The discussion regarding gangways continued, and one was made up for Svitzer *Stanlow*, with the intention of testing it on other tugs in the fleet. However, the fabricated gangway was found to be too heavy. Another gangway was tested on one of the tugs, and photographs of the arrangement were exchanged between the tug

and the Liverpool office (**Figure 11**). In May 2018 the project for supplying gangways to all the tugs in Liverpool was temporarily halted pending the imminent move of Svitzer UK's permanent mooring docks from Bramley to an alternative site.

Figure 11: Ramp used in gangway trial

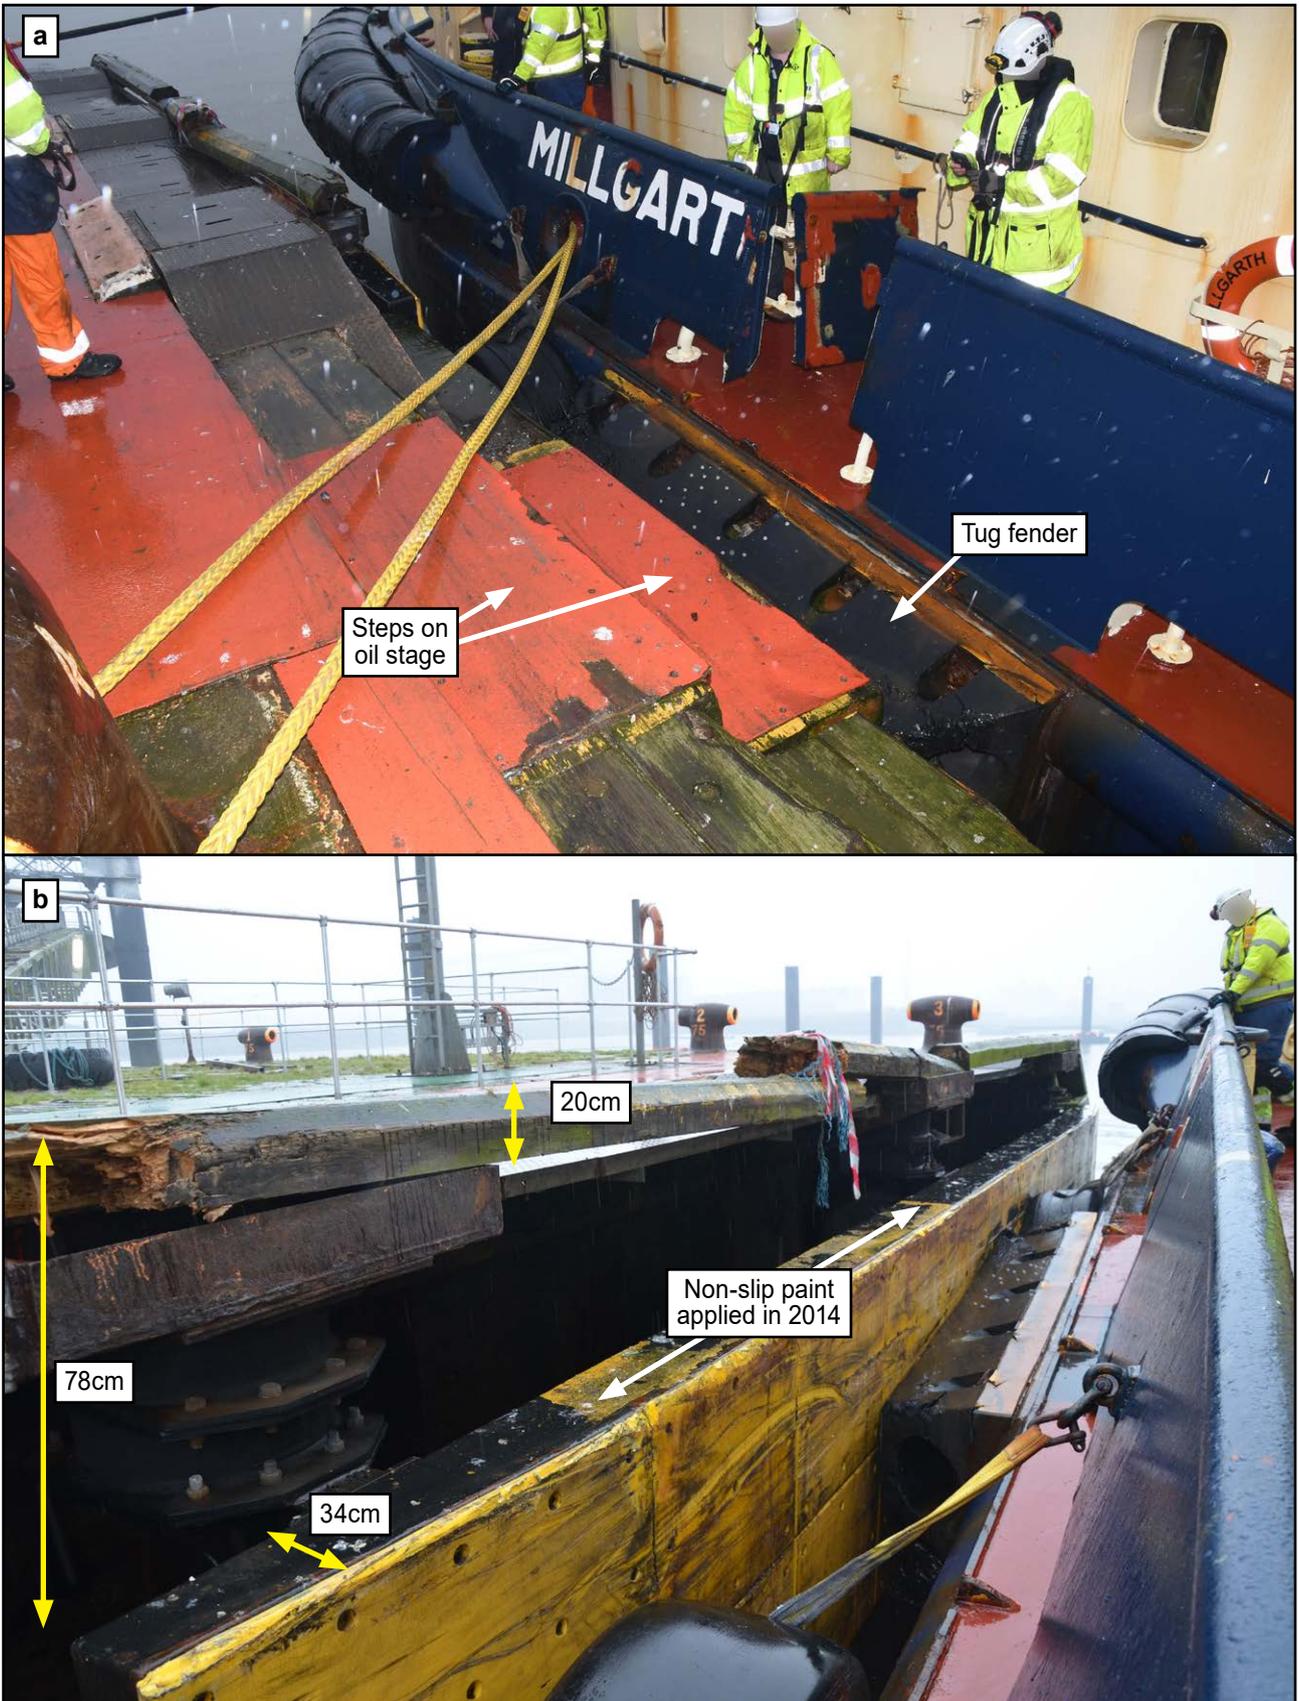
- It was possible to make fast *Millgarth* to the bollards on the oil stage with the tug access door aligned with the oil stage steps. It was noted that the mooring lines posed a trip hazard on the access steps (**Figure 13a**).

- When the tug door was aligned with the steps, there was little or no air gap between the tug fender and the steps on the oil stage. It was possible to step directly onto the oil stage steps from the tug's deck without having to step onto the tug fenders.
- When the vessel was moved ahead 2 to 3m, the tug door was aligned with the non-slip paint on the top of the fender and the damaged section of the timber over-rider (**Figure 13b**).

Figure 13: Reconstruction (a: tug gate aligned with the steps, b: approximate location of *Millgarth* when chief engineer attempted to board)
