Rail Accident Investigation Branch

Rail Accident Investigation: Interim Report

**Track workers struck by a train at Margam,
South Wales
3 July 2019**

Report IR1/2019
December 2019

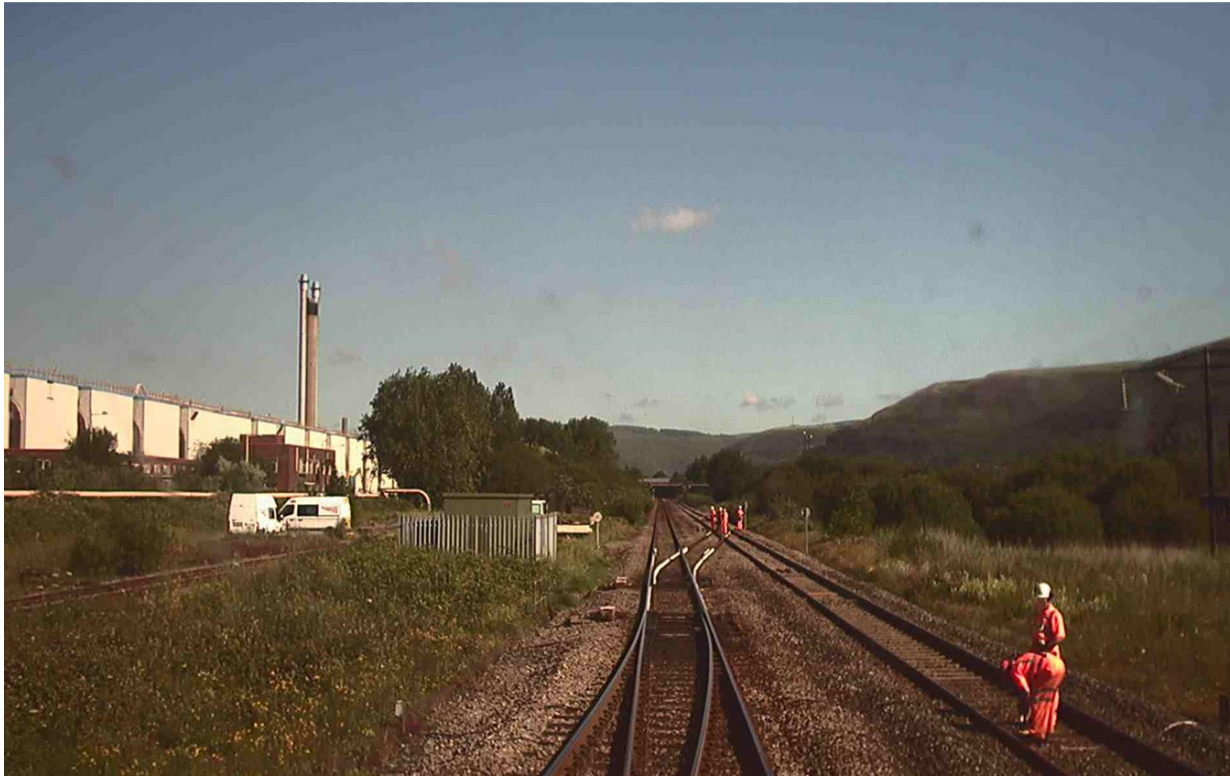
Figure 3: FFCCTV image looking towards Port Talbot from a train on the down main line at approximately 09:24 hrs, showing the two groups working on the open up main line approximately 100 metres apart

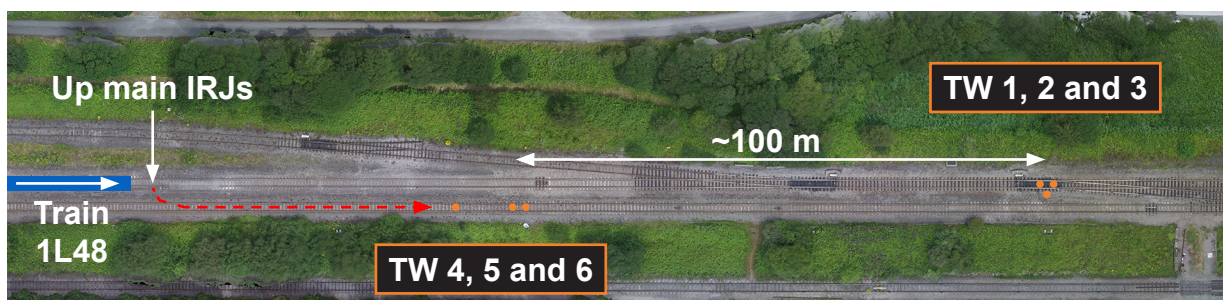
39 When they had completed their work on the IRJs, the COSS (TW4), the lookout (TW5) and the other track worker (TW6) crossed from the up main line to the down main line and walked back along the down main line towards the access point. They were walking facing the direction of traffic on that line, and therefore had no need to look out for trains approaching from behind them on the other line. Train 1L48 approached from behind them on the up main line travelling towards Cardiff. At this time they could see the other three track workers about 100 metres ahead, and they have stated that they were surprised to see them working on 9577B points on the up main line with a train so close (figures 4 and 5).

Figure 4: Position of workers immediately before the accident

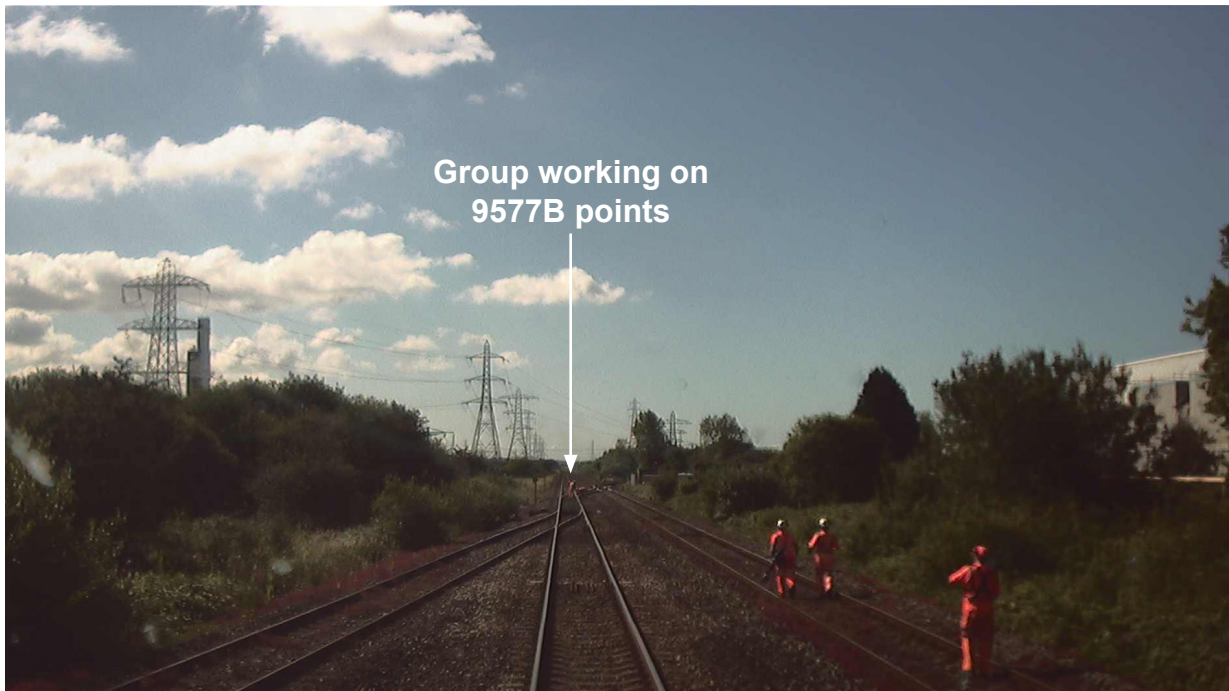
- 42 As the train passed him, the lookout, TW5, who was with the group walking on the down line, also began blowing the horn he was carrying. The other two track workers in the group began to shout and they all moved faster towards the three working on 9577B points (figure 5).

Figure 5: Image from FFCCTV from train 1L48 as it was passing the group walking on the down main line
