SS Richard Montgomery 2005 Survey Report

Executive Summary

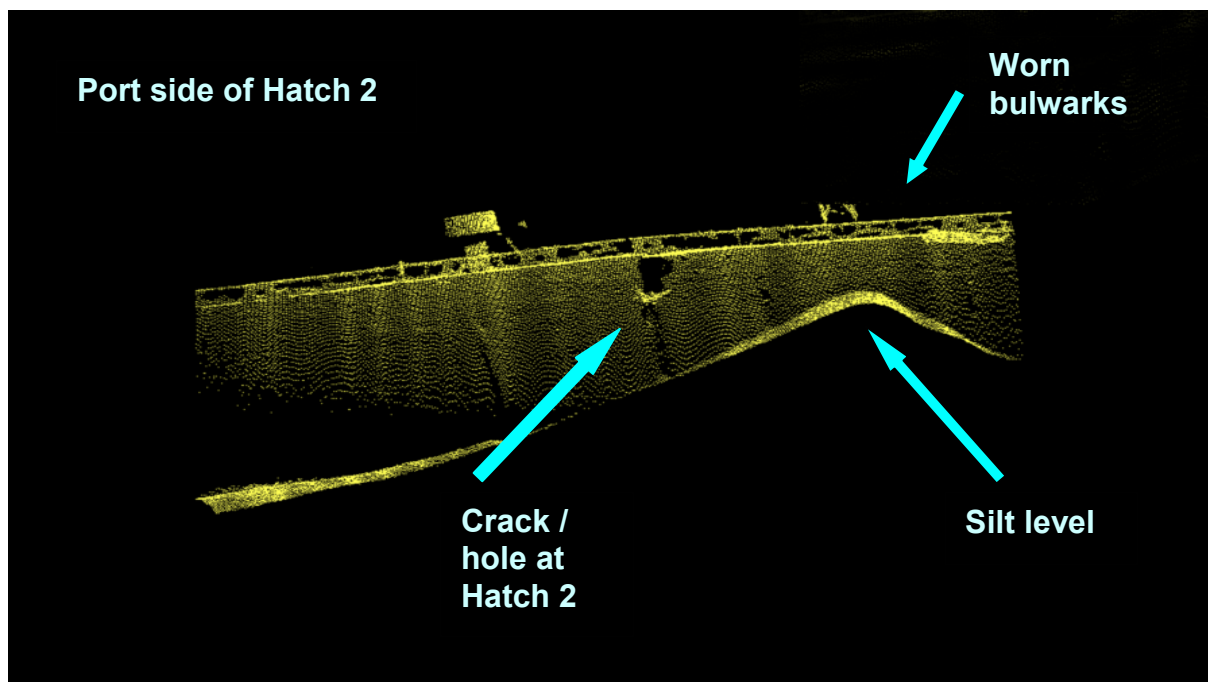
The hull separation, which happened when the vessel sank in 1944, has caused extensive collateral damage in the area and most visible elements of the structure have irregular edges, splits and apertures in the immediate vicinity.

The relatively thin plating of the bulwarks is corroded all around the wreck, and numerous apertures in the main deck and on the boat deck are evident. These are likely to be constructed of thinner steel than the 5/8" (15.5mm) of the hull plating, but even here, where the hull form provides strength to the whole structure, there is evidence of corrosion in the irregular shape of most apertures and edges to splits.

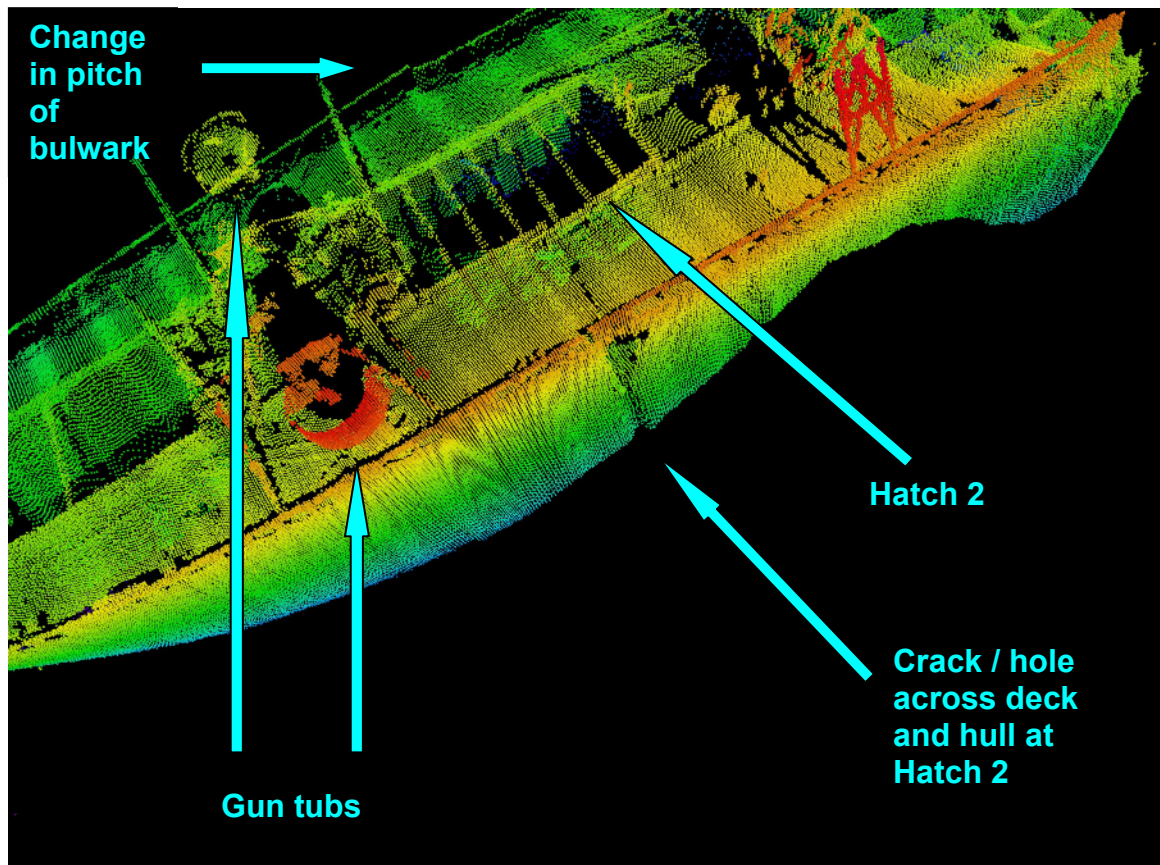
There is distortion of the hull and buckling of the plates for the length of Hold 2, probably caused by the weight of cargo and structure pressing down in this area, as well as buckling and splitting of deck plates. This distortion is mirrored on the port side, indicating that the weight of the contents of Hold 2 is pressing outwards.

The survey indicates localised corrosion in the area of the main crack by hold 2 (detailed in previous reports), a split in the starboard side of the forward section with overlapping plates as well as buckling and splitting of deck plates on both the port and starboard sides. The data indicates that the structural integrity of the wreck is inevitably being compromised by a number of cracks in the hull and decks.

Distortion is apparent in the bow section, probably owing to the weight of cargo, and this is especially noticeable in Hold 2. On the starboard side this has resulted in a longitudinal crease in the hull plating at 'tween deck level running for 11m from a major split to the aft end of Hold 2. Below this the side of the ship just above the turn of the bilge has been pushed outboard by up to 2m. Forward of the split there appears to be a 4m long aperture just detectable at the turn of the bilge.

A significant internal change in the wreck, the apparent collapse of part of the cover over the hatch to lower Hold 2, took place sometime between 2002 and 2005.

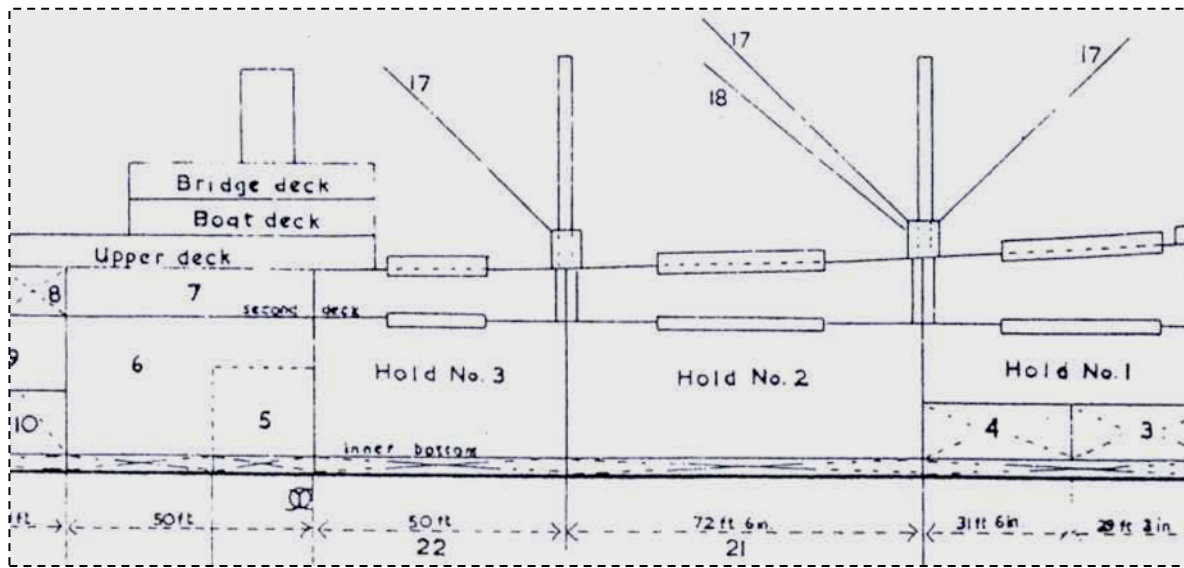
Debris from upper Hold 3 is piled on the seabed between the two sections against the bulkhead of Hold 3. Two larger pieces of debris, one port side of the forward section, the other starboard side of the after section, are also apparent.

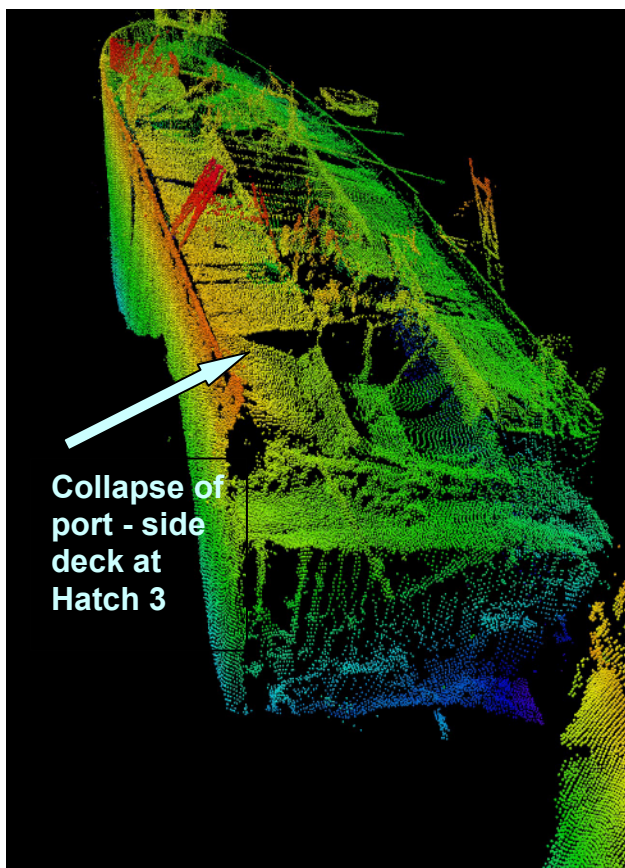
A section of the deck along the port side of Hatch 3, has collapsed. This is also evident from the 2002 survey, but appears to be more pronounced in the 2005 survey.
