SS RICHARD MONTGOMERY SURVEY REPORT 2003

RICHARD MONTGOMERY SURVEY REPORT 2003

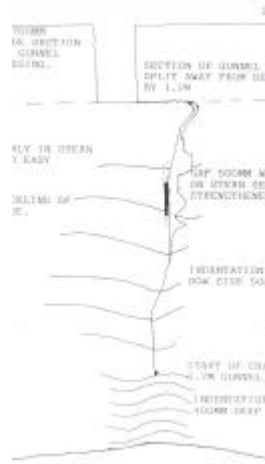
25. The 1991 survey stated that "Much of the hull plate particularly in stern section is badly corroded and easy to break away by hand. Area of crack has general buckling of plates in bank approx 3 m wide. Gap 50 cms at greatest point. Plate on stern section completely corroded. Strengthener can be felt in bow section. Difference in deck levels at split are 14 cm. Stern section lower than bow section."

Main crack on port side from surveys in 1985, 1991 and 2003. Approximately to scale

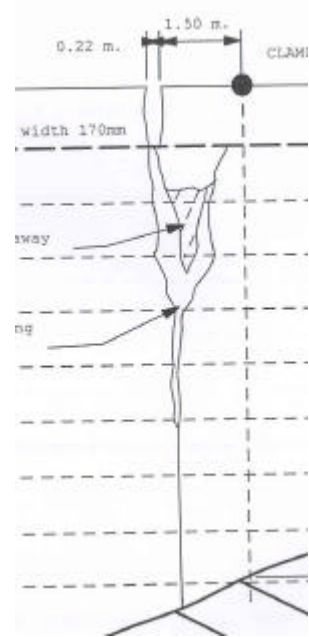
13. The 2003 survey identified that there is a gap in the gunwale of 22 cm at the top, reducing to 17 cm at deck level. The forward and stern sections are misaligned by 5 cm. The hull crack is 101.6 cm wide at 1 m below deck level and is 106.6 cm wide at 2 m below deck level. The crack was 15 cm at 3 m below deck level. At this point there was some debris protruding from the crack. At 4 m below deck level, the crack was 7 cm. At 5 m below deck level the crack was 6 cm. The crack closed completely at 16 cm below the 5 m mark. It is suggested that the central section of the Y – shaped crack may have broken away, to account for the larger crack size.

14. The deck crack associated with the hull side crack was measured 18 cm wide at 1.2 m from the gunwale. At 2 m from the gunwale it was 14 cm. The aft section of the plate was 15 cm lower than the forward section

32. There are drawings of the main crack at No 2 Hold from 1985, 1991 and 2003. These are presented alongside each other in order to give an idea of the changes over time. It will be observed that the crack has increased in width in the top three metres below deck level. However, there appears to be no significant increase in size below three metres. This suggests material falling away due to erosion around the break, rather than movement in the hull itself. From the drawings there appears to be some discrepancy over the size in the break in the gunwale. This may be due to either a misinterpretation on site (given the poor visibility) or may represent an actual change due to a shift in the wreck, though this seems unlikely as the deck crack has not materially changed in the last 10 years, and the lower part of the main crack does not appear to have altered.

36. It is recommended that a further detailed survey of the main cracks is commissioned in due course to monitor any further change to the cracks.
