A SURVEY OF THE WRECK OF  
THE SS RICHARD MONTGOMERY

A SUMMARY REPORT

The Maritime and Coastguard Agency

June 1998

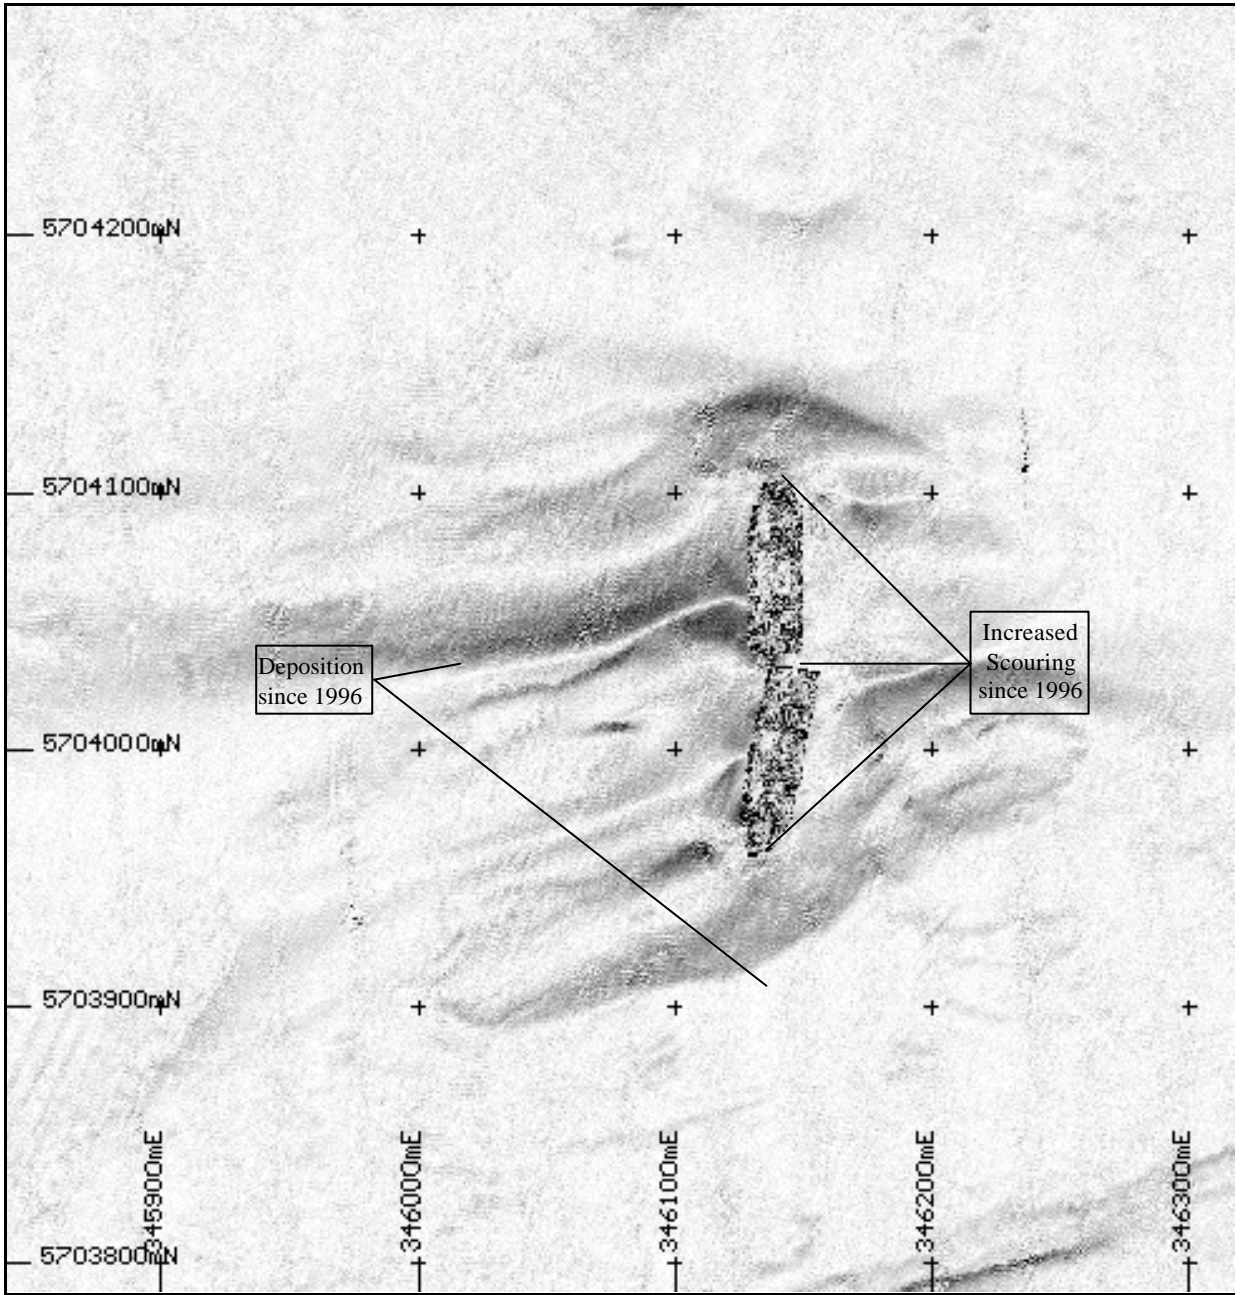
MONOCHROMATIC GRADIENT PLOT

A monochromatic gradient plot at Annex C reveals details of the ship's structure. This plot also reveals details of small seabed topographical features such as sand ripples over the area.

- 20 The objects situated to the west of the aft section were visible on the gradient chart. Inspection of the raw survey data had again revealed that the objects were not exposed but were affecting the surrounding seabed.

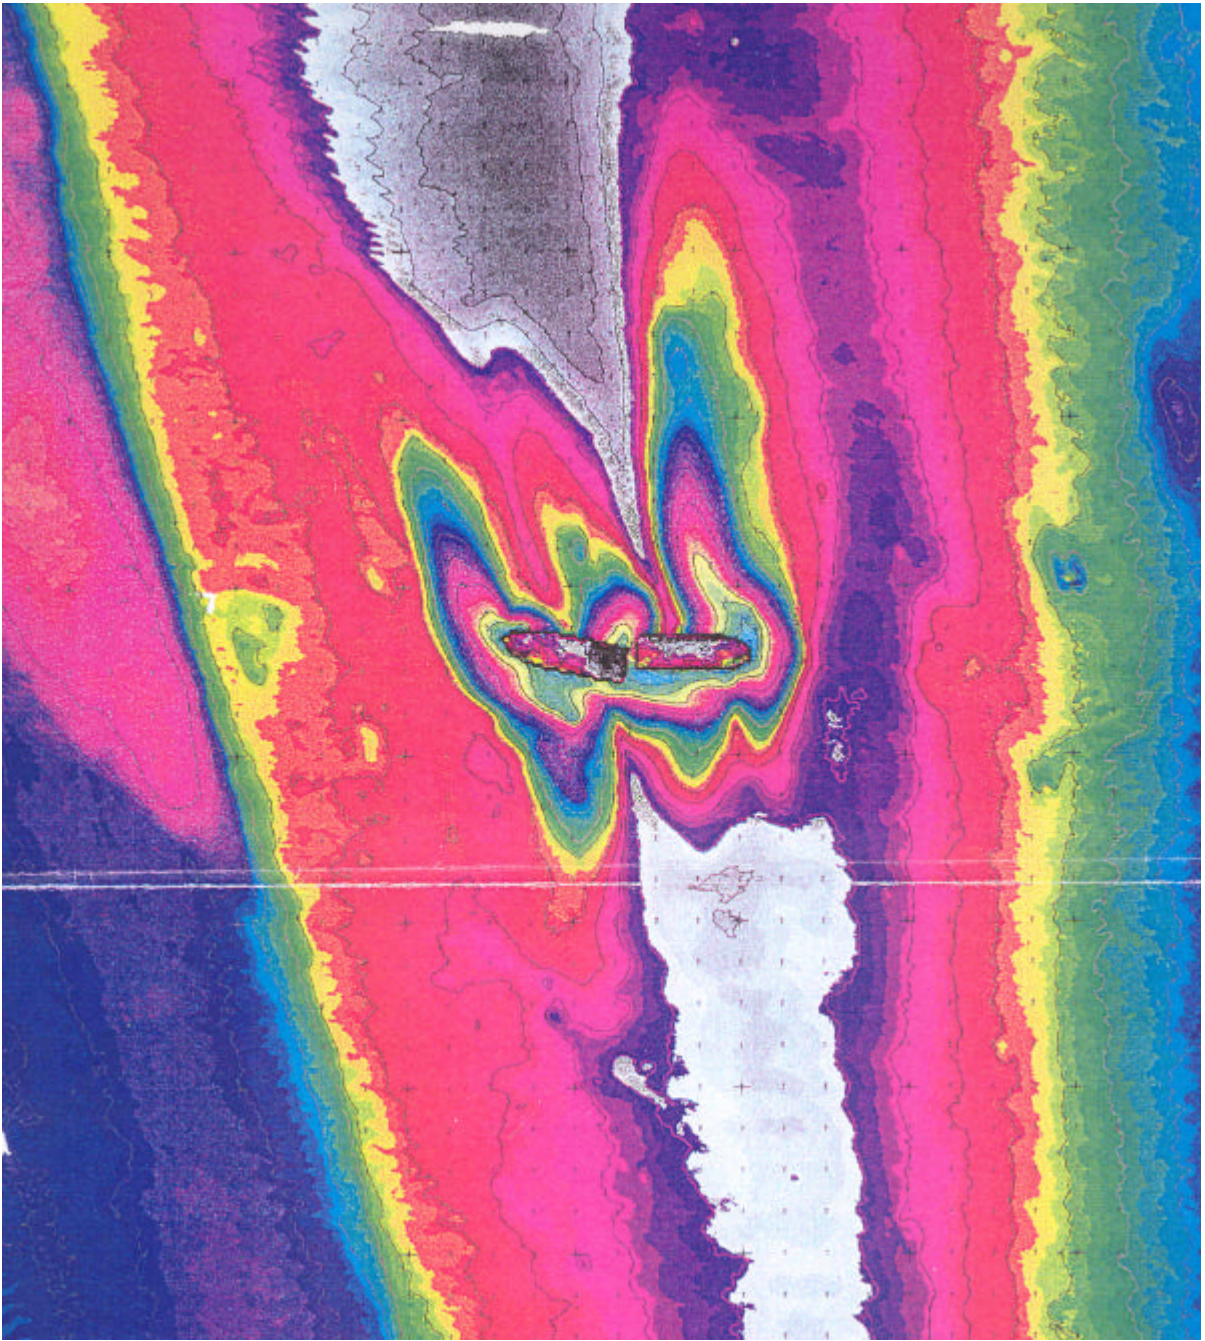
**The Wreck Site** The wreck site occupies the central part of the survey area. It is the area enclosed by the 9-metre contour and may be considered to be the area of seabed topography most influenced by the presence of the wreck.

**The Medway Dredged Channel** The Medway dredged channel occupies the southern part of the survey area, which is orientated in the region of 072°/252° and is bounded by the southernmost 9- metre contour in the survey area.

**The Sheerness Middle Sand** The Sheerness Middle Sand occupies the central part of the survey area. This sand bank is most extensive in the western part of the survey area. It is broken by the wreck site and continues to the east of the wreck site. The 6-metre contour of this feature is continuous to the north, and to the south this feature is continuous along the 8-metre contour.

The survey shows that the 15-metre contour is more extensive than shown on the published chart. This contour now extends some 10 to 30 metres from the east side of the wreck into two elongation's to the west side of the wreck. On the east side, the contour is at its maximum distance from the wreck opposite the centre part of each section. The elongation at the bow of the vessel extends some 80 metres on a bearing of 238°, at the stern the elongation is shorter at only 25 metres to the south west. From the colour contour plot at Annex D it can be seen that the shallowest parts of the wreck are at a similar depth to the shallow parts of the Sheerness Middle Sand.
