SERIOUS INCIDENT

Aircraft Type and Registration:	Airbus A321, YL-LCQ	
No & Type of Engines:	2 International Aero Engine V2533-A5 turbofan engines	
Year of Manufacture:	2004 (serial number 2211)	
Date & Time (UTC):	22 July 2019 at 2319 hrs	
Location:	On approach to London Stansted Airport	
Type of Flight:	Commercial Air Transport (Passenger)	
Persons on Board:	Crew - 8	Passengers - 211
Injuries:	Crew - None	Passengers - None
Nature of Damage:	None reported	
Commander's Licence:	Airline Transport Pilot's Licence	
Commander's Age:	56 years	
Commander's Flying Experience:	13,468 hours (of which 3,095 were on type) Last 90 days - 222 hours Last 28 days - 74 hours	
Information sources:	Aircraft Accident Report Form submitted by the pilot, Mandatory Occurrence Report submitted by ATC and further enquiries by the AAIB

Synopsis

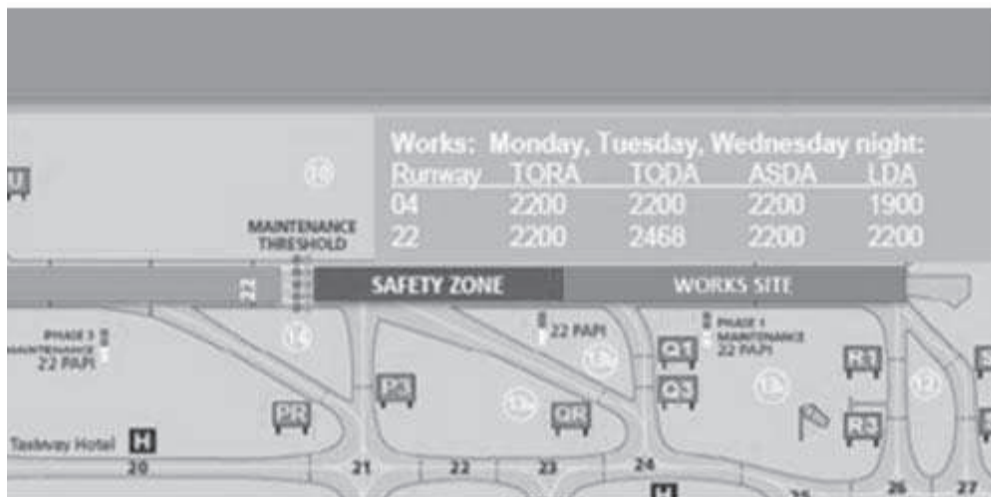
Figure 1

SUP 024/2019 works timetable and operational impact

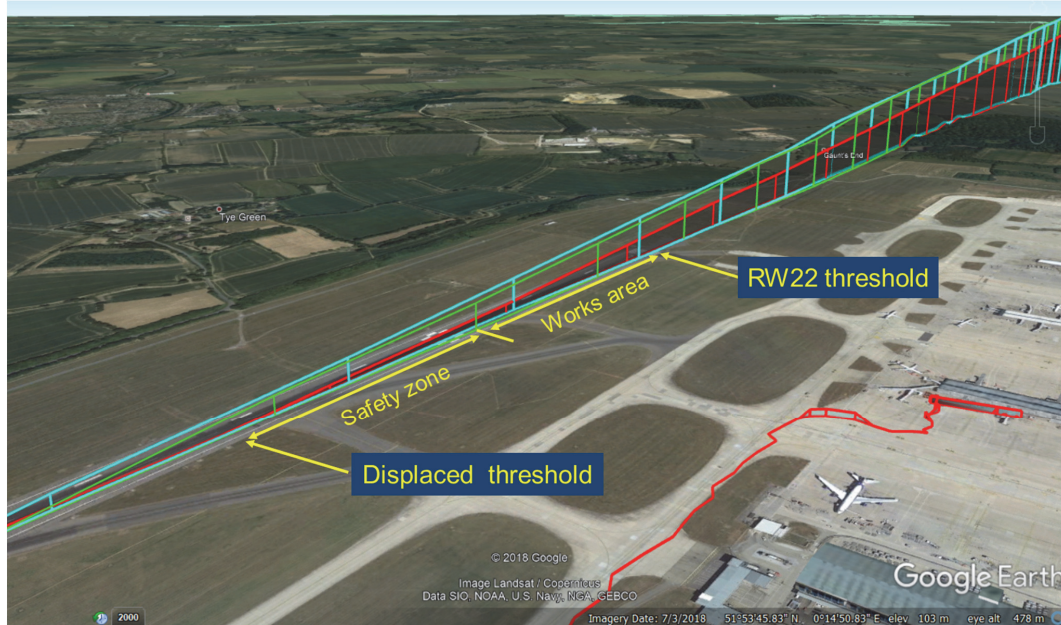
Figure 3

Radar data for the incident aircraft and the two aircraft that landed after it revealed that YL-LCQ was consistently lower during the approach than the following aircraft which had both flown the RNAV22C procedure (Figure 3).

Comparative radar traces (YL-LCQ trace in red)

Radar data and eye witness testimony confirmed that YL-LCQ was lower than expected over the THR 22 works area at STN. The aircraft appeared to have touched down close to the displaced threshold. Flying the RNAV22C procedure would have placed YL-LCQ 50 ft higher over THR 22C and thus greater clearance over the works area would have been achieved.

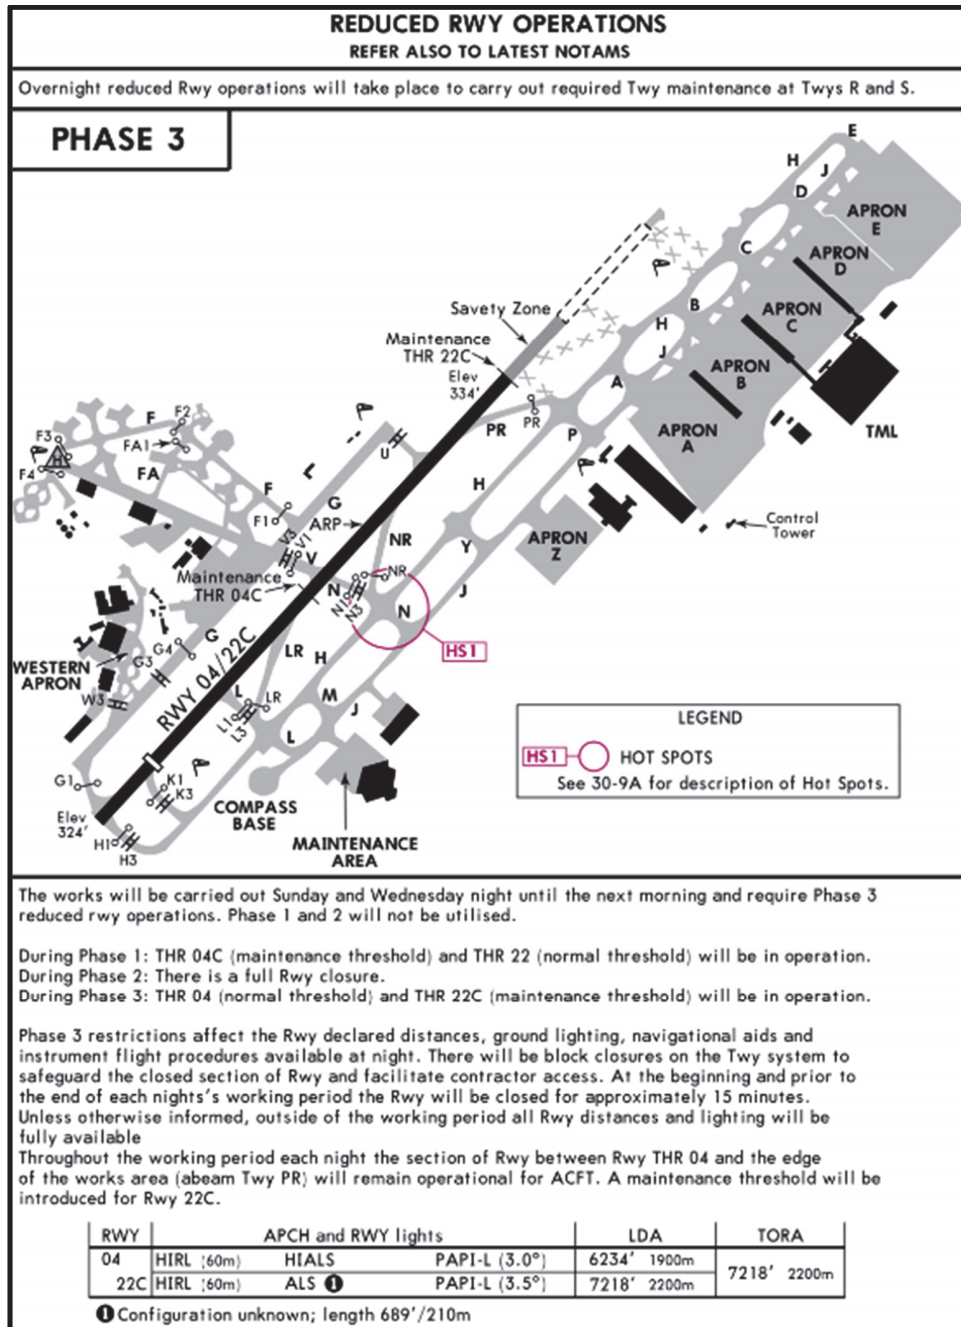
Figure 5

Temporary airfield chart available to the pilots

The wording on the temporary airfield chart stated that works would be carried out on 'Sunday and Wednesday night' rather than Sunday through to Thursday night. Having been made aware of the incorrect data after the incident, the chart manufacturer conducted an internal investigation. They identified how the error in data transposition had occurred and took steps to prevent similar slips in the future.

An error in the temporary airfield chart available to them misled the pilots into thinking that the runway works were not active on the night of the incident. They planned for and flew a standard RNAV22 approach. Neither holding during the temporary runway closure nor ATC's repeated references to reduced runway operations and the displaced threshold triggered a realisation that the works were taking place. The crew appeared to have exhibited a degree of confirmation bias; they were expecting a standard RNAV arrival and did not perceive the cues directing them to fly the alternative procedure.

- The aircraft operator alerted their crews to the error in the temporary airfield chart and the requirement to fly the revised RNAV procedure when the THR 22 works were active.
- The Stansted Airport air traffic services unit terminal control interface manager was tasked to raise the issue of incorrect or incomplete readbacks with the terminal control unit; the aim being to ensure that future poor radio phraseology would be robustly challenged.
- The airport's user safety group was tasked to conduct a full review of the phraseology used for the reduced runway operations.
- The chart manufacturer undertook an investigation into how the works scheduling had been incorrectly represented on the temporary airfield chart and took remedial action to prevent similar data transposition errors in the future.
