SAFETY FLYER TO FISHING INDUSTRY

Fishing vessel *King Challenger* (BA 87), fatal man overboard accident, 23 June 2016

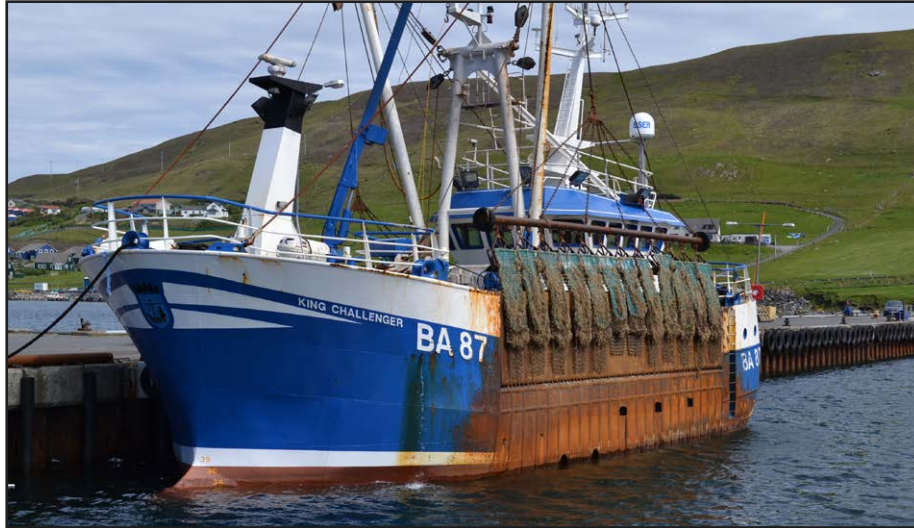
Figure 1: Scallop dredger *King Challenger*

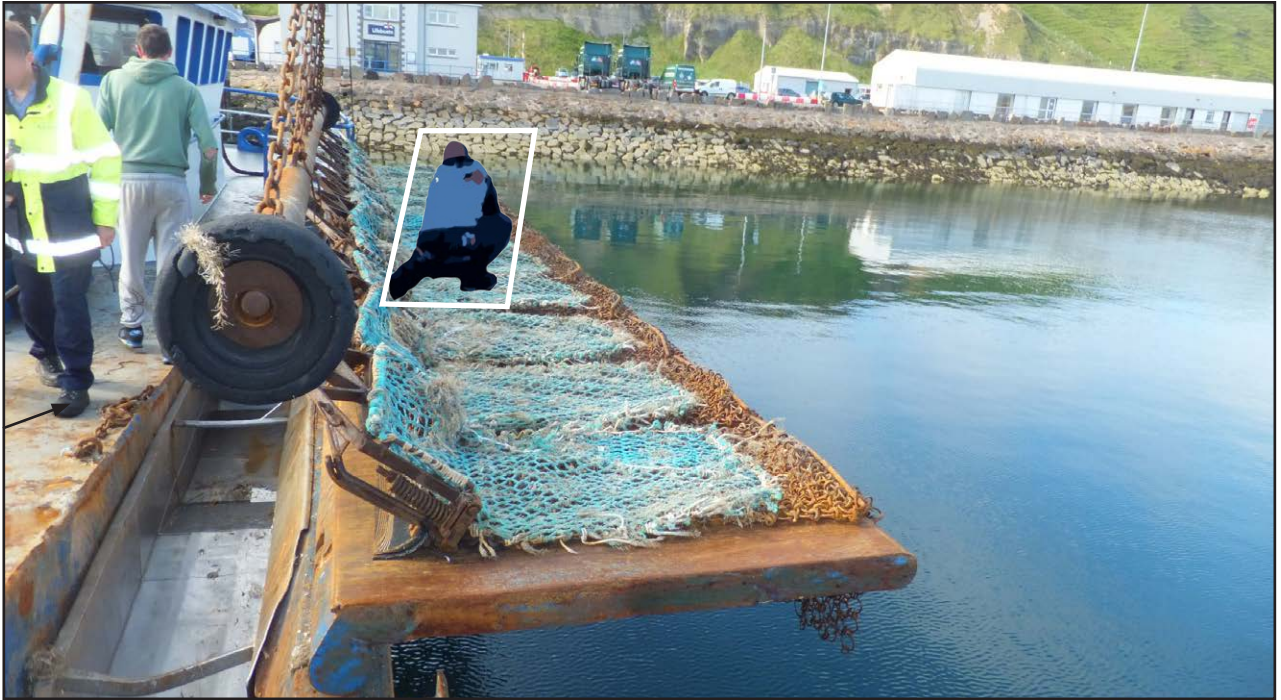
On 23 June 2016, at about 0940, a crewman from the 21.3m long scallop dredger *King Challenger* (**Figure 1**) fell overboard when he was attempting to unhook a damaged dredge bag from the end of the tipping door (**Figure 2**). He was not attached to a safety line and was not wearing a lifejacket. At the time of the accident, the vessel was 12nm south-west of Scalloway in the Shetland Islands. The sea water temperature was 10.5°C.

- The vessel's risk assessment should have recognised that the practise of walking on the tipping doors was unsafe, and identified safe alternative working practices.
- Had the crewman been wearing a lifejacket when he entered the water, it is likely that he would have been recovered alive.
- Unless appropriate, realistic manoverboard drills are carried out, the crew's reaction will be unplanned, risking delays in recovering a casualty and potentially resulting in additional casualties.

Figure 2: Position of crewman before he fell overboard

1. Tipping doors have no protective barriers around them or interlocks to stop them from moving. They should only be accessed under strictly controlled conditions. Safe alternatives, which do not include walking on the tipping door, must be identified for maintenance tasks such as dredge bag repairs.
