First Monitoring Report for 4 Low-Volume Sealed Roads in Kenya

Final Report

Prepared for Kenya Materials Testing and Research Department (MTRD)

AFCAP Project – KEN2043C

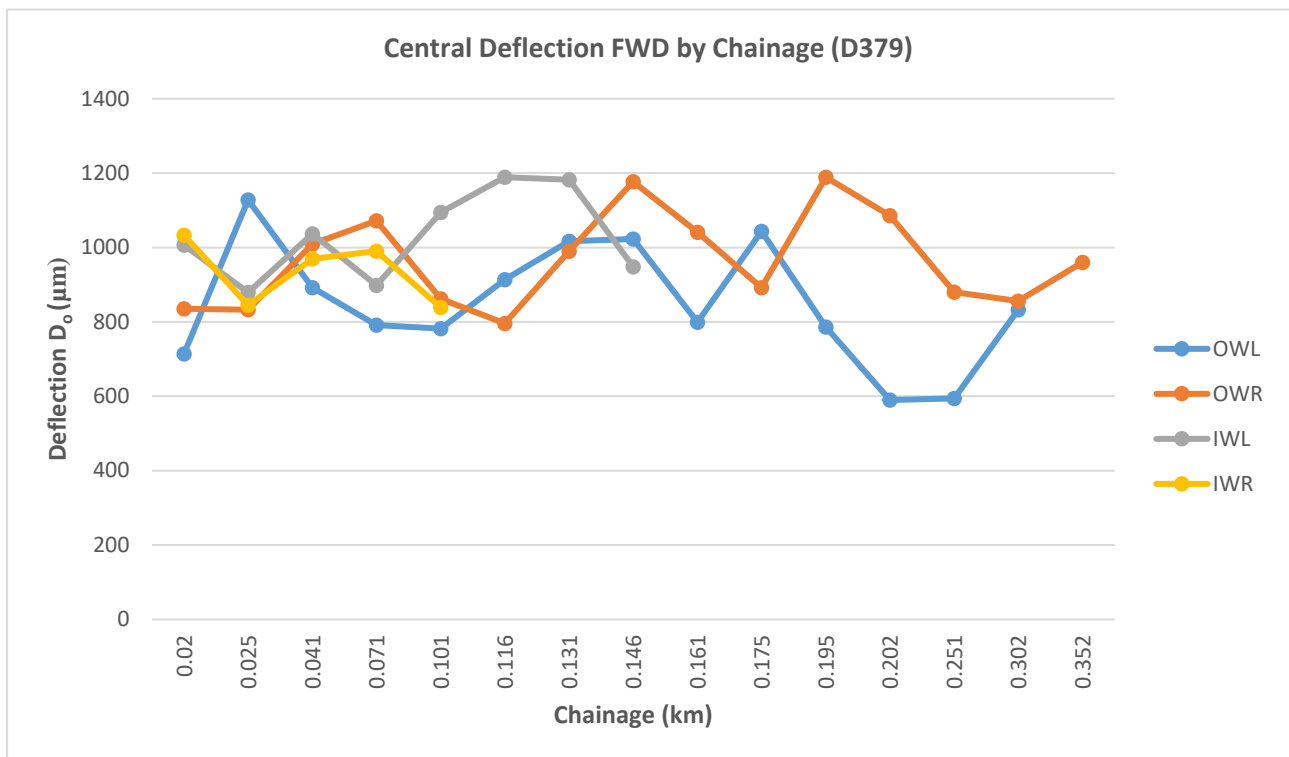
Figure 3-3: Central deflection by chainage (D379)

Figure 3-3 shows a graphical representation of the central deflection by chainage. The values are highly variable for each lane along the road. As compared to values obtained in the baseline survey, the first monitoring round showed higher values of deflection.

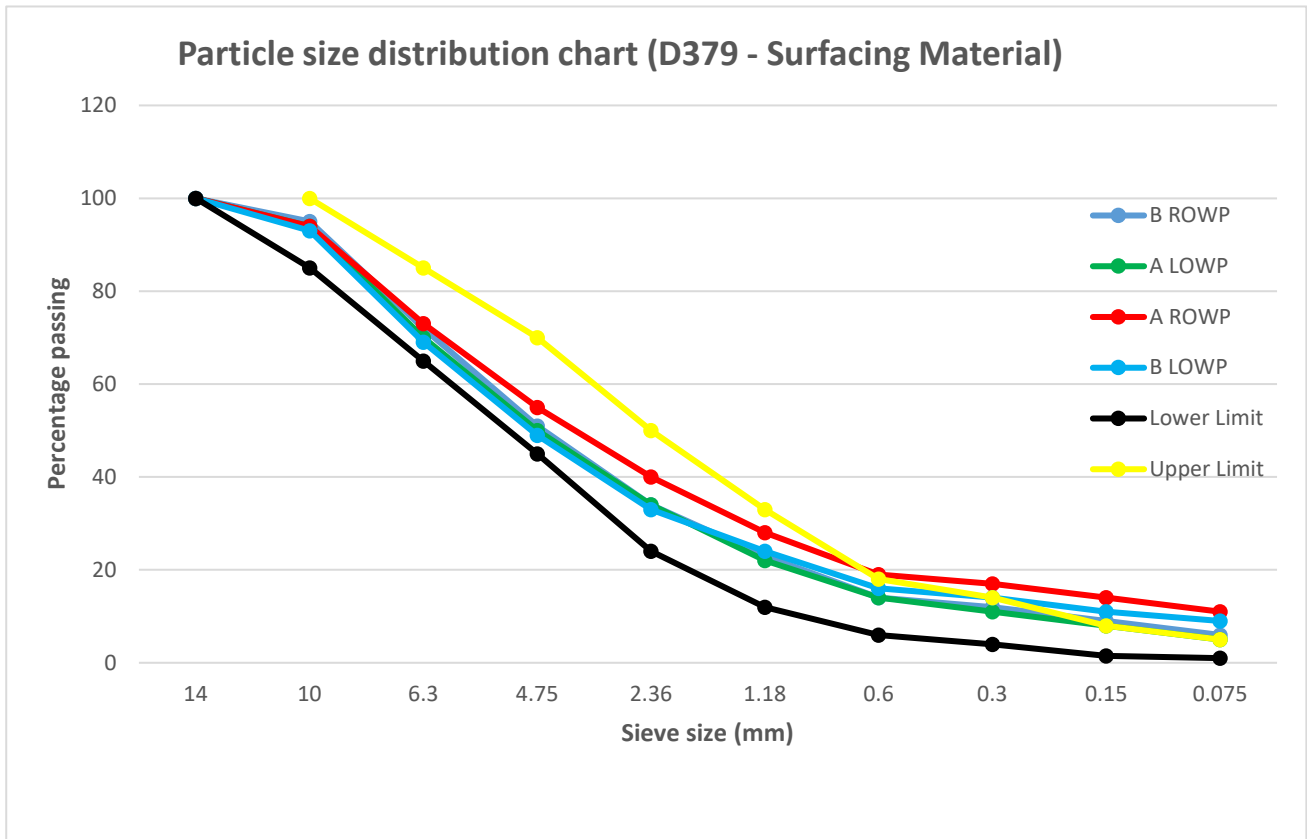
Figure 3-5: Particle size distribution of the base material (D379)

Figure 3-5 plots show the particle size distribution for the surfacing layer. The surfacing materials all fit into the specification envelope except for a small portion of the finer particles. The specifications are as per the LVSR Pavement Design Guideline.

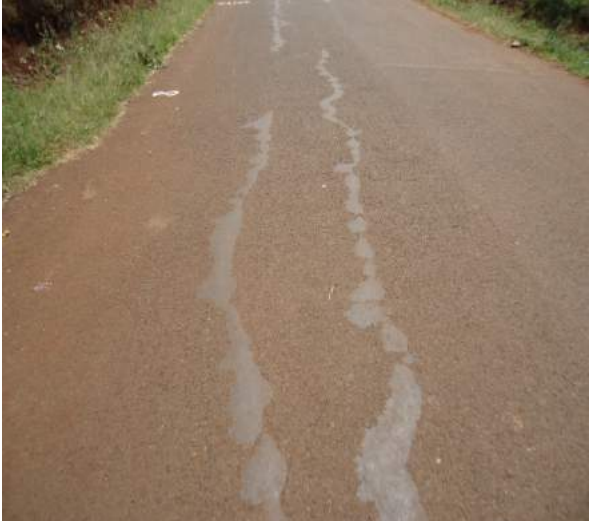
<p>Fig 4</p>	<p>Km 0+130– 0+145 main carriage way at the centreline</p>	<p>-Sealed Longitudinal cracks and light vegetation at the side drains</p>

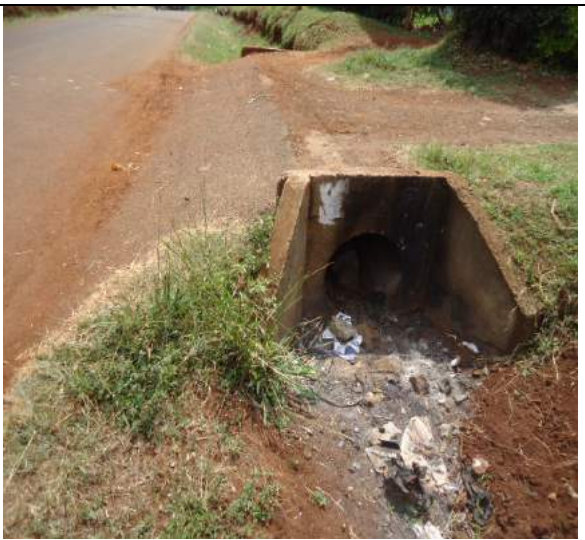
<p>Fig 5</p>	<p>Km 0+160 – 0+175RHS</p>	<p>-Partially blocked culvert</p>

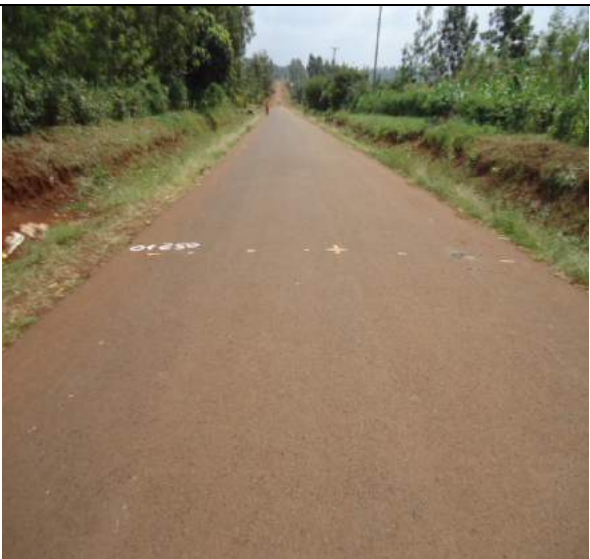
<p>Fig6</p>	<p>km 0+220 – 0+300</p>	<p>-No visible defect from</p>

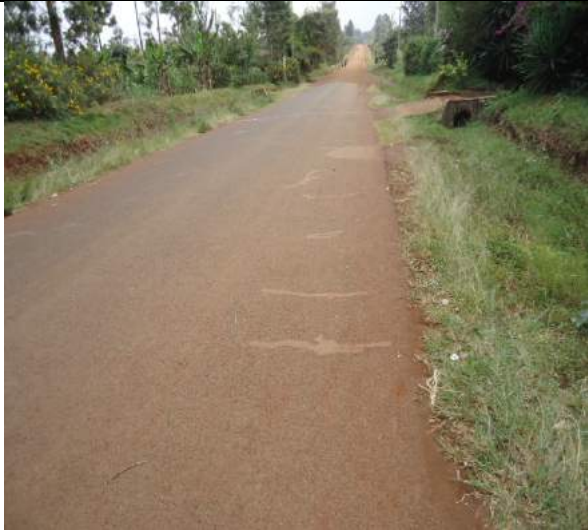
Fig 7	Km 0+330- 0+345	-Sealed Transverse cracks on carriage way RHS and light vegetation at the shoulders and side drains

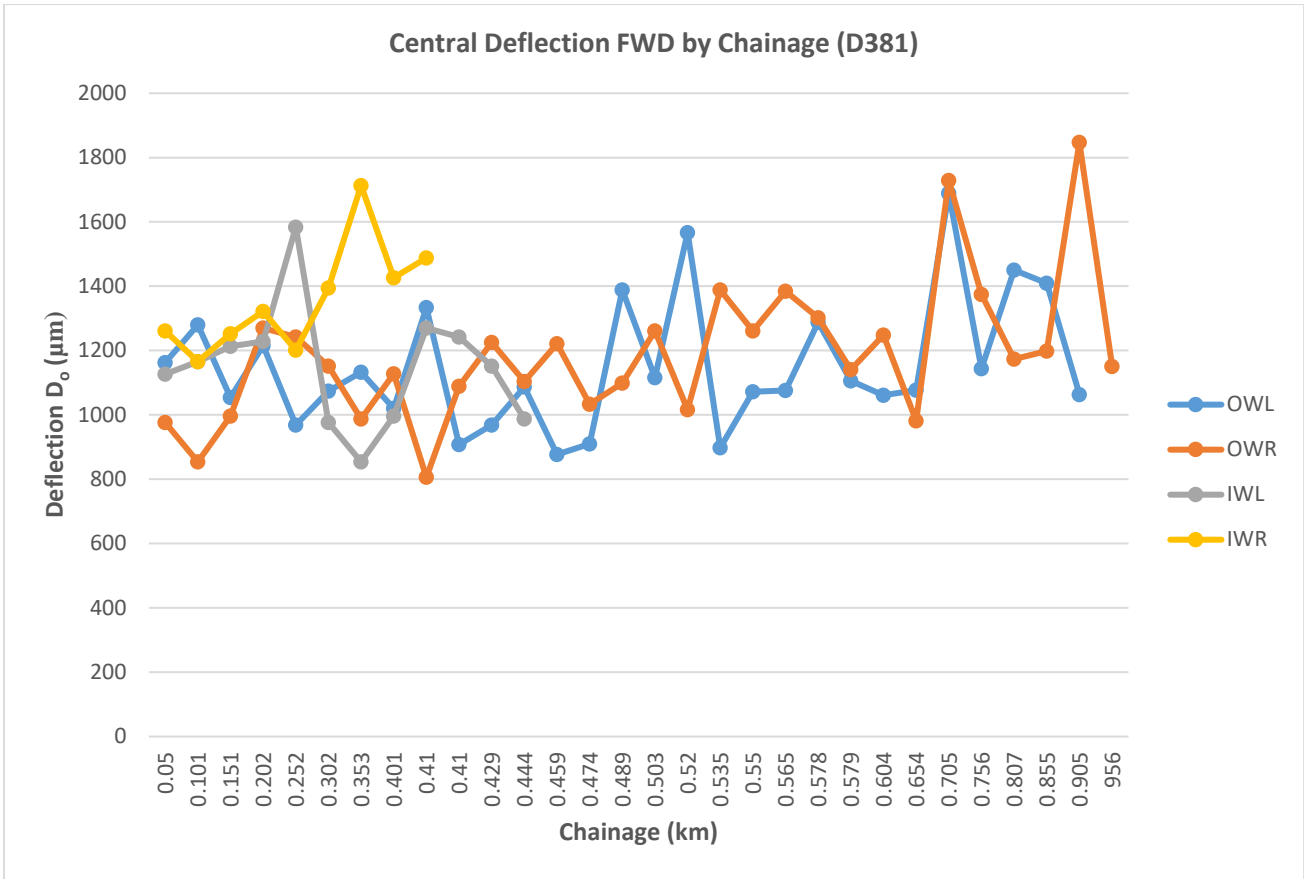
Figure 4-3: Central deflection by chainage (D381)

The complete deflection outputs from the FWD for all the sensors (D_0 up to D_6) for all the test locations are presented in the Appendix section of the report as Annex 1-5. Figure 4-3 shows the central deflection by chainage along the road. The deflection values are highly variable. The deflection values are almost within the same range as those obtained in the baseline survey.

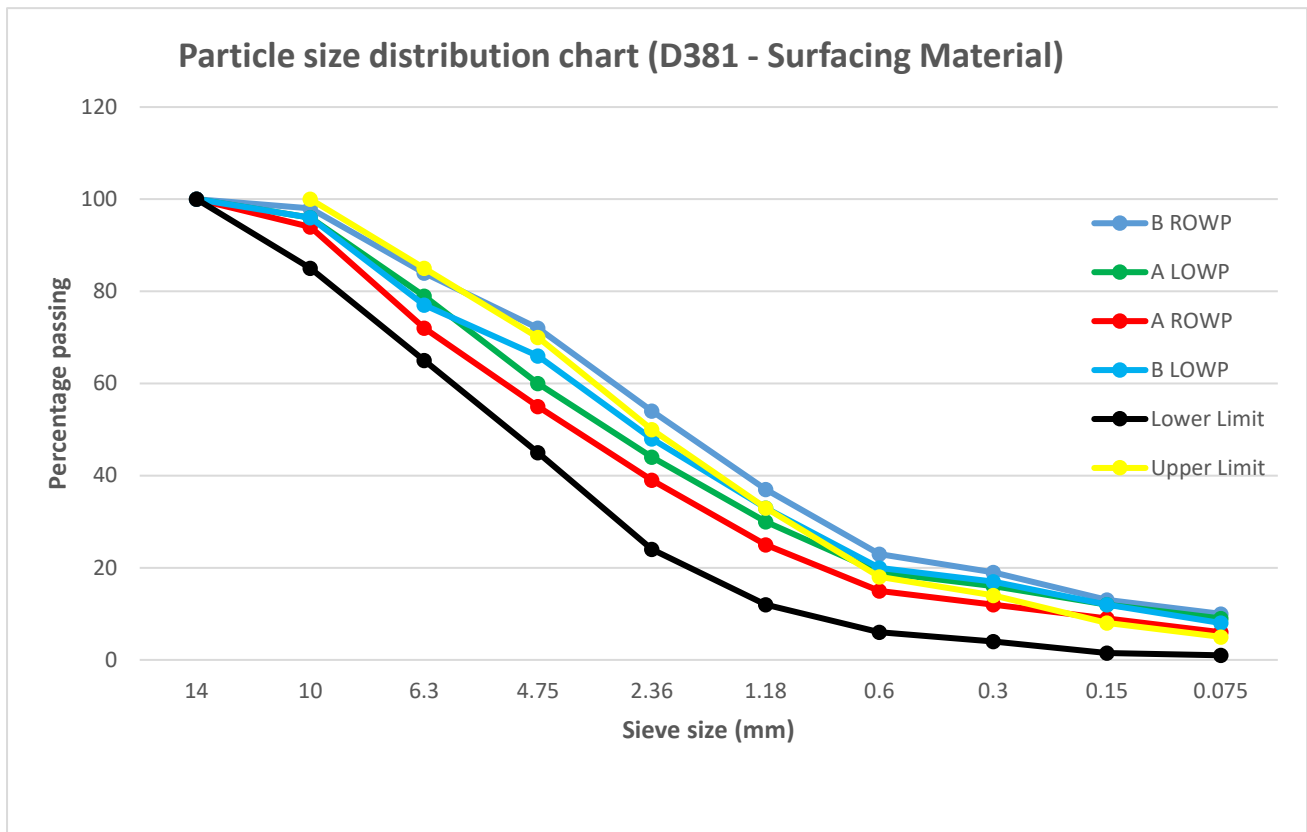
Figure 4-5: Particle size distribution for base material (D381)

The plots in Figure 4-5 below illustrate the particle size distribution for the surfacing layer. The material generally lies within the envelope. An exception is material obtained from panel B on the right-hand side which has most of the particles outside but close to the specification envelope. The specification is obtained from LVSR Pavement Design Guidelines.

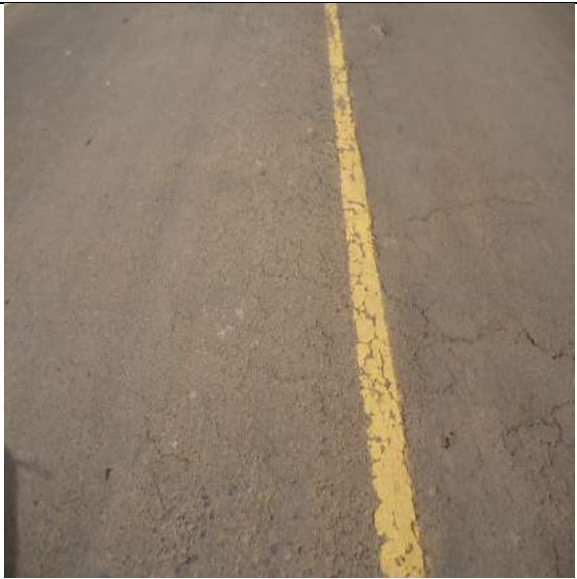
Fig No	Location (Km)	Defect assessment and description	Photos illustrating the pavement distress & defect
Fig 1	Km 0+000 – 0+200 main carriage way	-Alligator cracks

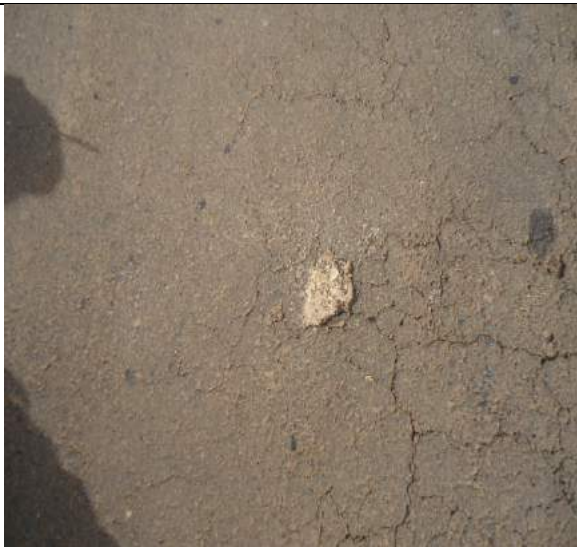
Fig 2	Km 0+080 main carriage way centreline	-Fatigue cracks and Pothole

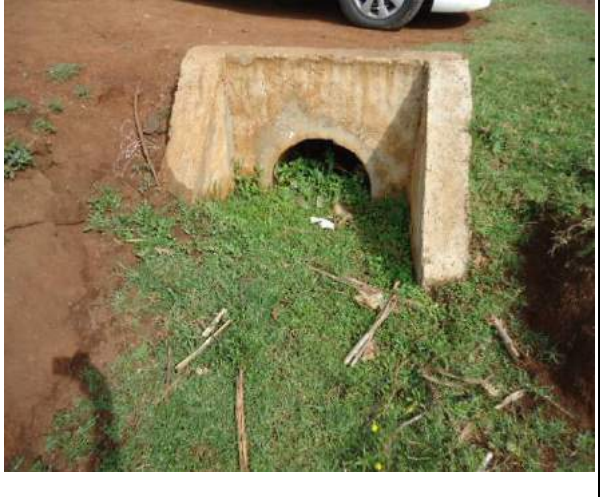
Fig 3	Km 0+050	-Partially blocked culvert

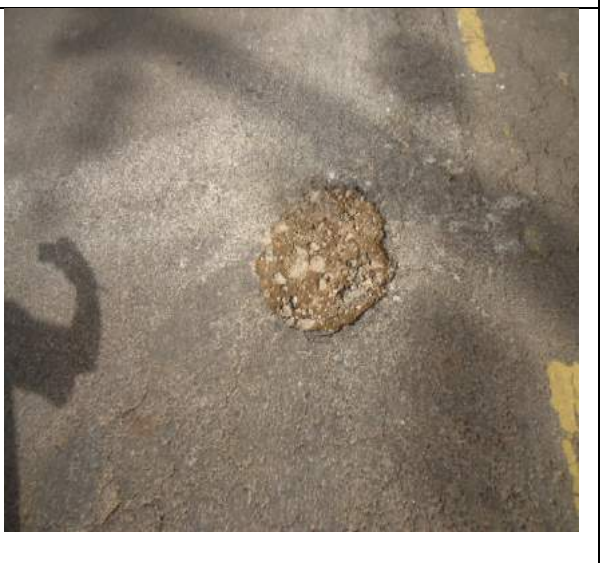
Fig 4	Km 0+080	-Pothole developing due to thin surfacing

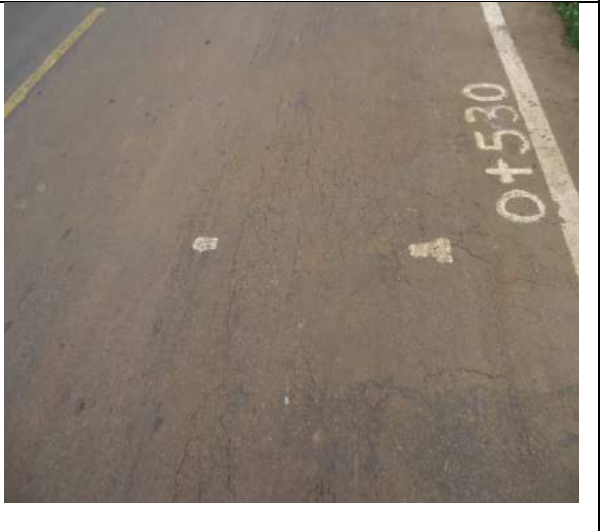
Fig 5	Km 0+530 RHS	-Alligator cracks

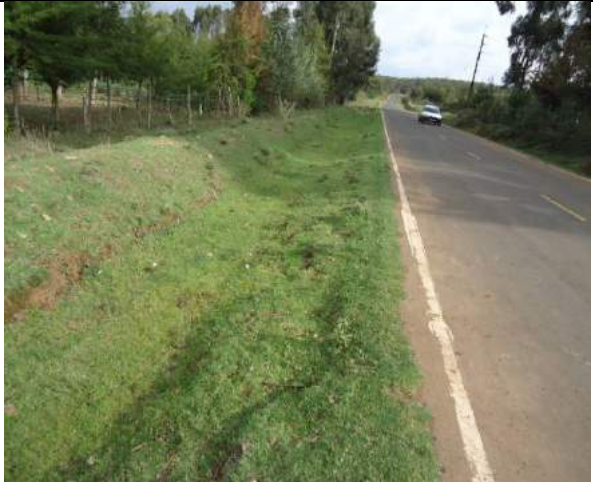
Fig 9	Km 0+700 – 0+800	- Light vegetation on the LHS shoulder

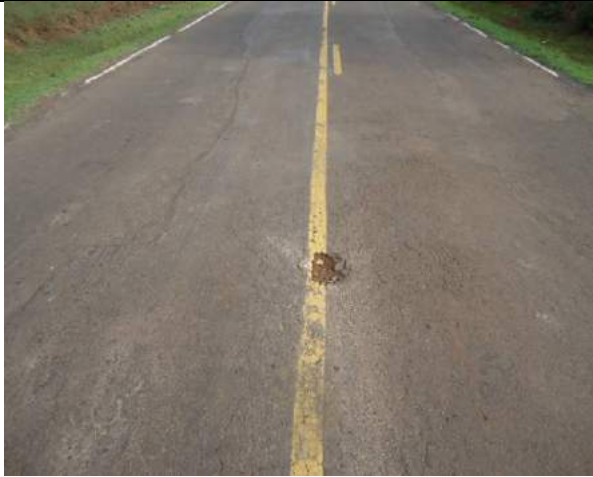
<p>Fig 11</p>	<p>Km 0+800 – 0+850</p>	<p>-Pothole and Fatigue cracks</p>

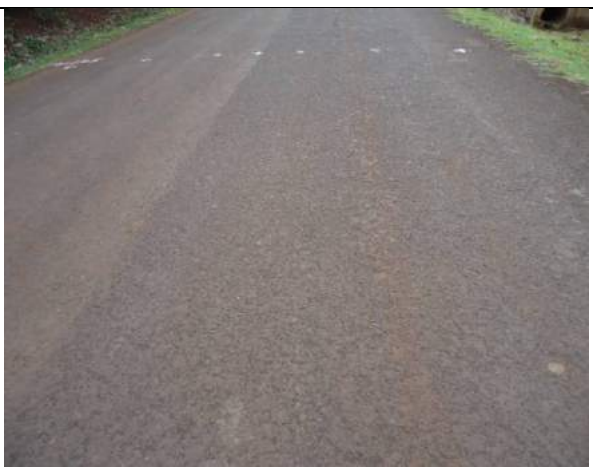
<p>Fig 7</p>	<p>Km 0+270 RHS</p>	<p>-Partially blocked access culvert</p>	 
<p>Fig 8</p>	<p>Km 0+273 – 0+300 RHS</p>	<p>- Rough Texture because of rainfall during the construction of the road</p>

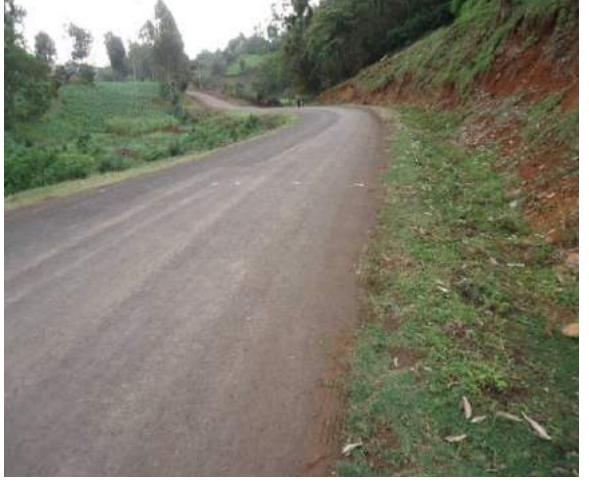
Fig 13	Km 0+550	-No visible defect on the carriage way -Slight vegetation on the road shoulder

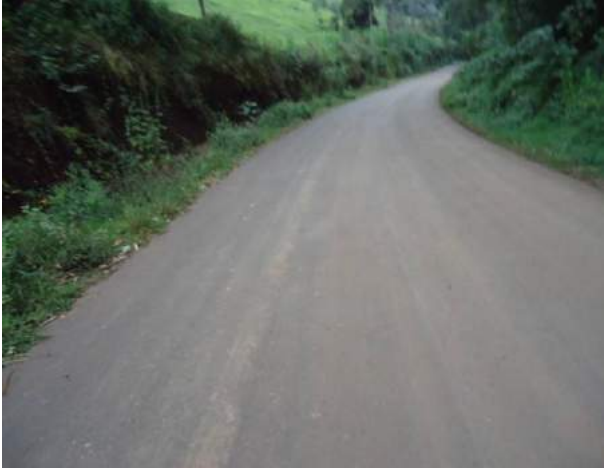
<p>Fig 10</p>	<p>Km 0+450 – 0+800</p>	<p>-No visible defect on the carriage way - light vegetation at shoulders and side drains</p>

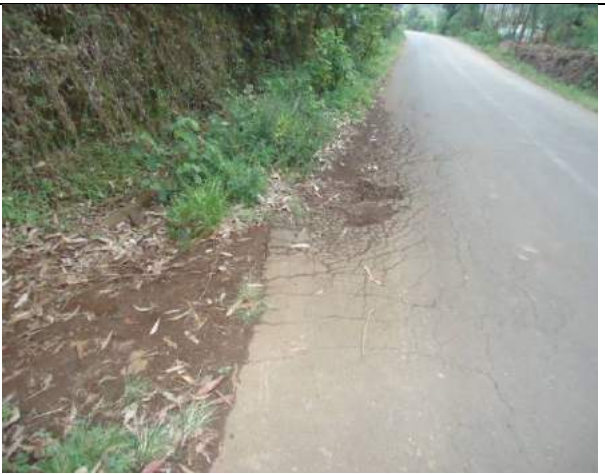
<p>Fig 11</p>	<p>Km 0+650 LHS</p>	<p>-Edge deformation and subsidence</p>

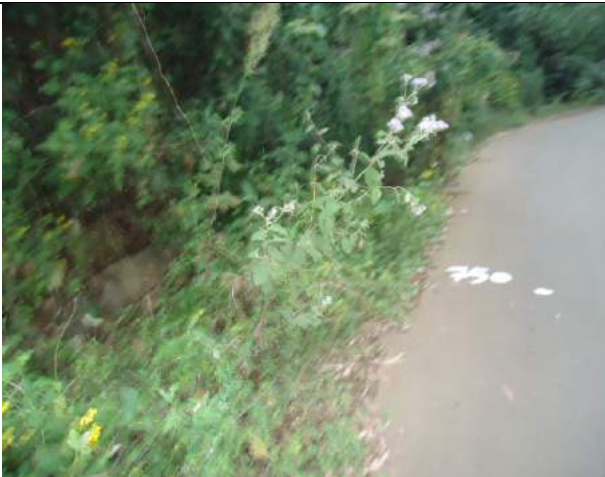
<p>Fig 12</p>	<p>Km 0+750 LHS</p>	<p>- Vegetation on the shoulder and side drain</p>

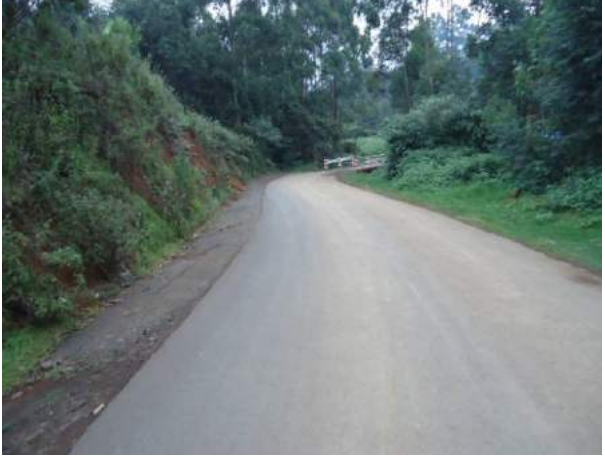
Fig 16	Km 0+800 – 0+850	<p>-Deposits blocking the LHS side drain</p> <p>-Light vegetation at the RHS and thus no drainage structure</p> <p>-No visible defects on the carriage way.</p>
