## Collision between the bulk carrier *Gülnak* and the moored bulk carrier *Cape Mathilde* River Tees, England on 18 April 2019

### SUMMARY

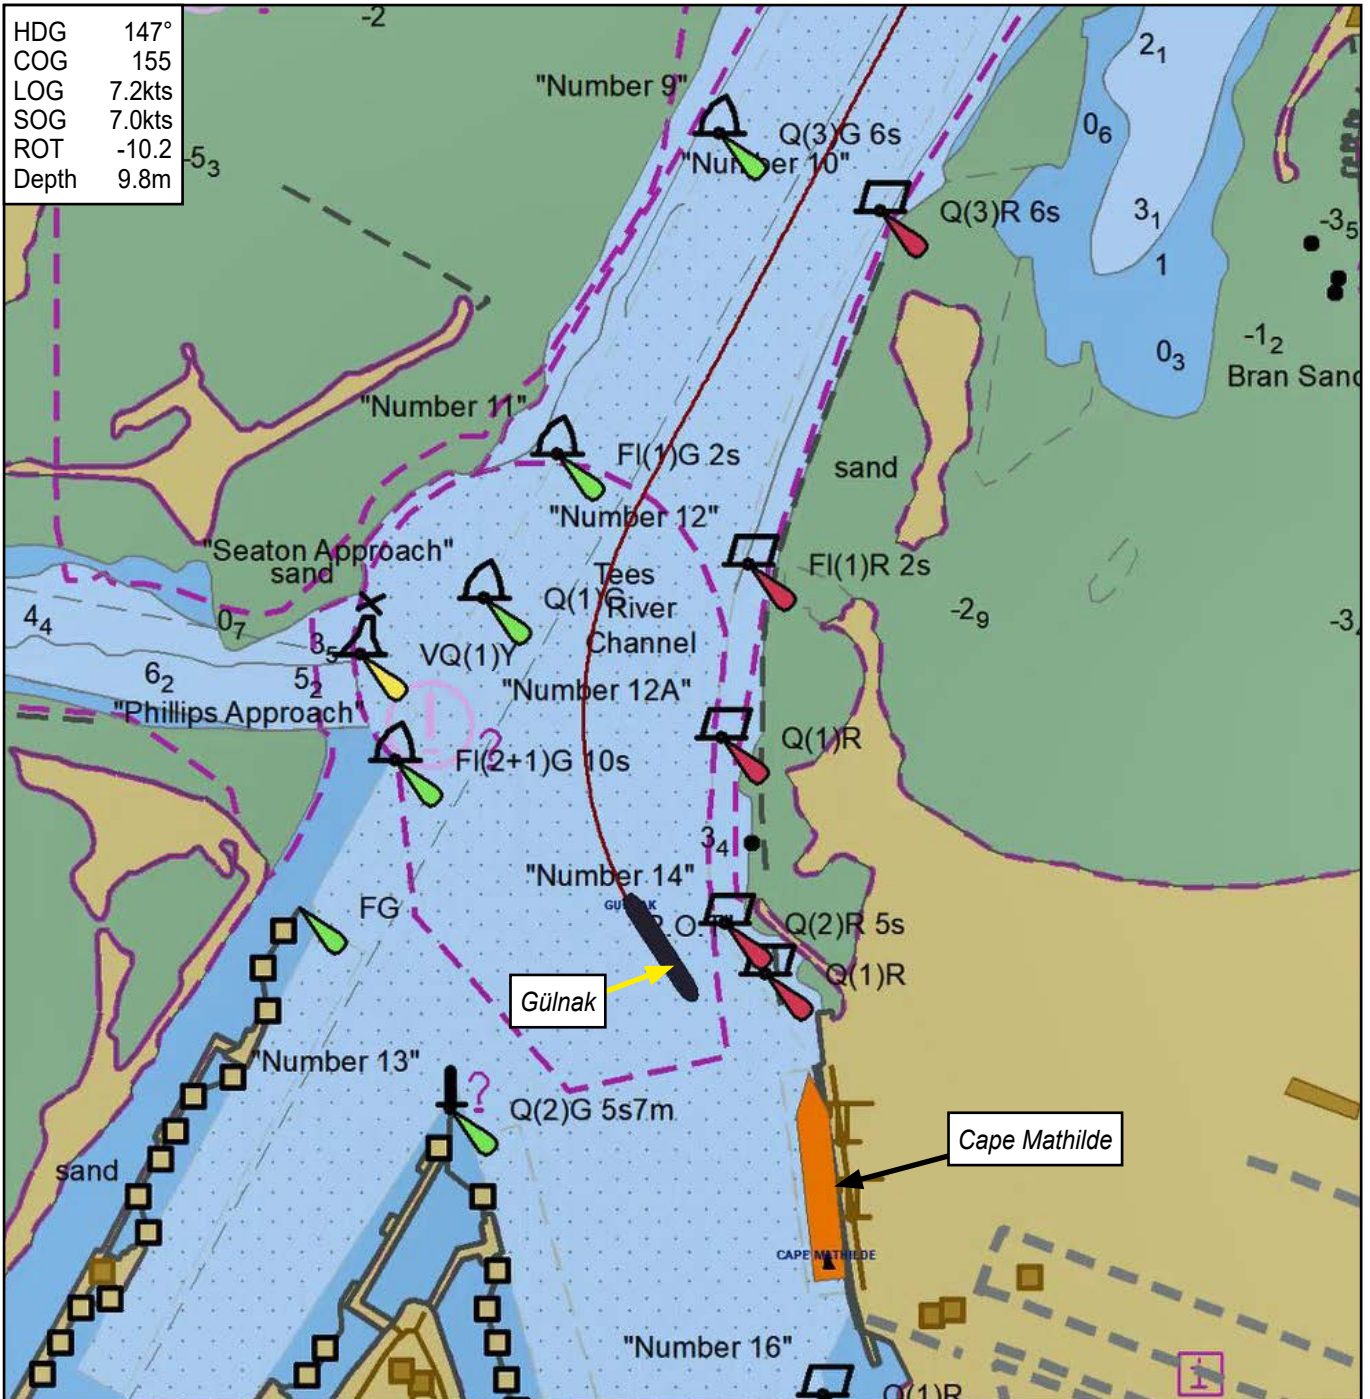
Figure 4: Position at 0323:23 when engine put to 'full astern'

By 0323:23, *Gülnak*'s speed was 7kts, the rate of turn had reduced to about 10°/min to port and the vessel's heading was passing 147°. The bulk carrier *Cape Mathilde* was moored 220m ahead (**Figure 4**) and the master ordered the forward mooring party to be ready to let go the anchors. The skippers of the two tugs that were waiting to assist off the bulk terminal saw the potential hazard and manoeuvred towards *Gülnak*. Although *Gülnak*'s rate of turn continued to decrease, the pilot and master realised that a collision was inevitable. The pilot moved to the port bridge wing and ordered 'full astern'.

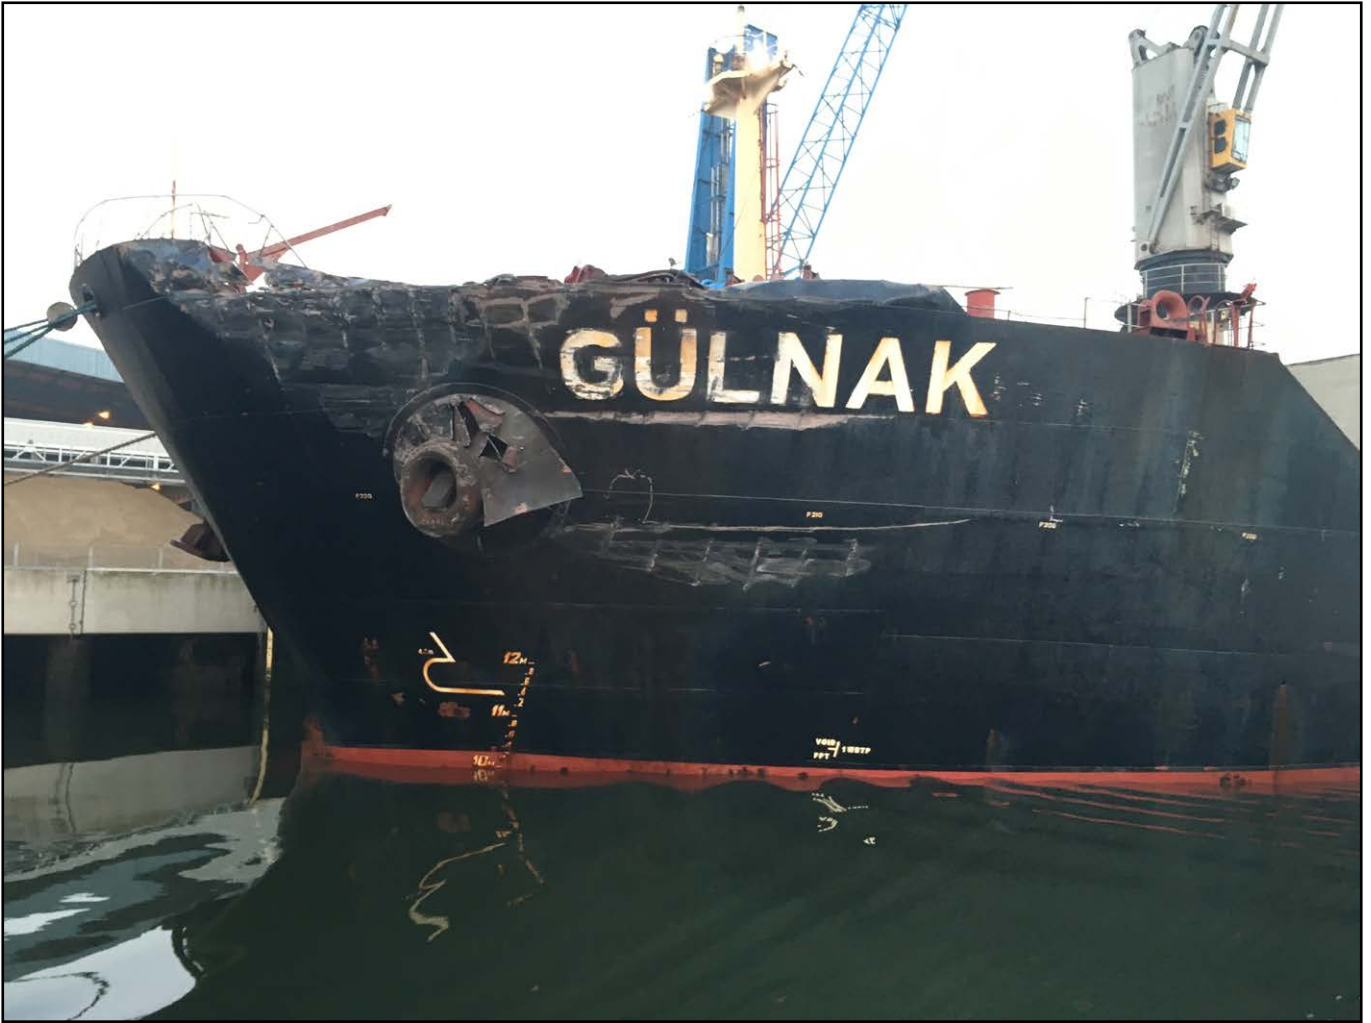
**Figure 5:** Damage to port bow of *Gülnek*

The collision resulted in significant indentation and steelwork damage to *Gülnak*'s port bow (Figure 5) and the shearing of the port anchor at the stock. *Cape Mathilde*'s port side was damaged above the waterline in way of the No 1 and No 2 wing ballast tanks (Figure 6), with the lower section of *Gülnak*'s port anchor embedded in the forward part of No 1 ballast tank. The vessel's mooring lines remained intact.

Temporary repairs to both *Gülnak* and *Cape Mathilde* were completed in Teesport. The vessels were then authorised by the Maritime and Coastguard Agency and their respective classification societies to sail for permanent repairs. *Cape Mathilde* arrived in Dunkerque, France on 10 May 2019 and *Gülnak* arrived in Turkey on 12 May 2019. During *Gülnak*'s departure from Teesport, the embarked pilot noted that the master seemed uncertain about whether the main engine speed indicator on the centre console gauge was operating correctly.
