Train collision with tree near Spittal, Pembrokeshire, 17 October 2019

Summary of the accident

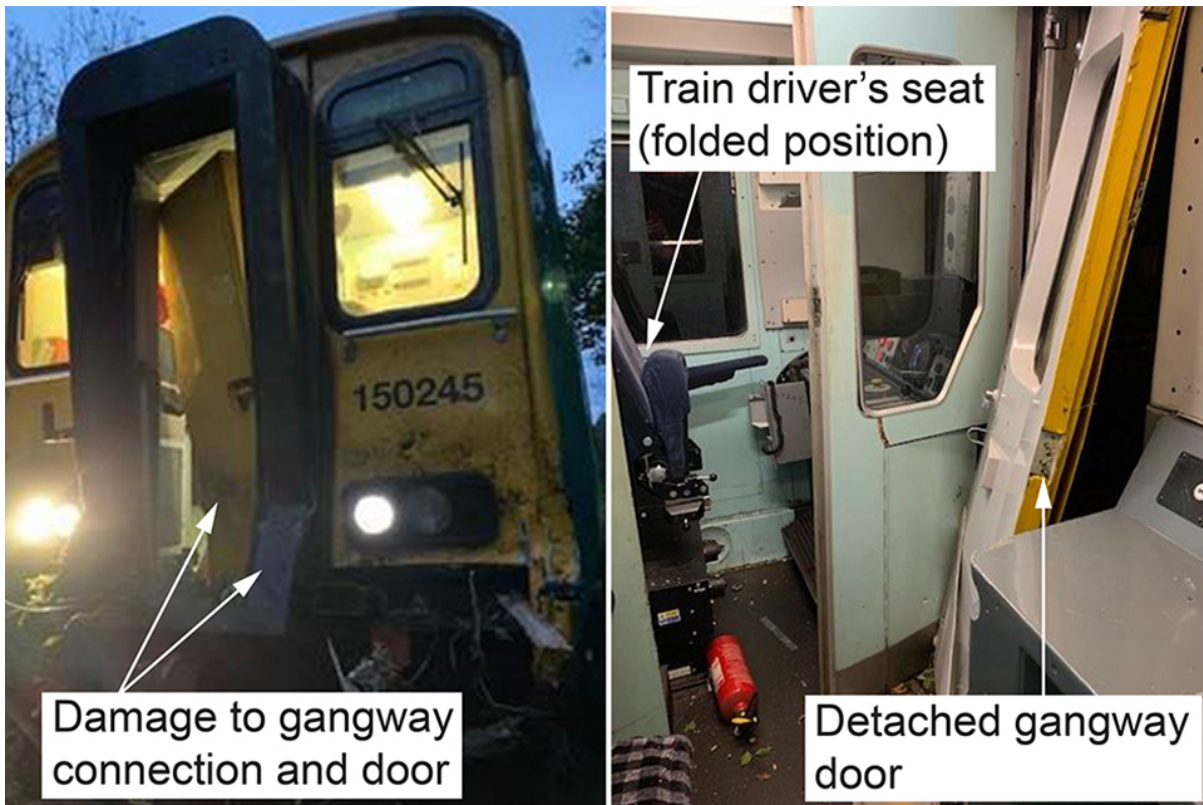
At around 18:33 hrs on 17 October 2019, a train carrying 13 passengers and two crew members collided with a large oak tree that had fallen across the railway between the villages of Spittal and Treffgarne, Pembrokeshire. The train was travelling at around 55 mph (89 km/h), the maximum permitted speed at this location, when the collision occurred. Although the train did not derail, the front was badly damaged, and it was unable to continue its journey. The train driver suffered a minor injury and was left shocked by the accident.

Damage to the train front and driving cab area (images courtesy of Network Rail)

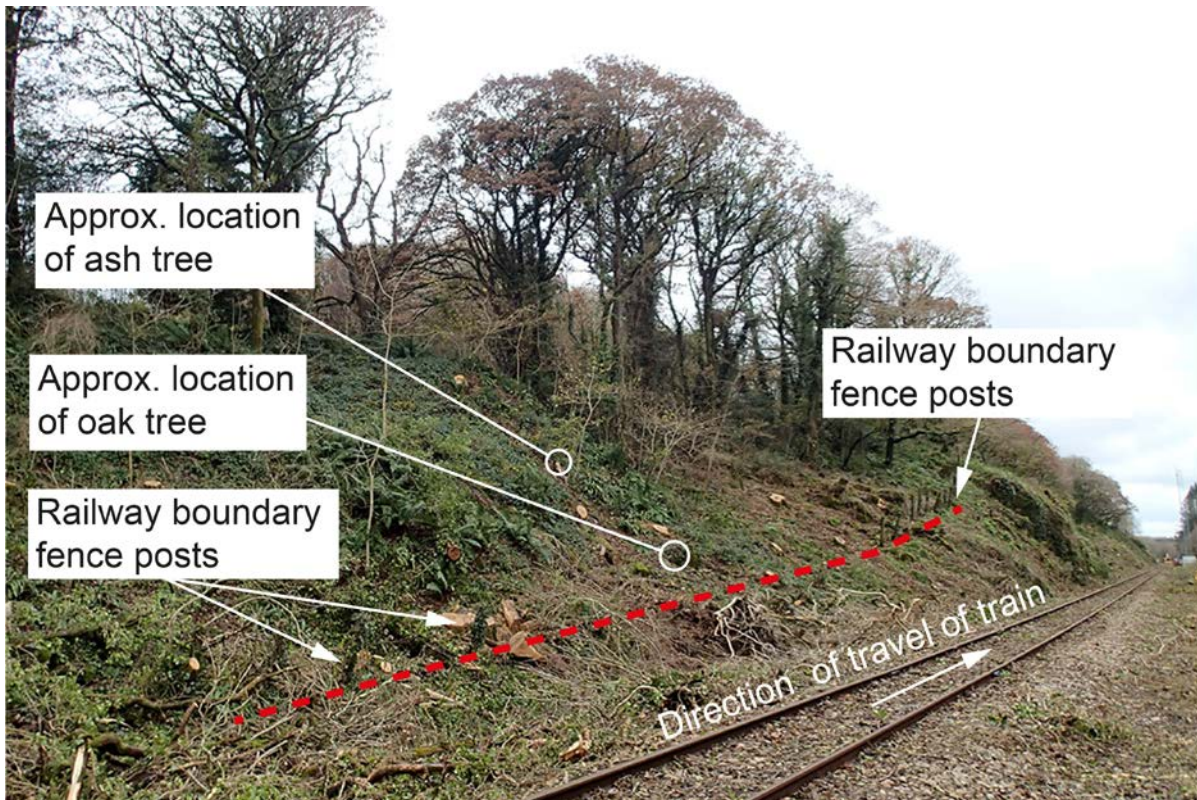
The tree that fell across the railway was an oak tree, estimated to be around 24 metres tall. It had grown around 8 metres from the railway track at a location about 0.4 metres outside the railway boundary fence. It fell because a diseased ash tree had fallen against it. The ash tree was around 21 metres tall and had grown about 12 metres from the railway track and about 4.4 metres outside the railway boundary.

Trees at the site of the accident, including those outside the railway boundary, have shallow root structures because they are growing in shallow soil on a rocky slope. The shallow root structure is the most likely reason that the oak tree fell after being struck by the ash tree.

Location of the oak and ash trees (dashed red line shows railway boundary)

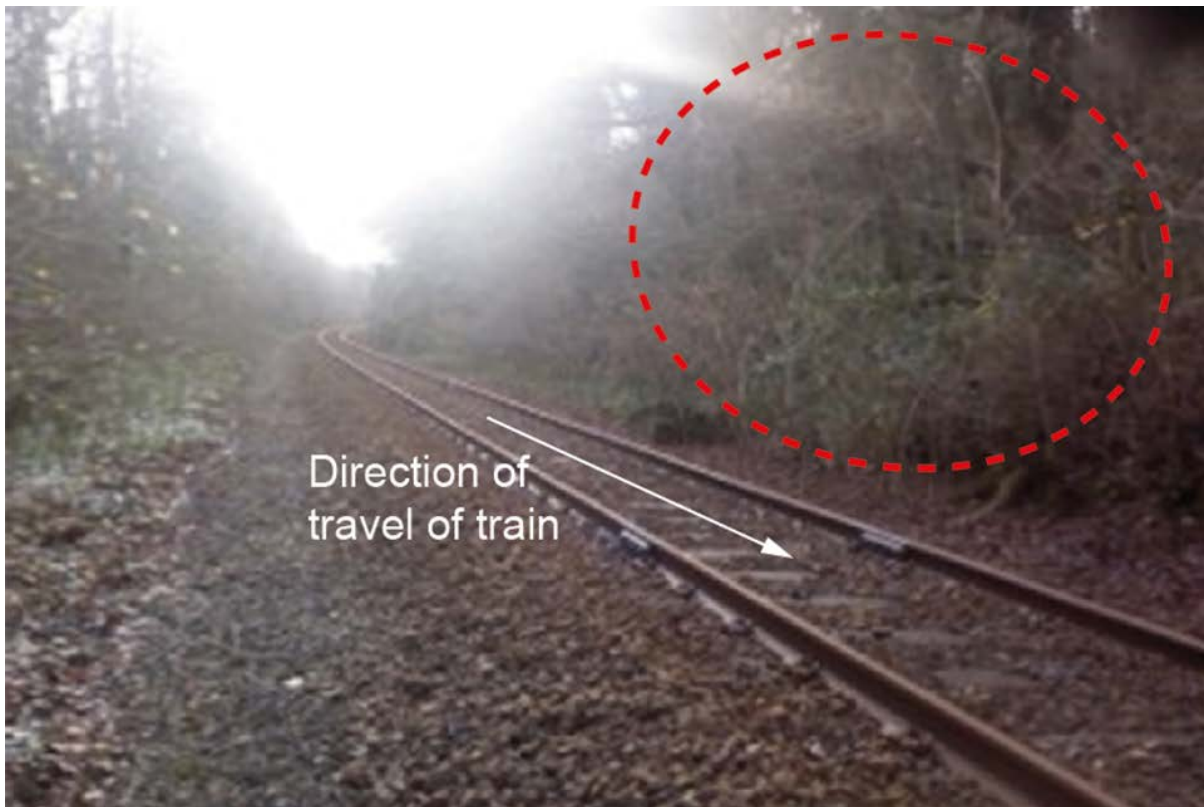
Although Network Rail procedures required tree inspections to include trees outside the railway boundary, the diseased part of the ash tree was near the ground and was probably not visible from within the railway boundary due to the presence of other vegetation. Access to the bottom of the ash tree would have been difficult due to underfoot conditions and other vegetation. In addition, Network Rail staff are not expected to walk outside the railway boundary when carrying out inspections as they do not have a legal right to enter neighbouring land for this purpose.

Pre-accident image with dashed line showing area from which trees fell (image courtesy of Network Rail)
