# AIRCRAFT ACCIDENT REPORT 1/2020

Report on the accident to  
**Piper PA-46-310P Malibu, N264DB**  
22 nm north-north-west of Guernsey  
on 21 January 2019

## Air Accidents Investigation Branch

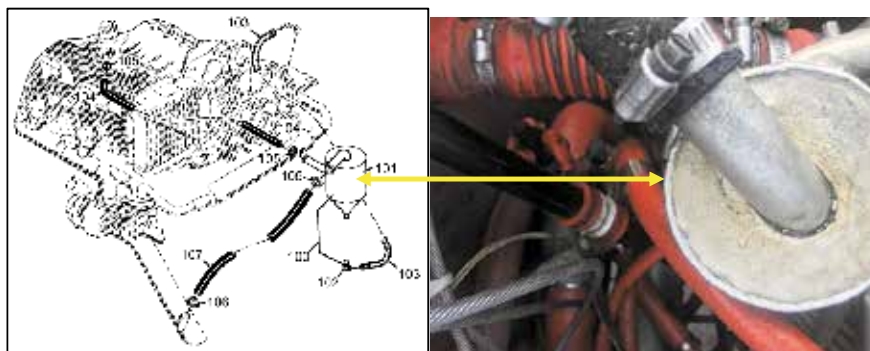
**Figure 10**

Following the engine ground run carried out at Nantes to investigate the bang on the outbound flight, the pilot noticed what he thought might be a small oil leak from the top of the oil accumulator, which he believed had been present for some time. The pilot took photographs, which he sent to the individual who managed the aircraft who then forwarded them to the FAA IA. From one of the photographs, the component was identified by the engine manufacturer as the air / oil separator assembly (Figure 10).

Photograph sent by pilot showing location of oil leak from the air / oil separator (item 101 in the left image)

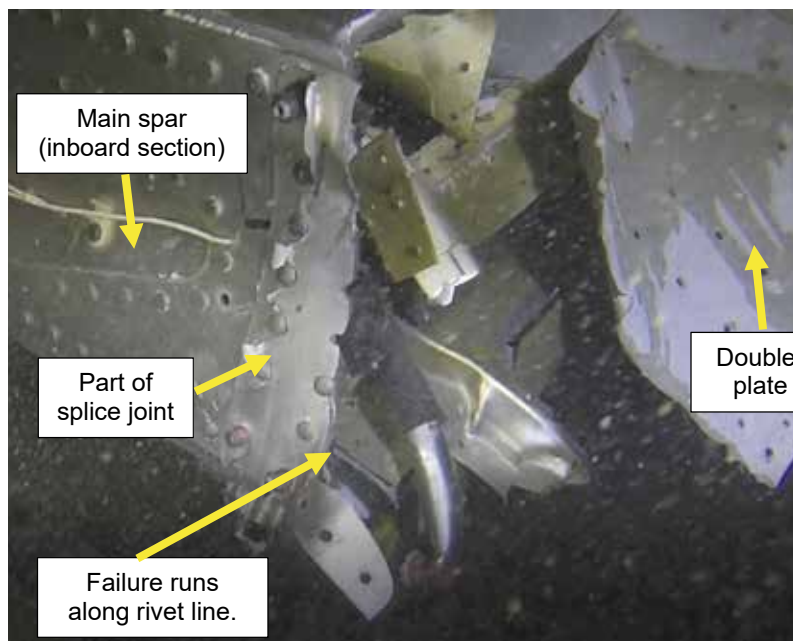
**Figure 16**

Failure of left-wing main spar at the splice joint  
(Image taken from a video provided by Blue Water Recoveries)

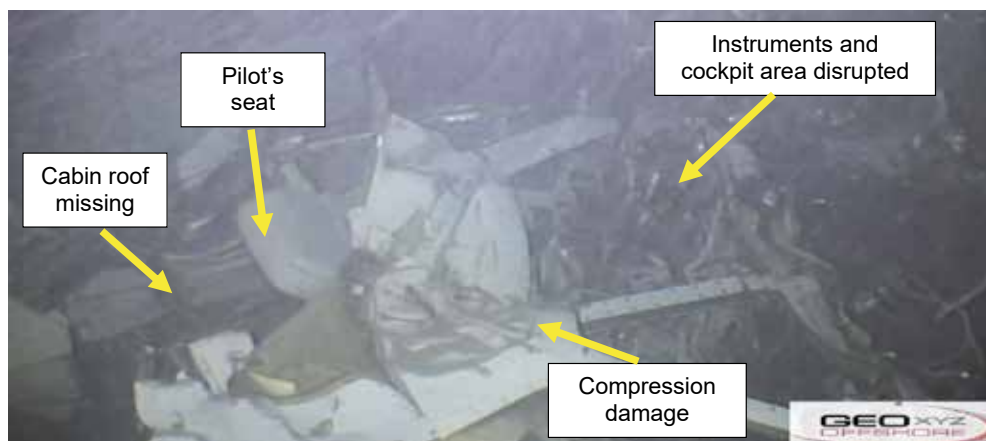
**Figure 17**

Damage to cockpit roof

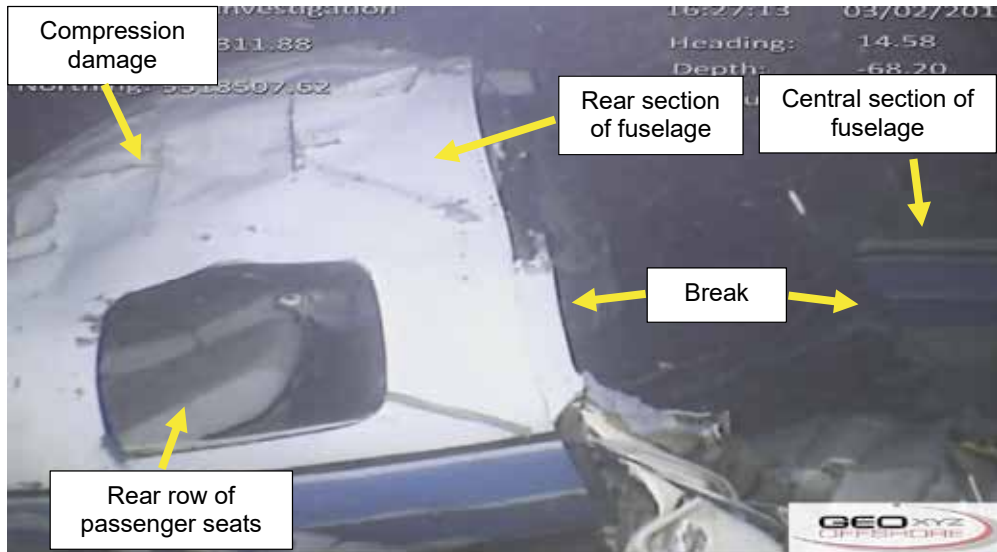
**Figure 18**

Break in central fuselage

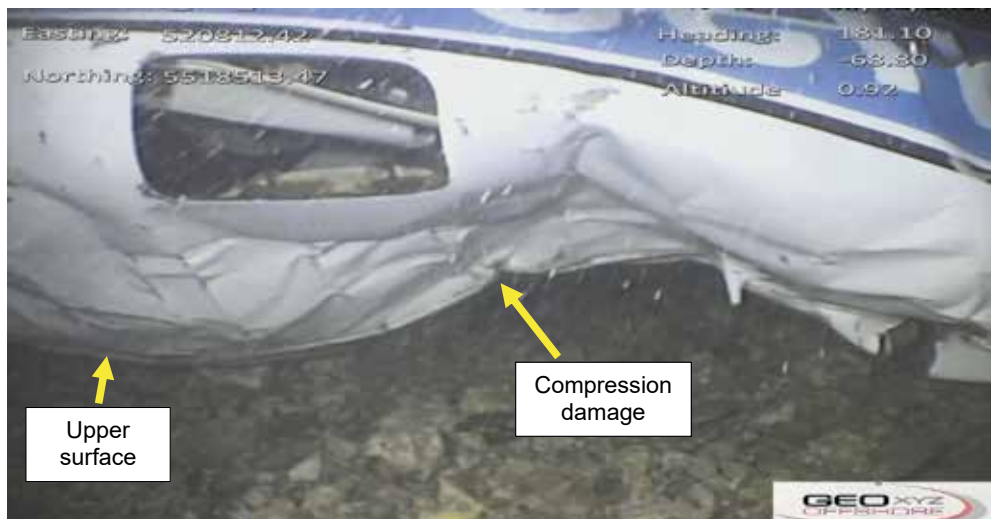
**Figure 19**

Damage to roof of rear section of the fuselage  
(This section of the fuselage has been rotated by the tidal flow)

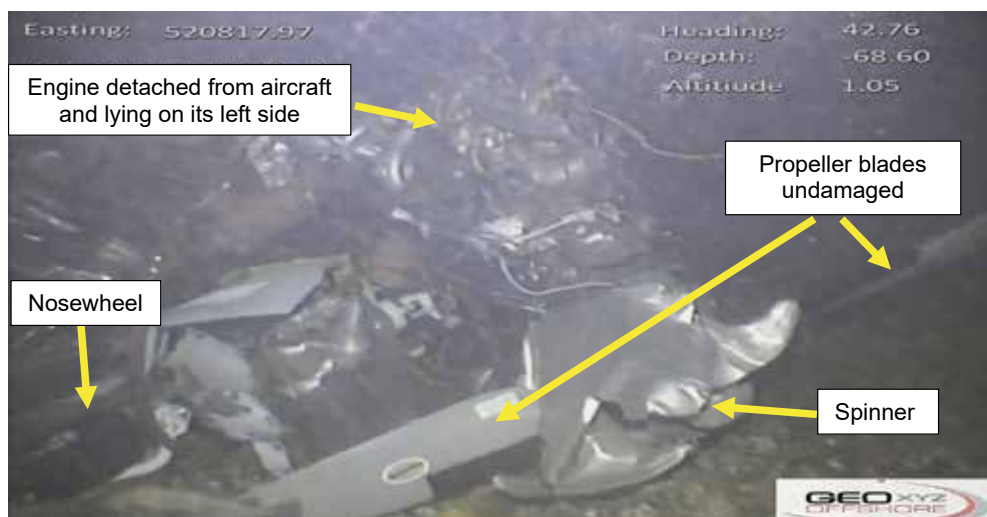
**Figure 20**

Apart from a slight rearward bend in one of the blades, the propeller blades were undamaged. The engine cowlings had detached and the engine and nosewheel had rotated 90° relative to the front of the cockpit. Several components had detached from the engine. The right tailpipe / heater shroud was still attached to the right turbocharger and video footage of part of the right tailpipe showed no evidence of scoring on the inside. There was no evidence of burnt oil residue on the inside of the exhaust. The induction, heating and ventilation pipes, and the engine baffles had been disrupted. The ignition harness was still connected to the engine.

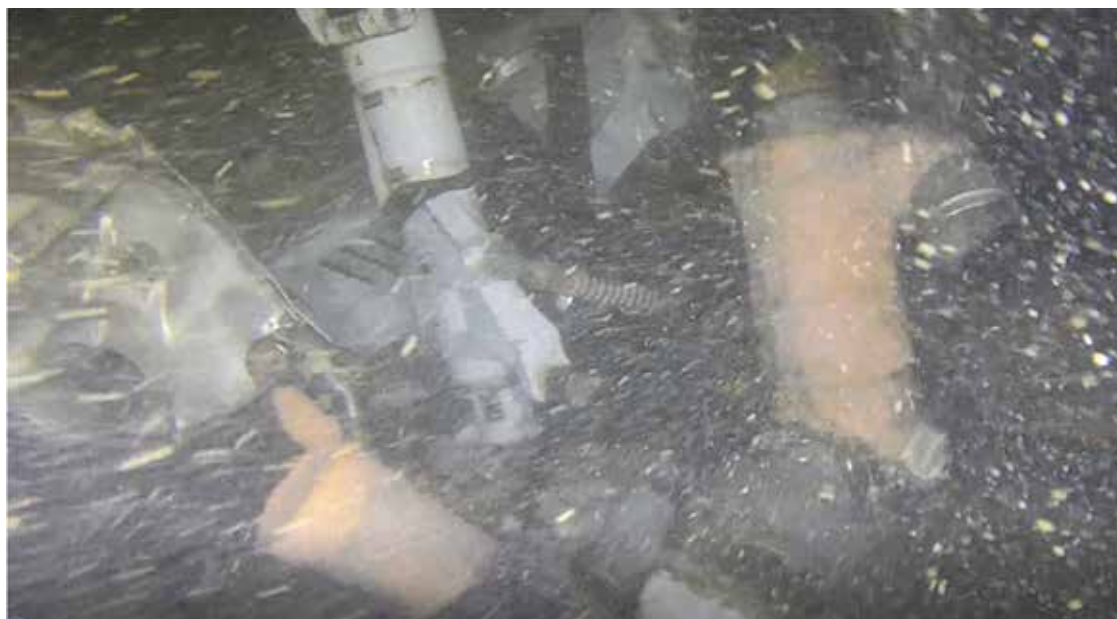
**Figure B-7**

Right tailpipe and heater muff / shroud  
(image taken from video provided by Blue Water Recoveries)

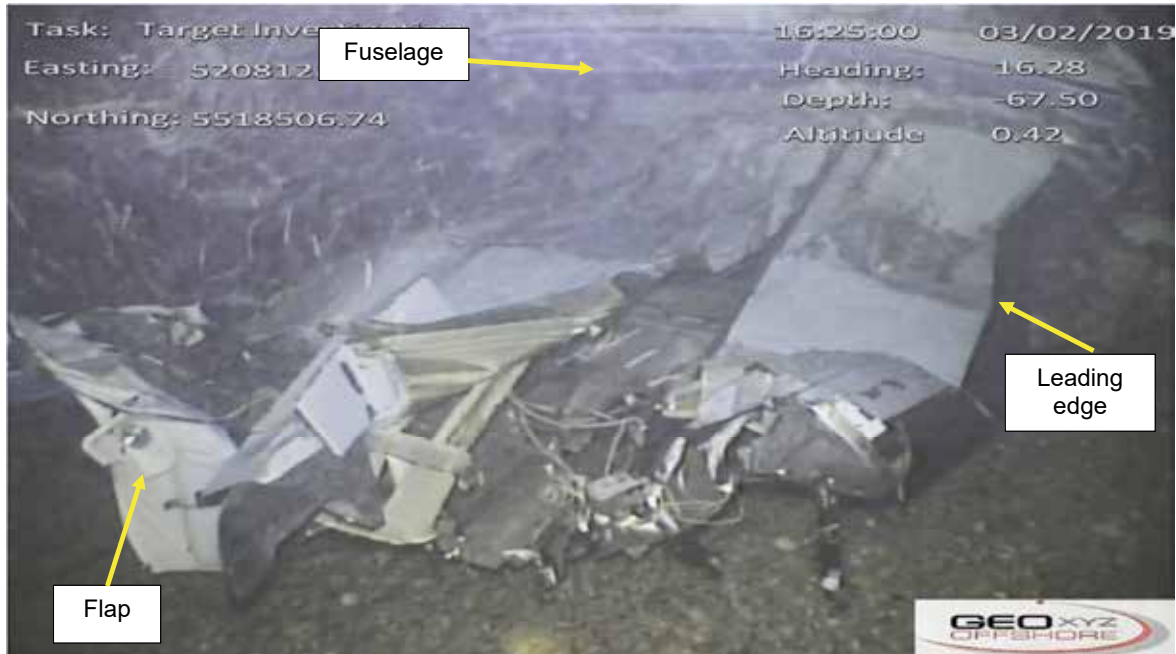
Figure B-8  
Remains of right wing

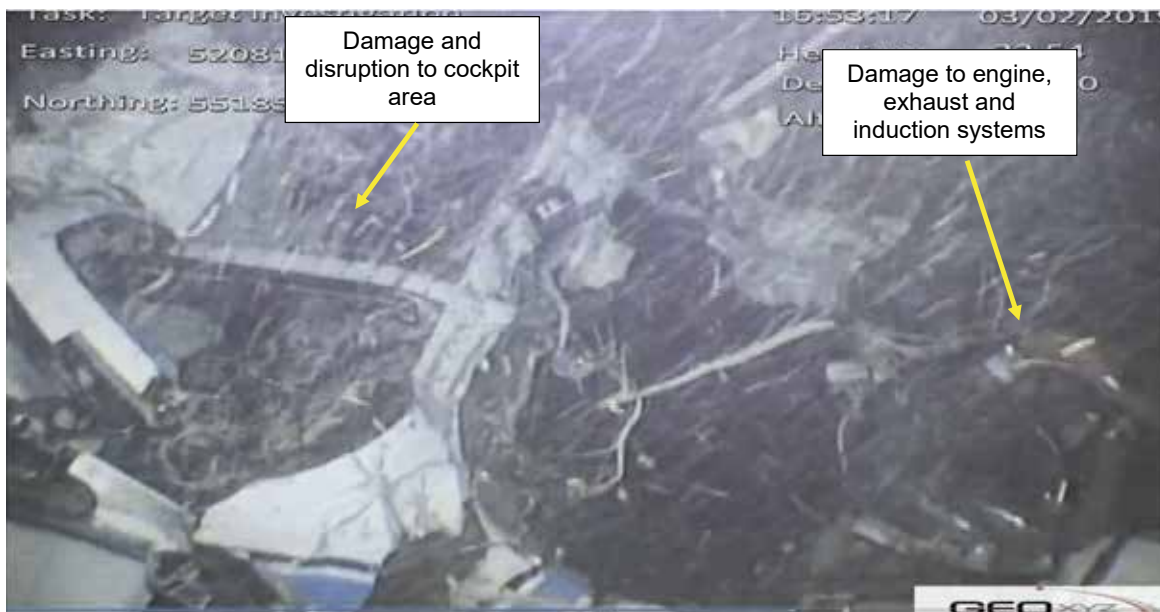
**Figure B-10**

Disruption to cockpit and engine

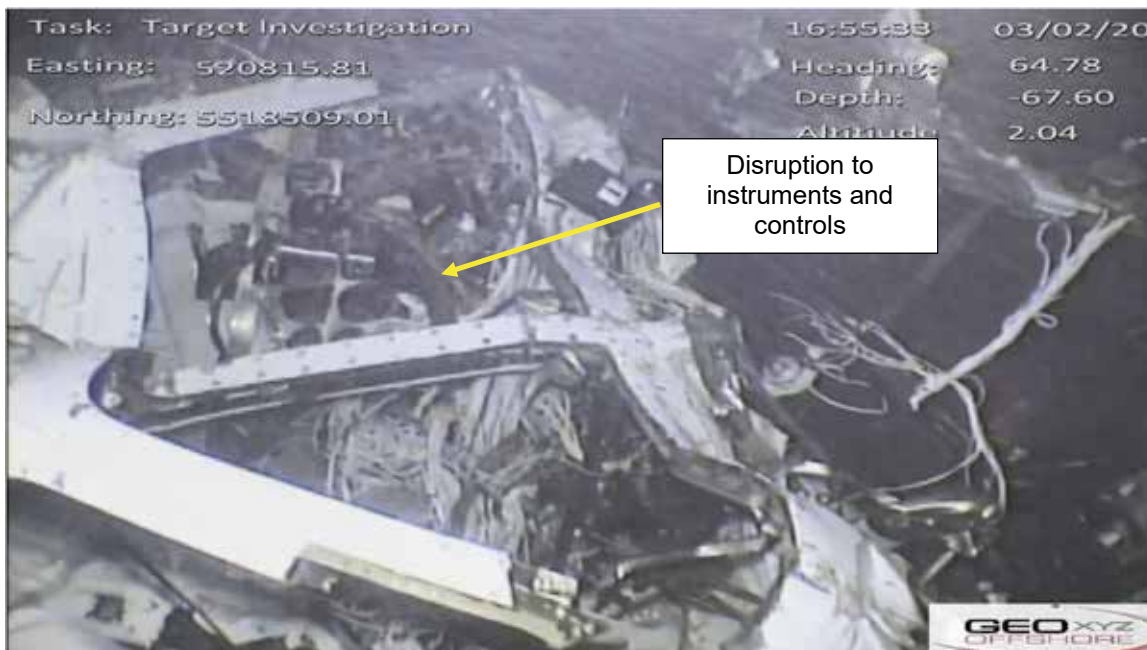
**Figure B-11**

Damage and disruption to instruments and controls

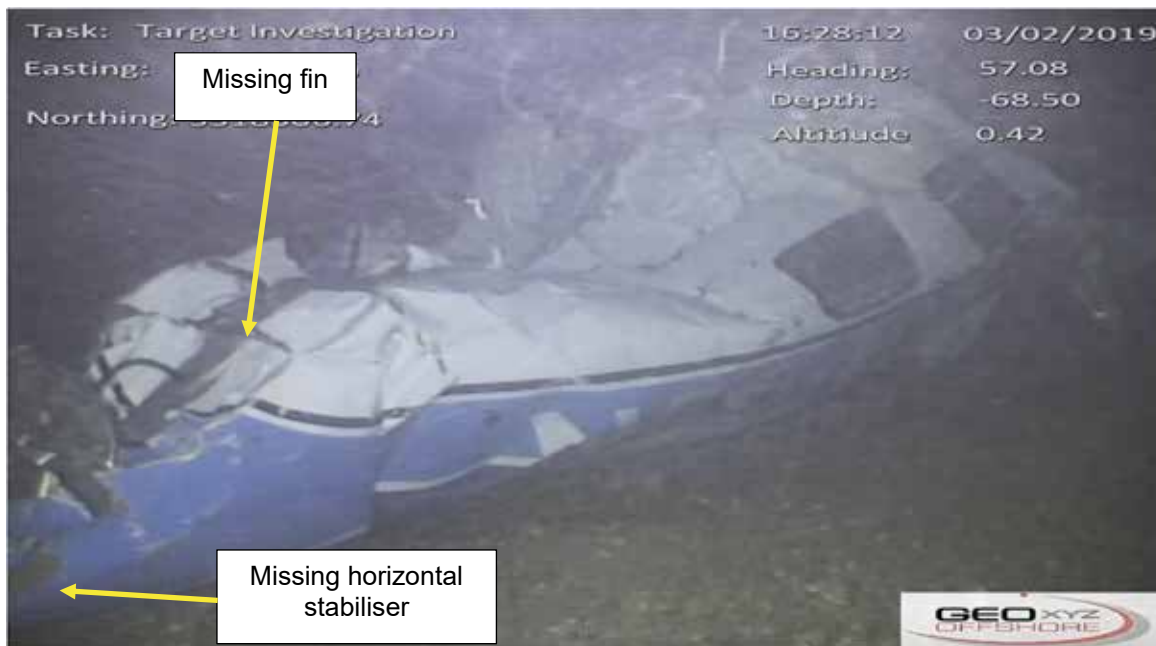
Figure B-12

Missing fin and horizontal stabiliser
