Report on the investigation of the collision between
the container vessel
ANL Wyong
and the gas carrier
King Arthur
in the approaches to Algeciras, Spain
on 4 August 2018

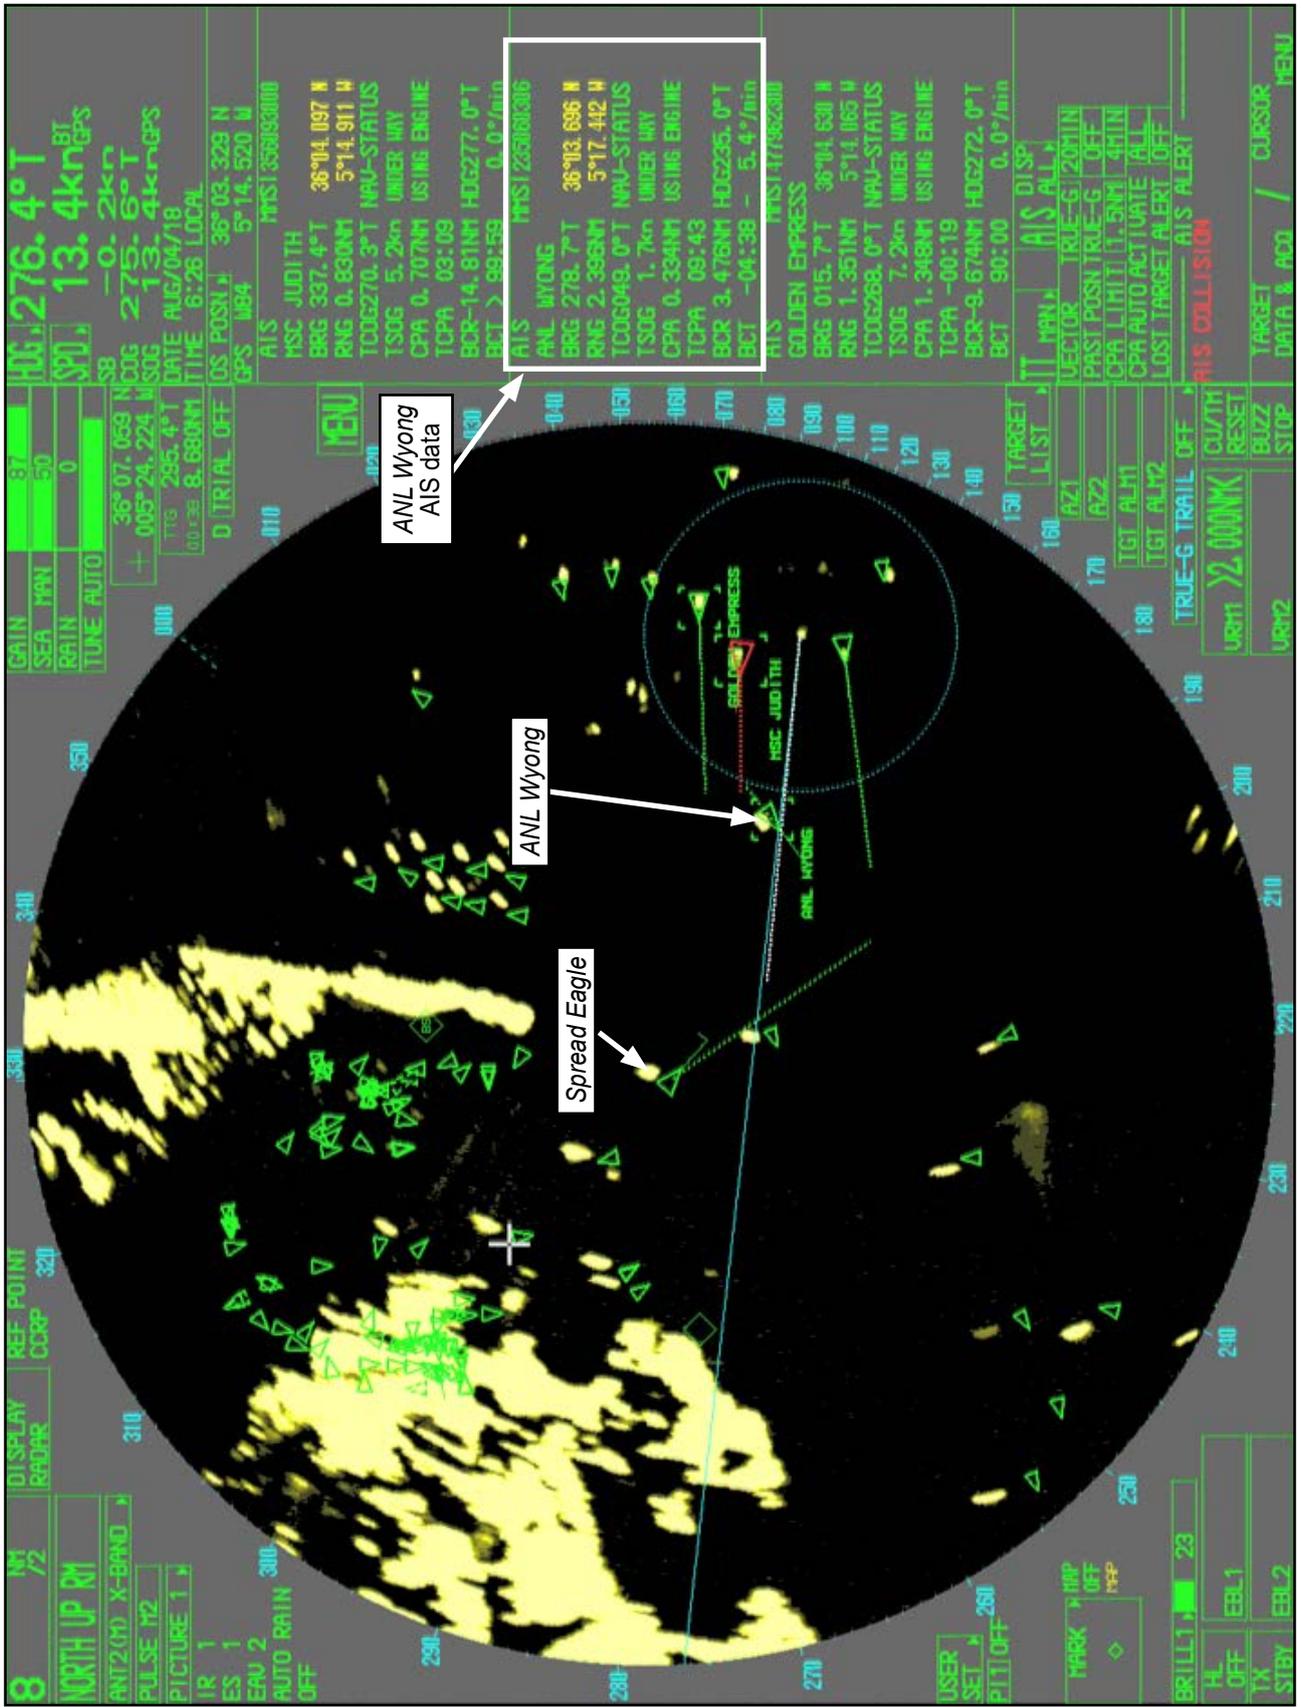
Having completed the turn to port, *King Arthur's* master observed a new radar contact about 2.4nm ahead (**Figure 8**). From automatic identification system (AIS) data, *King Arthur's* master established that the new contact was ANL Wyong and, from the orientation of the AIS symbol, that it was heading in a south-westerly direction. The master also observed from AIS information that ANL Wyong's navigational status was 'underway using engine'. At the same time, *King Arthur's* chief officer was monitoring the situation and had noted that ANL Wyong's predicted CPA was 0.3nm on *King Arthur's* starboard side.

Figure 8: King Arthur's starboard radar display at 0626, in use by the OOW, showing ANL Wyong ahead of King Arthur and AIS data selected in the target data section

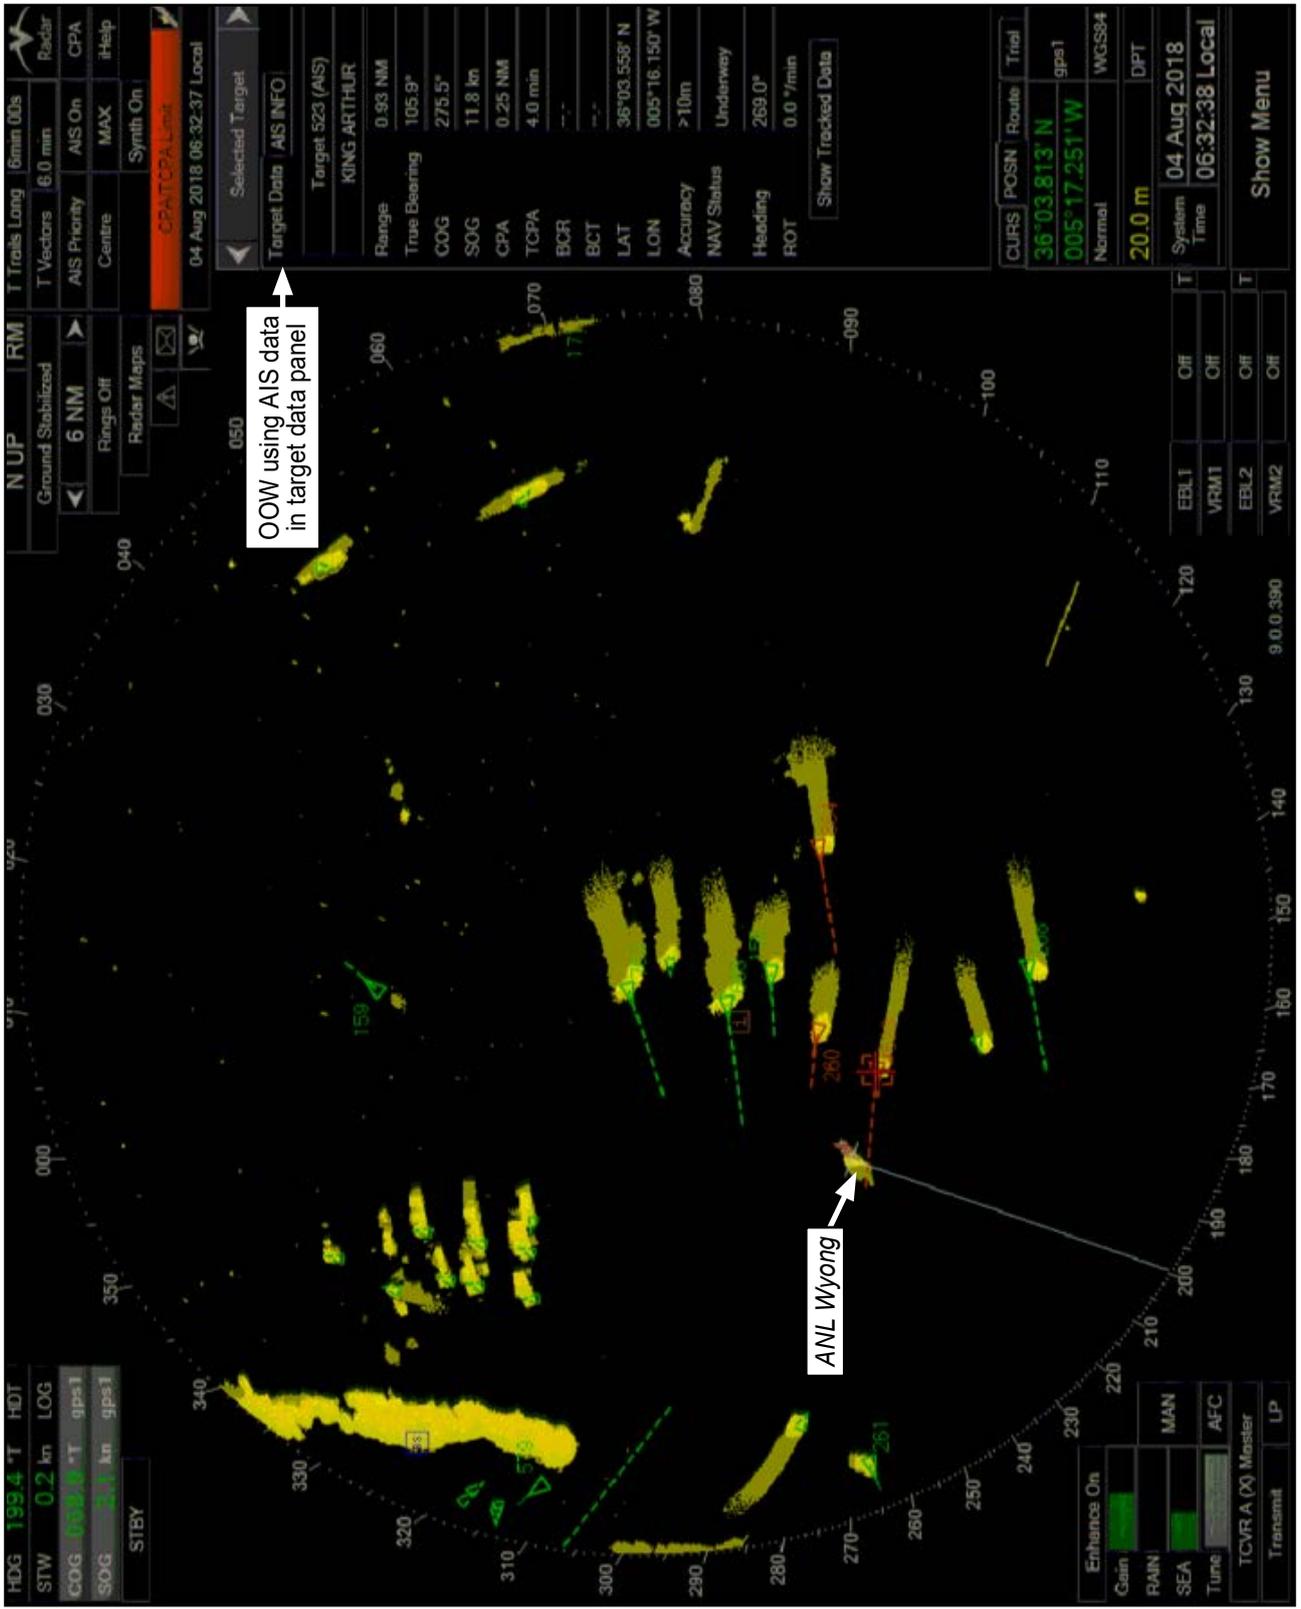
At 0632 ANL Wyong was stopped in the water on a heading of 197°; due to the north-easterly current, its course and speed over the ground (COG and SOG) was 060° at 2.2kts. ANL Wyong's OOW continued to monitor the situation and the radar display was still showing numerous contacts approaching from the east with three CPAs, including *King Arthur's*, below the alarm value and shown in red (**Figure 9**). By this time, the visibility was very poor in dense fog. Aware of the numerous vessels approaching on the port side and the poor visibility, ANL Wyong's OOW sent the deck cadet to the port bridge wing to keep lookout there.

Figure 9: ANL Wyong's starboard radar display at 0632 showing three contacts with CPA values below 0.4nm and AIS data selected in the target data section

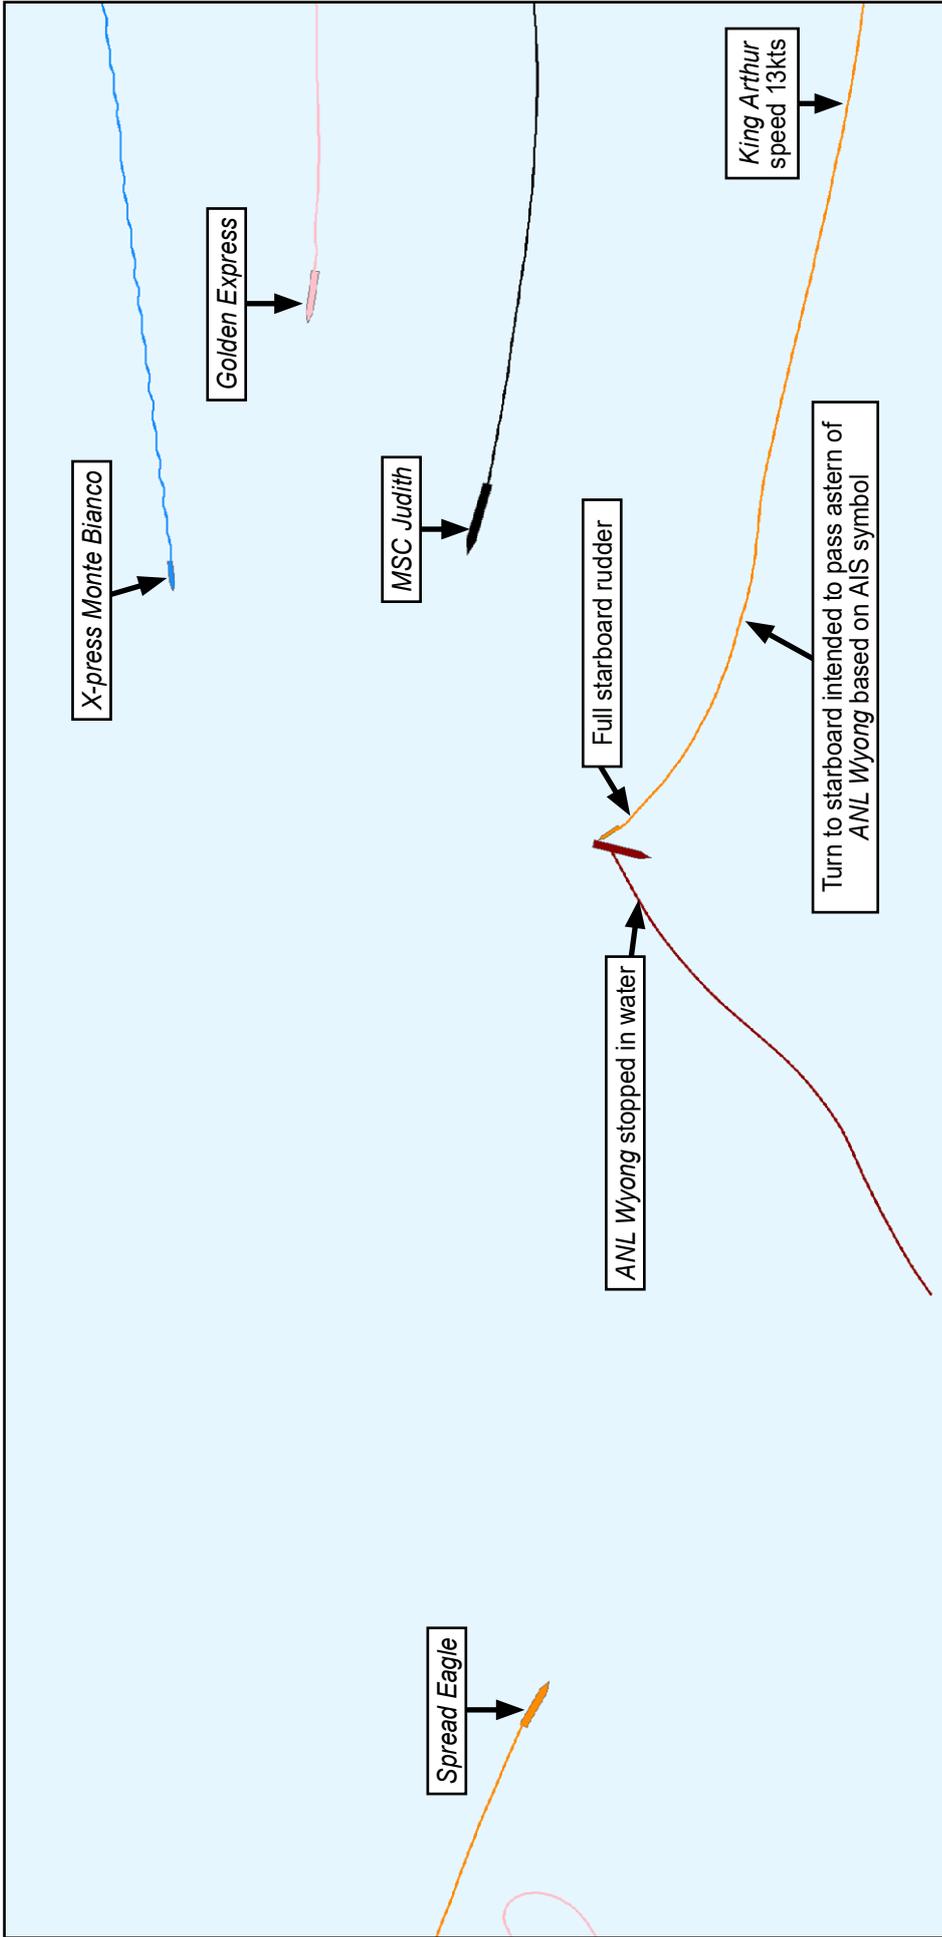
During the VHF radio conversation with *Spread Eagle* (**Table 3**), *King Arthur*'s master made an alteration of course to starboard (**Figure 10**) to a heading of 300° intending to avoid *ANL Wyong* by passing its stern. This course change was also intended to increase the CPA of *Spread Eagle*, which was approaching to port. Noticing that the CPA of *ANL Wyong* had not increased as expected, *King Arthur*'s master increased to full starboard rudder. At the same time, the OOW of *ANL Wyong* noticed that the CPA of *King Arthur* was reducing, so he used the VHF radio to attempt to establish communications with *King Arthur*.

Figure 10: Plot showing the tracks of ANL Wyong and King Arthur prior to collision

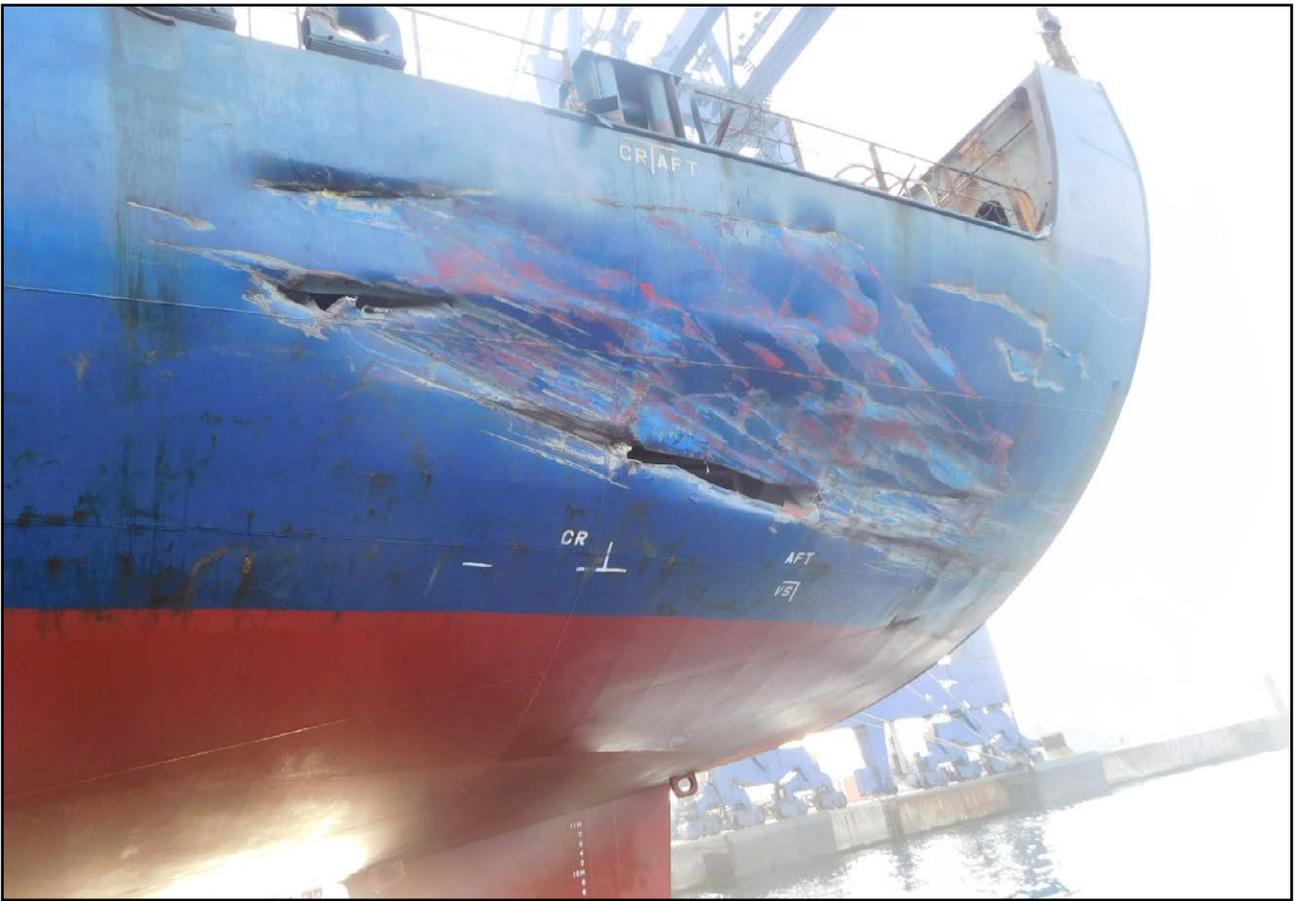
Both vessels were significantly damaged by the collision. An area of approximately 14 x 3 metres (m) on *ANL Wyong's* port quarter was dented, holed and scraped, with the hull penetrated in several places (**Figure 11**). The port side of *King Arthur's* bow flare was badly damaged (**Figure 12**).

Figure 11: Detail of damage to ANL Wyong's port quarter

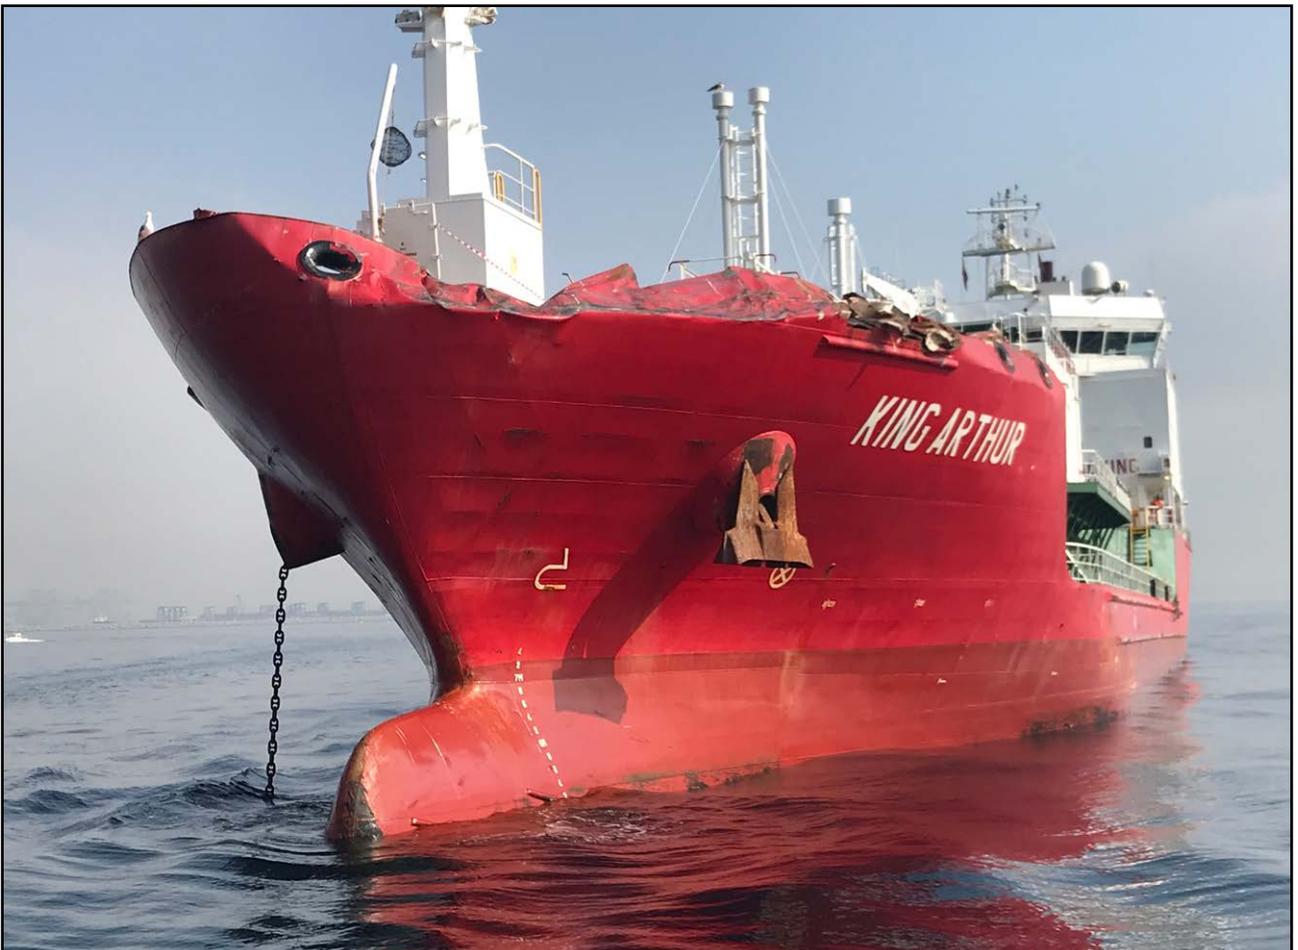
Figure 12: Detail of damage to King Arthur's port bow

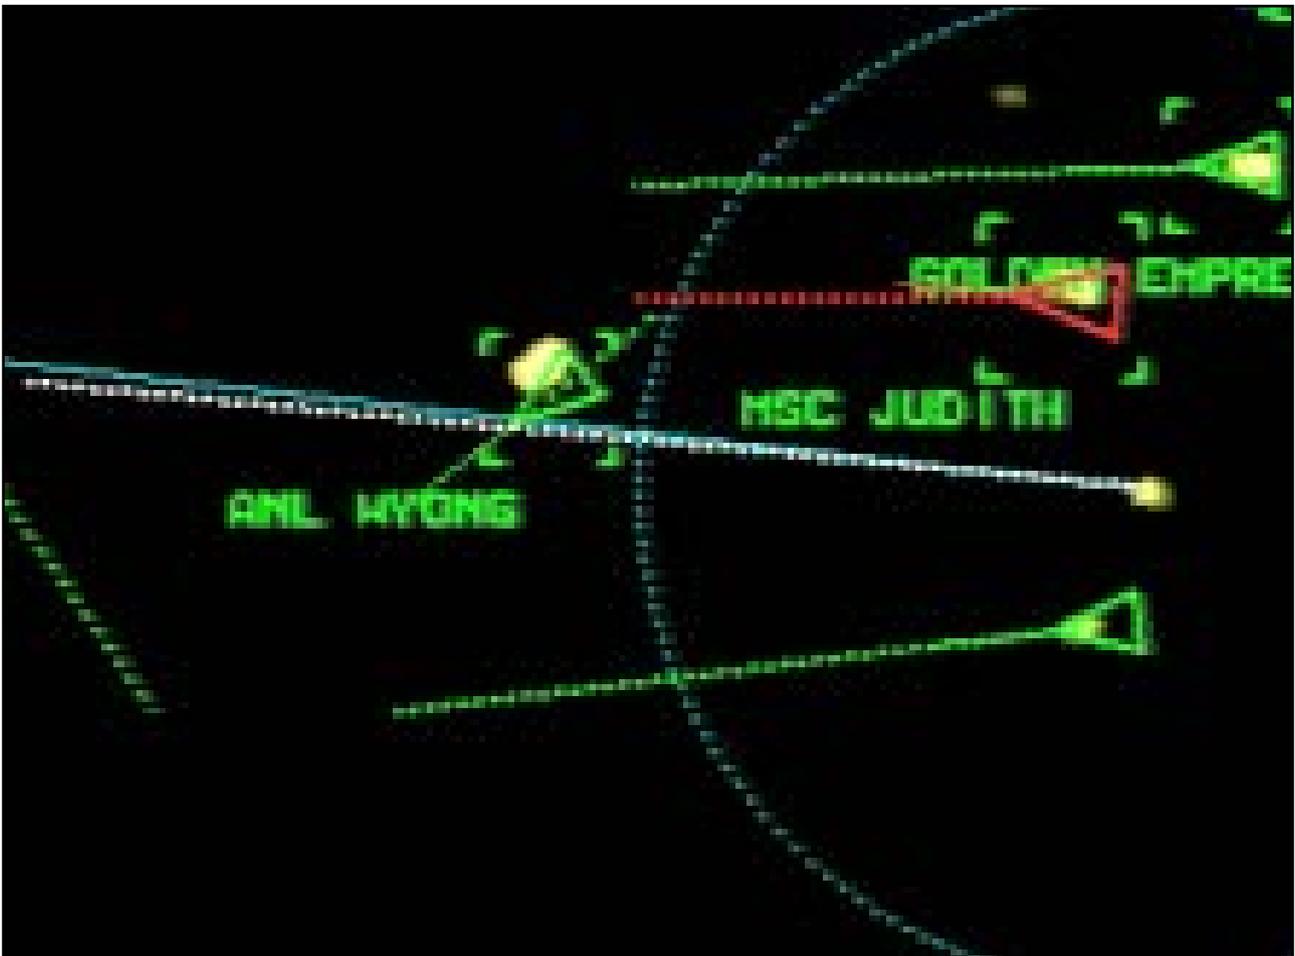
When *King Arthur*'s master analysed *ANL Wyong*, he assessed, from AIS data, that it was heading in a south-westerly direction (**Figure 17**) and was underway using its engine. Soon after, he became aware of the presence of *Spread Eagle* heading towards and expected to pass on the port side. Given this assessment, the master decided to alter course to starboard to increase the CPA on both these vessels and to avoid passing ahead of *ANL Wyong*. Had the master maintained his heading, *ANL Wyong* would have passed close to starboard [Section 1.2.1]; however, this alteration of course created a serious and immediate risk of collision. This happened primarily because, contrary to the master's assessment from AIS, *ANL Wyong* was actually stopped in the water and not making way on a south-westerly heading.

Figure 17: Detail from *King Arthur*'s starboard radar display showing the AIS symbol for *ANL Wyong* heading in a south-westerly direction

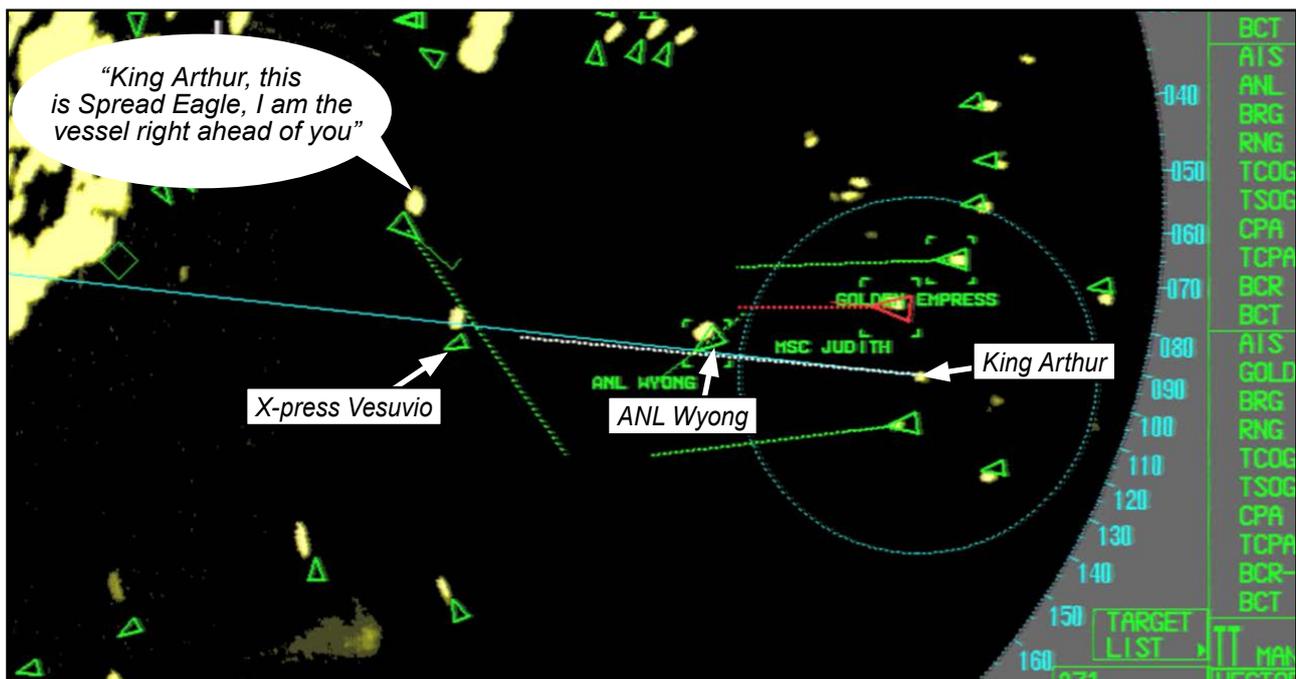
When *King Arthur's* chief officer responded to the VHF radio call from *Spread Eagle*, it was not immediately apparent to him which vessel / radar contact was calling. When asked by *King Arthur's* chief officer to clarify the situation by repeating the hailing vessel's name, *Spread Eagle* responded by describing itself as 'the vessel right ahead of you'. At that moment, *Spread Eagle* was one of three vessels that could be described as 'ahead' of *King Arthur* (**Figure 18**).

Figure 18: Detail of *King Arthur's* radar when called by *Spread Eagle* showing that there were three vessels that could be assessed as 'ahead' of *King Arthur*
